# Analysis of Behaviour of Prefabricated Staircases with One-Sided Suspended Stairs

## Analiza ponašanja montažnih konzolnih stubišta

Professional paper • Stručni rad

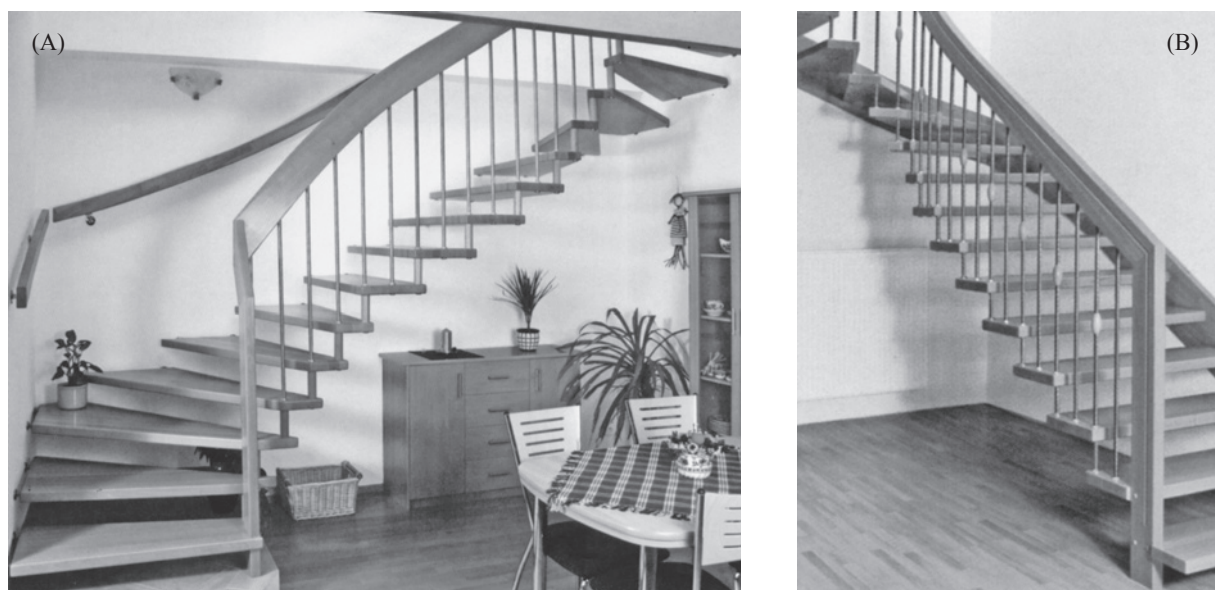
Figure 1 Prefabricated staircase with one-sided suspended stairs (Jema Svitavy a.s., 2006)

A prefabricated staircase with one-sided suspended stairs (Fig. 1) consists of stairs without risers, which leads to a lighter construction.

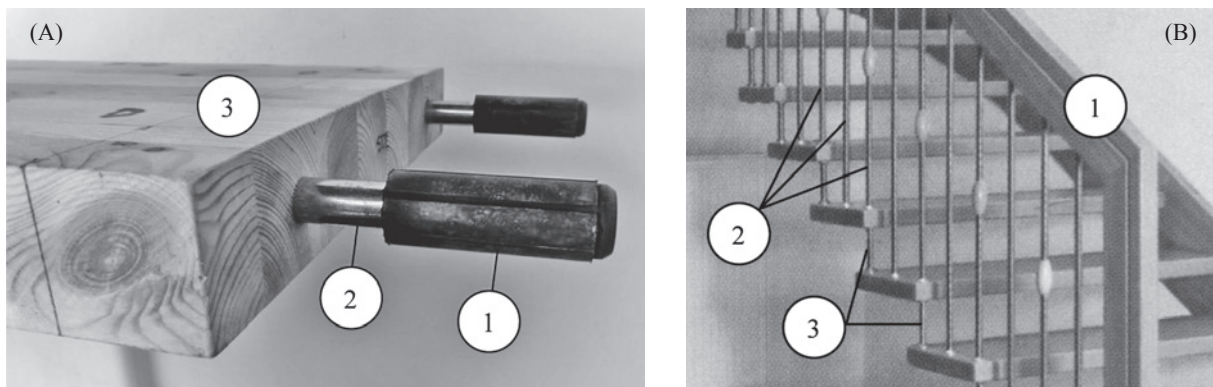
**Figure 2** Details of the wooden prefabricated staircase: (A) Detail at the side of the wall (1 – rubber cases, 2 – steel bars, 3 – stair); (B) Detail at the side of the massive handrail (1 – massive handrail, 2 – system of bars, 3 – distance elements) (Jema Svitavy a.s., 2006)

The stairs at the side of the wall are usually anchored in the bearing wall with the use of 2 steel bars and partly anchored in the staircase bolt. In order to eliminate footfall sound spreading into bearing walls, the bars are put in rubber cases in the wall. A part from this type of mounting, the mounting used in the design of the staircase prototype can be used as well. At the outer side, the stairs are suspended with the system of bars anchored in a massive handrail. The height position of stairs is delineated with the use of distance elements, which are placed in between stairs on a stair edge. The details of the wooden prefabricated staircase are shown in Fig. 2.

At the outer side, the stairs were suspended with the use of a system of steel bars (24 pieces) of profile of  $\varnothing 12/2$  mm to the bearing massive handrail, which is taken along the outer side of the whole staircase. Each stair was suspended on three bars (Fig. 1) and (Fig. 2) and was connected with the previous and the following stair with the use of wood distance elements (Fig. 1a). At the wall side, the stairs were placed with the use of 2 steel bars  $\varnothing 16$  mm that were embedded in the bearing wall through rubber cases (Fig. 2a).

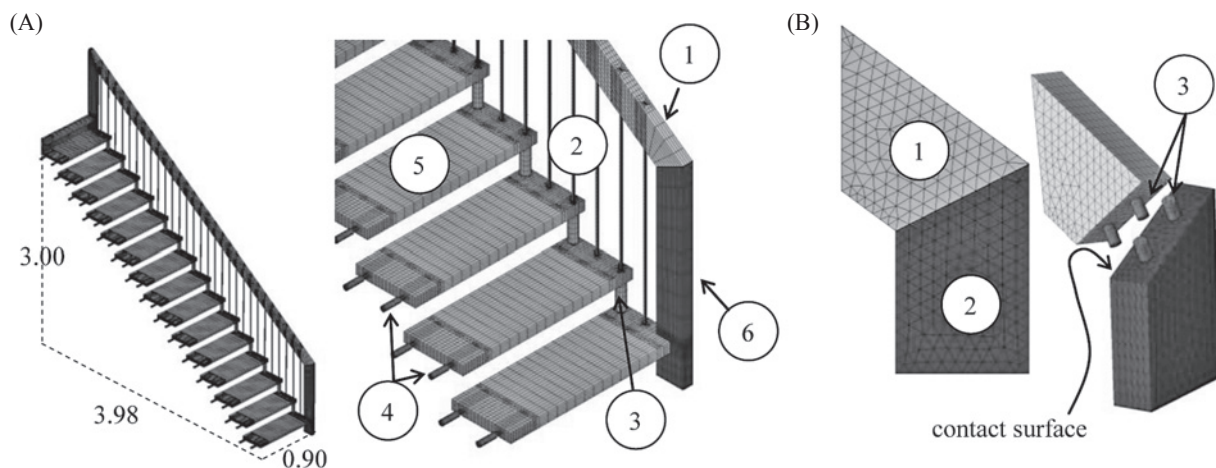
**Figure 3** 3D analysis model (A): 3D analysis model and its detail; dimension in m; (1 – massive handrail, 2 – system of bars, 3 – distance elements, 4 – rubber cases, 5 – stair, 6 – bottom newel) (B): Partial analysis models of massive handrail and bottom newel connections (1 – massive handrail, 2 – bottom newel, 3 – connection pin) with contact surface between 1, 2 and 3  
**Slika 3.** 3D model analyze (A): 3D model analyze s detaljima (dimenzije u m) (1 - masivni rukohvat, 2 – sustav šipki, 3 – elementi kojima se određuje udaljenost stuba, 4 – gumeni dijelovi, 5 – stuba, 6 – donja ograda); (B) modeli djelomične analize spoja masivnog rukohvata i donje ograde (1 – masivni rukohvat, 2 – donja ograda, 3 – spoj između rukohvata i donje ograde) s kontaktnom površinom između 1, 2 i 3

A 3D analysis model, where a fixed connection of all construction parts was assumed, was developed with the use of finite elements type of SOLID45, SOLID92, SOLID95 and SURF154 (ANSYS, 2012b). 3D models (Fig. 3) were developed for stairs, rubber cases, connecting screws, screw washers, bars, distance elements, handrail, and top and bottom newels.

Partial analysis models of massive handrail and bottom newel connections (Fig. 3b) using submodelling methods (ANSYS, 2012c) were developed with the use of finite elements of the type of SOLID92 (ANSYS, 2012b). The real glued connection between the handrail and newels was considered for these models. The connections were modelled with contact elements TARGE170 and CONTA174 (ANSYS, 2012b). In this case, the contact elements allowed the contact to

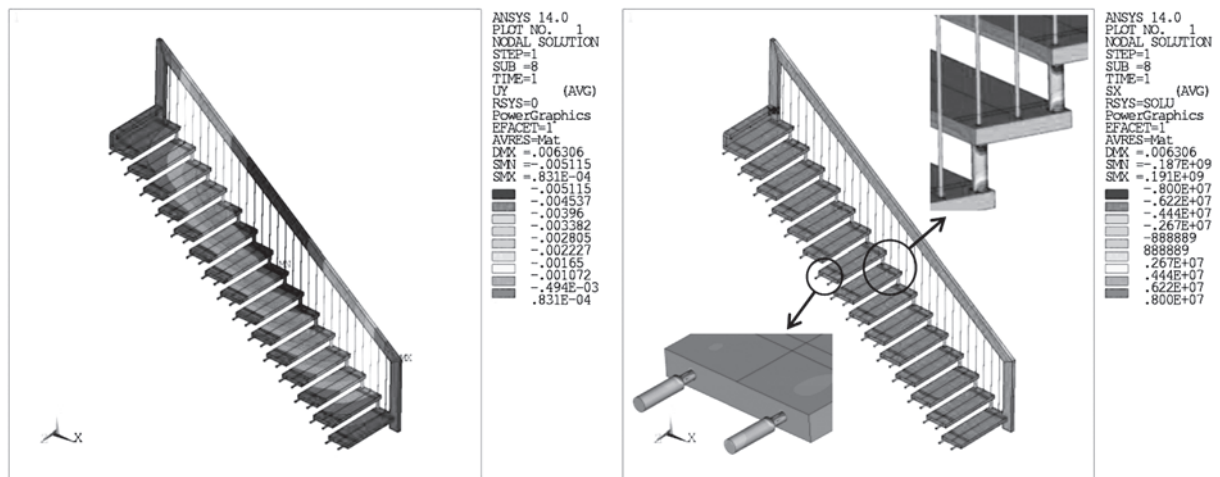
**Figure 4** 3D analysis model – results for uniformly loaded staircase in intensity of uniform serviceability load  $V = 3.0 \text{ kN/m}^2$  and self-weight (A): Vertical displacement  $U_v$  (m) (B): Normal stress in the direction of grains (Pa) in the interval  $\{-8; +8\}$  MPa; examples of “critical” places

staircase in intensity of uniform serviceability load  $V = 3.0 \text{ kN/m}^2$  (ČSN EN 1995-1-1, 2004) and self-weight is shown in Fig. 4. The average values of normal stress and principal stress in individual wooden construction parts of the staircase were in the range of the interval of the wood strength. The stress was distributed uniformly in the majority of construction parts of the staircase. Using interactive failure criteria Hoffman’s criterion (Hoffman, 1967; Berthelot, 1998; Galicky and Czech, 2013) and Tsai-Wu criterion (Tsai and Wu, 1971; Danielsson and Gustafsson, 2013; Galicky and Czech, 2013) “critical” places of the staircase structure were identified (places of the contact of distance elements with stairs, at places of laying stairs on steel bars, at places of the suspension of stairs with the use of steel bars, and at places of the handrail contact with the top, or bottom, newel).

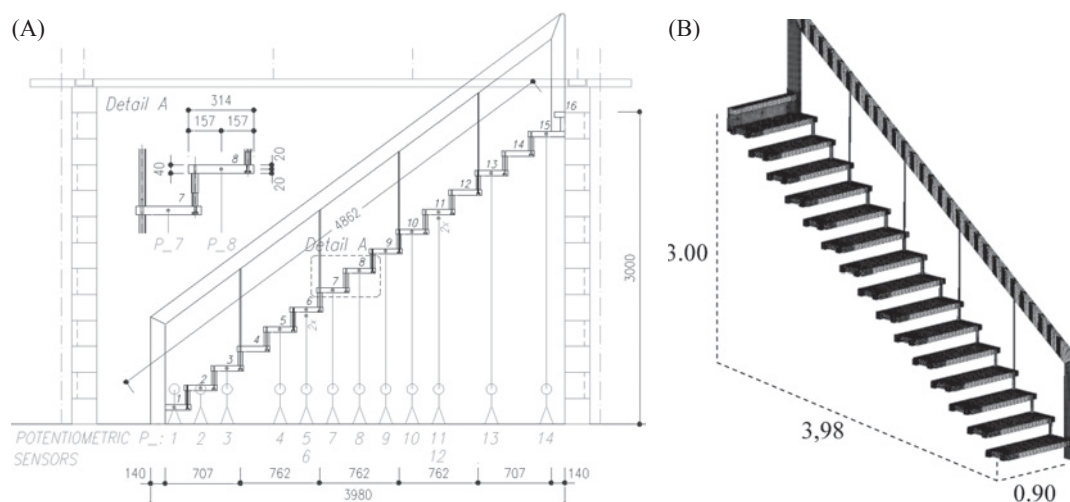
**Figure 5** Prototype of a wooden straight prefabricated staircase: (A) Dimensions and measuring points with potentiometric sensors of the type MS04; (B) 3D analysis model

centration of stress at places of these details. The designed changes were numerically reanalysed. After their numerical verification, they were integrated in the prototype design of the prefabricated staircase with one-sided suspended stairs (Fig. 5).

During the static loading tests, the values of vertical displacements at the stair faces at the selected 12 stairs (Fig. 5a) were continuously recorded with the MS04 with the accuracy of 0.05 mm and the measurement units HBM SPIDER 8 (2006). The measuring points were located in the middle of the width and thickness of the stairs. Two stairs No. 6 and 11 were also equipped with potentiometric trajectory sensors (Fig. 5a) in order to monitor vertical displacements at the bearing wall. The position of the measuring points was selected at the lower side of the stairs in the middle of the stairs 30 mm of the edge.

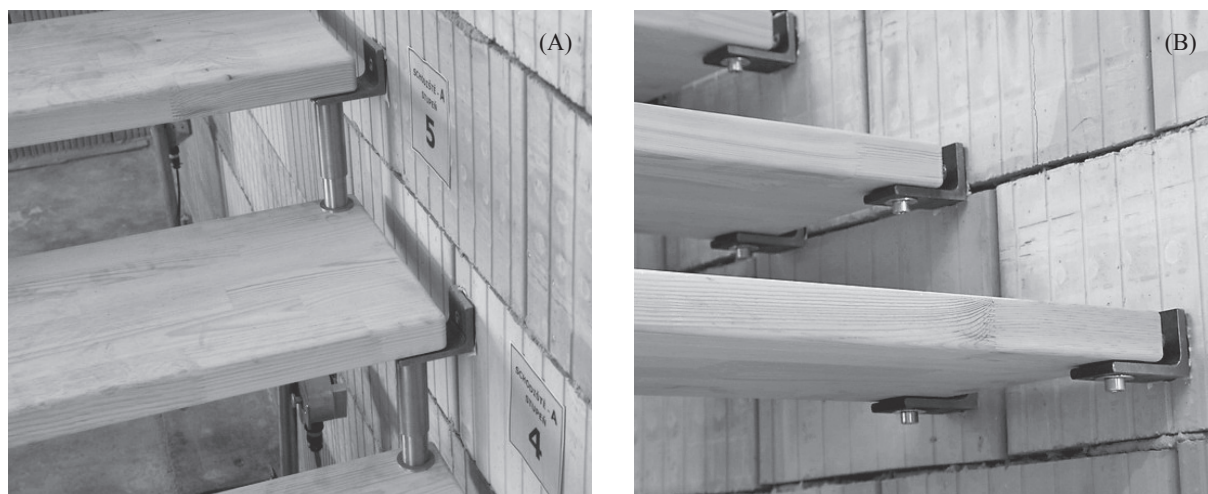
**Figure 6** Different ways of fixing the stairs into the bearing wall: (A) Version A (the stairs supported by a steel profile and by a distance element); (B) Version B (the stairs supported by two steel profiles)

The two versions of the prototype of a wood straight prefabricated staircase differed in the way the stairs were fixed into the bearing wall. In the first version marked A, the stairs were supported at the entry edge by a steel profile L 80 × 60 × 8 mm and at the exit edge by a distance element made of stainless steel (Fig. 6a) without being fixed to the bearing wall. In the other version marked B, the stairs were supported at the entry and exit edge by a steel profile L 80 × 60 × 8 mm (Fig. 6b).

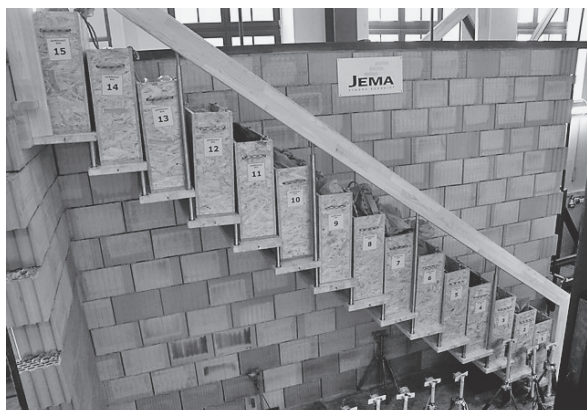
**Figure 7** Prototypes of the staircase in version A during static load test - staircase loaded with uniform serviceability load ( $V = 3.0 \text{ kN/m}^2$ ) increased by the 0.3 multiple  
**Slika 7.** Prototip stubišta verzije A tijekom testa statičkog opterećenja – stubište je opterećeno ravnomjernim opterećenjem  $V = 3,0 \text{ kN/m}^2$  uvećanim za 0,3 puta

The staircase A was loaded in compliance with Czech design standard ČSN 73 2030 (1994) in two steps. In the first step, the staircase was loaded with uniform serviceability load ( $V = 3.0 \text{ kN/m}^2$ ), which was increased in the second step by the 0.3 multiple of the uniform serviceability load (Fig. 7). Under the effects of the increased load (1.3 multiple of uniform serviceability load), an extreme value of vertical displacement of 20.66 mm occurred at the stair No. 8, which is lower than the limit value according to (ETAG 008/2002, 2002; ČSN EN 1995-1-1, 2006) amounting to 29.797 mm ( $(1/200) \times L_s / \cos \alpha$ ;  $L_s = 4.862 \text{ m}$  (Fig. 5b);  $\alpha = 35.3281^\circ$ ) (Table 2). The course of vertical displacements measured under gradual loading allows to clearly identify the course of loading and the moments, when the glued contact of the top (or bottom)

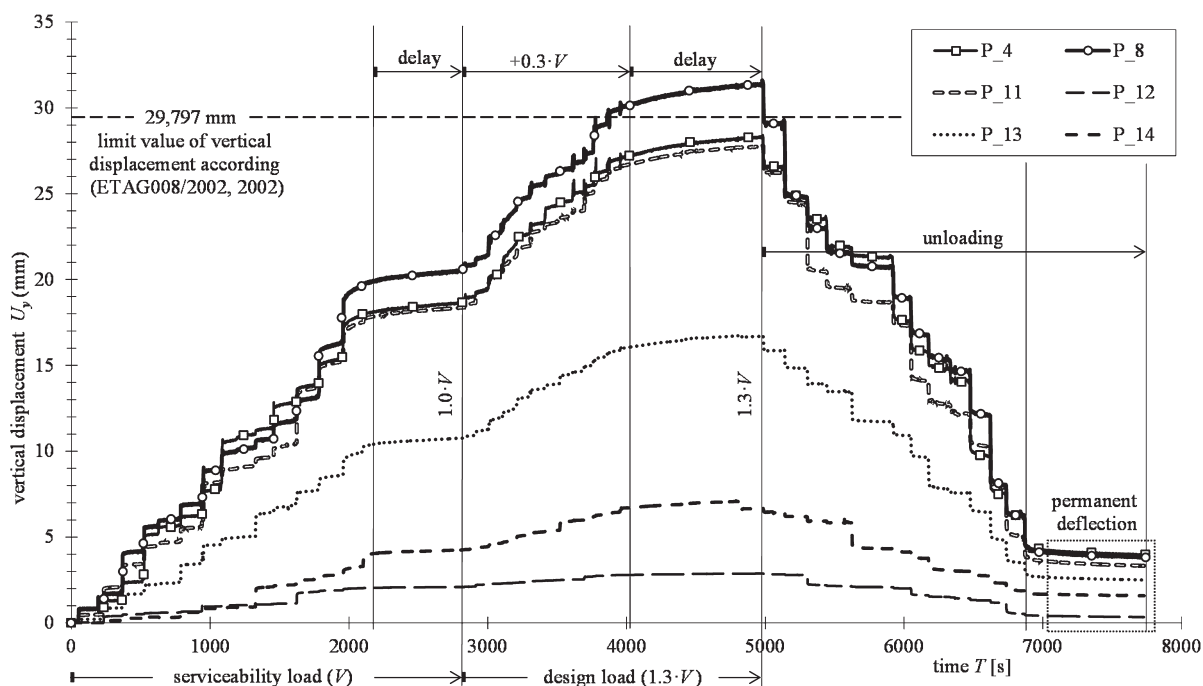
**Figure 8** Time record of vertical displacement  $U_y$  (mm) of the static load test of the staircase A; numbers of potentiometric sensors of the type MS04 according to Fig. 5

newel with the handrail was broken and opened. The values of vertical displacements in individual load steps are shown in Table 3. The graphical time record of vertical displacement of the static load test of the staircase A is shown in Fig. 8.

When relieving the load, there is a structure response and after the complete unloading, permanent irreversible deformations (notation PD in Table 3) appear amounting to 1.3 multiple of the uniform serviceability load of approx. 13.7 %. Under the loading, breaking occurred as well as partial opening of the glued contact of the top (or bottom) newel with the handrail, while the screw contact showed no faults and the joint between the top and bottom newel and stairs was slightly opened and a distance element was partially displaced from the bottom washer. Some anchoring screws from the bearing wall were slightly pulled out at some stairs, which was manifested by the turning of the steel  $L 80 \times 60 \times 8$  profile. After the load relief of the staircase A, the partially opened glued contact of the bottom and top newel, respectively, with the handrail was closed up.

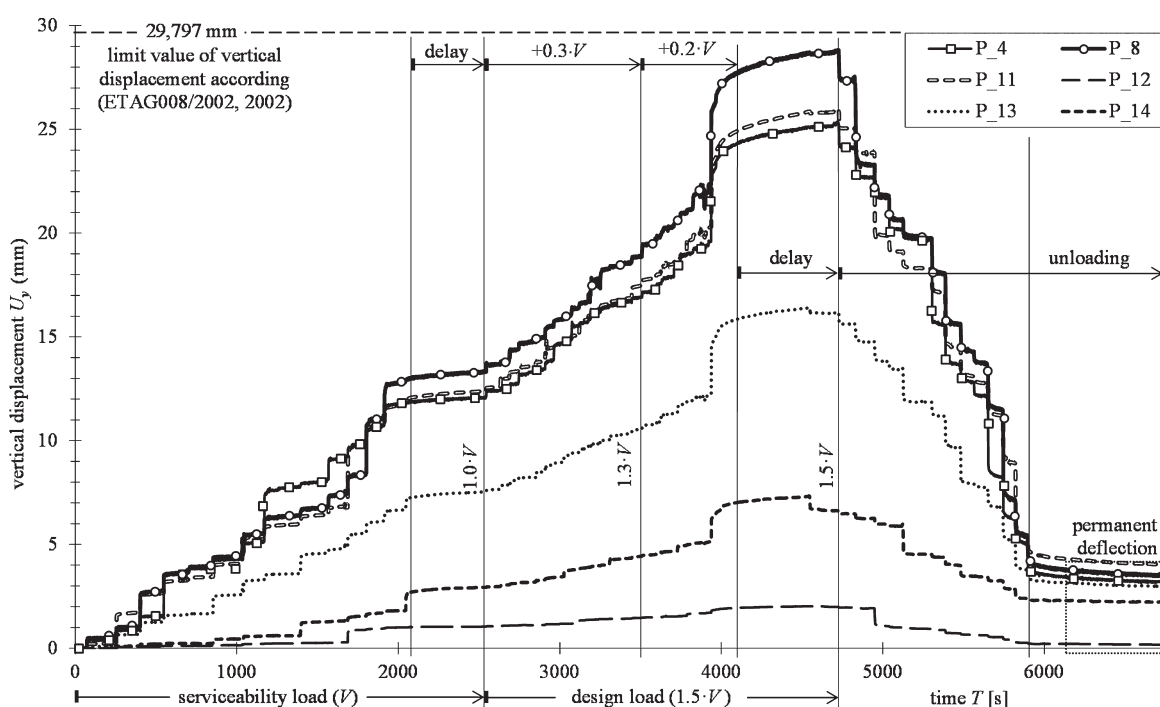
**Figure 9** Time record of vertical displacement  $U_y$  (mm) of the static load test of the staircase B; numbers of potentiometric sensors of the type MS04 according to Fig. 5

multiple and in the third step by 0.2 multiple of the uniform serviceability load. Under the effects of the increased load (1.5 multiple of uniform serviceability load), an extreme value of vertical displacement of 13.48 mm occurred at the stair No. 8, which is lower than the limit value according to (ETAG 008/2002, 2002; ČSN EN 1995-1-1, 2006) amounting to 29.797 mm (Table 2). The second part of the graph (Fig. 9) shows a noticeably sharp rise of vertical displacements caused by the broken contact of the bottom newel with the handrail. The

When relieving the load, there is again a noticeable structure response and after the complete load relief, permanent deformations (PD in Table 3) appear amounting to 1.5 multiple of the uniform serviceability load of approx. 12.8 %. Similarly to the situation with staircase A, breaking and partial opening of the glued contact of the top newel with the handrail occurred under this load. In addition, a partial split of the handrail
