UDK 528.02:551.242:624.074.1
Izvorni znanstveni članak / Original scientific paper

Recent Structural Set and Load Test of Simply Supported Pernica Bridge

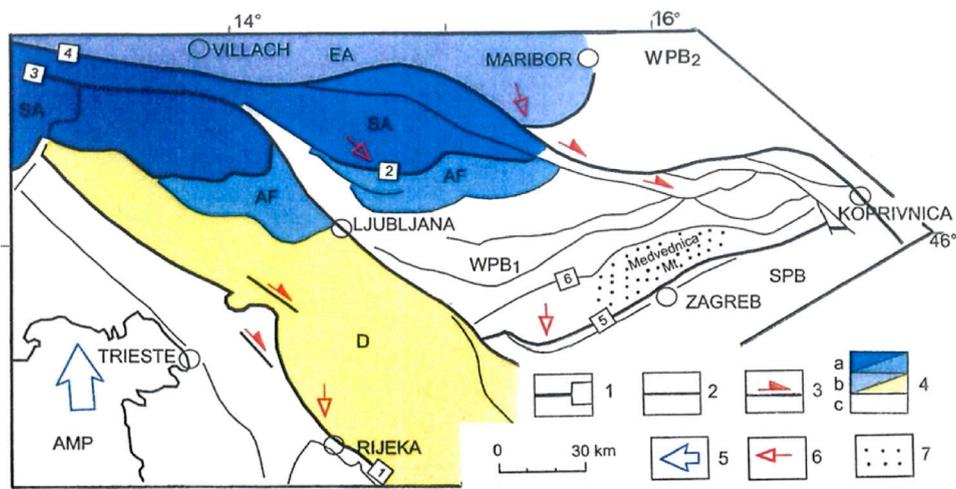
Fig. 1. Regional geologic structural relations (Pribičević et al. 2007).

The first notable regional structural set (Fig. 1) is highlighted in the recent tectonic activity review. These regional structural units are present in Slovenia: Southern Alps (marked as SA) and Prealps (AF), Eastern Alps (EA), Dinarides (D), Adriatic microplate (AMP) and the western part of the Pannonian Basin, which includes the Sava fold (WPB1) and the Slovenian hills (WPB2). In these boundaries important structural set faults are extended: faults Gorica – Illyrian Bistrica – River (1), the fault of the Southern Alps (2 – eastern part known as the Sava fault), fault Fella – Save! – Sheffield (3), Periadriatic – Drava fault (4) and Zagreb fault (5). Initial tectonic movements that cause the structural set are shifts of the Adriatic microplate. They condition the extreme compression in the Southern Alps and northern Dinarides. Consequently, reversing structure and transcurrent right shifts of the Alps and Prealps units arises. The rotation of individual units results in shifts. The western boundary part of the Pannonian Basin is located partly in the wedged position between the Alps and the Dinarides. The result is transpression space. This means that tectonic movements conditioned the space compression with a general right tectonic transport.

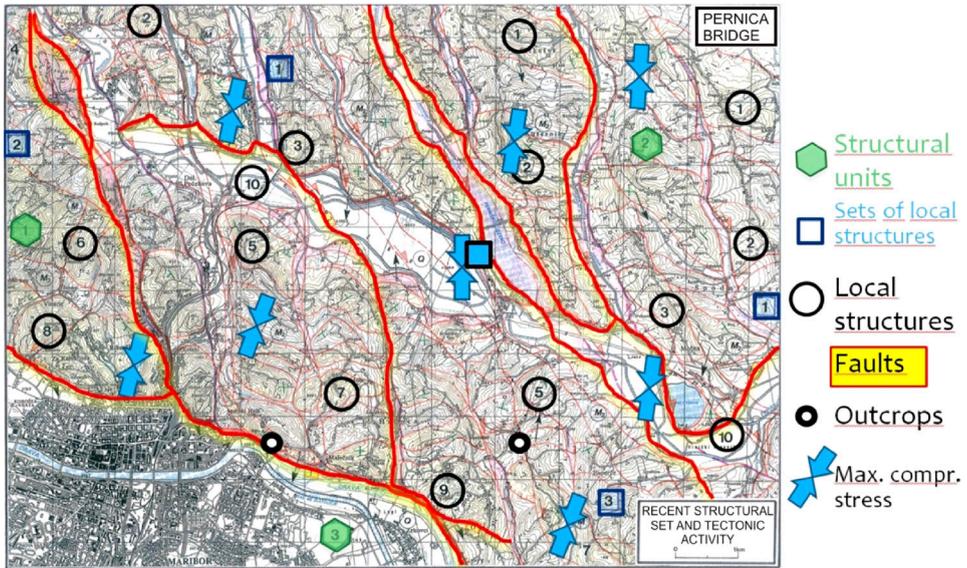
Fig. 2. Structures and faults in the relief for Pernica bridge.

The collected structural and geological data indicate that the structural set of the Slovenske Gorice (2) consists of a series of local reverse structures along which the reverse faults of the opposite vergence are spreading (Fig. 2). The existence of a reverse structures and faults are indicating dominant compression of this recent structural set. Structures are extensively intersected by faults in the NNW–SSE direction. One can identify the gaps and displacements of individual structures along the stretch. Some local structures stand out as the rising hills. A reverse faults of the opposite vergence are stretched between the raised portions of the relief along the steep slopes. In the relief, faults of the NNW – SSE direction (extending as deeply cut valleys mostly in straight-lines) are particularly noticeable. It should be noted that (due to the provision and position of the reverse structure) in Slovenske gorice (2) two relatively large series of a locally raised reverse structure stand out: Gradiška – Pernica lake – Partinje (1) and Košaki – Celestina – Vaniška vas (3). In both series there are three more prominent local reversing structures. Between the specified series in Pesnica valley, a relatively big suspended structure is recognizable. It is wedged between the reverse faults of the opposite vergence. Also the set Slemen – Pošpeh – Ribniško Selo (2) and two larger local reversing structures stand up in the part of Kozjak.

The bridge is located in the outskirts of the local reverse structure of Pesnica – Pernica lake – Spodnje Partinje (3). Pernica fault zone (7) stretches through Pernica lake. Faults from the zone are normal around the lake. Right shifts of the local structures can be noticed. There are main branches of the aforementioned faults across the bridge. Right horizontal component of the wing movement are also prevalent along these faults. Between the bridge and Pernica village the fault Pesnica – Pernica lake – Močna (4) is shifted about 600 m to its right (Fig. 2).

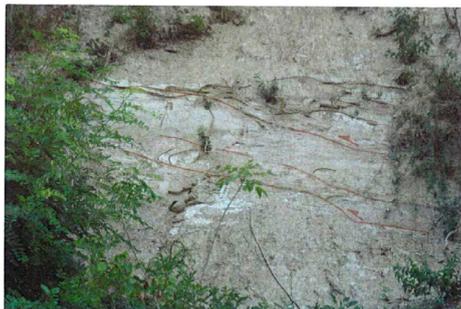
Fig. 3. T1 – at road Maribor – Malečnik: Šentilj – Maribor – Malečnik – Trčova (1) fault.

The most important in the discussed structural part is the Šentilj – Maribor – Malečnik – (1) fault. This is the zone with the width of 100–600 m between the

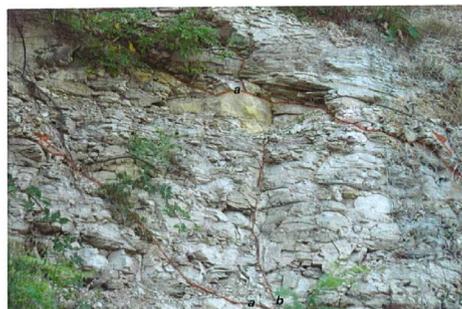
Fig. 4. T1 – layers of marl: a) two parallel faults, b) fault in the zone.

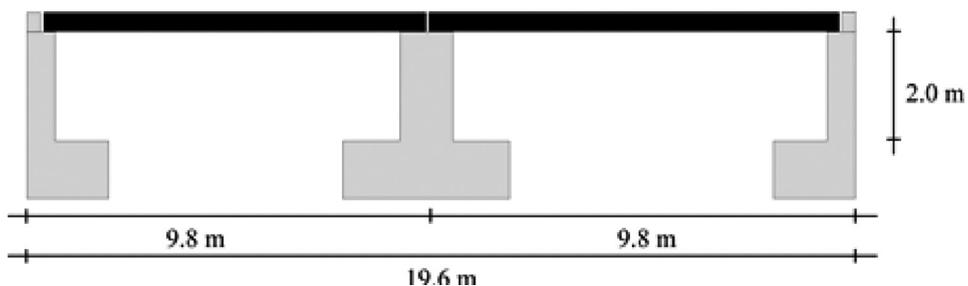
Fig. 5. Pernica bridge – the sketch.

As a real model for simply supported structure, the old bridge over the Pesnica River in Pernica near Maribor was chosen (Fig. 5). The bridge was built in 1968 and renovated in 1992. It is therefore a senior facility through which there is no longer traffic, as the result of the new highway Maribor – Murska Sobota in the vicinity. Unfortunately, a newer bridge was not found, because at that time the technology of bridge structure building made great breakthroughs and simply supported constructions are almost not constructed any more.

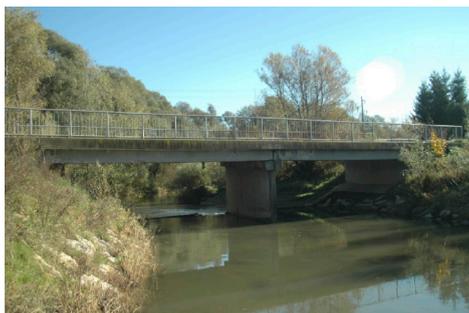
Fig. 6. *Pernica bridge across the Pesnica river.* Fig. 7. *Beam as a supporting structure.*

The bridge is 19.6 m long, 7 m wide and 2 m high. It is reinforced concrete bridge with two simply supported spans (Fig. 6). The bridge is constructed of 10 concrete carriers of 0.7 m width, laid one to another (Fig. 7).

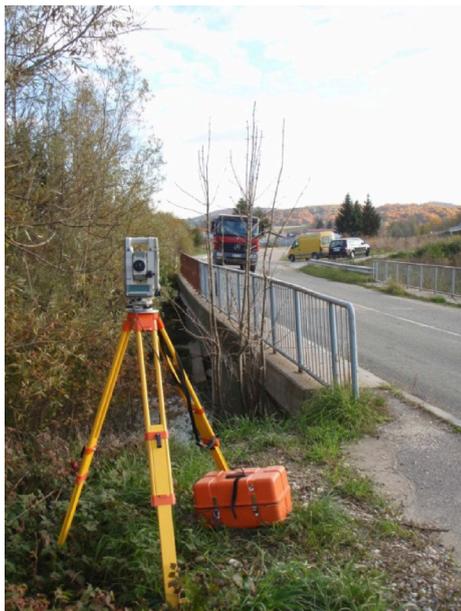
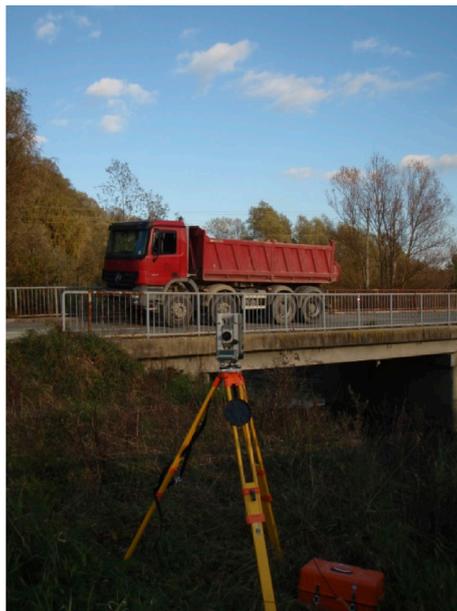
Fig. 8. *Total station 1 on the Pernica Bridge.* Fig. 9. *Total station 2 on the Pernica Bridge.*

The measurements of the object response to a static load (2 examples), which was caused by the 14 725.00 kg truck (Mercedes Actros 4141), were conducted during load tests. Dynamic load test was performed with the same truck driving through the bridge at 20 km/h, 30 km/h and 50 km/h (Štrukelj and Kamnik 2010). For geodetic measurements two electronic total stations Nikon DTM 720 were used (Fig. 8 and Fig. 9). Both instruments stations have been prepared on the left bank of the Pesnica River. For the measurements retro tape targets were fixed to the middle of the second field.

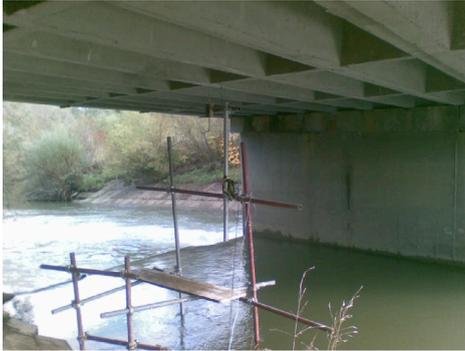
Fig. 10. Scaffold under the bridge.

A temporary scaffold was erected for an inductive transducer under the bridge (Fig. 10). The inductive transducer measured the response to a static and dynamic load and, as such, represents a reference measurement which can be later

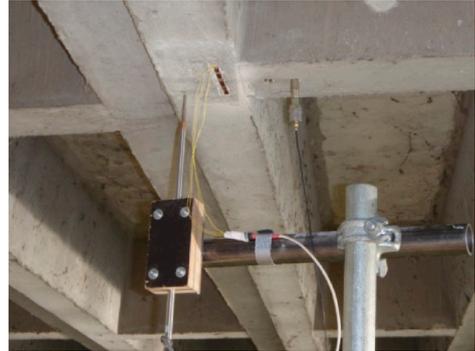
Fig. 11. Sensors under the Pernica Bridge.

compared to other measurements. In order to monitor the dynamic response on the bottom of the bridge, accelerometer has been mounted as well. Furthermore, during the load test the strains were measured using one 10 cm long strain gauge glued near the inductive transducer and accelerometer (Fig. 11). The surface of the concrete was prepared according to the recommendations (Kamnik et al. 2015).

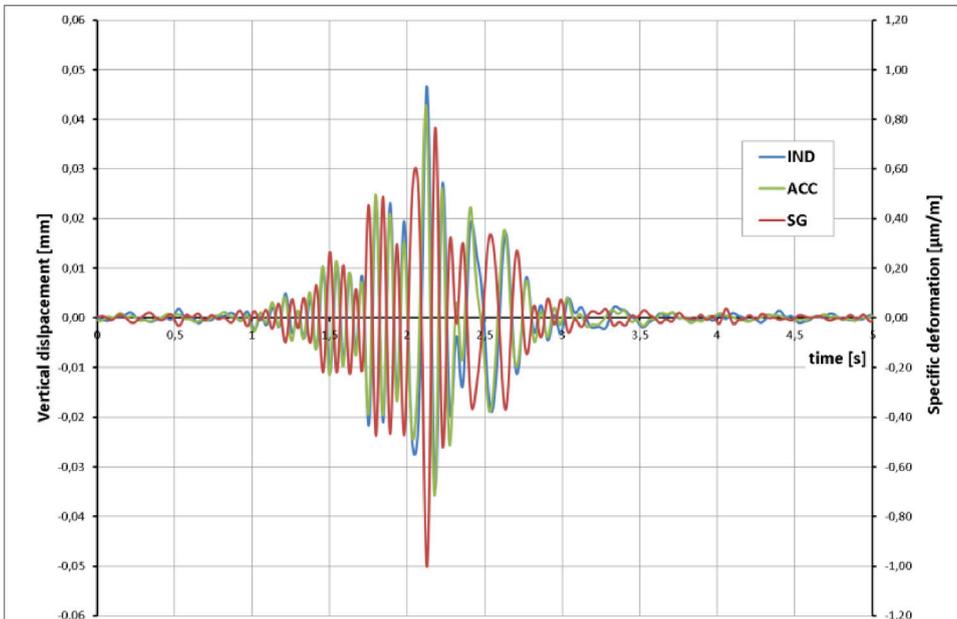
Fig. 12. Measured signals at dynamic part of the load test.

Fig. 12 shows filtered signals of inductive transducer, accelerometer and strain gauge measured at the dynamic load case (at 30 km/h). The green line shows the

signal of accelerometer (already twice (by time) integrated using Bruel&Kjær Type 2635 charge amplifier). The red line shows the signal of strain gauge and the blue line is the signal of inductive transducer. The signals are practically identical one to each other which means, that the reference was solid and stable and all sensors were well calibrated.

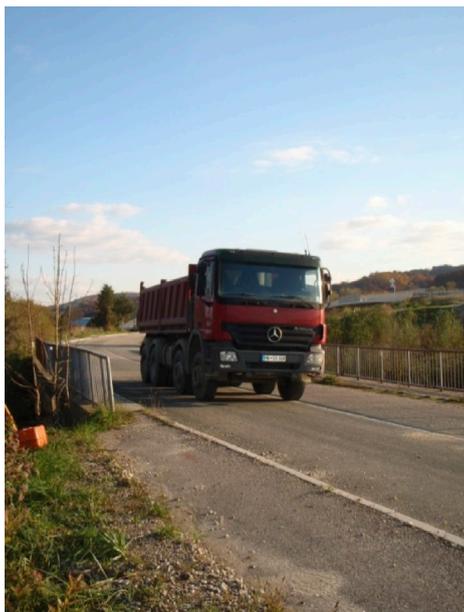
Fig. 13. *Static example 1 (on the left driving lane).*

Then two examples of a static load were performed. Fig. 13 and Fig. 14 show the position of the truck in a static load situation 1 and 2. The vehicle was positioned so that the last two tires of the truck were exactly over the sensors mounted below.

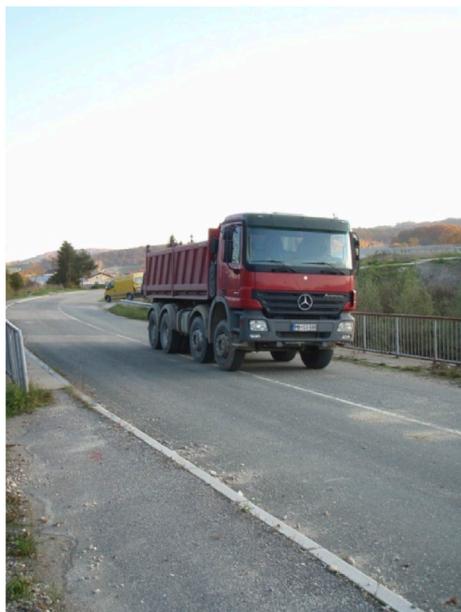
Fig. 14. *Static example 2 (on the right driving lane).*

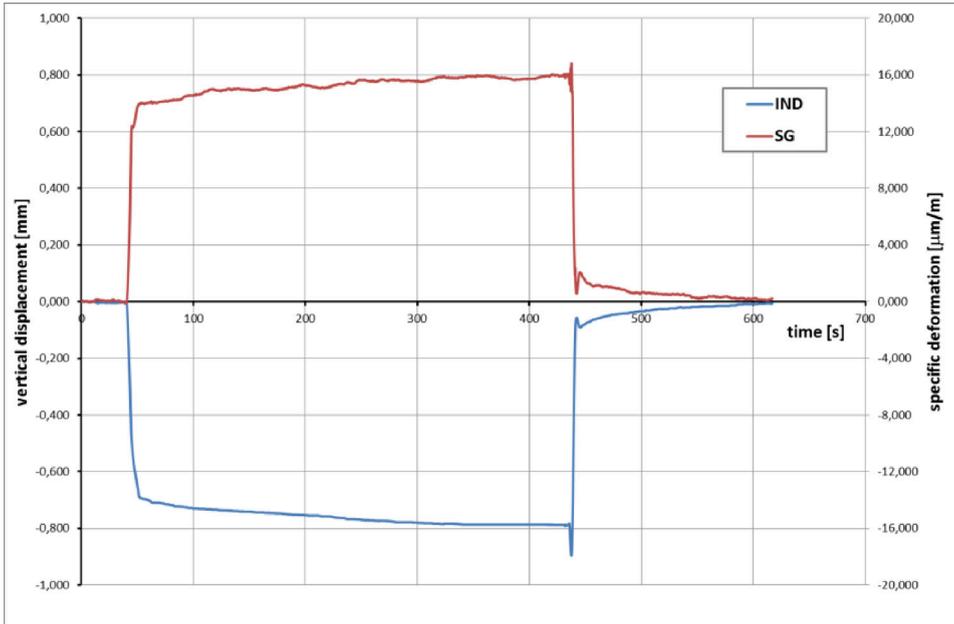
Fig. 15. Signal of strain gauge and inductive transducer at static example 1.

The measured specific deformations versus time for a static example 1 are shown in Fig. 15. In this case the average strain was $15.3 \mu\text{m}/\text{m}$. A very good agreement with the signal of inductive transducer (taken as a reference and measuring the vertical displacement) can be seen.

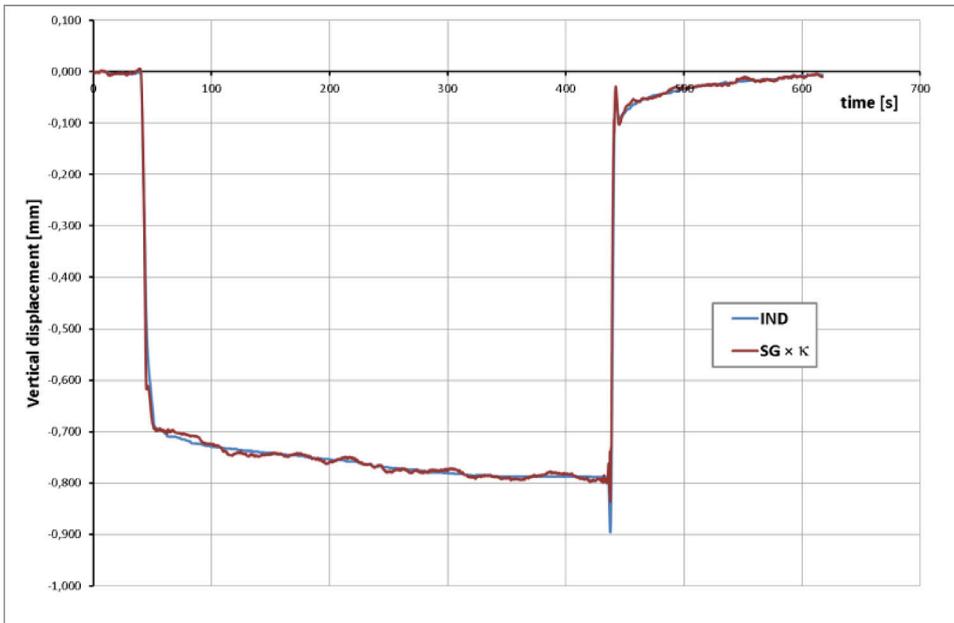
Fig. 16. Signal of inductive transducer and strain gauge multiplied by κ .

Fig. 16 shows specific deformations after they were multiplied by the average proportionality factor $\bar{\kappa}$ (-0.04975) calculated using the dynamic acceleration strain ratio (DASR) method (Kamnik 2014). A very good agreement with the signal of inductive transducer (taken as a reference) can be seen.
