# Development Trend of the Compressive Strength of an In-Service Sidewall Corroded by Sulphate with a High Concentration of $\text{Ca}^{2+}$

At the bedrock section of the auxiliary shaft of the Tong-ting coal mine, the sidewall has varying degradation degrees in different parts. The part on which water flowed is barely corroded, whereas the moist part near the pouring joints is seriously corroded. We first studied the mechanism of this phenomenon by chromatography, X-ray diffraction, and energy-dispersive X-ray spectroscopy. We then used simplified models built by particle flow code software (*i.e.*, particle flow code in three dimensions, PFC3D) to analyse how increasing degradation depth affects compressive strength and failure patterns. The results were as follows. (1) Gypsum and calcite in corrosive water were supersaturated. The part on which water flowed was protected by the crystallized precipitation on the concrete. By contrast, the degradation of the part where water flowed through pouring joints was aggravated by internal crystallization and dissolution. (2) PFC3D numerical simulation indicated that decreases in vertical ultimate stress were strongly linearly correlated

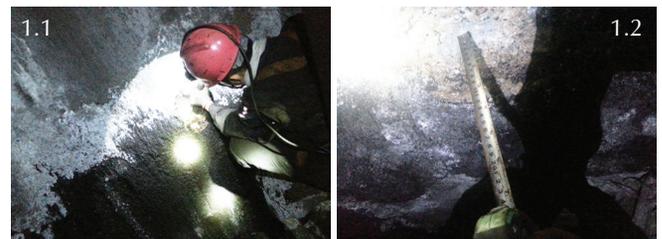
Fig. 1 – Corroded concrete at  $-355.5$  m  
Slika 1 – Korodirani beton na  $-355,5$  m

In the damaged parts, the concrete near the pouring joint is subject to severe bulging and cracking. The paste matrix is characterized by graininess, and the bond between the paste matrix and the aggregate is weak. The most seriously damaged part is located at  $-355.5$  m. The bulging layer at  $-355.5$  m is approximately  $80-100$  mm in depth and  $200$  mm in height. The photographs in Fig. 1.1 and 1.2 were captured before and after the degradation layer of the  $-355.5$  m damaged part was shovelled; the tape in Fig. 1.2 was placed to demonstrate the contrast. As shown in Fig. 1.1, the surface of the bulging part, which is slightly covered by white powder, is rough and higher than the nearby surfaces. The corrosive water from construction holes flows on the inner wall and is collected at the reservoir at the shaft bottom. As shown in Figs. 2.1 and 2.2 (which were captured at  $-430$  and  $-390$  m, respectively), the sidewall surface is flat and non-corroded under the protection of the dense layer.

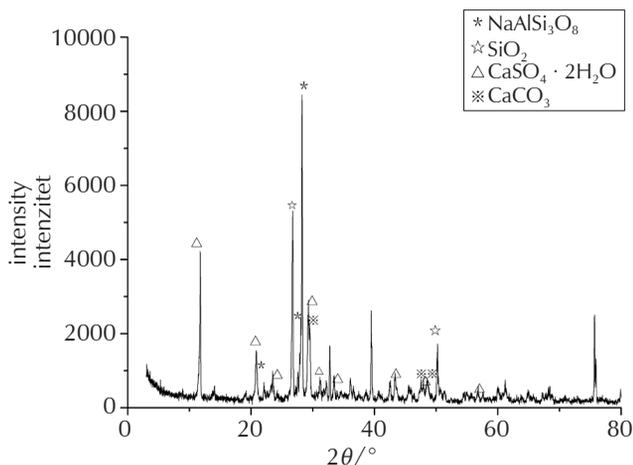
Fig. 3 – XRD analysis of the corroded concrete  
Slika 3 – Rendgenska difrakcijska analiza korodiranog betona

Fig. 3 shows that the corroded concrete mainly consists of albite (NaAlSi<sub>3</sub>O<sub>8</sub>), quartz (SiO<sub>2</sub>), gypsum (CaSO<sub>4</sub> · 2 H<sub>2</sub>O), and calcite (CaCO<sub>3</sub>). Portlandite, which is one of the main constituents of common concrete, was not found in the corroded concrete sample. On the contrary, gypsum, which is hardly found in common concrete, is the main stage.

According to different phenomena and degradation products, sulphate degradation can generally be divided into five types, namely, sulphate, ettringite, gypsum, thaumasite, and magnesium sulphate crystalline degradation. Degradation type is highly correlated with the temperature, pH value, and sulphate concentration of the corrosive water. For example, sulphate crystalline degradation typically occurs when the pH is less than 10.5, the concentration of SO<sub>4</sub><sup>2-</sup> is greater than 1000 mg l<sup>-1</sup>, and the major degradation product is gypsum. The average pH value and concentration of SO<sub>4</sub><sup>2-</sup> in the water samples are 7.69 and 1901.05 mg l<sup>-1</sup>, respectively. The main stage of the corroded concrete is gypsum. Therefore, the degradation type may be sulphate crystalline degradation. The reaction formula of this degradation type is as follows:

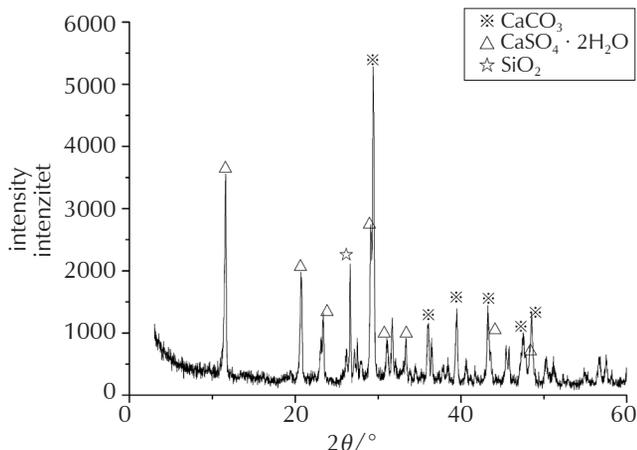
Fig. 4 – XRD analysis of the dense layer  
Slika 4 – Rendgenska difrakcijska analiza kompaktnog sloja

As shown in Fig. 4, the main components of the dense layer are calcite (CaCO<sub>3</sub>), gypsum (CaSO<sub>4</sub> · 2 H<sub>2</sub>O), and quartz (SiO<sub>2</sub>), which are the same as the components of the corrosive water. A FEI Quanta 250 FEG scanning electron microscope was used to observe the microstructure of the dense layer, and the observations are shown in Fig. 5. The magnification of Fig. 5 is 5000.

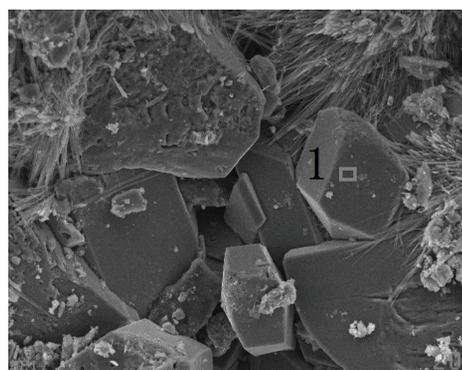
Fig. 5 – SEM image of the dense layer  
Slika 5 – SEM slika gustog sloja

The results of scanning electron microscopy and EDS show that the gypsum in the dense layer is predominantly at glassy state. As shown in Fig. 5, owing to the compact

structure of the glassy gypsum, the water permeability of the dense layer is low, thereby protecting the shaft concrete against the corrosive effect of the corrosive water.

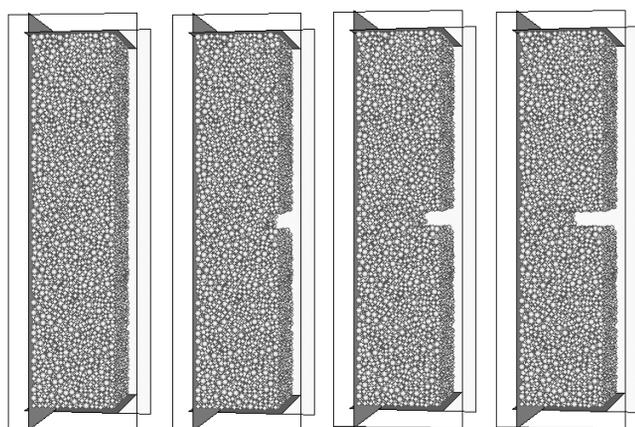
Fig. 8 – Simplified shaft models with different degradation depths

The pouring joint was simulated as a joint plane created with the JSET command. The position was specified by the DIP and ORIGIN keywords, and the weak properties were assigned on the plane. Given that the structure of the corroded concrete is loose and the bearing capacity is low, the particles in the corroded part were deleted in the simulation. A population of particles with an artificially small radius was created within the specified volume to improve the generation speed. Small-radius particles were easy to place in this manner because the available void space was large. The particles were then expanded until the desired porosity was obtained. The total numbers of particles of the 0, 100, 175, and 250 mm degradation-depth models were 21372, 21157, 20977, and 20791, respectively, as shown in Fig. 8.

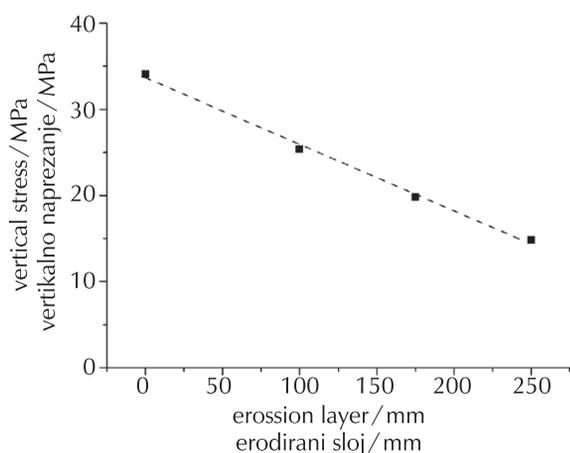
Fig. 9 – Relationship between vertical ultimate stress and degradation depth

As for the sidewall of the Tong-ting shaft at the bedrock section,  $d$ ,  $r$ ,  $\sigma_c$ , and  $p_h$  were 0.45 m, 3.4 m, 21 MPa, and 1.32 MPa, respectively. The calculated vertical ultimate stress  $p_v^b$  was 31.73 MPa, which was close to the PFC3D result of 34.1 MPa. These values suggest that the simplified PFC3D models can achieve satisfactory calculation accuracy. Fig. 9 shows the relationship between degradation depth and vertical ultimate stress based on PFC3D simulations.

The result showed a good linear relation between vertical ultimate stress and degradation depth in the range of 0–250 mm. The linear equation was  $p_{v,t}^b = -0.0773h_t + 33.673$ , and the related coefficient was 0.998. When the degradation depth reached 250 mm, the vertical ultimate stress was 14.8 MPa, which was less than the design value of 14.87 MPa. Reinforcement should be conducted before the degradation depth reaches 250 mm.

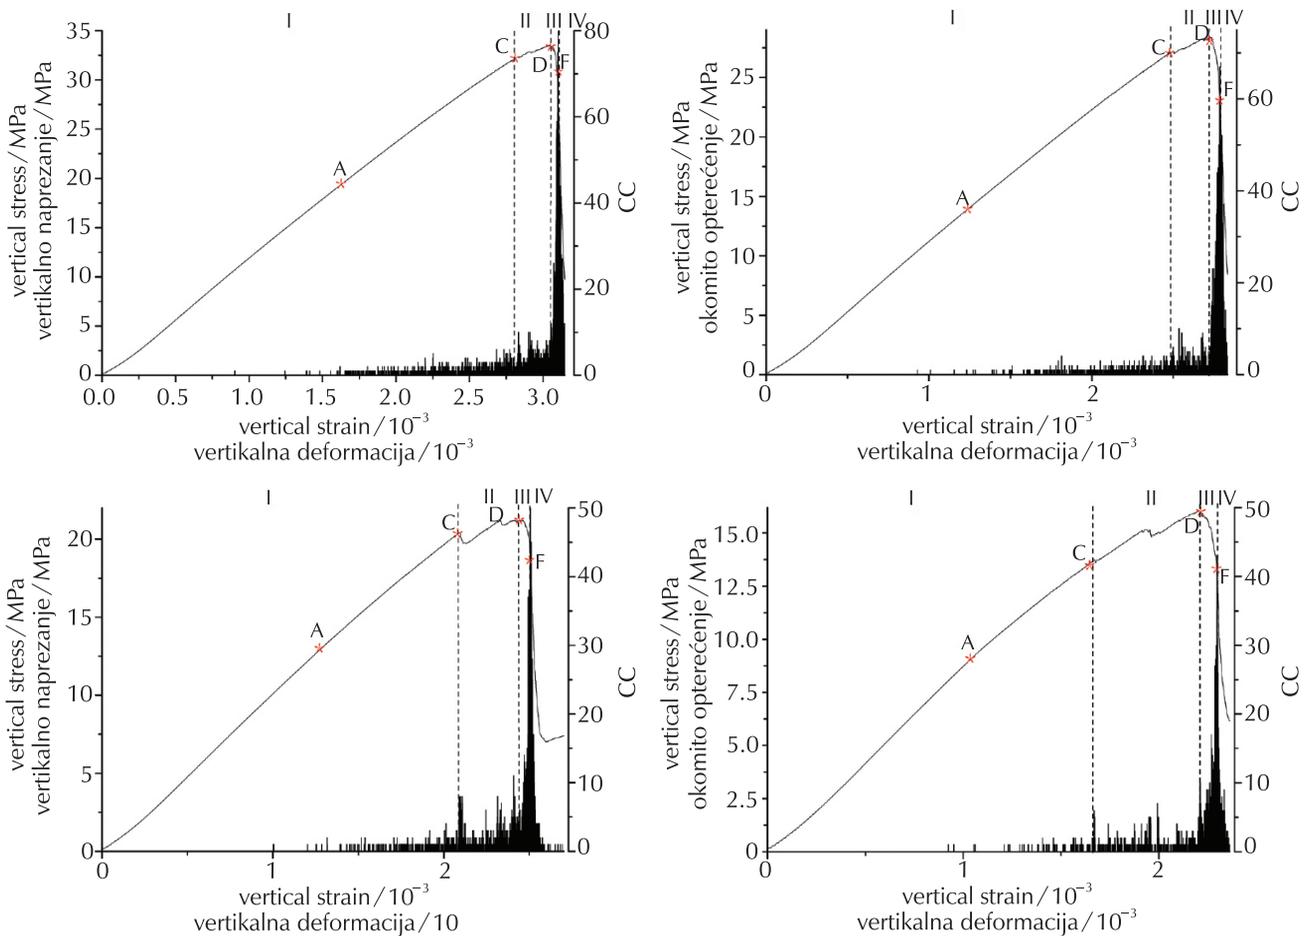
Fig. 10 – Stress–strain and CC curves with different degradation depths  
 Slika 10 – Dijagram naprezanja i CC s različitim dubinama razgradnje

Stress–strain and CC curves with different degradation depths are shown in Fig. 10. The monitoring points C, D, and F in Fig. 10 represent the proportional limit, ultimate stress, and CC peak point, respectively. The portion of the curve between the origin and point A was a straight line. In this portion, no initial stress or strain occurred. Up to point C, Hooke's law was obeyed according to which stress was directly proportional to strain. Point C was thus known as the proportional limit. Point D indicated the location of the value of the ultimate stress. The PFC3D model was considered to have completely failed once it reached the ultimate stress.

Fig. 10(a) shows that owing to the confining pressure, the vertical ultimate stress of the non-corroded model was 34.1 MPa, which was higher than that of C30 concrete (16.7 %). The stress was obviously reduced with a turning point at the stress peak, and the fracture mode was brittle fracture. In Figs. 10(b)–(d), the increasing degradation depth not only decreased the vertical strength but also the strain at the peak point. When the degradation depths were 0, 100, 175, and 250 mm, the vertical strains at the peak point were  $3.05 \cdot 10^{-3}$ ,  $2.72 \cdot 10^{-3}$ ,  $2.44 \cdot 10^{-3}$ , and  $2.21 \cdot 10^{-3}$ , respectively. When the degradation depths were 0, 100, 175, and 250 mm, the ratios between the strain at the proportional limit stress and peak stress were 0.918, 0.912, 0.857, and 0.751, respectively. The elastic portion of the stress–strain curve decreased rapidly.

In Fig. 10, the process of model failure can be divided into four stages, viz., the beginning stage (I), the rising stage (II), the tempestuousness stage (III), and the drop stage (IV). At the preliminary stage of loading, i.e., the beginning stage (I), stress increased as a linear elastic feature. At the compression stage (Segment OA), no cracks were generated. The first crack occurred at point A, and the initiation crack stresses were 19.36, 13.92, 12.99, and 9.07 MPa. At the rising stage (II), CC showed a steady increasing tendency.

In Figs. 10 (a)–(b), only one CC peak occurred right after the stress peak was reached. When the strain–stress curve entered the failure stage, the model destructed rapidly. The position of the major CC peak in Figs. 10(c)–(d) was almost the same as the position in Figs. 10(a)–(b). In Figs. 10(a)–(b), aside from the major CC peak, a small CC peak occurred between the beginning stage (I) and the rising stage (II). The fracture failure process is also a process of releasing energy. In Figs. 10(c)–(d), the plastic portion of the stress–strain curve increased because some energy was released at the second CC peak before breaking.

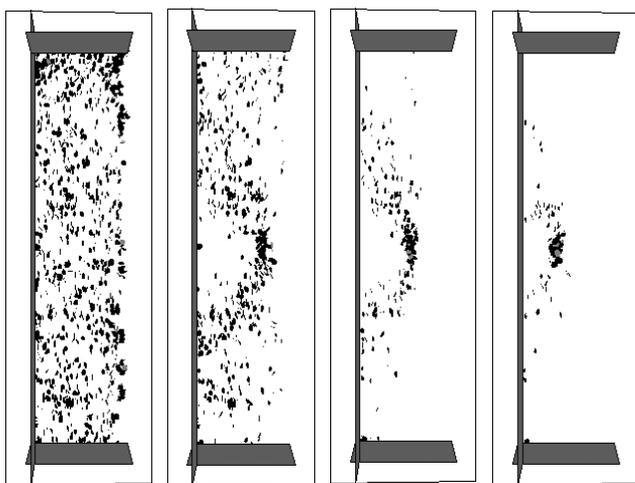
Fig. 11 – Crack shapes with different degradation depths at the proportional limit  
 Slika 11 – Oblici pukotina pri različitim dubinama propadanja na granici proporcionalnosti

Fig. 11 is a side view of the crack shapes of different degradation depths at the proportional limit stress. The black and grey points in Fig. 11 represent the shear and tensile cracks, respectively. In Fig. 11, nearly all cracks were shear cracks. Cracks were in homogeneous distribution in the non-corroded model. With an increase in degradation depth, the distribution of cracks gradually gathered at the bottom because of the stress concentration at the bottom of the damaged part. At the proportional limit point, the sidewall models with degradation depths of 0, 100, 175, and 250 mm contained a total of 1187, 644, 269, and 68 cracks, respectively.

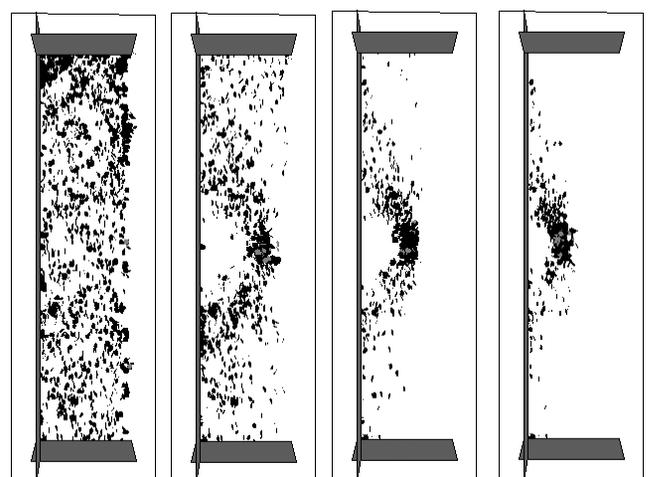
Fig. 12 – Crack shapes with different degradation depths at ultimate stress  
 Slika 12 – Oblici pukotina pri različitim dubinama propadanja pri tlačnoj čvrstoći

the shaft models transformed into unstable state. Fig. 12 is a side view of the crack shapes of different degradation depths at point D.

When a bond broke either for tensile or shear failure, a new microcrack formed in PFC3D. Fig. 12 shows the distribution of microcracks at ultimate stress. As shown in Fig. 12(a), the microcracks in the non-corroded model were almost uniformly dispersed, and the bearing capacity of the concrete was fully used. With an increase in the degradation depth near the pouring joint, the distance between the central axis of vertical loads and the section centroid where the concrete degradation increased, the distribution of microcracks concentrated on the upper and lower shear planes. Even when the degradation depth was 100 mm, no obvious sign occurred on the inner wall before failure, which was dangerous. Given that the sidewall models with degradation depths of 0, 100, 175, and 250 mm contained a total of 2477, 1470, 1193, and 633 cracks at the ultimate stress point, respectively, the energy release at the ultimate stress point decreased with an increase in degradation depth.

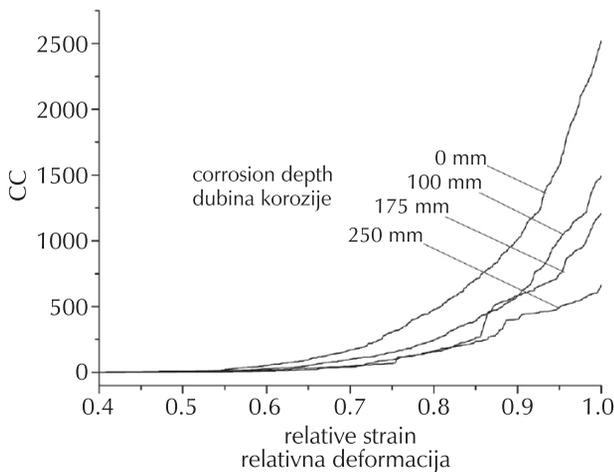
Fig. 13 – CC–relative strain curve with different degradation depths

In Fig. 13, the relative strain was the ratio between the current strain and the strain at the peak stress. Although the degradation depth differed, the CC of all four simplified models began to rise at the same relative strain of 0.55. With an increase in degradation depth, the CC–relative strain curve was rough, and the amplitude of the portion of the curve increased before the ultimate stress had reduced.
