Sondažna istraživanja crkve sv. Marka u Širokoj luci kod Plitvica Sela

Sondage excavations of St. Mark's church in Široka luka near Plitvica Selo

UDK: 904:726.54(497.5 Plitvica Selo)
Izvorni znanstveni rad/Original scientific paper

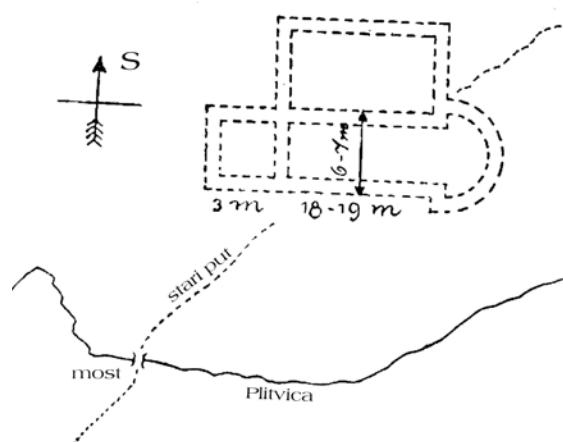
Sl. / Fig. 1: Tlocrt crkve / Plan of the church (Delić 1899, 110; obradio / processed by Srećko Škrinjarić)

sna svećenička odjeća] i crkvene stvari, pa i nešto novaca, sakrili u nju.«¹⁶ Osim tlocrta crkve postavljenog u odnos prema potoku Plitvica, Kamenko Delić daje i geografsku kartu s oznakom položaja crkve, kao i pećine (karta 1).

also provided a geographical map with the marked position of the church and the cave (map 1).

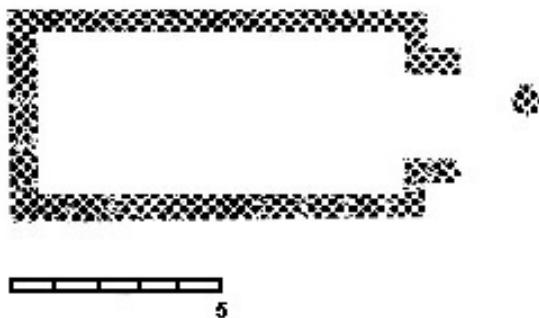
Sl. / Fig. 2: Tlocrt crkve sv. Marka / Plan of St. Mark's church (Horvat 2003, 24; obradio / processed by Srećko Škrinjarić)

I konzervator, Zorislav Horvat, 2003. spominje ovu crkvu, te je smješta u doba mađarsko-hrvatskih kraljeva i romanike s kraja 12. st. Napominje da su nam romanički objekti Krbavsko-modruške biskupije većinom poznati po svojim tlocrtima, ne i po elevacijama i detaljima ili sigurnim povijesnim podacima. U isti vremenski period smješta i pretpostavljenu crkvu i pavlinski samostan na gradini Krčingrad nad Gradinskim jezerom na Plitvičkim jezerima, čiji je tipični romanički tlocrt nastao tijekom 12.–13. st., nakon 1185. g. kad je osnovana Krbavska biskupija. Uz tlocrte drugih crkava, daje i mogući tlocrt crkve sv. Marka, s tim da je kod završetka apside stavio upitnik (sl. 2).¹⁹

This church is mentioned also by the conservator Zvonimir Horvat in 2003, who dated it to the time of the Hungarian-Croatian kings and the Romanesque period at the end of the 12th century. He stated that the Romanesque buildings of the Krbava-Modruš Diocese are known to us mainly by their ground plans, not by the elevations and details or credible historical data. He also dated the presumed church and the Pauline monastery on the Krčingrad hill above the Gradina Lake in the Plitvice Lakes to the same period, whose typical Romanesque plan was formed during the 12th–13th century, after the foundation of the Krbava Diocese in 1185. In addition to the plans of other churches, he offered also a possible plan of St. Mark's church, beside whose apse he placed a question mark (Fig. 2).¹⁹

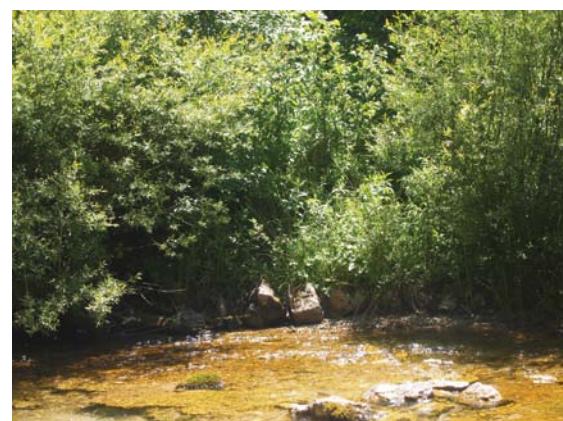
Sl. / Fig. 5: Kamenom ograđen potok Plitvica u Širokoj luci / Stone-lined Plitvica brook in Široka luka (snimila / photo by Iva Kostešić, 2012.)

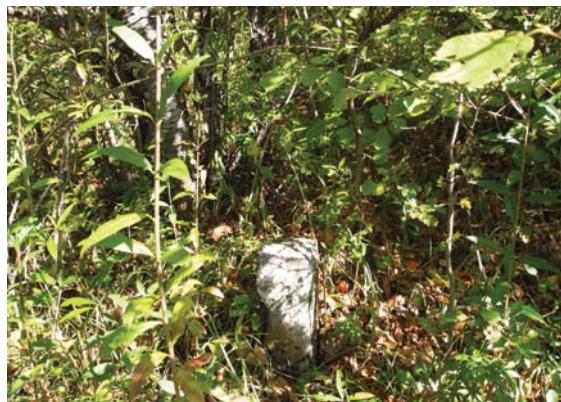
Sl. / Fig. 7: Cestovna oznaka – kameni stup na istočnom ulazu u Široku luku / Road mark – stone pillar at the eastern entrance to Široka luka (snimila / photo by Nera Šegvić, 2012.)

At the eastern end of Široka luka, near the beginning of the path leading to Hajdukovića pila, adjacent to the Plitvica brook, a pile of stones was found in a dense thicket on slightly elevated terrain, together with another stone pillar (*unka*), this one without any marks (Fig. 7). Since the present-day path towards Hajdukovića pila, in the direction of the Big Waterfall, is the only possible path, the old path presumably led along the same route, and it was marked with stone pillars.

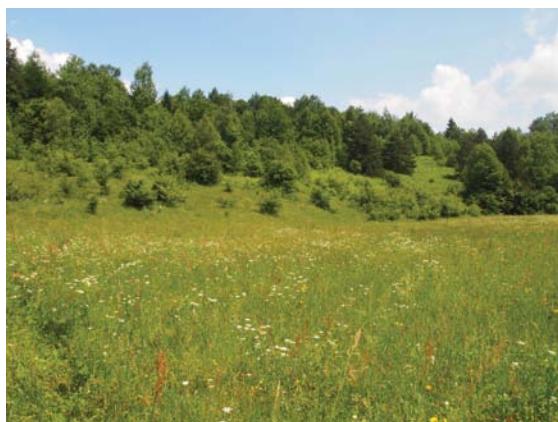
Sl. / Fig. 8: Pogled na lokaciju crkve sv. Marka u Širokoj luci, prije iskopavanja / A view of the position of St. Mark's church in Široka luka prior to the excavation (snimila / photo by Nera Šegvić, 2011.)

Na povišenom terenu Široke luke započeli smo iskopavanja crkve sv. Marka (sl. 8).

We started excavating the church of St. Mark at the elevated ground of Široka luka (Fig. 8).

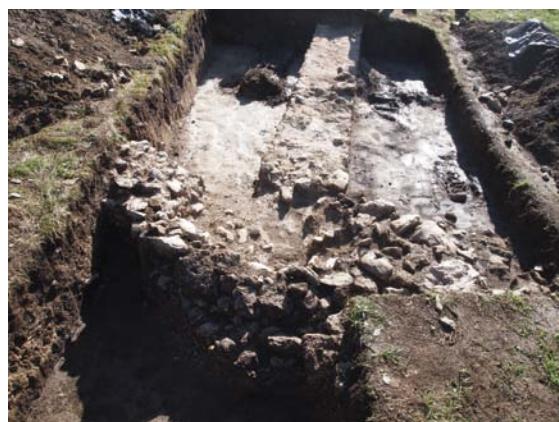
Sl. / Fig. 9: Kameno urušenje zapadnog zida, s vidljivim ostacima tri istražena groba / Stone debris of the western wall with visible remains of three excavated graves (snimila / photo by Nera Šegvić, 2012.)

U sondi 2 otkriveni su dijelovi zapadnog i južnog zida i ugao, te su pronađena i tri groba (sl. 9).

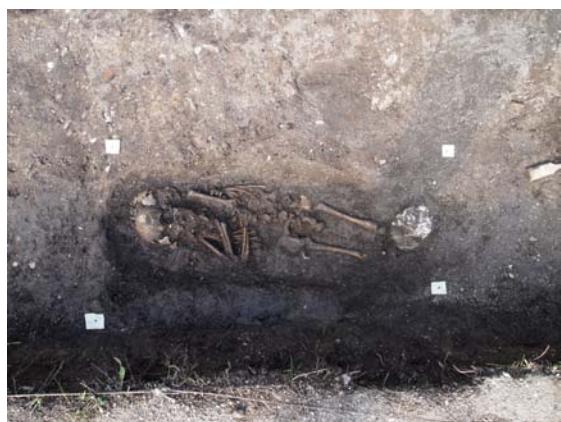
Sl. / Fig. 10: Grob 1, nađen s vanjske strane južnog zida crkve / Grave 1 was discovered outside the southern wall of the church (snimila / photo by Iva Kostešić, 2012.)

Grob 1 (dijete?) nalazio se s vanjske strane južnog zida. Kostur očuvan, položen na leđa s glavom na zapadu. Noge su ispružene, potkoljenice nedostaju. Ruke – desna podlaktica podignuta na sredinu toraksa, a lijeva položena na trbuš (sl. 10).

Grave 1 (child?) was located on the outside of the southern wall. The skeleton is preserved and was found in a supine position with its head towards the west. The legs are extended, and the lower legs are missing. Arms – the right forearm is placed at the middle of the thorax, the left forearm is placed on the abdomen (Fig. 10)

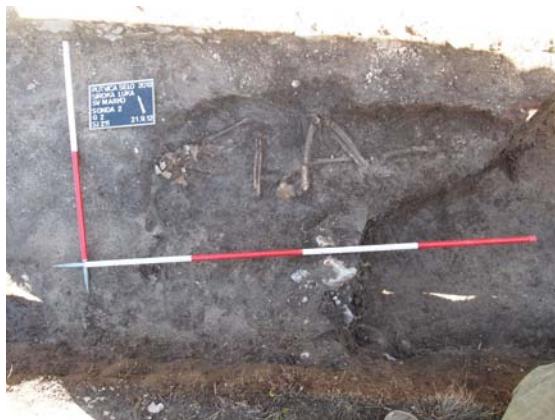
Sl. / Fig. 11: Grob 2, nađen s vanjske strane južnog zida crkve / Grave 2 was discovered on the outside of the southern church wall (snimila / photo by Iva Kostešić, 2012.)

Grob 2 (žena?) nalazio se s vanjske strane južnog zida. Kostur dobro očuvan, s glavom na zapadu.

Pokojnica je položena na lijevi bok, lijeva nogu je ispružena, a desna zgrčena. Pokojnica ima desnu podlakticu položenu na trbuhi (sl. 11).

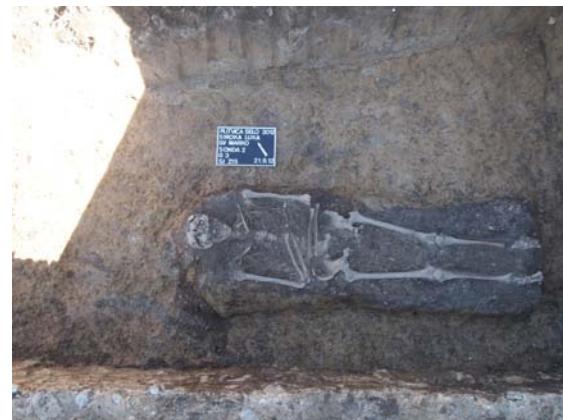
Sl. / Fig. 12: Grob 3, nađen u unutrašnjosti crkve / Grave 3 was found inside the church (snimila / photo by Iva Kostešić, 2012.)

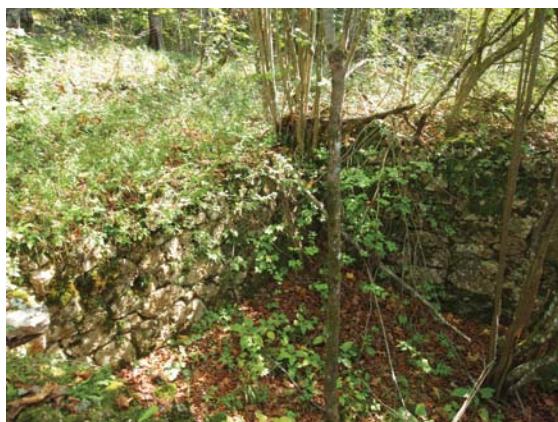
Sl. / Fig. 13: Porušena kuća, »stan« od Sertića, nedaleko od jame – pećine / The collapsed house, “dwelling” of the Sertić family, near the pit-cave (snimila / photo by Iva Kostešić, 2012.)

a prema riječima jedne od vlasnica, Marice Sertić, stan je bio u funkciji do 1990 g., kad je napušten uslijed ratnih zbivanja (Domovinski rat). Stan se sam od sebe urušio tijekom vremena. Zanimljivo je da nitko od njih (Rodići, Sertići, rendžeri Parka, mještani...) nije znao niti čuo za pećinu u kojoj su, prema predaji, bile sakrivene »crkvene stvari i nešto novaca«.

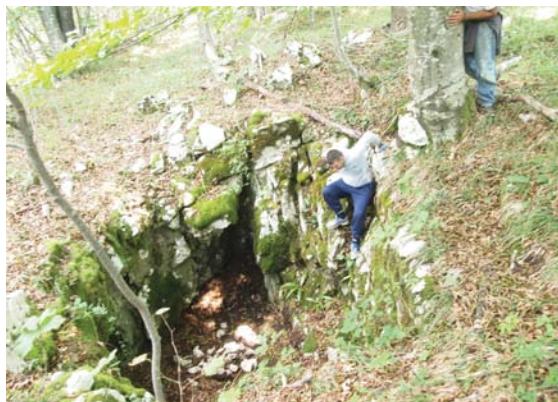
Sl. / Fig. 14: Spuštanje u jamu-pećinu kod crkve sv. Marka (na slici Bojan Grbić, mještanin) / Descent into the pit-cave near St. Mark’s church (Bojan Grbić, a local resident, is pictured in the photo) (snimila / photo by Iva Kostešić, 2012.)

Cvjetko Vurster writes that there is a cave in the vicinity of the church, *full of all kinds of bones*.²¹ The position of the cave is marked on the map provided by Kamenko Delić in 1899. It is situated on the northern side of the wooded old trail leading to the (presently) crumbling shepherd dwelling of the Sertić family (Fig. 13). The trail has no beginning or end because the entire land had been covered by forest and ferns. The trail is partly supported by a wall, and on the southern side there are massive undressed stones. It is possible that the trail begins at the entrance to Široka luka, where the numbered stone pillar was found. West of the shepherd dwelling, next to the trail, there is a large pit, measuring 3.60 x 4.70 m, 2.80 m deep. Its walls consist of rectangular bedrock with fairly smooth sides. The bottom of the pit is filled with a thick layer of leaves and rotting branches (Fig. 14). We cleaned the pit of leaves and branches, whereupon we found out that, beneath this layer, the pit was filled with large stones, which we were not able to move without additional equipment. At the depth of 3 metres, along the eastern wall of the pit, we uncovered a small hole, or a passageway, through which a man might be able to pass, although with difficulty (Fig. 15). This opening could be expanded by removing the large stones that fill the pit. In case there is indeed a cave there, it is possible that this passage leads into it. However, considering that, during the clearing of the cave, we did not find any traces of human activity, our exploration stopped there, keeping in mind that traces of human history might perhaps be found if the massive stone blocks were to be removed.

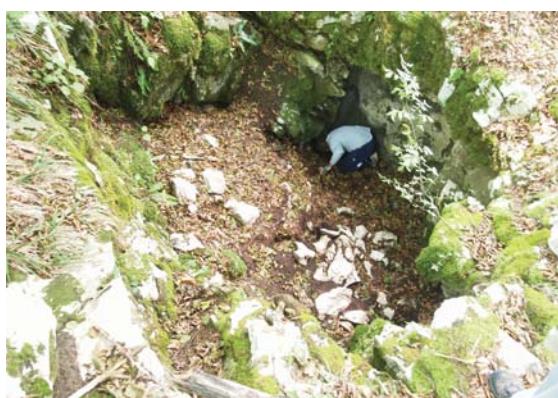
Sl. / Fig. 15: Pokušaj ulaza u uski prolaz koji (moguće) vodi u dubinu pećine (na slici Bojan Grbić, mještanin) / Attempt to pass through the narrow passage that (might) lead into the cave (Bojan Grbić is shown in the photo) (snimila / photo by Nera Šegvić, 2012.)

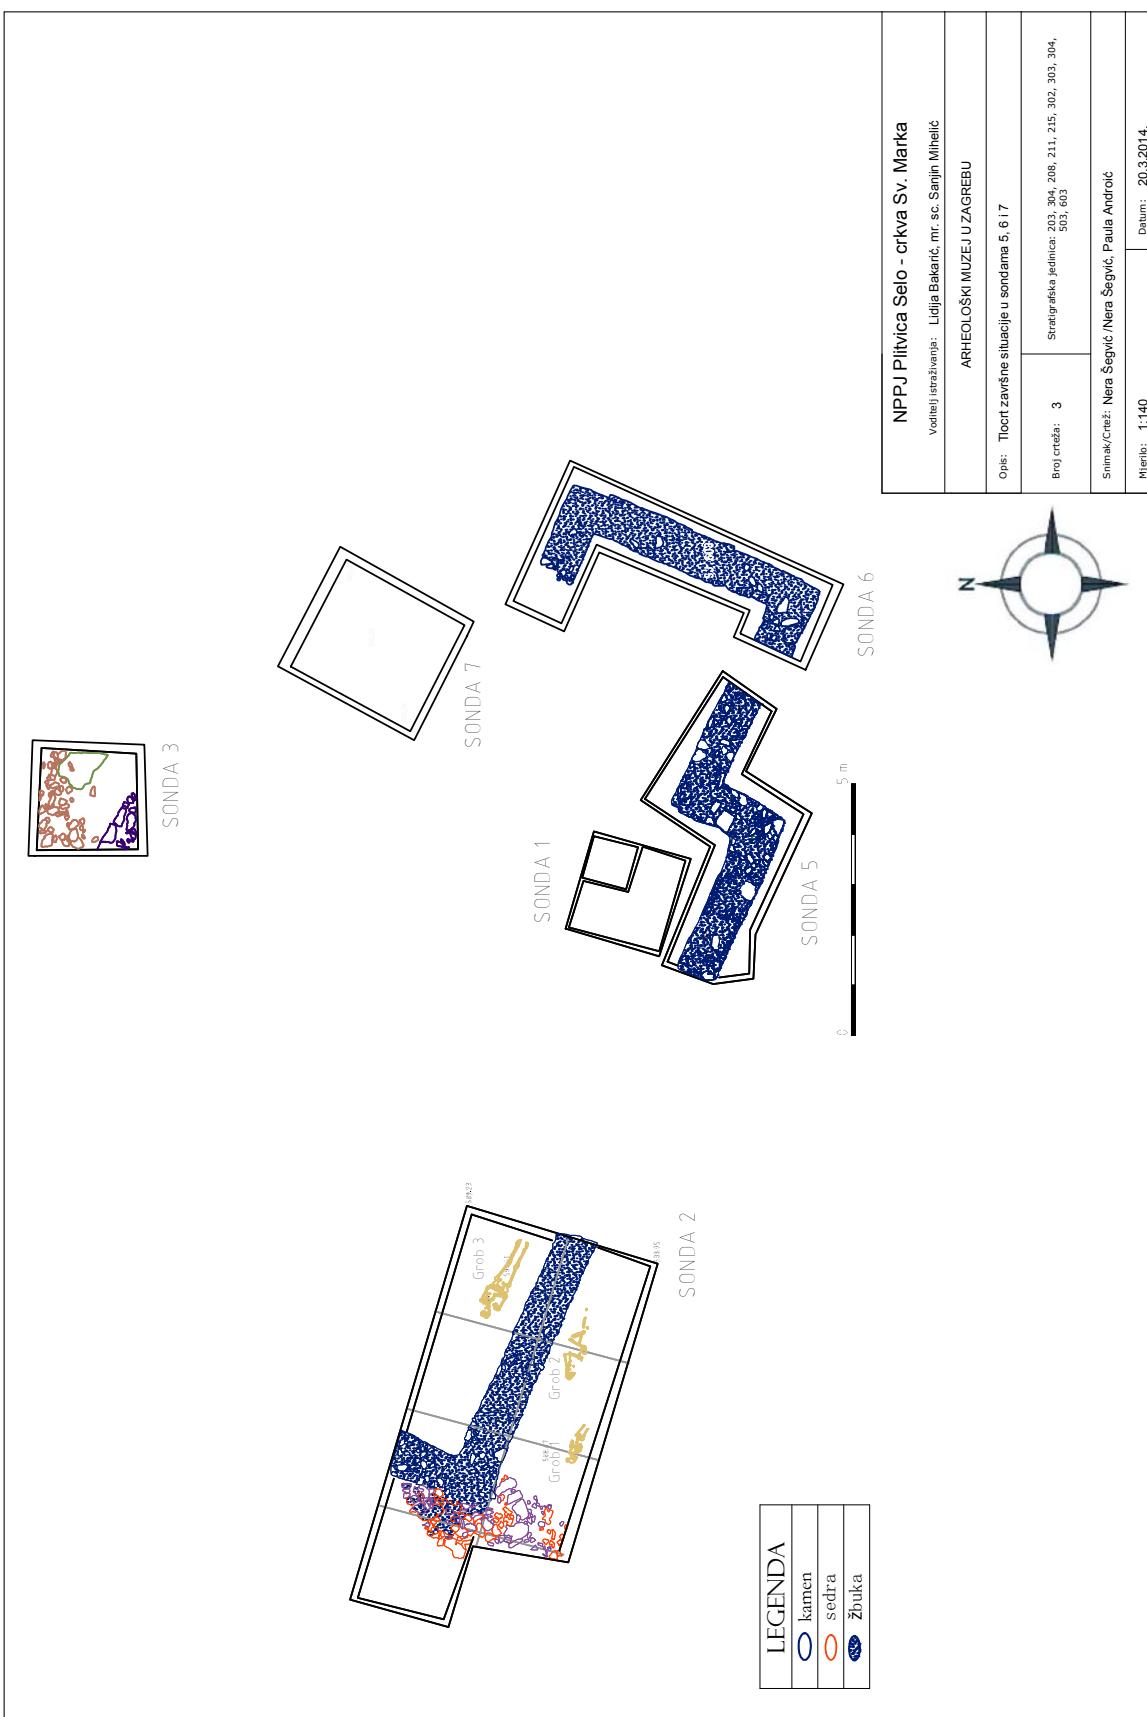
Tabla / Plate 1: Crkva sv. Marka – uctirane su sonde 1, 2, 5, 6, 7 / St. Mark's church – Sondages 1, 2, 5, 6, 7 are marked (crtež / drawing by Nera Šegvić, Paula Androić, Iva Kostešić; priredila za tiskak / design by Iva Kostešić, 2014.)

Sonda 1 nije odmah dala rezultat (naknadno smo ustanovili da je postavljena u unutrašnjosti crkve), te smo otvorili sondu 2, dimenzija 2 x 2 m, koju smo proširivali. Ukupna površina sonde 2 je 28 m², u njoj su otkriveni dijelovi zapadnog i južnog temelja zida crkve, te tri groba. Jedan grob (grob 3) nalazio se unutar zidova crkve, uz južni zid, a dva paralelno s južnim zidom s vanjske strane crkve (grob 1 i 2) (T. 1).

Since Sondage 1 did not immediately yield anything (we later discovered that it was positioned in the interior of the church), we started excavating in Sondage 2, measuring 2 x 2 m, which we later enlarged. The total area of Sondage 2 is 28 m², and it yielded parts of the western and southern foundation walls of the church, as well as three graves. One of the graves (grave 3) lay inside the church walls, next to the southern wall, while the other two lay parallel to the southern wall on the outside of the church (graves 1 and 2) (Pl. 1).

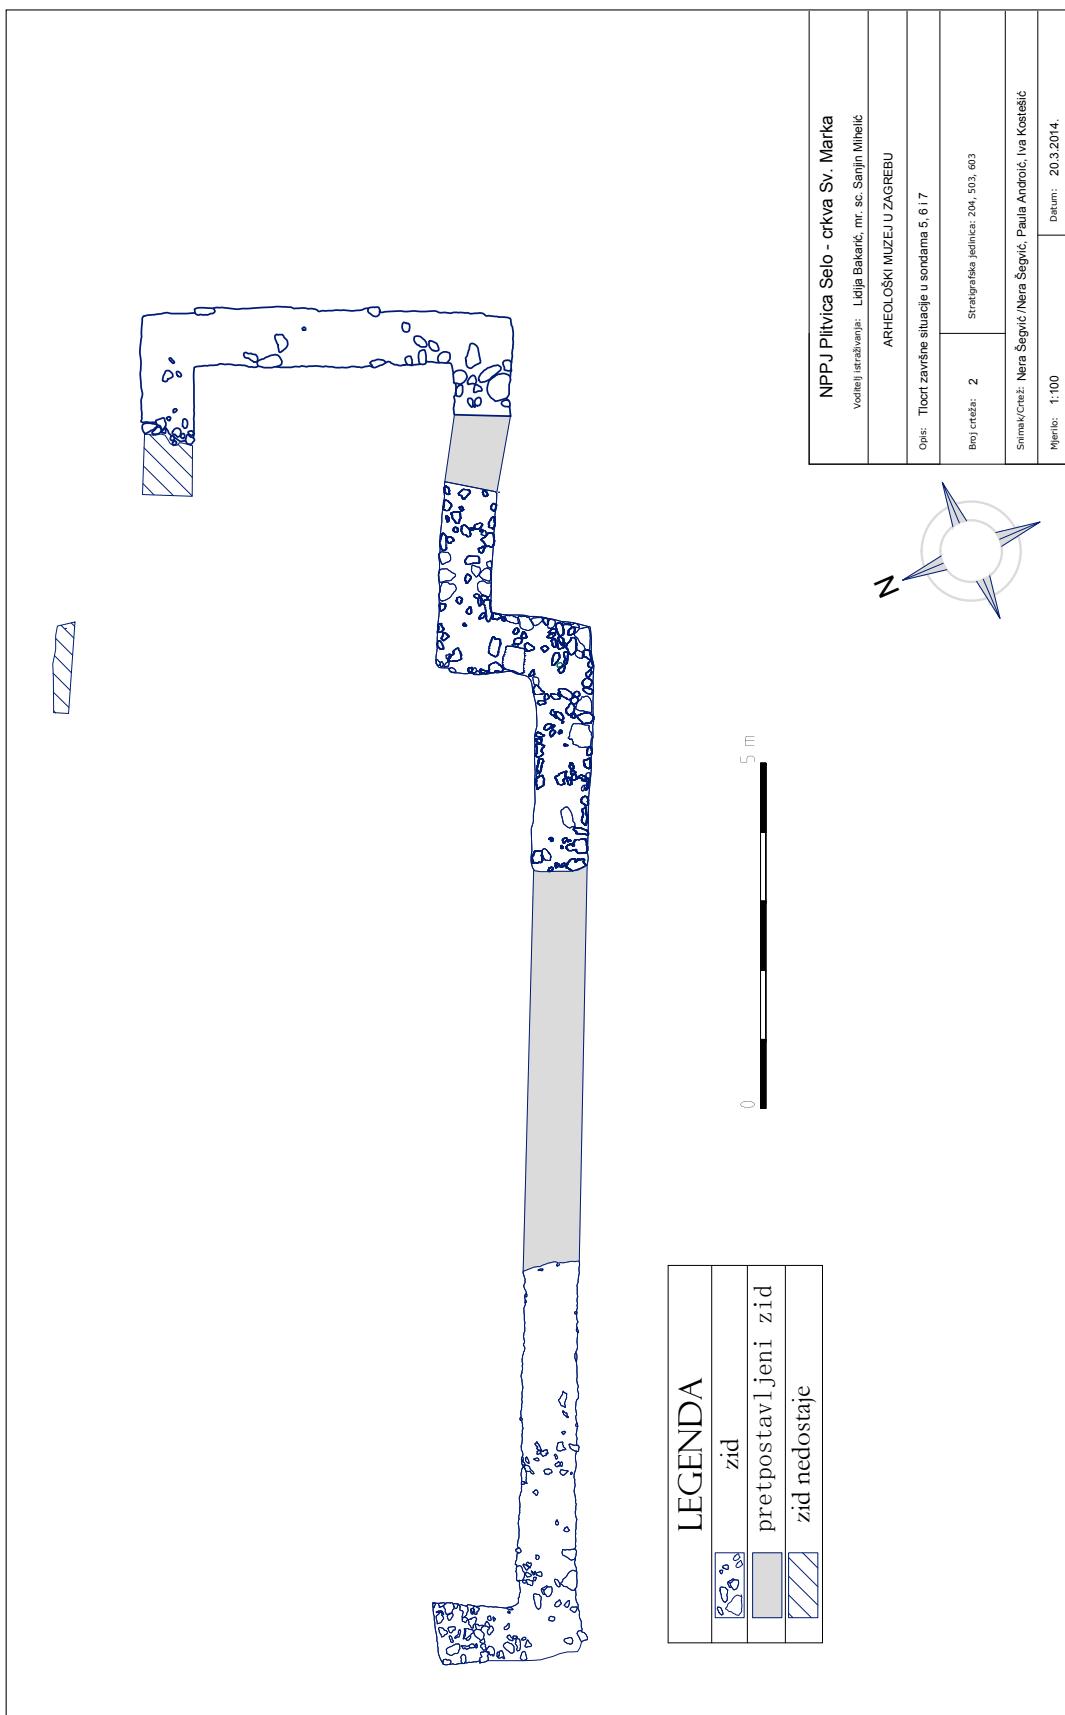
Tabla / Plate 2: Crtež otkopanih dijelova temelja zida crkve sv. Marka / A drawing of the excavated parts of the foundation walls of St. Mark's church (crtež / drawing by Nera Šegvić, Paula Andrić, Iva Kostešić; priredila za tisk / design by Iva Kostešić, 2014.)

Due to lack of time, the excavation was limited to the uncovering of the wall, with the aim of revealing the plan of the church while bypassing (potential) graves. Apart from a minor part of the south-western end, the church interior was not investigated. We followed the wall of the church in the width of 0.30 m at either side (the width of a shovel). With minor omissions in the excavation of the foundations (Sondages 2, 5, 6), we obtained the following plan: the church is oriented east-west with a 24° tilt towards south-east. The rectangular apse, narrower than the church aisle, is located in the east. The apse is 4.31 m long by 5.32 m wide, the aisle is 15 m long, but its width has not been ascertained. If we assume that the church had a regular plan, it would have been 7.85 m wide (Pl. 2 and Pl. 3).

The foundation of the wall of the entire excavated part of the church is 0.75–0.90 m wide and 0.30 m high. The surface of the excavated foundation wall is fairly flat, without grooves. The church foundations were built of roughly dressed stones bound with mortar. The western wall of the church, where the entrance was probably located, collapsed in a semi-circular manner. The debris consists of undressed and semi-dressed stones, as well as a few lumps of travertine. Since travertine is easily worked and above all light, it was probably used as a building material for the church vault. This is also the only type of stone found around the excavated portion of the foundation wall. Surface stones, as already stated, were removed to clear the land for cultivation. The northern foundation wall of the apse abruptly stops after less than 2 m, clearly because the stones were taken away. The purpose of Sondage 7 was to find the continuation of the northern wall, and it was revealed that it was missing.

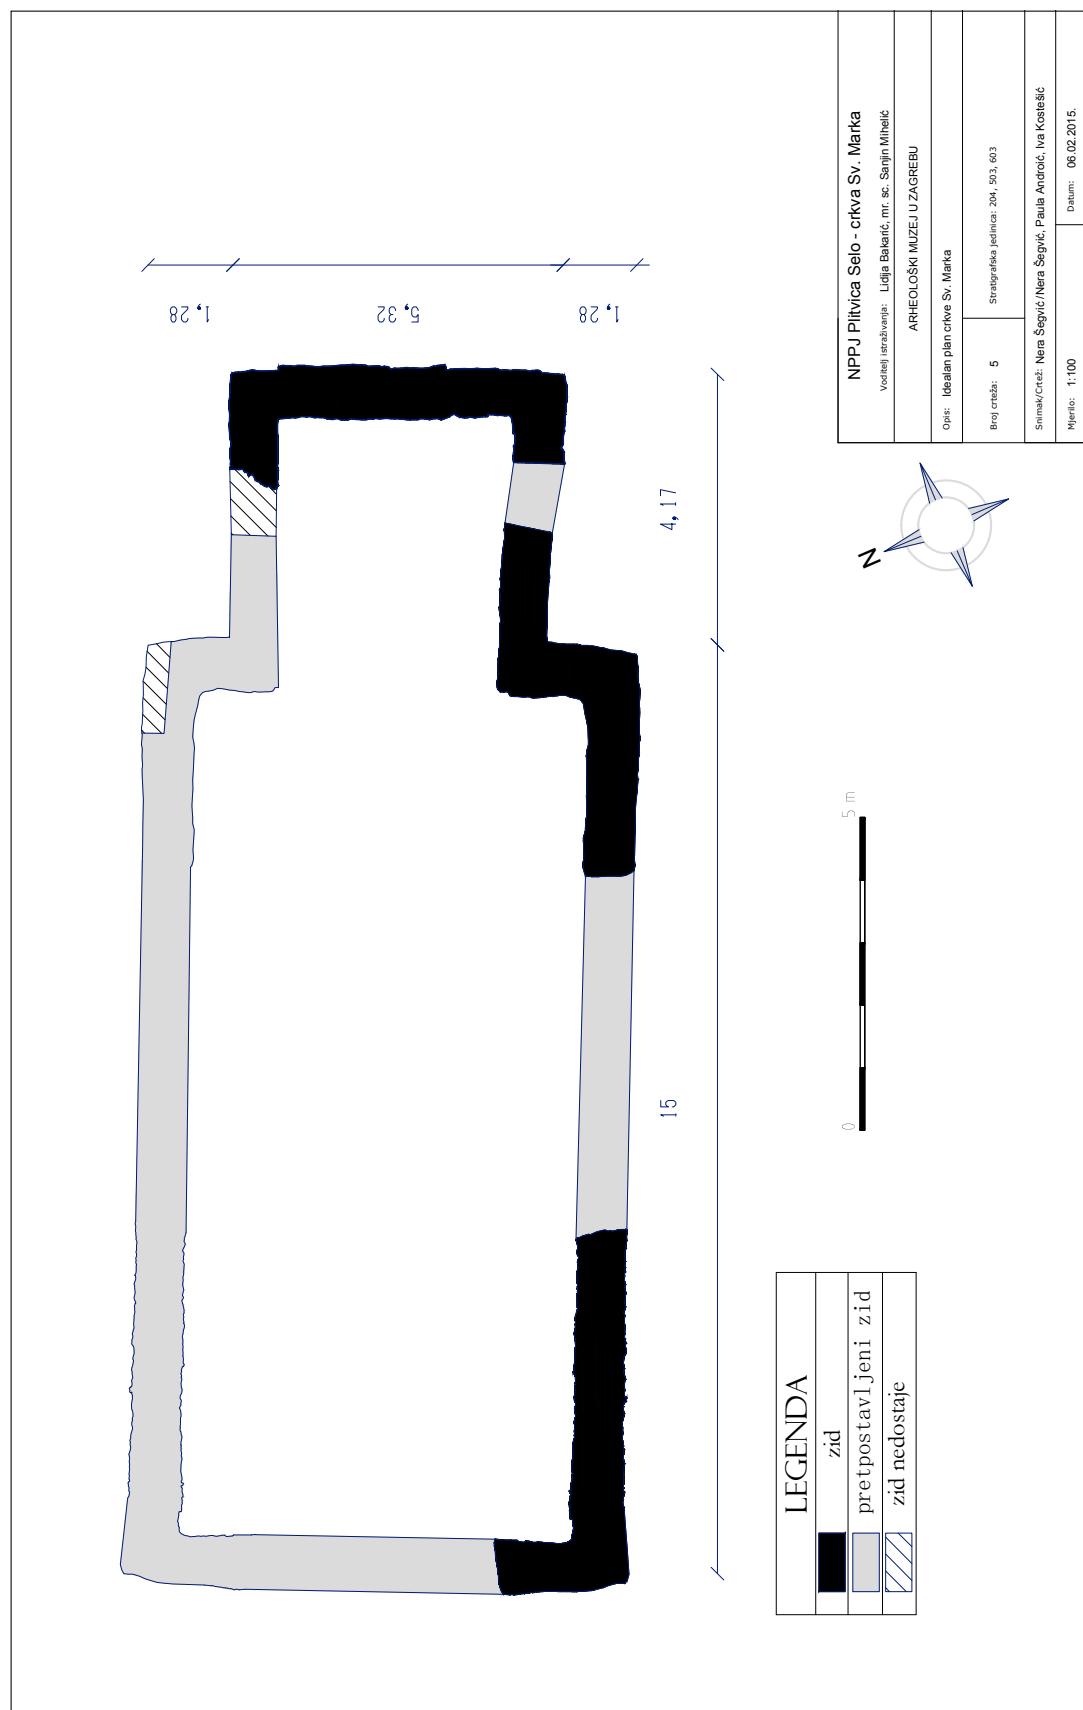
Tabla / Plate 3: Crtanje idealne rekonstrukcije crkve sv. Marka. Naznačeni su otkopani dijelovi zida temelja, pretpostavljeni dijelovi, kao i dijelovi zida koji nedostaju / A reconstruction drawing of St. Mark's church. The excavated portions of the foundation walls are marked, as well as presumed portions and the missing portions of the wall (crtež / drawing by Nera Šegvić, Paula Androić, Iva Kostešić; priredila za tisk / design by Iva Kostešić, 2015.)
