A research regarding the improvement of some operations that cause defects related to the suit production

UDK 687.01/.02
Professional paper

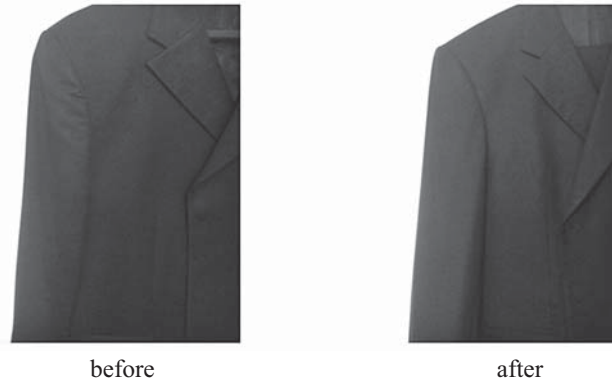
Fig.1 Taut arm problem

If wadding with proper size and thickness was not used, lining wristband and jacket wristband were discrepant with each other and taut arm problem was experienced. In order not to have taut arm problem wadding with proper size and thickness should be used. The photo of the jacket remedied after eliminating the factors that cause defect is shown in Fig.1.

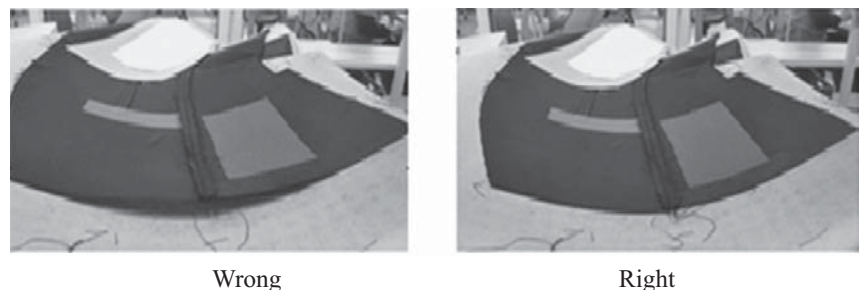
Fig.2 Front body and side cup positioning

As a result of placing side cup and front body on the form press tightly,

surface may be stretched and after the press it may cause ruffle. In order to remove this error, surface should be placed properly without pulling and pressed not so tightly. Photo related with correction is given in Fig.2.

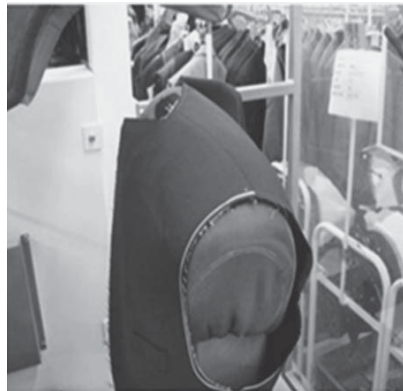
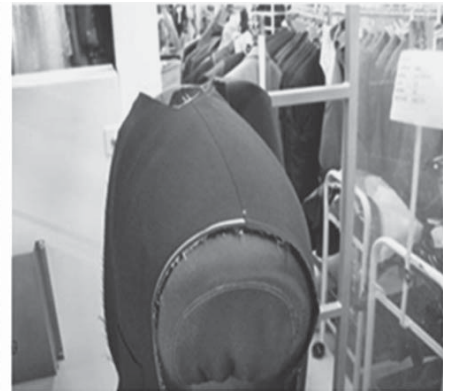
Wrong

Right

Fig.3 Wrong and right positioning of wadding to the press

Because of the wrong positioning of shoulder and wadding in the back armhole may cause recess appearance. When shoulder is placed from back to the front as shown in Fig.3 above, undesired recess appearance at the back is removed.

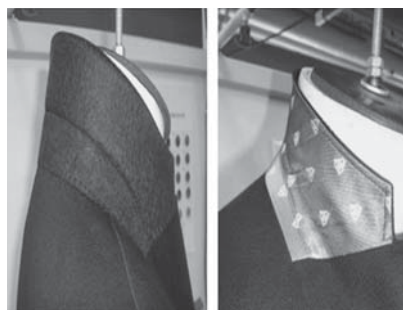
Fig.4 Felt and liner surfaces stitched under collar

Slippage of the satin fabric stitched under collar is an undesired situation. This problem occurs by the reason of slippery surface of satin fabric. Slippage is prevented by adhesion of the interlining tape between satin fabric and collar. An alternative solution is to use felt fabric instead of satin fabric (especially in wool jackets) and stitching with zigzag seam from the sides (Fig.4).

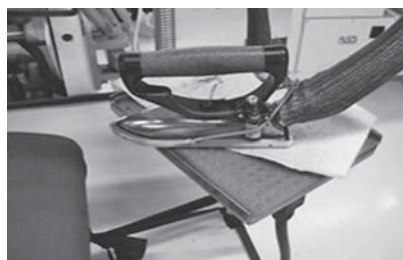
Fig.6 Placing felt under the iron base

Iron base is subjected to wearing caused by impact and friction to inappropriate places during taking or leaving the iron. This results in the wearing or impairment of the surfaces during the ironing.

Preventing the wearing that may occur under the iron base and decreasing the deformation of the fabric surfaces created by this wearing are purposed, as shown in Fig.6 above felt is put where the iron is placed.

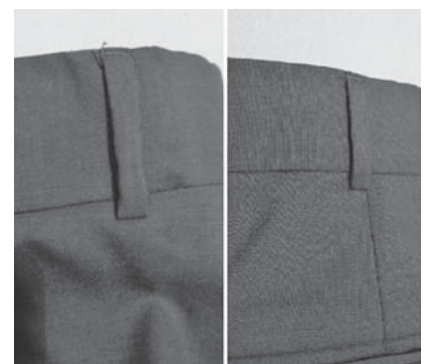
Fig.7 Pants belt loop correction work

At the end of stitching, choppy appearance and turning of the belt loops is an undesired situation. This error is more clearly observed with gossamers. In order to remove this turning, belt loops should have more harsh feel. For this reason loops are stabilized with adhesion of the interlining tape. In this context, undesired quality errors such as turning and shrinkage are prevented. Before and after

forms of the correction made in belt loops are shown in Fig.7.

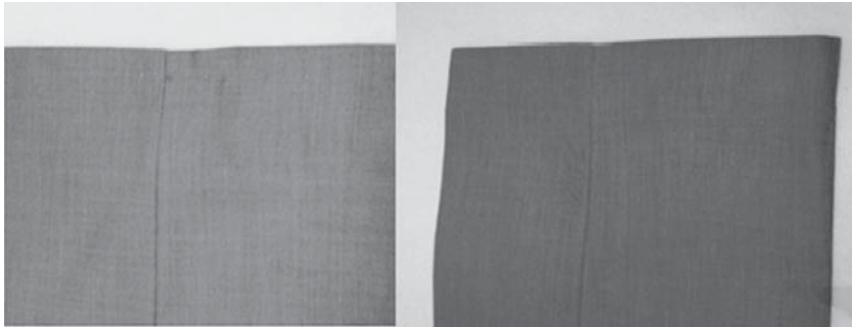
Fig.8 Trouser leg appearance after lapel operation

For twisting of trouser leg lapel sewing machine is used. With this machine, it is provided that the appearance of the sewing thread does not seem from the outside the fabric. However especially on thin fabric, it is observed that sewing thread appears on the surface of trouser leg and this also makes slight shrinkage appearance on the fabric.

In order to prevent this error seen especially on thin and satin fabrics, adhesion of the interlining tape is done to the region for lapel to be made. In this context as it is seen from the Fig.8. exit of the stitch to the outside is prevented and it is provided that needle take reference from interlining for the submerging distance from the fabric.
