Load growth coupled with aging transformers is a disaster waiting to happen

Advanced transformer condition assessment

Part II

Transformer lifecycle and risk assessment

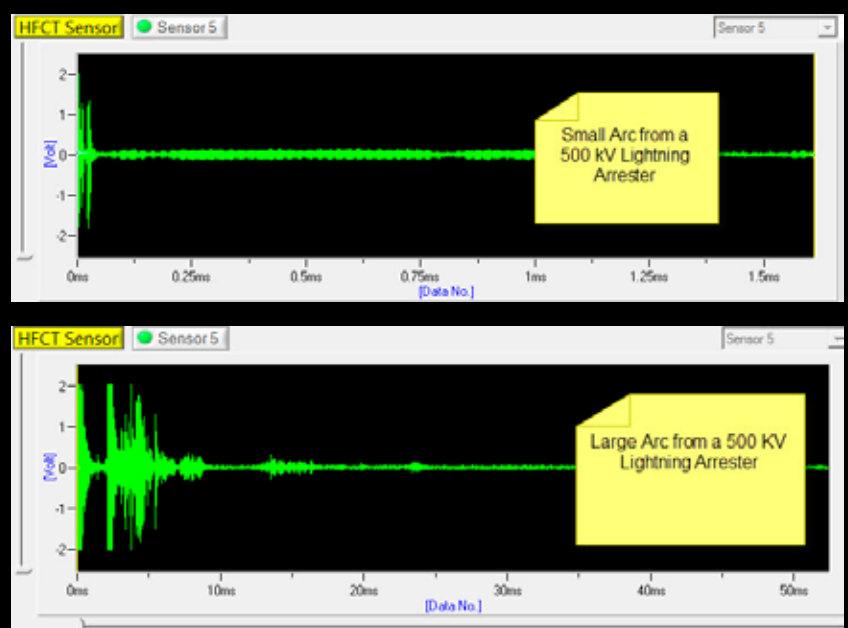
Figure 7. Screenshots of a 500 kV lightning arrester arcing at full voltage

The two screenshots in Figure 7 indicate internal arcing in a 500 kV lightning arrester (LA), energized at full voltage, and the test set is in the HFCT trigger mode. Twenty minutes is the agreed-upon test time that was determined by years of experience.

A good arrester will have no activity and indicate a straight line green trace on the scope

Normally, lightning arresters have no activity; if this arcing problem had not been detected and corrected early, the fault would likely have resulted in a catastrophic failure. This arrester was consequently removed from service, tested off-line and disassembled. Off-line testing (watts loss) was done at 10 kV and did not find the problem. Upon disassembly we found evidence of moisture ingress and major arcing. Testing LAs/SAs at full voltage is the best way for determining the health. Using infrared inspections while they are energized is the other recommended method for arrester testing. If the arrester is arcing, it will normally not display any heating. If it is heating, it will normally not be arcing. This is what my experience has shown. There may be a case where there is arcing and heating in the same unit, however, I have never seen it.

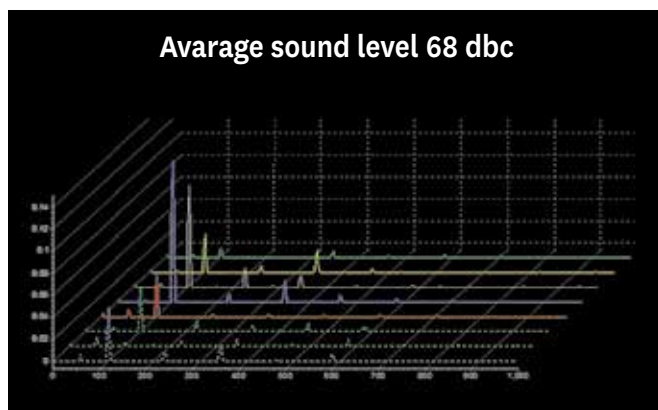
Figure 8. Normal, tight signature of an oil-filled power transformer. Note the sound level in “C” weighting

The transformer in case study 1 is a fully loaded 30 MVA transformer (Figure 8). Because of the angle of the plot, the first peak appears to be at 100 Hz; however, it is actually 120 Hz. The next peaks shown on the plot are all harmonics of 120, which are 240, 360, 480 and 600 Hz. Notice the amplitude is only 0.14 inches per second (3.56 mm/s).

Case study 1: Normal oil-filled power transformer - waterfall plot

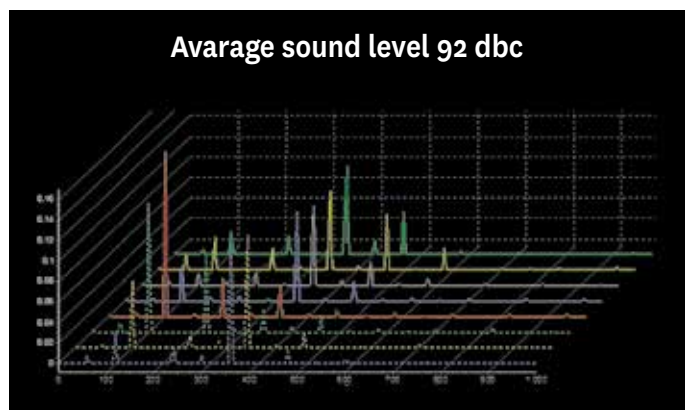
Figure 9. Typical loose signature with accompanying increase in sound level. Note the energy shift to the right

The transformer in case study 2 is loaded to approximately ½ load. Notice the shift

in the spectrum out to 360 Hz and the increase in sound level to 92 DBC. The sound level is always increased when the transformer is loose. Notice also that the 120 Hz has dissipated where the energy has shifted.

Case Study 2: Loose core form transformer

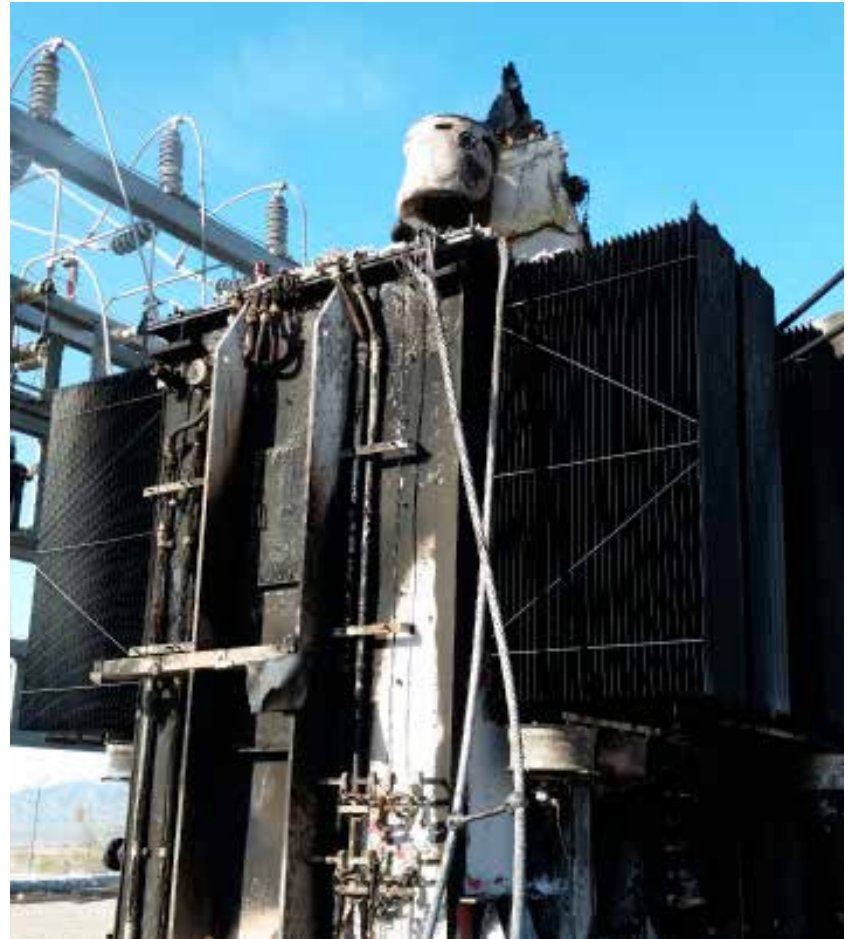
Figure 10. Catastrophically failed 500 kV transformer

Figure 10 shows a 500 kV transformer that failed catastrophically, with smoke still coming from the bushing mounts. Its sister transformer, which is 40 feet (12 meters) away and still operating, has been tested showing PD and arcing. Although these issues are different from those on the failed transformer, they will have to be addressed soon. The burst interval for the operating transformer is 4 milliseconds.
