# THE CONSERVATION HISTORY OF MOSAIC PAVEMENTS AT THE CATHEDRAL SITE IN POREČ: 1862-1990

ANN TERRY

Original Scientific paper

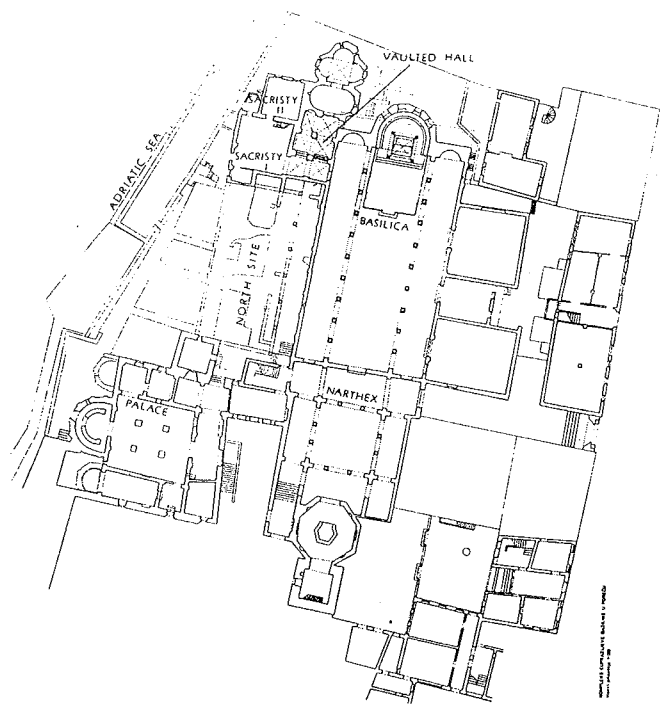
Fig. 1: The Cathedral Site at Poreč, ca. 1960, Annotated (Courtesy of the Institut za povijest umjetnosti, Sveučilišta u Zagrebu, planoteka 2899)

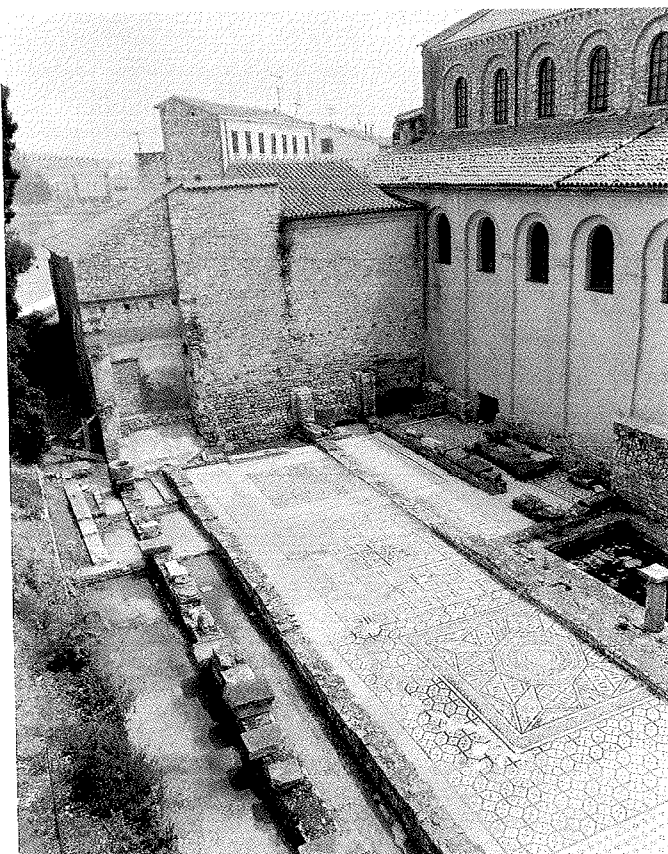
Fig. 2: The North Site, 1994 (Photo: Author)

several earlier phases of building.<sup>2</sup> Chief among these are mosaic pavements from at least three and possibly four different periods: Eufrasian, Pre-Eufrasian (fifth century), First Basilica (late fourth century), and, possibly, Roman (third or early fourth century).<sup>3</sup> Pavements from the First Basilica and the Pre-Eufrasiana survive in abundance. Most are located at the north site (Fig. 2), an enclosed area between the basilica and the sea

a report in which an embattled Tommasi tried to stem the rising tide of expert opinion opposed to his plan (1899-D#1807). The surface of the mosaics were extremely uneven, as the penetration and run off of sea water produced bulges and depressions. Many tesserae had detached from a base that was largely decayed. The colors of the stones were changing because they lay on damp ground which regularly flooded with high tide. In Tommasi's vision, Moro-Lin would make exact drawings of the pavements, and the tesserae would be lifted and placed on a new bed of concrete exactly as they had been originally, except 40 cm higher. Walls and other features, such as thresholds, would remain *in situ*. Tommasi's fear that the mosaics faced certain destruction was well founded, but his final plea indicates he misunderstood the archaeological nature of the objections (1900-D#0302). Given that the coast of Istria is "sinking" (rise in sea level), and the pavements no longer lay at their original level anyway, he argued, what would it matter if they were raised (1900-D#0302). The experts enlisted by the CCD prevailed in 1900, when a ministerial decree specified that the pavements were to remain *in situ*, and approved necessary repairs only (1900-D#1105). Thus, the work done during the Austrian administration involved excavation, cleaning, and restoration *in situ*. The final mention of pavements in the Austrian documents, in 1908, concerns arrangements for their viewing (D#1705). It appears in the context of a discussion of the cistern to the north of the basilica, which, filled with earth, rose high above the pavements of the north site. The document includes a sketch of the arrangement by which one viewed the pavements. As shown in Fig. 9, access to a construction with a shed roof and windows was provided by the rubble-filled cistern, sandwiched between the pavements and the basilica.

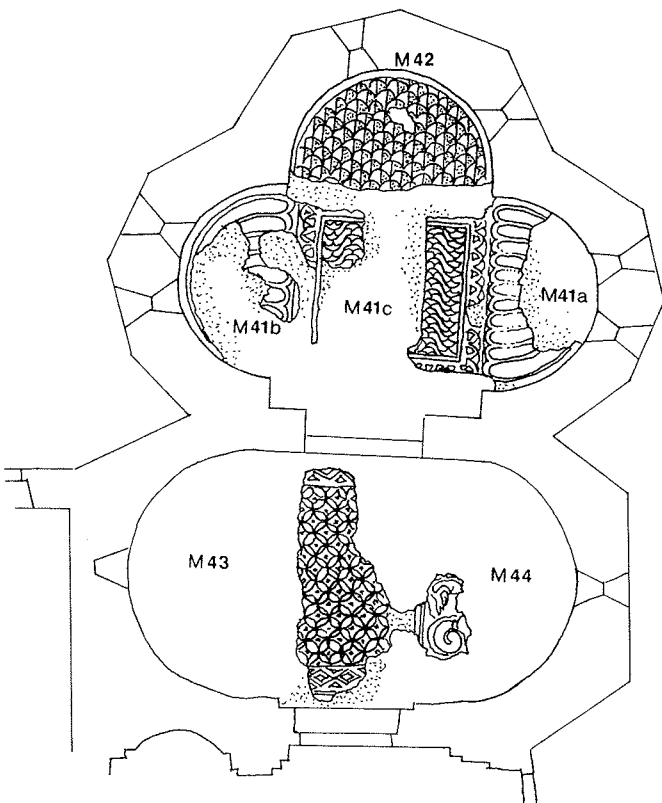
Fig. 5: Plan of Eufrosian Mosaic Pavements in the Cella Trichora, Redrawn from Piazza (1939), and annotated.

<sup>17</sup>For M47, see MOLAJOLI, *La basilica*, 54, fig. 78. Several additional tracts of Eufrasian pavement, conserved *in situ* under the Italians, survive in the *cella trichora* (M41-44; Fig. 5); see MOLAJOLI, *La basilica*, 60.

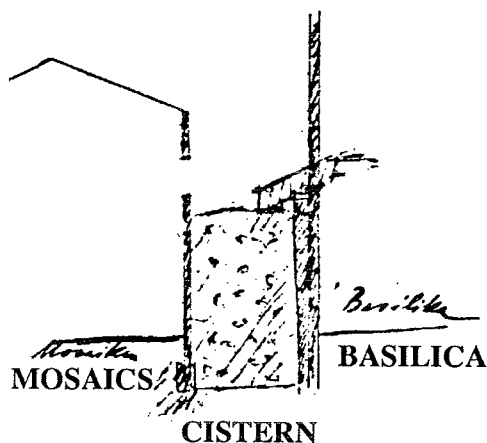
Fig. 9: Sketch of Arrangement for Viewing Mosaics (D#1705, 1908), Annotated

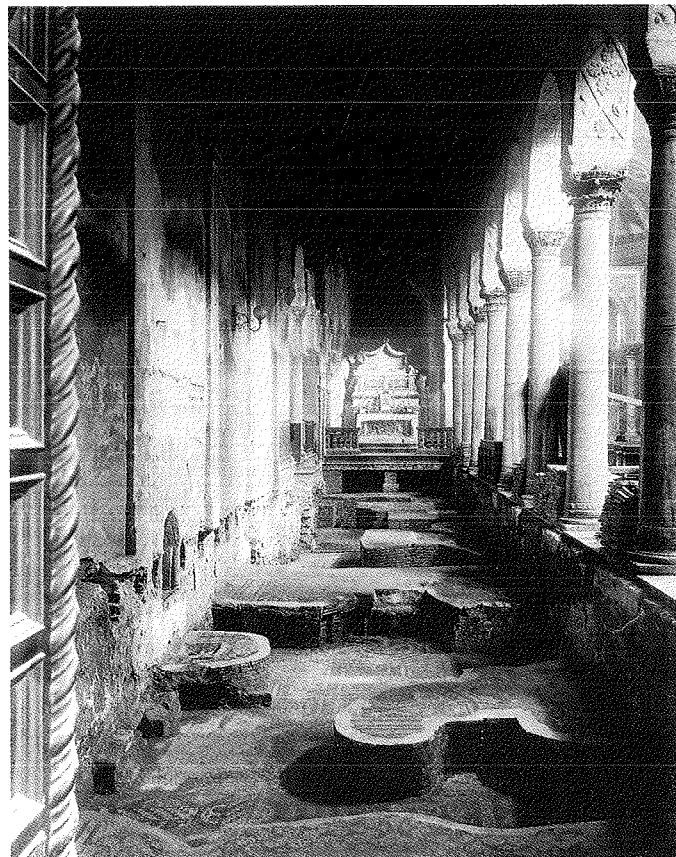
Fig. 10: Mosaic Pavements under the North Aisle, 1921 (Photo 307: Soprintendenza-Trieste)

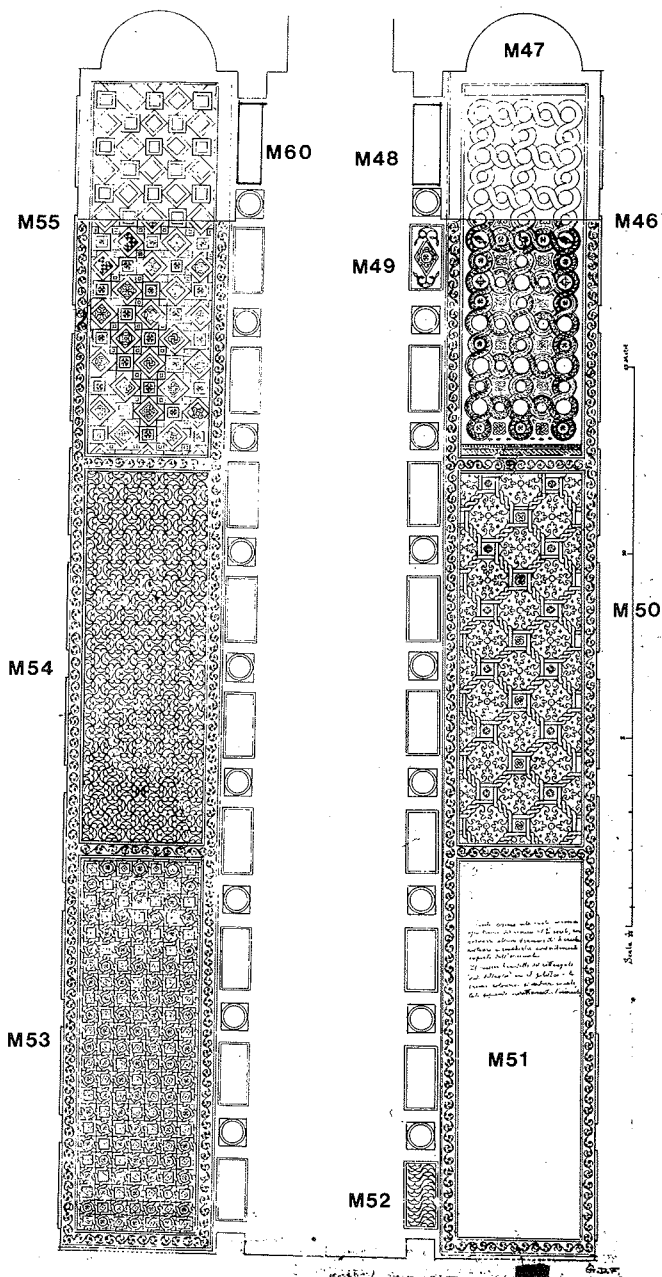
Fig. 7: Plan of Sixth-Century Eufrasian Mosaic Pavements by De Franceschi (before 1880), Annotated (Photo: Soprintendenza-Trieste)

<sup>13</sup>About De Franceschi's drawing, see B. MOLAJOLI, *La basilica*, fig. 77, p. 54. Additional evidence is preserved at the Millet collection at the Sorbonne in Paris. The materials of Professor Gabriel Millet, who excavated at Poreč in 1901, are preserved in an archive at the *Centre d'Études Gabriel Millet - Photothèque (École Pratique des hautes études- Sciences Religieuses)* at the Sorbonne in Paris. Included are copies of finely detailed drawings of several of the Eufrasian panels. These are not identified, but they appear to be related to De Franceschi's drawing. Certainly by 1901, these Eufrasian panels had disappeared. For information about this archive, and assistance in making inquiries, I am grateful to Nora Laos and Slobodan Čurčić of Princeton University. I am also deeply indebted to Dominique Couson-Desreumaux, curator of the collection, who has given most generously of her time and expertise.

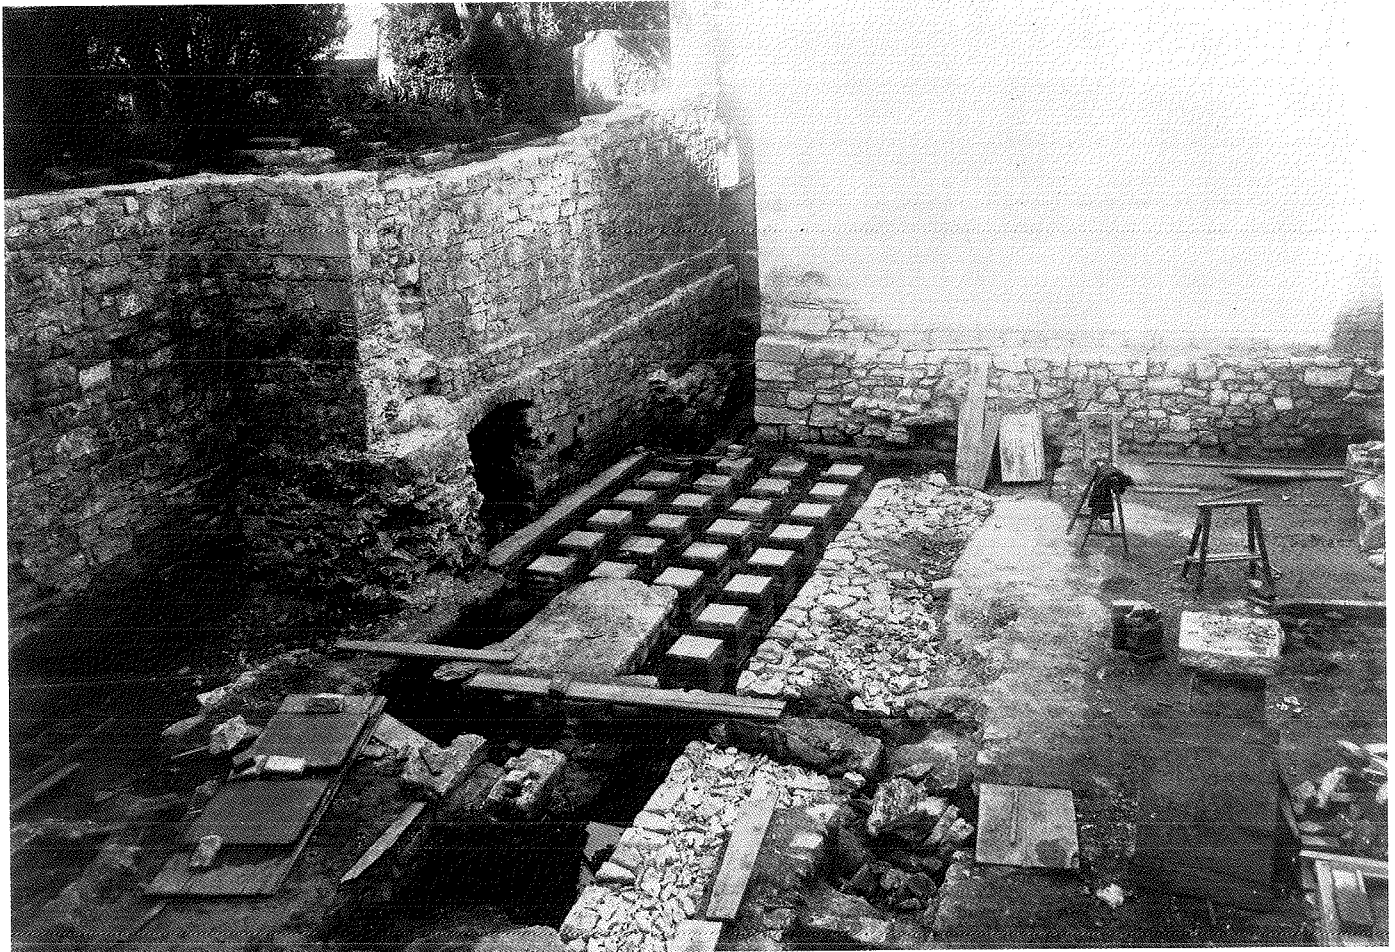
Fig. 12: Restoration of Mosaic Pavements at the North Site, 1924, View to East (Photo: Soprintendenza-Trieste 1742)

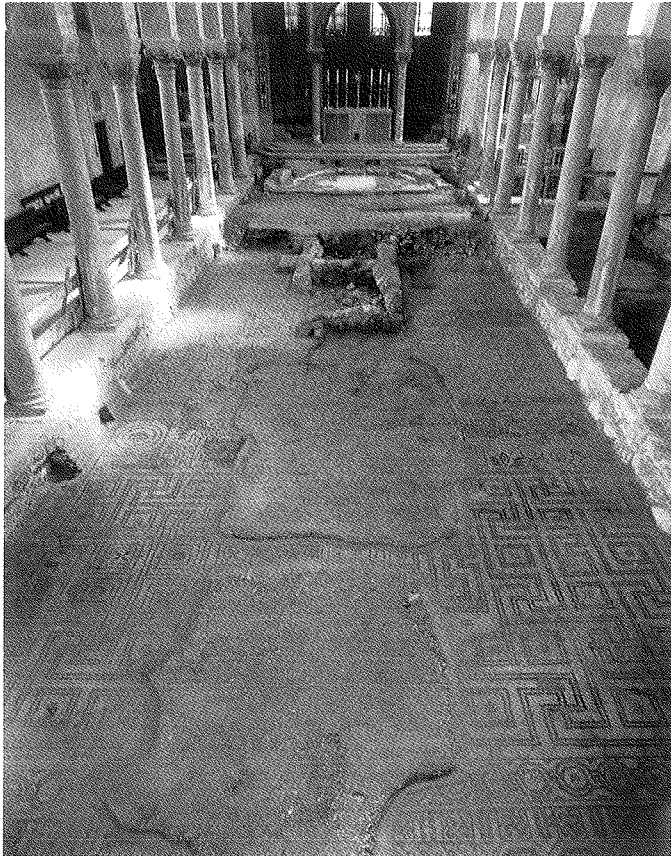
Fig. 13: Pre-Eufasian Mosaic Pavements Under the Nave of the Basilica, 1936 (Photo: Soprintendenza-Trieste 1742)

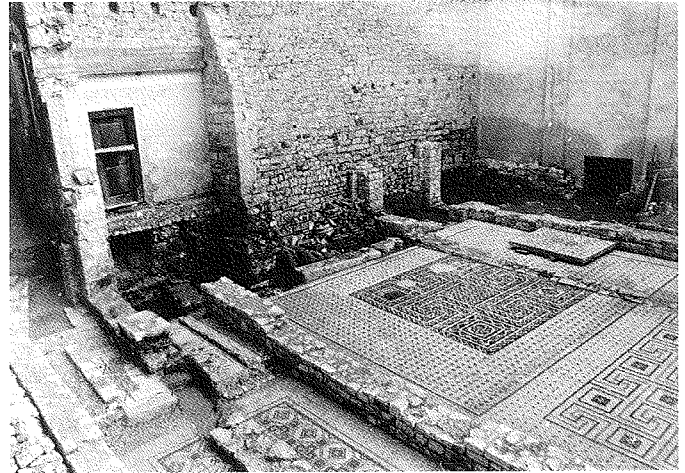
Fig. 14: North Site Mosaic Pavements, Replacement copies, after 1968 (Courtesy of RZZSK), M39-40, lower left

Some pavements excavated by Šonje, and attributed by him to the First Basilica, were restored *in situ*, such as: the expanse of M38b, paving with large brick tesserae; M38a, a small inset panel with colored tesserae; the northern halves of M39-40, which were very heavily restored and remade (Fig. 14).<sup>48</sup>
