UDK 528.47:551.311.21:(282.24)Dunav)  
Review / Pregledni znanstveni članak

# Geodetic Mobile Survey Methods for Riverbank Erosion Observations

Luka BABIĆ, Boško PRIBIČEVIĆ, Almin ĐAPO – Zagreb<sup>1</sup>

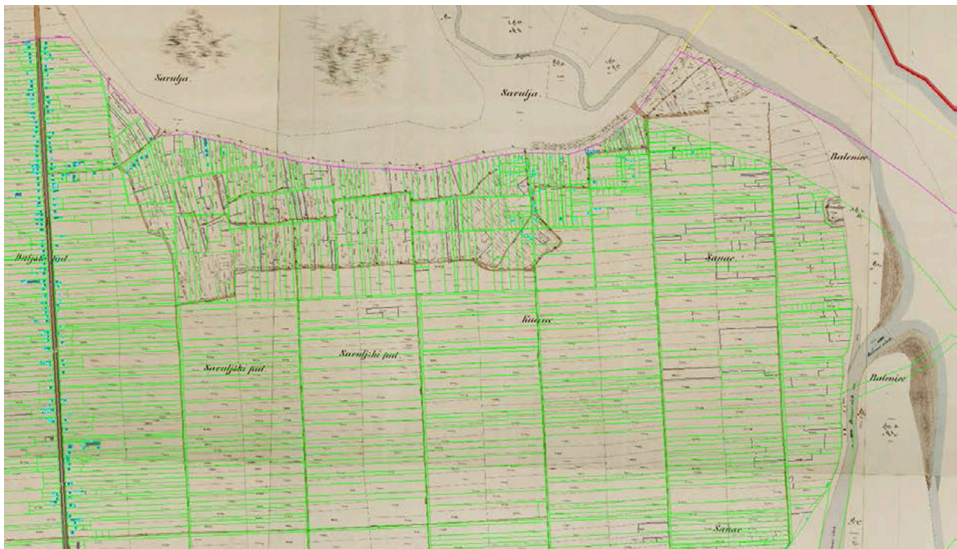
Figure 3. Latest cadastral plan made in the period of 2008–2010 (DGU 2014) (green lines; vectors) overlaying the 1963 plan (graphic representation) is 250–300 m shorter in the coastal area (upper right side).

For determining locations of Danube’s greatest migrations, an overview and analysis of historical maps and plans had to be made. Hence, cartographic representations dating all the way from 1733 were obtained to ascertain those locations. Atlas of the Vukovar Landownership (Figure 2) and its accompanying documentation have long had applicable value, and today it is the oldest, the most comprehensive and the only cartographic source for the Vukovar landownership from the first half of the 18<sup>th</sup> century (Poslončec-Petrić 2006). All plans, apart from the general plan, were made at the same scale that is graphically presented in Vienna fathoms. But even so, the scale and detail of the Atlas were still low in comparison to cadastral maps. Thus, it was only possible to use it as a starting point for investigative actions. For a more detailed and precise identification of migration locations and their amounts, 1863 cadastral plans were used (Figure 3).

Precision and accuracy of those plans is more than adequate from the standpoint of river migration investigations. Even more importantly, survey methods, dimensions and scale of those plans are well documented. Furthermore, representations on the plans have a clear correlation to most recent plans, which allowed for precise dimensioning and georeferencing. The resulting analysis produced discrepancies in excess of 200 m, and even up to 300 m in some areas (Figure 3). Considering the 150-year period, it amounts to an annual riverbank dislocation of up to 2 m/yr. Still, this is an average amount and not an indicator that the coastline actually moves to that extent each year.

As can be seen from the above image, erosion of riverbank is excessive and has a high cutting trend on river bends where the flow direction is deflected away from Croatian coast (left bends). But, at the same time, deposition trends of similar magnitudes can also be observed on areas where the river turns back toward the Croatian coast (right bends). The problem lays in risk to property as well as human life from further bank erosion events, as can be seen from Figure 4.

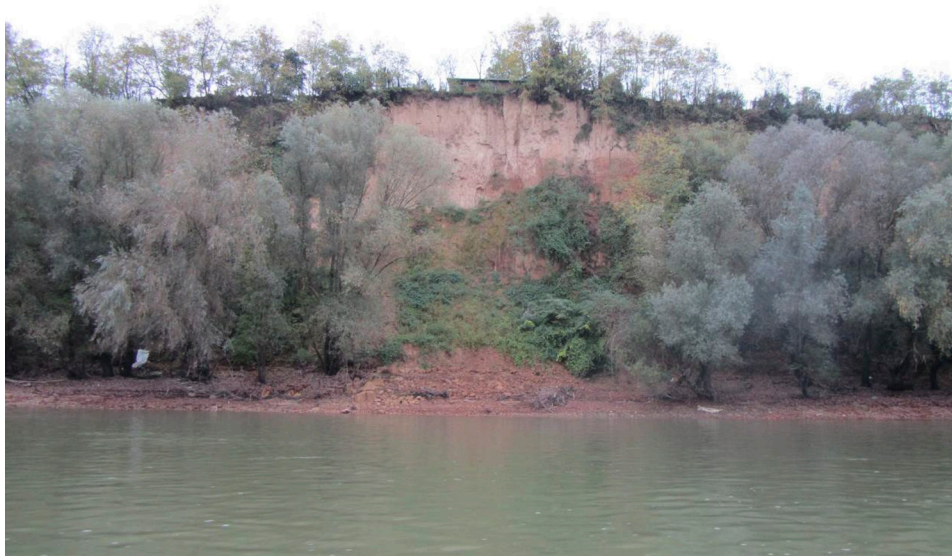
Figure 4. *High loess bank with manmade objects near the edge of the cliff.*

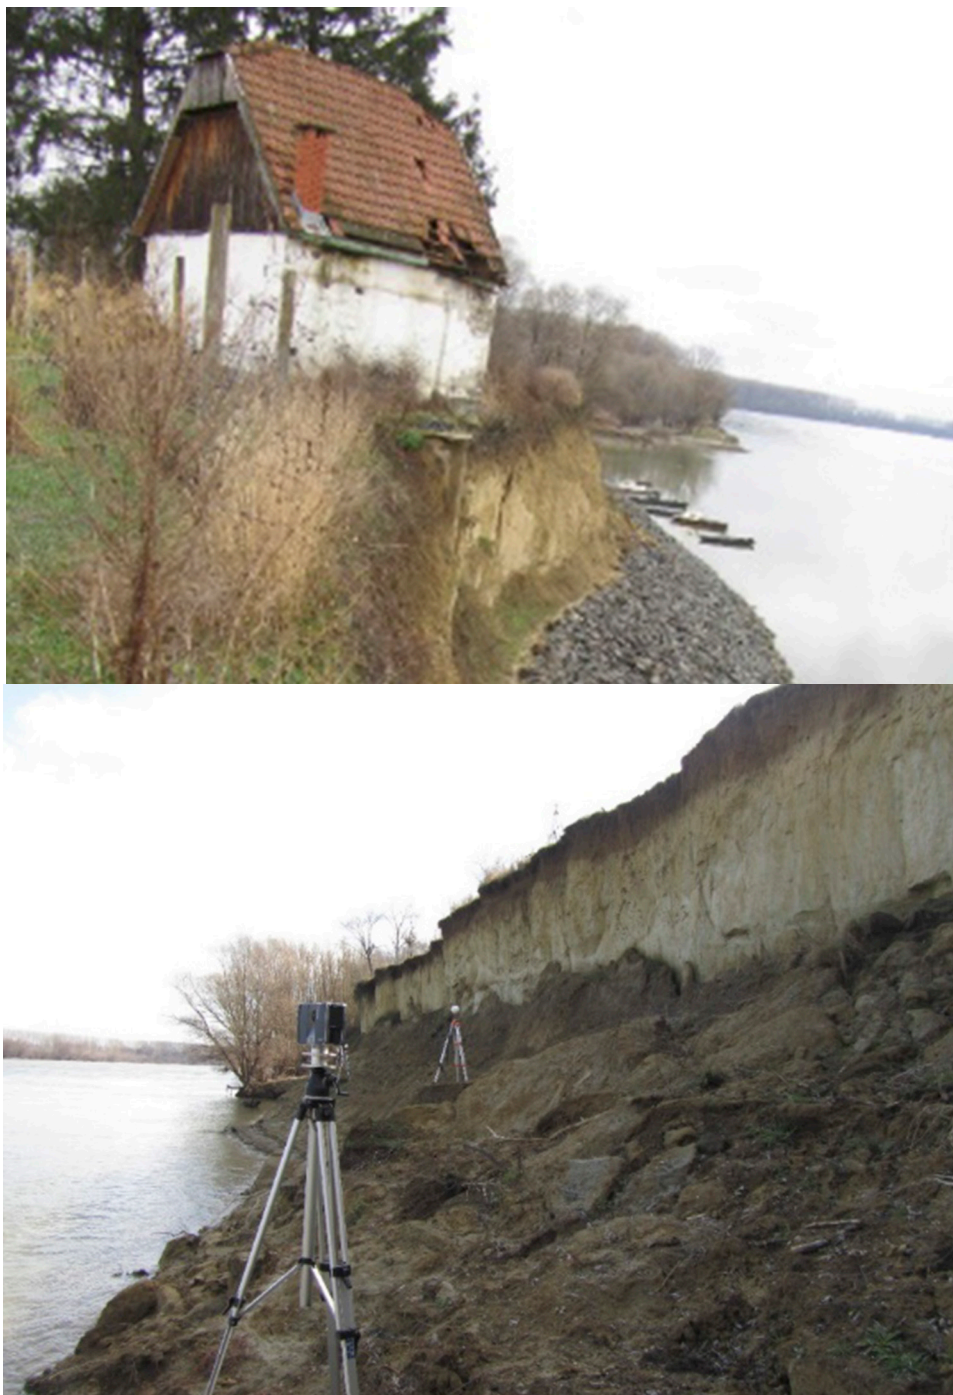
Figure 5. Vacation home endangered by erosion (left) and laser scanning of the bank (right).

Settlement Savulja, near Borovo Naselje, mostly comprised of vacation homes, was one of the locations chosen for investigative works. Two primary reasons were its accessibility by land vehicle, and, above all, the high erosional trends observed from historical overview. Since “the best” position for a vacation home is next to a water front (in this case a river), the risks accompanied by such positioning are easily discernable when the river in question has a high erosional rate like in the case of Danube. In Figure 5 (left) the problem and property damage resulting from such positioning is obvious. There are numerous other similar settlements on Danube's shores facing events that can and, eventually, will result in, primarily, property damage but also pose a danger to human lives.

As TLS, in terms of accuracy and comprehensiveness, has been greatly explored, it was used to create a reference base and precisely determine the extent of changes on the site. To enable cross referencing with subsequent MLS surveys, georeferencing

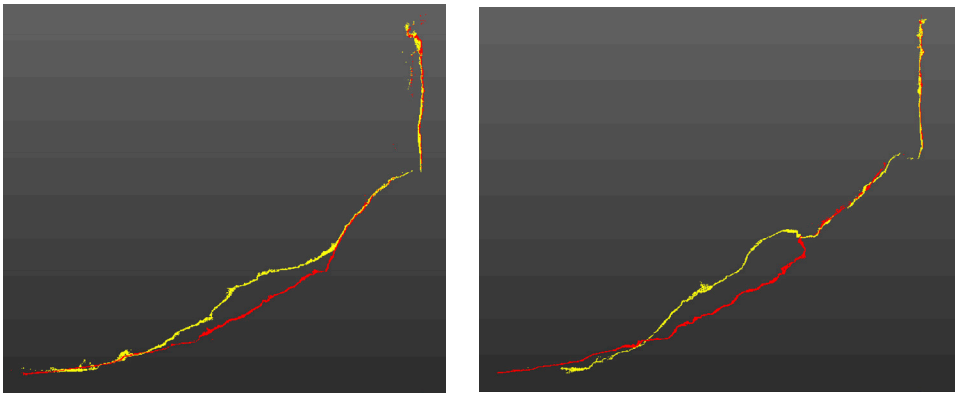
Figure 6. Cross sections produced from two sessions of survey.

Surveys were conducted during low water levels prior and following high water level events. During the length of the project (September 2013 to September 2015) there were no significant (flood) water level events that would have caused substantial material displacements and caused major bank collapses easily described in results. Despite such conditions, changes were observed on lower parts of the bank (Figure 6). This clearly shows that there is a constant erosional process at work even during lower water levels. Surface point to point horizontal and vertical differences observed were up to 1.5 m and 1.7 m respectively.

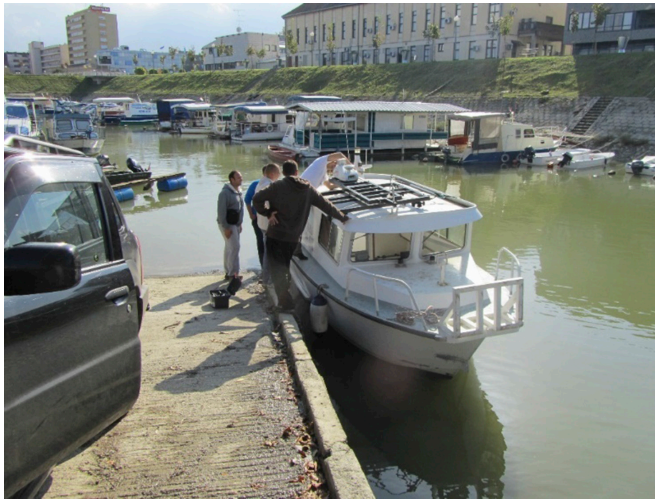
Figure 8. *MDL mounted on a boat.*

cost system in terms of MLS systems price ranges. The system was mounted on a boat (Figure 8), and CROPOS was used for geolocation and data georeferencing. Since the same service was used for TLS positioning (georeferencing) previously, this allowed easy placement of both data sets into the same coordinate system and provided comparable accuracy and precision. Boat based setup allowed fast approach and easy access to even the most demanding sites as water approach capability is, unlike land approach, always 100%. Not only that, but the survey vessel moves along the coast and is not wasting time doing round trips like the ones that would have to be made using land vehicles.

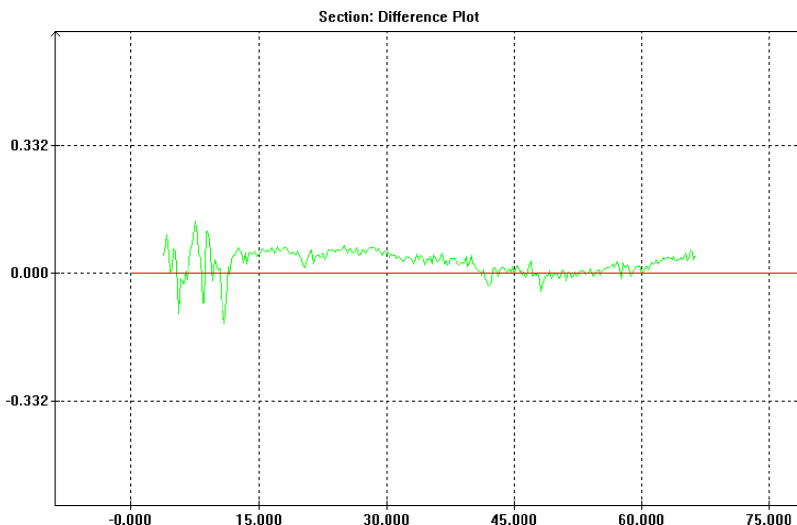
Figure 9. *Surface to surface analysis on a bare cliff face.*

The resulting clouds acquired through mobile survey were then overlapped with the clouds obtained using TLS. The main issues during overlap were the noise and vegetation cover obstructions causing differences in comparison where, in reality, there are none. Another issue was the level of detail (resolution) obtained using these two systems. The gathered data had to be “cleaned”, meaning the unwanted points had to be removed to allow for adequate comparison. The resolution plays a great part here as the greater the resolution the easier it is for unwanted data to be identified and removed. Since the research area was mostly vegetation free, the minimal amount of “cleaning” was necessary. The analysis of the data showed that the two clouds had a medium of 5 cm discrepancies between them (Figure 9). This was even better in some (clear) areas, but worse in others, where vegetation obstructions were an issue (Figure 10).
