Monitoring, diagnosis and fault

finding on a power transformer

Experiences and challenges during monitoring, diagnosis and evaluation

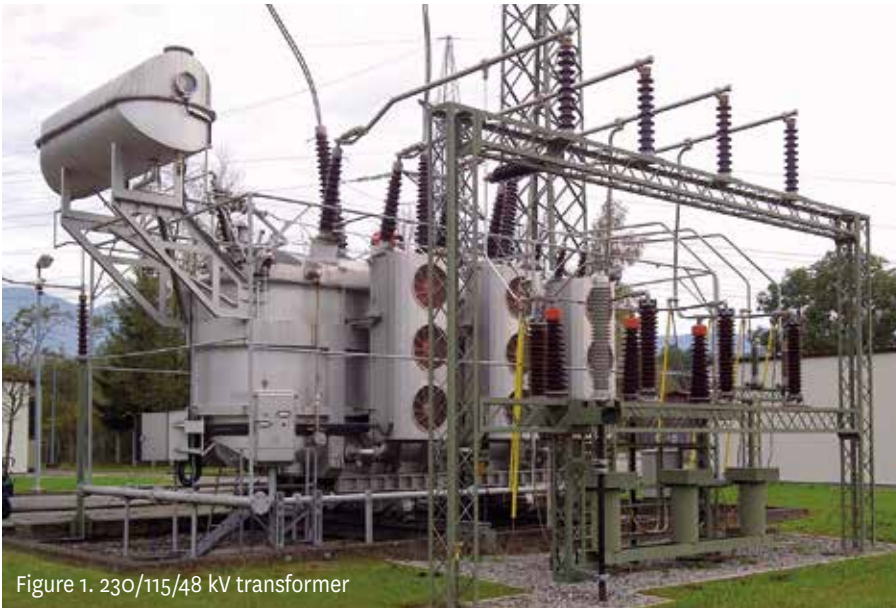
A monitoring system was mounted on a 130 MVA transmission transformer with 230/115/48 kV because of high hydrogen and methane concentrations dissolved in the oil, detected by the Dissolved Gas Analysis (DGA) (Fig. 1). The system contained a gas sensor for four fault gasses. Additionally, Partial Discharge (PD) measurements were performed with sensors at the bushing

Figure 1. 230/115/48 kV transformer

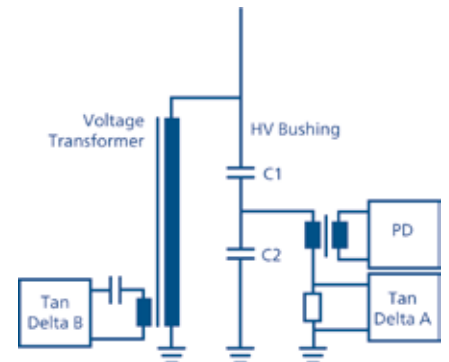
Figure 3. System for the simultaneous measurement of capacitance, dissipation factor and partial discharges

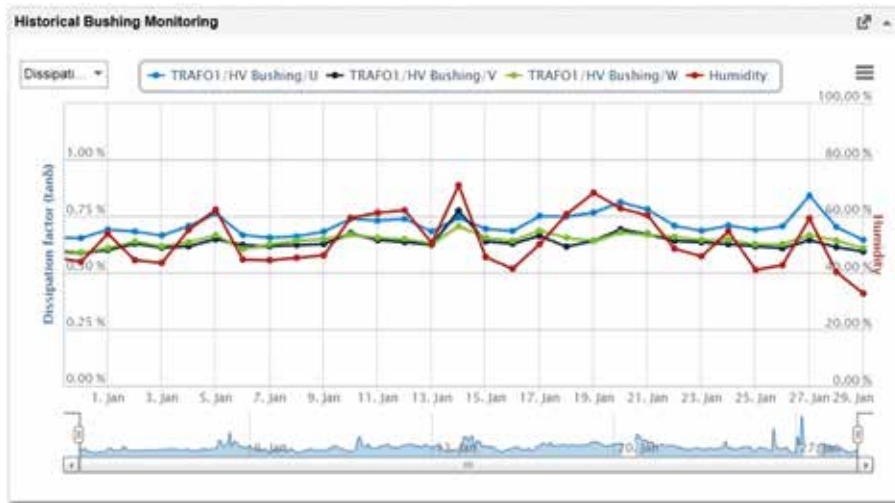
The diagnosis of the bushing was performed by analyzing the capacitance and dissipation factor trends, their magnitudes and rates of change. Additional off-line diagnosis is recommended in cases when the capacitance and/or the dielectric dissipation factor values rise significantly. Fig. 4 shows the trend diagrams of DF and the ambient humidity at the monitored bushings. It can be seen that the DF slightly increased when a high humidity was recorded, which may have been caused by moisture on the surface of the bushing’s insulators. The results showed that the bushings seemed to be in a good condition. The monitoring system consisted of one acquisition unit connected to the bushing’s taps and to an UHF sensor at the oil drain valve, and one acquisition unit connected to the voltage transformers. The scheme of the whole monitoring system is shown in Fig. 5.

Figure 4. DF trend of 3 phases and trend of humidity (red line) with absolute measurements

“The dissipation factor slightly increased when a high humidity was recorded, which may have been caused by moisture on the surface of the bushing’s insulators

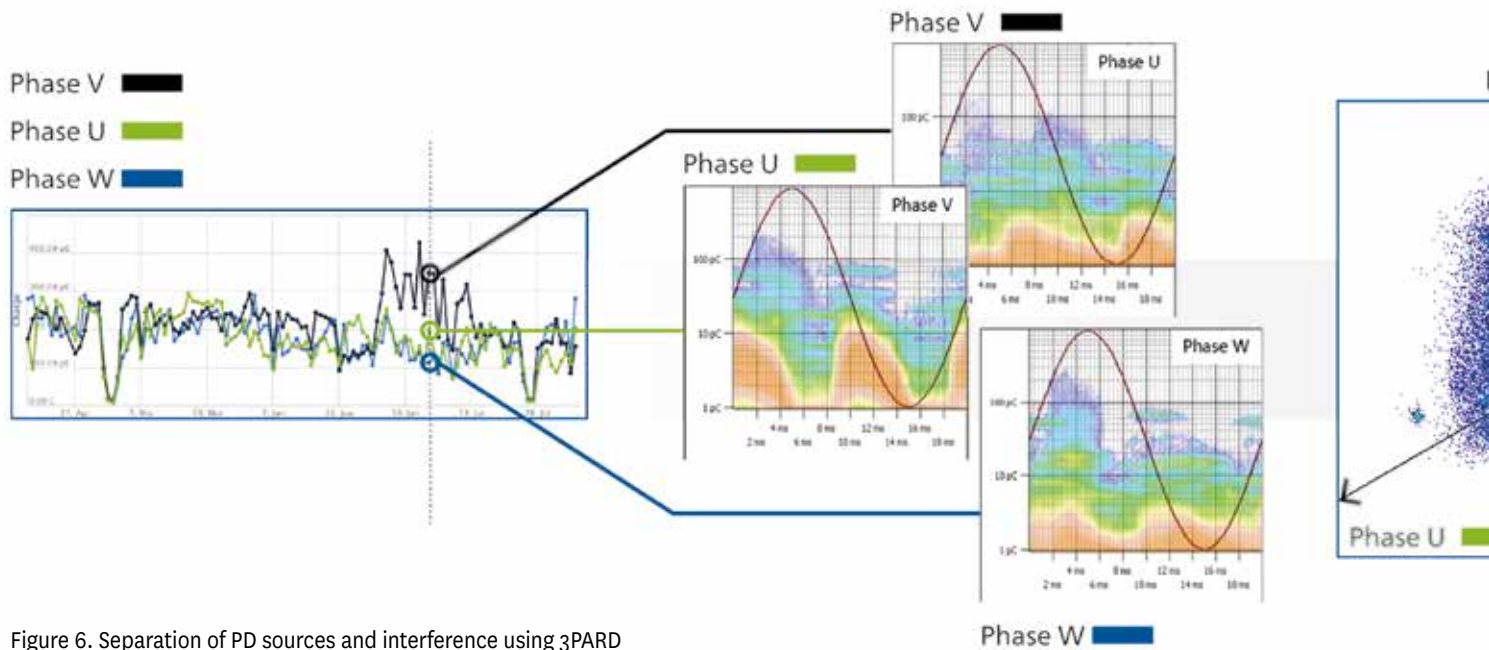
6). In order to separate clusters of different PD sources, a synchronous multi-channel PD evaluation technique was applied [5]. The 3PARD diagram visualizes the relationship between amplitudes of a single PD pulse in one phase and its crosstalk signals into the other two phases. By repetition of this procedure for a large number of PD pulses, PD sources as well as noise appear as a clearly distinguishable concentration of dots in a 3PARD diagram. By examining individual clusters in the 3PARD diagram, a separation between noise and PD phenomena is possible. The back-transformation to PRPD patterns of the clusters 1 and 2 is presented in Fig. 6.

Figure 6. Separation of PD sources and interference using 3PARD

In Fig. 6 the patterns of the phases U, V and W are shown without filtering and with 3PARD filtering. The pattern of the cluster 1 in the 3PARD diagram indicates the presence of partial discharges at phase V. The highest amplitude of the signal was detected at phase V, but signal crosstalk to phases U and W is also visible. The PRPD pattern of the cluster 2 in the 3PARD diagram appears to be generated by partial discharges in the vicinity of phase W. The other clusters visible in the 3PARD diagram are most probably generated by external interferences.

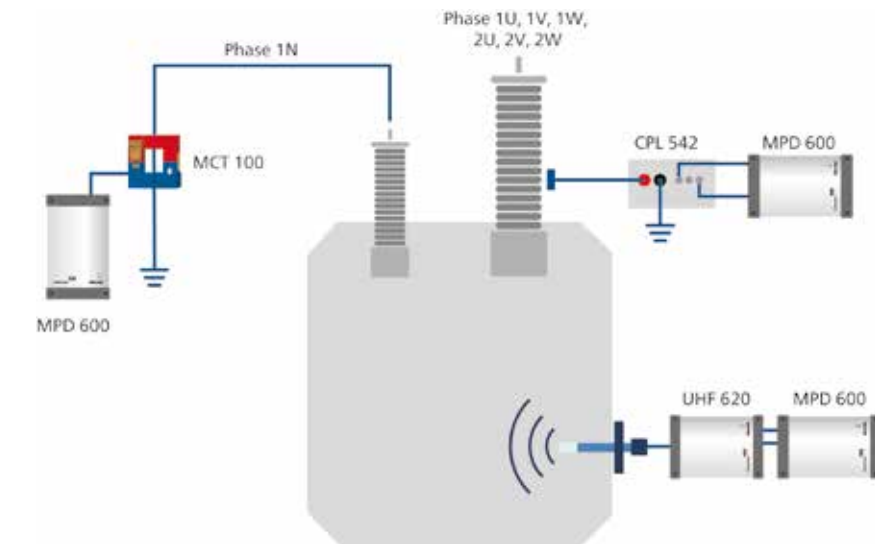
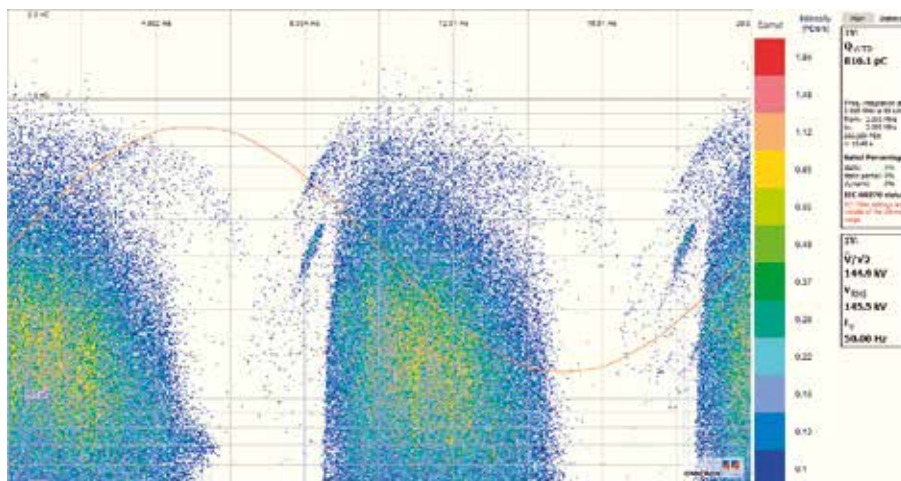
Figure 8. PD patterns at bushing phase 1V

The PD patterns measured with MPD 600 showed good correlation to the results of the monitoring system. Fig. 8 shows PD patterns at bushing phase 1V.

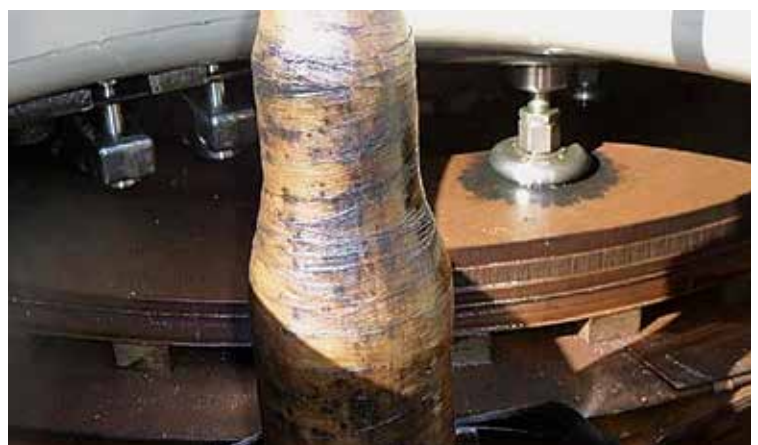
The bushings were removed and the damage at the leads between windings and bushing could be seen (Fig. 11). Due to partial discharges, X-wax was produced at the insulation paper and inside the windings. X-wax is a solid material which is formed from mineral oil as a result of electrical discharges and which

Figure 11. Traces of PD at the bushing lead

consists of polymerized fragments of the molecules of the oil. If it is built inside the oil ducts, the cooling of the transformer can be blocked.

A repair of these faults would have meant that the transformer had to be rewound at least partially, at worse completely. Due to the age – the transformer was built in 1967 - and the condition of the transformer, it was decided to scrap it prior any hazard in service.
