The Vaults of the Subotica Synagogue after 114 Years: Condition Assessment and Repair Recommendations

Milan KEKANOVIĆ, Viktorija ALADŽIĆ, Arpad ČEH

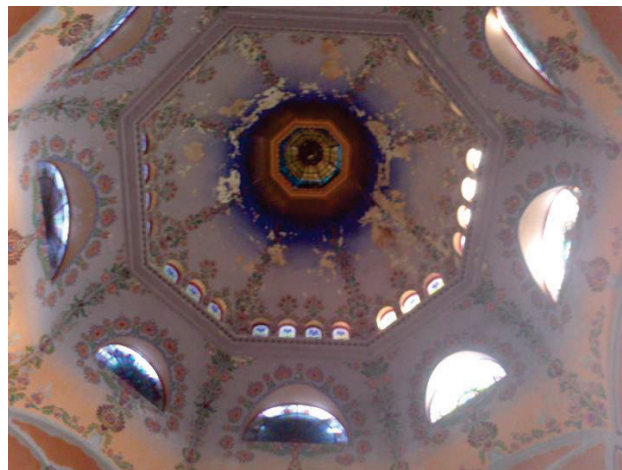
Synagogues and other religious buildings have been painted on the walls and ceilings. Decorations of the dome with gilding during the winter would fall off from the ceiling due to the occurrence of condensation (Fig. 1), since they were not insulated from external side as they were built according to the original architectural heritage of Synagogues from the homeland of the Jews.

Figure 1 Damage on the vaults because of condensation

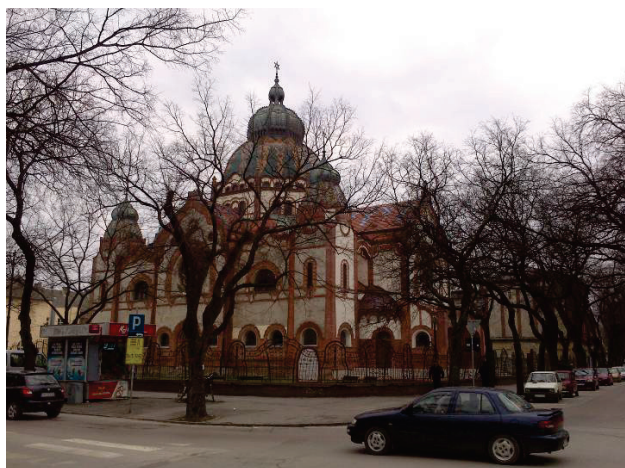
The synagogue was built in a traditional way, with foundations and walls made of local materials, stone or a combination of brick and stone masonry, with a relatively weak but a flexible bonding medium, such as plaster (Fig. 3).

Figure 3 The walls of the Subotica synagogue are made of brick masonry and the foundations of stone

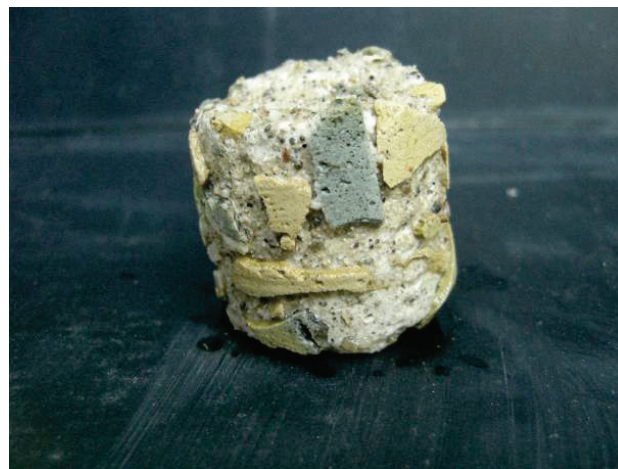
A major disadvantage of gypsum as a binder is that it is corrosive to steel. Gypsum as a binder is compatible with lime which is highly alkaline and provides an alkaline environment in concrete. The authors assume that during the casting of concrete intended to be reinforced with steel, the builders of the synagogue necessarily applied lime, $\text{Ca}(\text{OH})_2$, in addition to gypsum in order to make the concrete more alkaline and thus avoid steel corrosion; this will not occur if the concrete alkalinity provides an environment with a pH value greater than 12. For aggregate the builders must have used inert, granular material typical for traditional concrete, such as river sand and gravel with the addition of pozzolanic materials, natural or artificial. For artificial pozzolans crushed fired clay was used (Fig. 4).

Figure 4 Sample from the concrete vault of the Subotica synagogue with a coarse crushed fired clay aggregate and gypsum, which partly dissolved in water

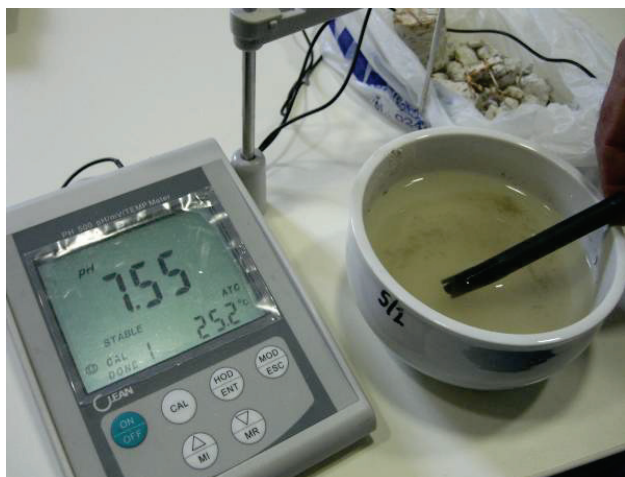
Concrete test samples from the vaults were analysed for pH-value in the laboratory of the Faculty of Civil Engineering in Subotica. The authors were expecting that this value will at least approximately correspond to the required standards considering that the concrete is reinforced with steel. The measured value of $\text{pH} = 7.55$ is not even close to the present norms for reinforced concrete, which require a $\text{pH} \geq 12$ (Fig. 7).

Figure 7 Measuring the pH-value of a concrete sample from synagogue in Subotica

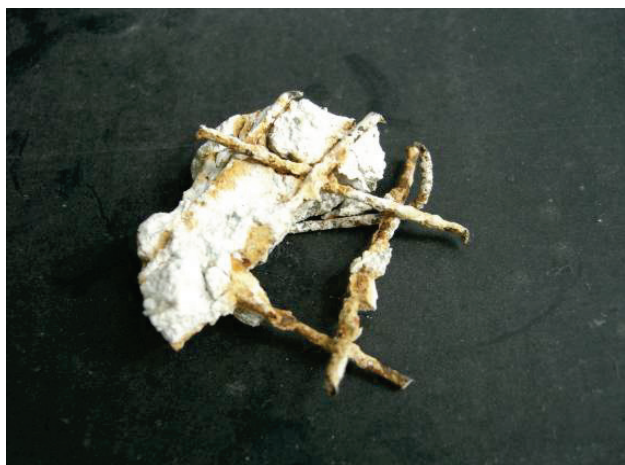
On a sample, obtained from the concrete vaults thin steel reinforcement wires can be seen, corroded over the past 114 years. We have measured the depth of corrosion on the steel wires, reaching 1 mm (Fig. 8).

encouraging. The compressive strength of the concrete dome could have been reduced in the past 114 years. Today, we cannot say that the concrete is not good. The concrete is 114 years old and still satisfies stability. What is alarming is the corrosion of the steel in the concrete. Corrosion is clearly visible and measurable. By measuring the pH value of 7.55, we found that the concrete does not protect the steel from corrosion (Tab. 1). The authors are led to assume that some technological mistakes were made in the production of the concrete used for the dome and vaults. Lime as the binder should have been combined with gypsum, at least equal in weight with the gypsum.

Figure 8 Corrosion of steel in concrete sample from synagogue in Subotica

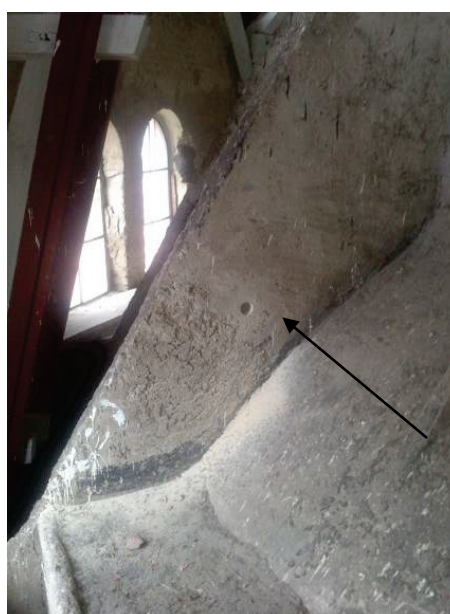
Testing of the concrete strength on cylindrical samples obtained from the dome showed poor concrete quality with an average compressive strength of 7.6 MPa. This strength was measured on small, 50 mm diameter cylindrical cores. The results presented are not

Figure 9 Sampling of concrete from the dome in Subotica Synagogue
