ABSTRACT

bushing, dissipation factor, moisture, aging, power transformer

Dispersing the clouds: Gain clear insight into your bushings using advanced diagnostic methods

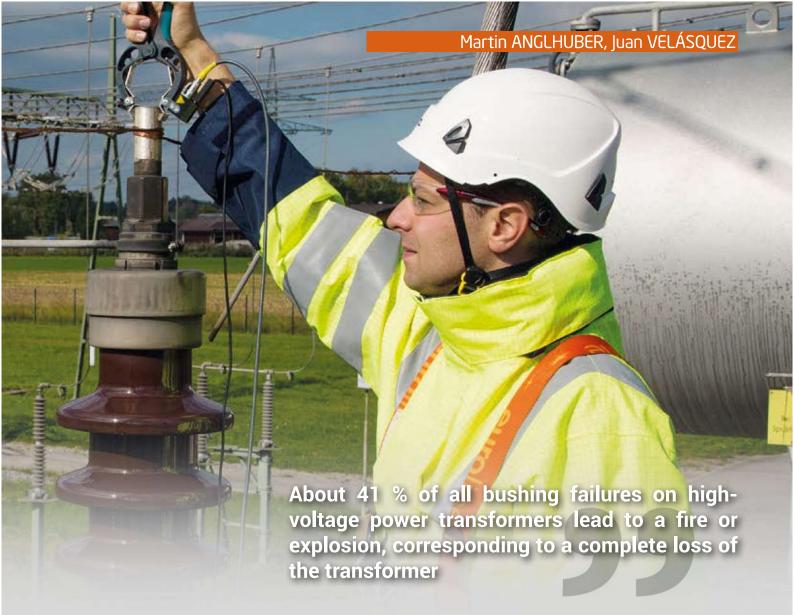
Figure 1. Failure locations of fires and explosions of power transformer failures (left) and external effects of bushing failures (right) [1]

However, such a conclusion would be very short-sighted. About 41 % of all bushing failures on high-voltage power transformers lead to a fire or explosion of the transformer, Fig. 1 – this corresponds to a complete loss of the transformer [1]. Also, about 37 % of all fires or explosions of power transformers are caused by bushing
