# Oil-impregnated paper bushing insulation diagnostics

Special application of Dielectric Frequency Response measurements

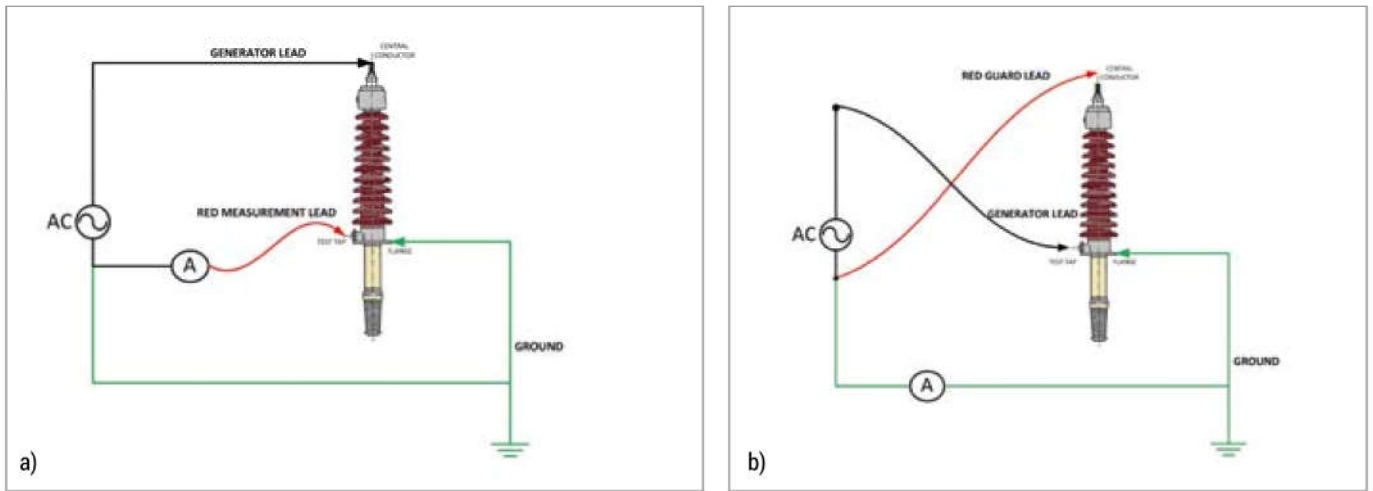
Figure 1. OIP EHV bushing, power factor / dissipation factor and Dielectric Frequency Response hook up diagram: a) Test on  $C_1$  capacitance (UST mode); b) Test on  $C_2$  capacitance (GSTg mode)

Through this test tap, main core insulation of the bushing is divided into two sub-capacitances:  $C_1$  representing the insulation between the HV conductor and the test layer; and,  $C_2$  representing the insulation between the test layer and the flange or ground when mounted on the transformer [2]. The test tap facilitates the execution of tests such as DFR, including PF/DF and capacitance of  $C_1$  and  $C_2$  as presented in Figure 1.

In the field, the value of  $C_1$  capacitance and PF/DF can be tested and compared against the information on the bushing's nameplate.  $C_1$  capacitance is tested under a UST (Ungrounded Specimen Test) mode.  $C_2$  capacitance, as it is the measurement between the test and the flange intrinsically connected to ground through

the tank of the transformer, is tested under a GSTg (Grounded Specimen Test with guard) mode. Bushing insulation PF/DF is typically a very low value because, among other reasons, it is generally processed to a greater degree of dryness than transformer insulation [3].

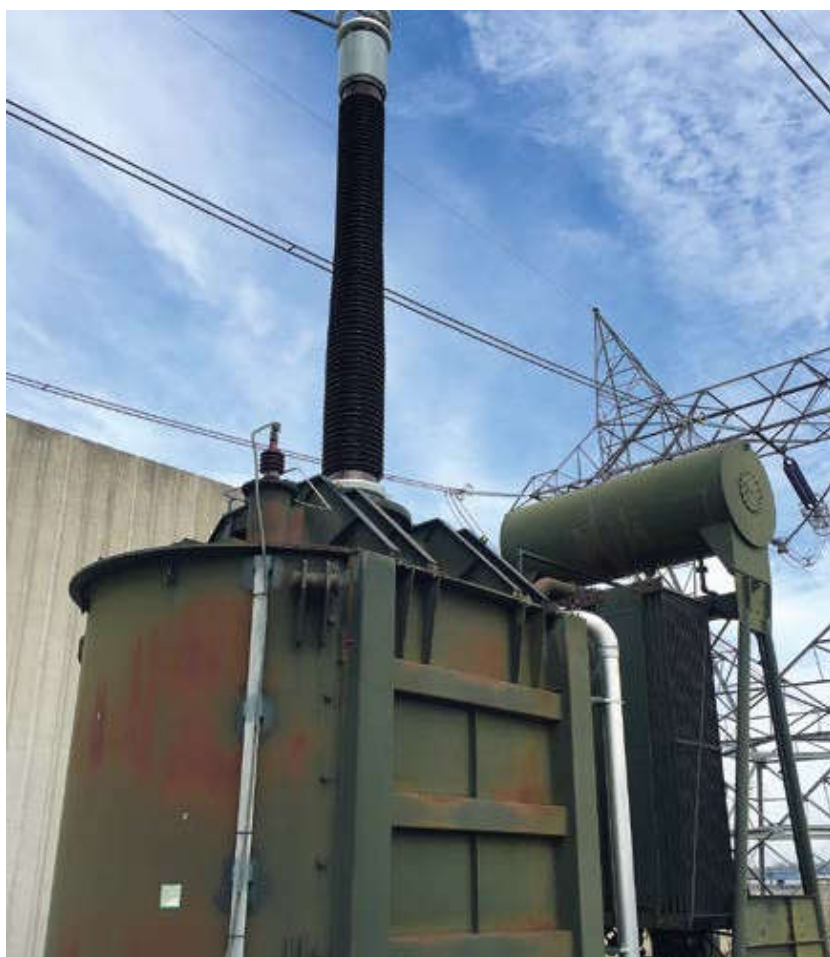
Figure 3. Shunt reactor with EHV OIP bushing

The asset management team embarked on a planned investigation to identify the root cause of failure in EHV OIP bushings mounted on shunt reactors at 735 kV power yards. High EMI and temperatures below 20 °C accompanied the testing procedure. A 735 kV shunt reactor with the EHV OIP bushing mounted is presented in Figure 3.

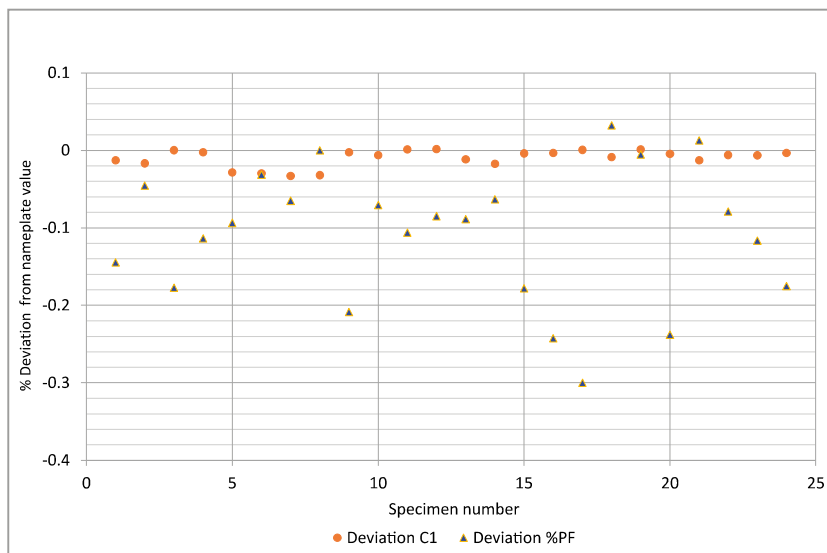
Figure 4. Percentage deviation from nameplate data; %PF and capacitance of C<sub>1</sub> for 24 specimens

From the PF/DF test at 10 kV and at line frequency, the numbers did not provide relevant distinction nor deviation from acceptable limits, as presented in Figure 4.

As observed in Figure 4, there is almost no deviation of field tested capacitance and certainly no increase of PF/DF at 60 Hz values properly corrected to 20 °C. It was interesting to observe values of PF with deviation below 20 % from the nameplate data. The decrease in PF is under investigation.

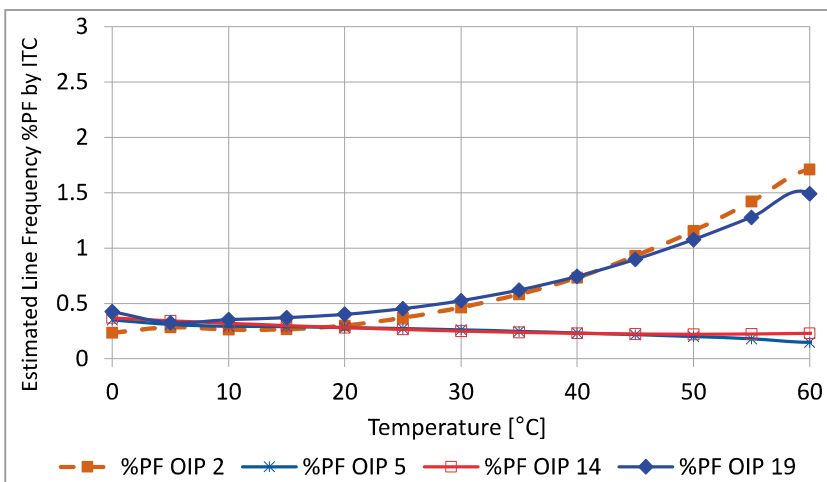
Figure 7. Dielectric thermal response (DTR) of EHV OIP bushings

Based on these results, the dielectric frequency response data was converted into the dielectric thermal response following the ITC principles and it was possible to confirm the differences in the thermal behavior of line frequency PF/DF values at different temperatures. The analysis confirms the condition evaluation of the EHV bushings in the frequency domain or in

the “temperature” domain, as presented in Figure 7.

The conversion from DFR into DTR using the individual temperature correction (ITC) algorithm was previously published in Transformers Magazine [4]. The Dielectric Thermal Response (DTR) becomes another tool for condition analysis of the insulation system based on the thermal response of PF/DF properly converted to a wide range of temperatures between 5 and 60 °C. The data suggests establishing PF/DF temperature indicators at 40 and 50 °C. Correlation with DGA analysis is carried out and summarized in Table 7.

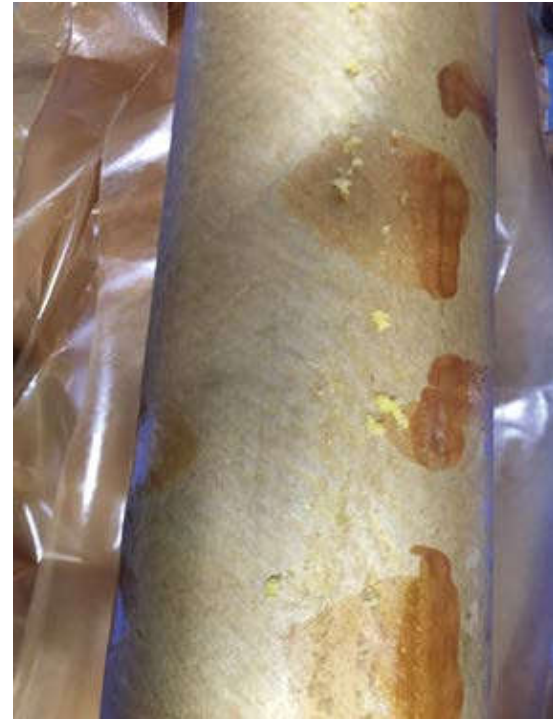
Figure 6. X-wax found on the most-inner layer of the EHV bushing disected

From Table 6, two units were selected for physical investigation (OIP 2 and OIP 19). Four key gases showed abnormal values and the dielectric response at 1 Hz was significantly higher than the other 22 units. The units were carefully disassembled and their gradient capacitance of each layer was tested. The bushing dissection re-

vealed the presence of X-wax on the most inner layer of the insulation system. Unit OIP 17 did present abnormal concentration of C<sub>2</sub>H<sub>2</sub> but no deviations in the DFR tests. OIP 17 is under observation.

The experimental work and the dissection carried out on the specimens determined that DFR technique can be used to detect the presence of solid particles of carbon and hydrocarbon polymers (X-wax).
