Cable Aging Management Program Implementation in Krško NPP-NEK

Marko Pirc

NEK d.o.o.

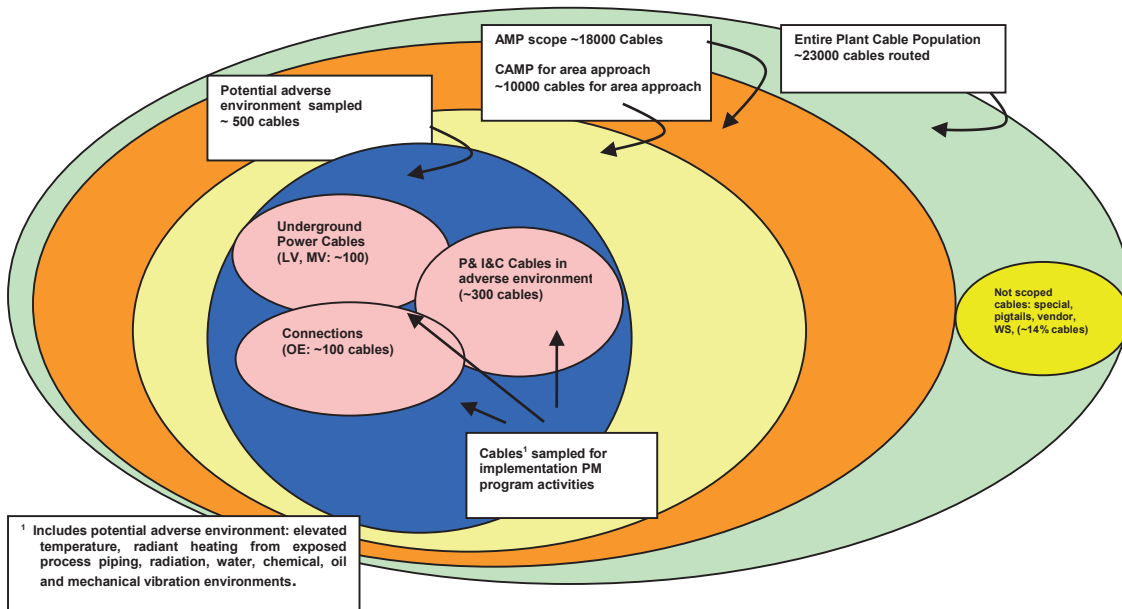
Figure 1: Cable scoping and sampling process [1]

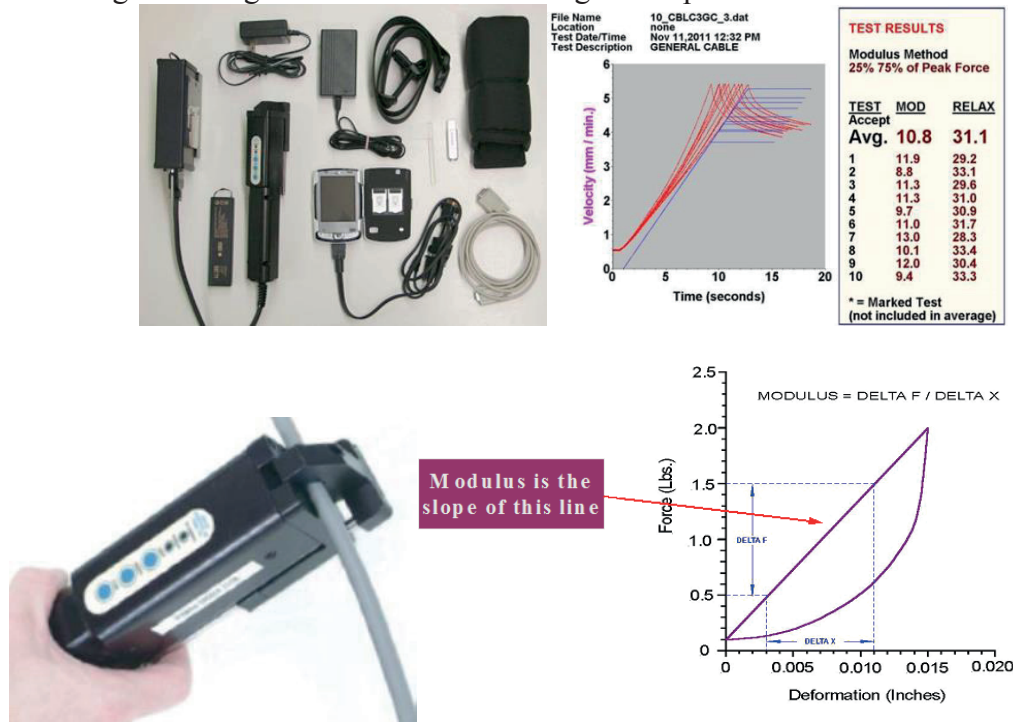
For onsite mechanical test, evaluation of tensile strength (hardness), Indenter Modulus (IM) testing method was implemented and acceptance criteria developed. This method, shown graphically in Figure 6, uses a small-diameter probe to press against a cable. The force needed to compress the EPR jacket to a limited, defined extent is measured. The force F used and the displacement X are plotted against each other as shown in Figure 6. The indenter modulus σ of the material is the slope of the line relating the change in force ΔF to the change in displacement ΔX .

Figure 5: Concept and Equipment for Indenter Modulus Test

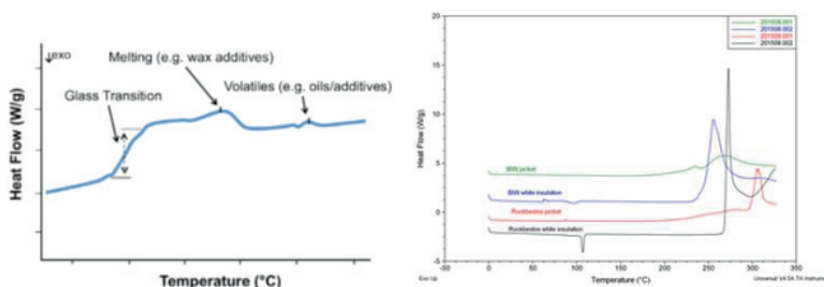
- **DSC Differential Scanning Calorimetry** Differential scanning calorimetry (DSC) is a technique that is especially useful for characterization of semi-crystalline polymer systems. DSC measures the flow of heat in and out of test samples over time as a function of sample temperature. Features in a DSC curve include phase change transitions. As illustrated in the DSC curve of EPDM and Oxidation Induction Time (OIT) in Figure 10, heat flows into a sample with rising temperature to effect endothermic transitions including transition from solid to a glassy state, the glass transition, and from a glassy solid to a melted liquid. Heat is also consumed in the evaporation of volatile compounds such as added processing aids. In a semi-crystalline polymer, it is the material in the crystalline regions that undergoes a distinct melting transition. The integral of the melting peak in the DSC curve is thus a direct measure of the crystalline content of the system. The shape of the DSC curve, including the location of glass transition, is also related to chain scission and cross-linking that the polymer may have experienced.

Figure 10: Description of DSC Curve of EPDM Showing Glass Transition, Melting Point and Evaporation of Processing Additives [3], [9]

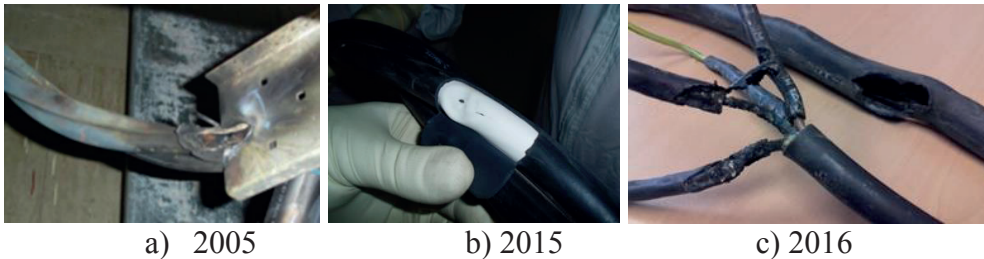
- Insulation resistance (IR) or Megger test as standardized test is not giving very useful results finding mainly severely damaged, failed cables: 3 LV power cables failure found due mechanical damage in tray (all triplex power cables without jacket) shown on Figure 12 and one N1E underground failure c), in splice .

Figure 12: Failures due of LV power cables found with IR test

- LIRA 8 testing done 8 findings and deviations: 3 on field cables and 5 at beginning LIRA instrument testing with known location of cable damage (short circuit, bad connection, cut in insulation, local burned insulation). In figure 18 Spot Signature (dB) is shown with LV cable failure at two locations. Short circuit on Figure 12 was found on 30m from cable end (at load) is visible as left marked pick on Figure 18 b) and c).

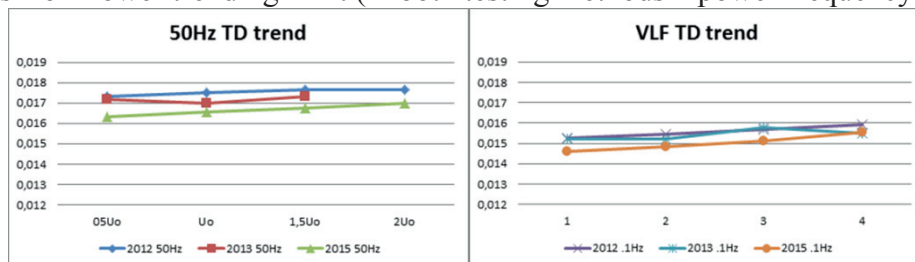
- 55 MV cables were tested with 5 findings in trending criteria for $\tan \delta$ results (all with accessories – connections and splices). The only qualified cable trending results for last three tests conducted in 2012, 2013 and 2015 on Figure 13 does not show significant changes from lower trending limit (in both testing methods – power frequency and VLF).

Figure 13: Trending results for $\tan \delta$

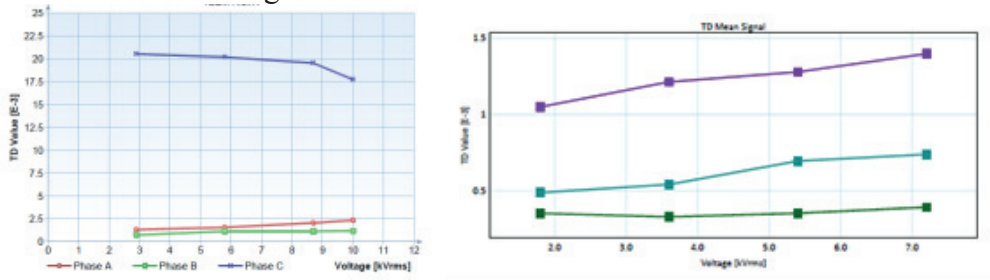
- MV cable N1E with XLPE insulation and splice improved trending results significantly after corrections in field Figure 14.

Figure 14: $\tan \delta$ results for XLPE after corrections

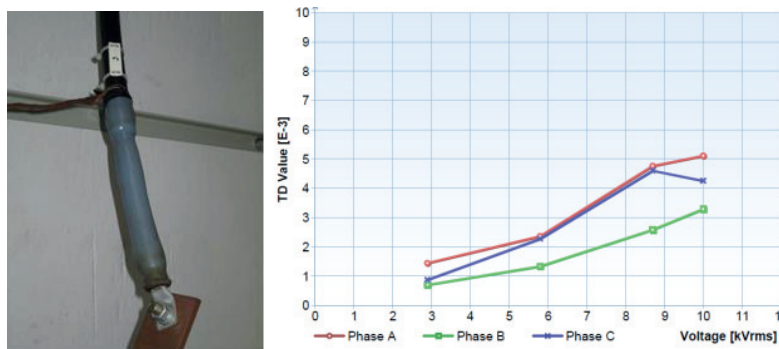
- MV cable N1E with XLPE insulation found bad connection

Figure 15: Found deficiency on XLPE cable connection with diagnostic test

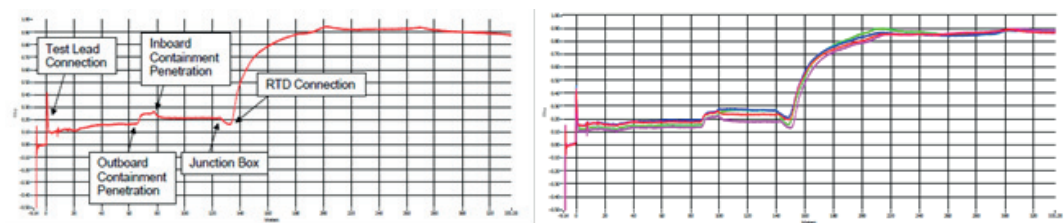
- TDR results of RTD cables after modification on Figure 16

Figure 16: TDR test plot for comparison

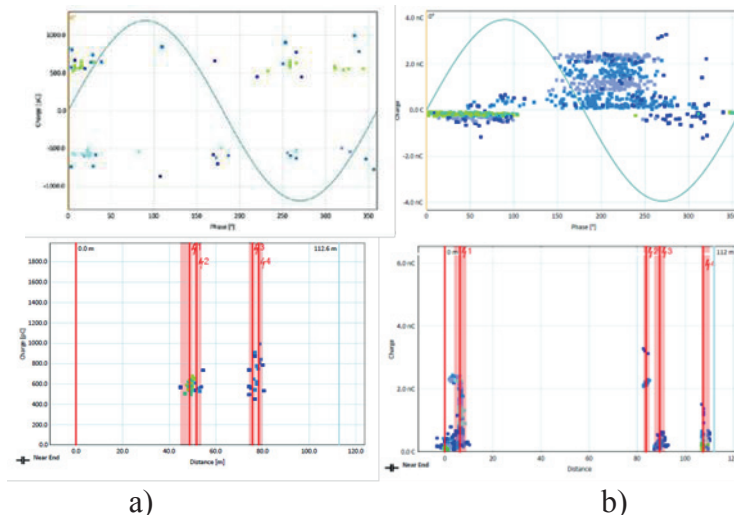
- MV cable Partial Discharge test results on Figure 17.

Figure 17: a) Nonsignificant PD events at 50m and 80m of cable end; no action taken
 b) Significant PD events: XLPE cable failure at 5 m from cable near end-replacement

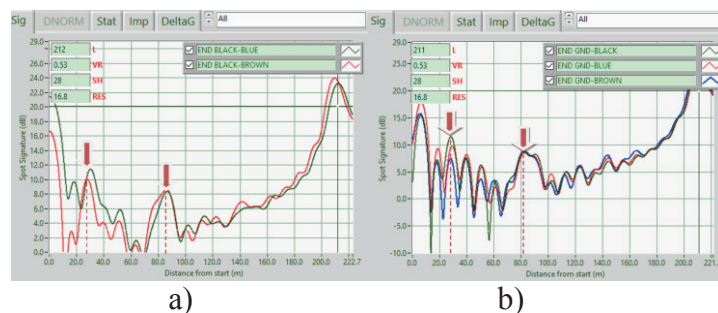
Figure 18: a) Location of two failures on LV cable between phases from cable end (at load) and b) between phase and ground
