CLIMATE CHANGES AND LANDSLIDE HAZARD

Nenad Petrović, Branko Božić and Ivo Lukić

University of Applied Sciences Velika Gorica, Velika Gorica, Croatia

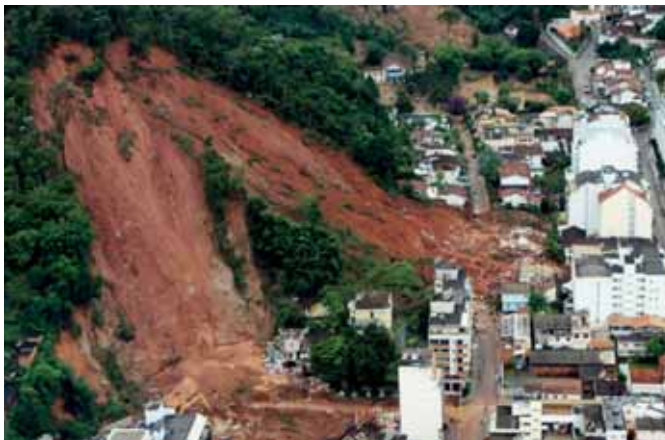
Figure 1. Landslides effects on electric power facilities [1]

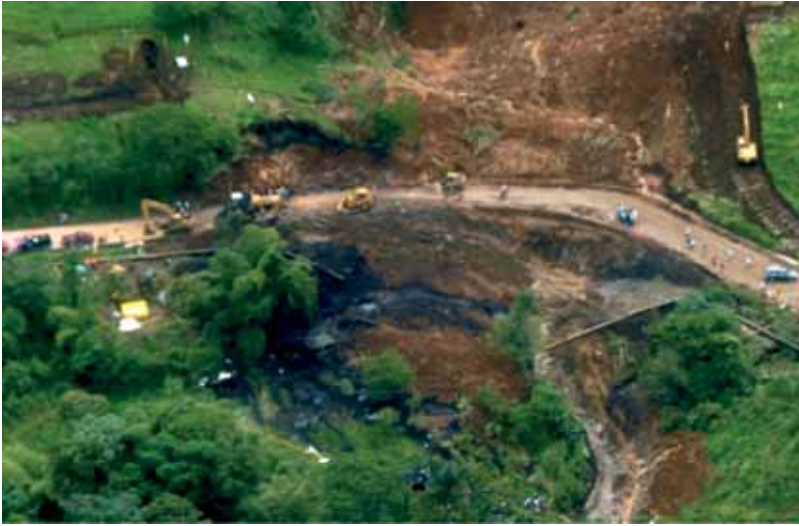
Figure 2. Landslide impact on Trans-Ecuador pipeline [13]

In Ecuador in May 2013, the Trans-Ecuador pipeline is ruptured in a landslide. The volume of oil released to the environment was reported to have been about 11500 barrels. The oil flowed into the Coca River making its way downstream. The initial impact was on the city of Coca, which has 80.000 inhabitants, which had to shut down its drinking water supply [13]. Over the years, engineering and design standards have improved and are generally seen within the oil and gas sector to be more ro-

bust in the face of current landslide risks. However aging infrastructures are at risk, particularly linear infrastructures such as pipelines (Figure 2) [14].

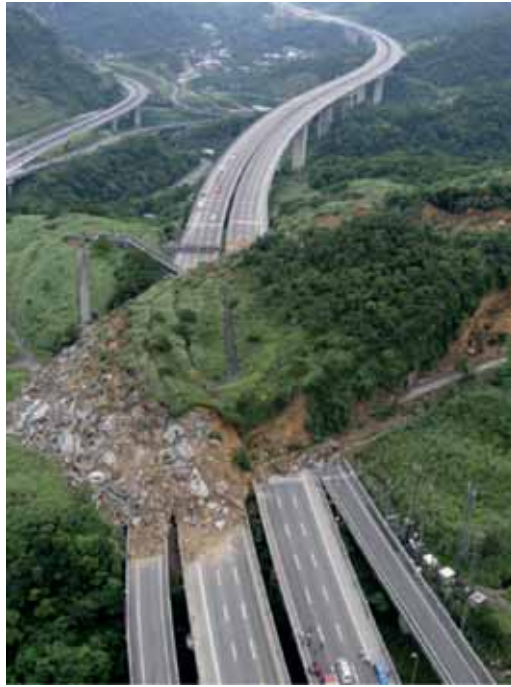
Figure 3. The impact of landslides onto the highway [1]

A 2-km-long landslide occurred at Pink Mountain in late June or early July 2002 [21]. The Pink Mountain landslide is a rock slide-debris avalanche. This landslide may have been triggered by the delayed melt of an above-normal snowpack, followed by a week of intense rainfall. The landslide destroyed 43 ha of non-commercial forest, covered an access road, and came to rest within a few kilometres of a ranch house (Figure3).

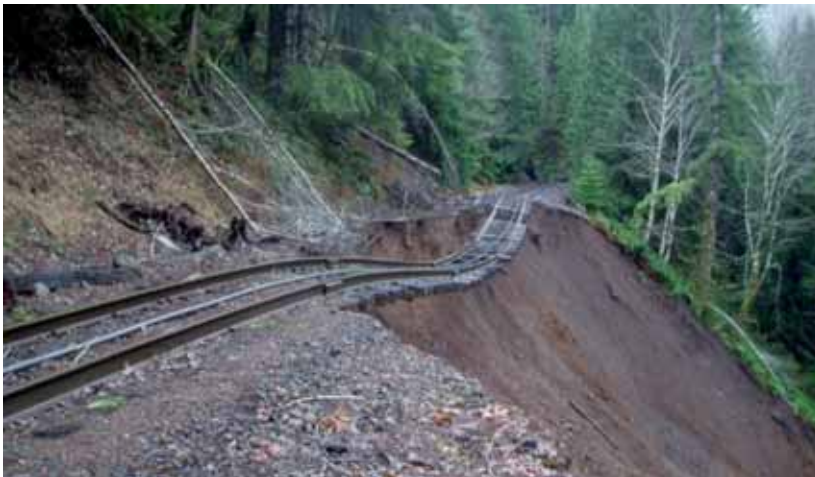
Figure 4. The impact of landslides onto the railway [1]

country's economic and national security [23]. Due to the earth movement, tracks can be damaged and the train can derail. Such an example is the derailment as consequence of a landslide near St. Moritz in Switzerland, in August 2014 [1]. The trigger for this event was heavy rain (Figure 4).
