## ABSTRACT

# Transformer bushings and oil leaks

## A cost effective way to address oil and nitrogen leaks

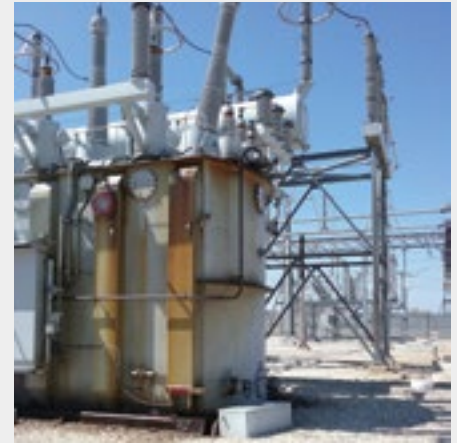
Figure 1. Unsightly oil leaks running down the side of a large power transformer

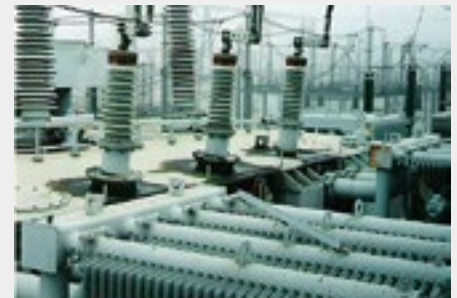
Figure 2. Oil leaks at the base flange of high voltage bushing pockets

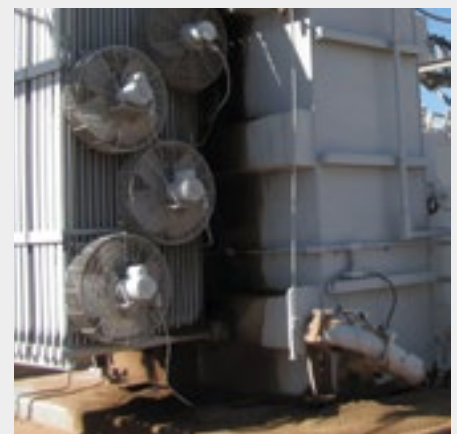
Figure 3. Oil leaks running down the side of a large power transformer and contained with oil absorbent material

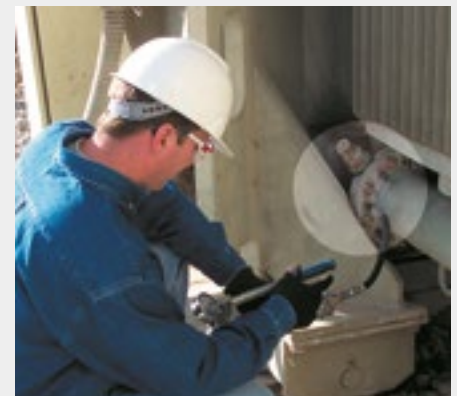
Figure 4. Repair being made to a lower level radiator flange by injecting sealant into the gasket groove with the transformer in normal service

Figure 4 depicts a technician injecting sealant into a gasket groove on a lower level radiator (cooler) flange. This type of leak repair can easily be performed with the transformer still in service. Thus the leak repair is completed in hours versus the days or weeks required to drain the transformer and remove the radiators to regasket the leaking flange.

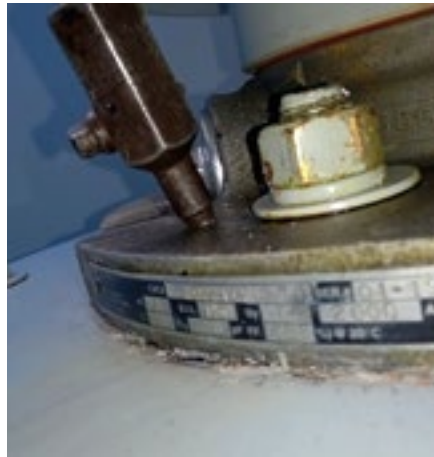
Figure 5b. Actual injection valve in place

Figure 5a is a close up sketch of the valve used to inject the sealant compound into a gasket groove. Figures 5b and 5c are actual photos of injection valves in place ready for pumping sealant into a gasket groove. This can be a piping flange gasket

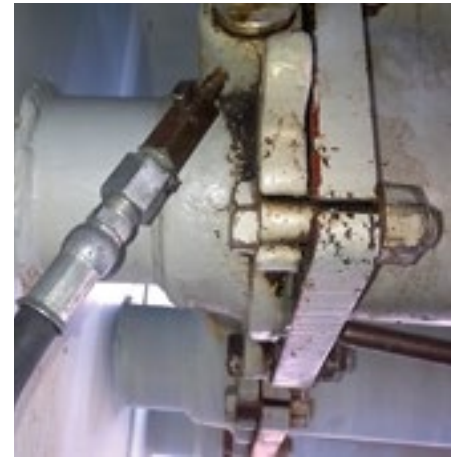
Figure 5c. An injection valve with the hose to the injection tool connected

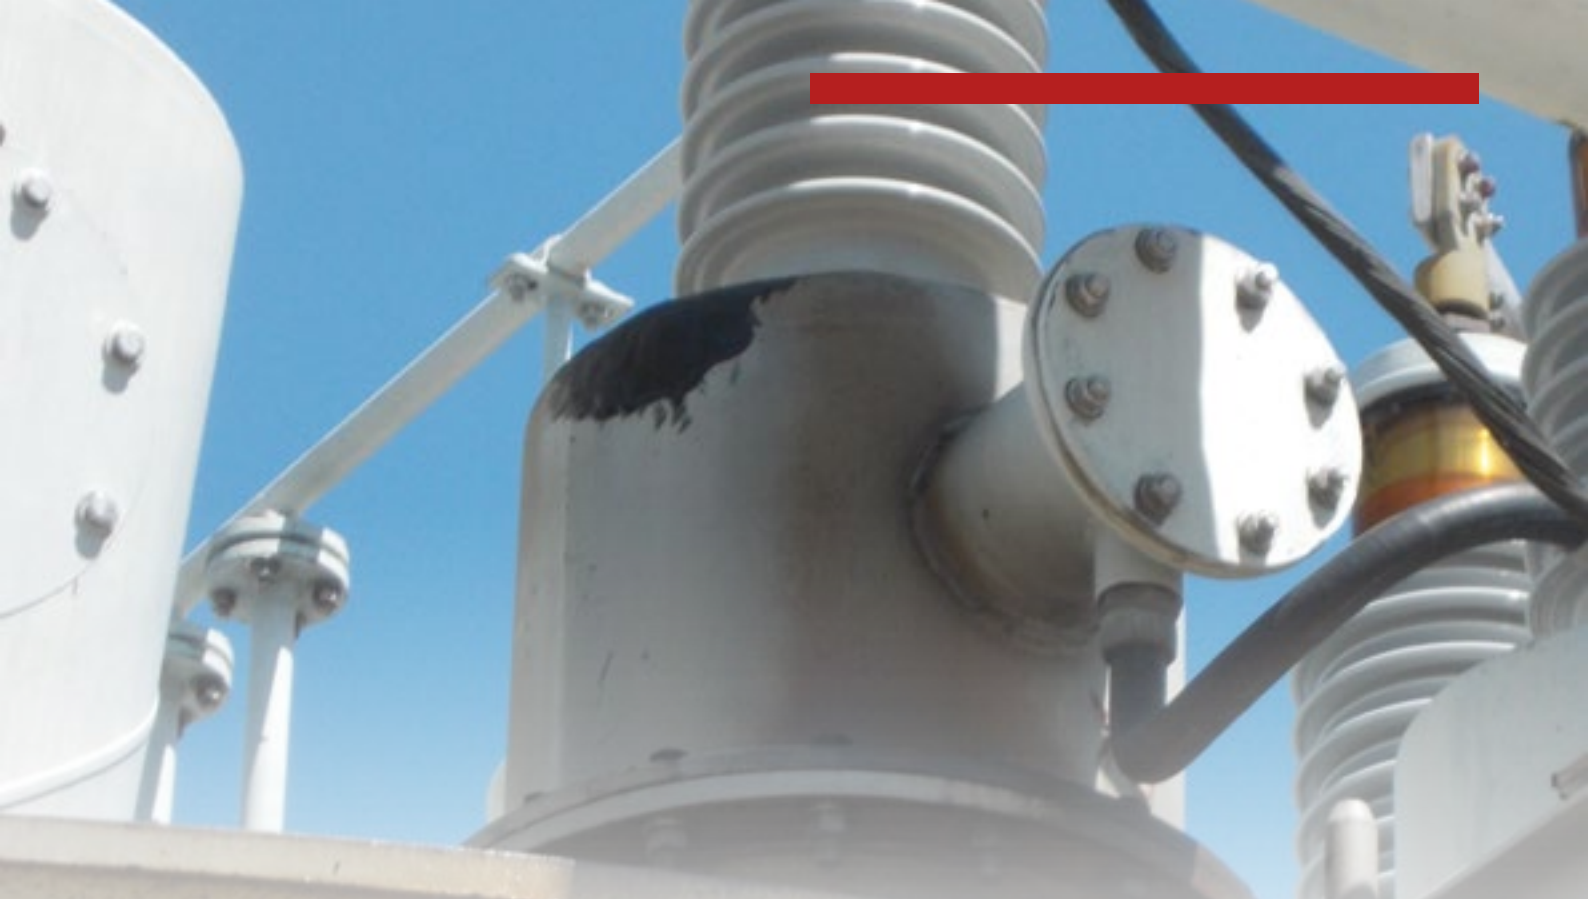
Figure 6. High voltage bushing pocket with oil stains running from the transformer top down the side. Note the black material at the top of the pocket, which is most likely an attempt by the utility to stop the leak with an externally applied material.

Bushing pockets introduce another set of gasketed flanges requiring sealing. Figure 6 shows a common style of bushing pocket. The technique of drilling an access hole to the gasket groove and injecting under pressure the sealant compound into the gasket groove, essentially creating a new gasket without disassembly of the transformer to access the gasket groove. Then the drilled hole is threaded and a plug is inserted to contain the sealant under pressure.

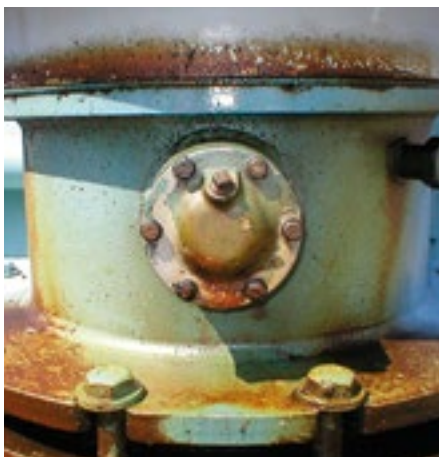
Figure 7. High voltage bushing leaking at the interface between the porcelain and the steel base

creates an additional cavity over the leaking flange that can contain the sealing compound under pressure and stop the leak. Figure 7 shows a bushing leaking at the interface between the porcelain and the steel base of the bushing.

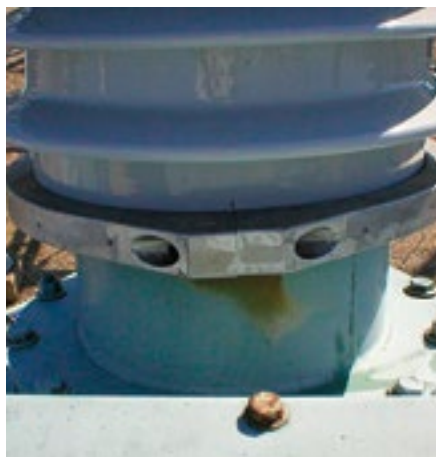
Figure 8. Close up of a precision fabricated aluminum clamp installed at the base of a high voltage bushing

Figure 8 shows the precision fabricated aluminum clamp installed around the leaking bushing at this porcelain and steel interface. This clamp becomes the cavity that is filled with the leak seal compound. Figure 9 shows half of the aluminum clamp before the other section is bolted in place, showing also the cavity in the center

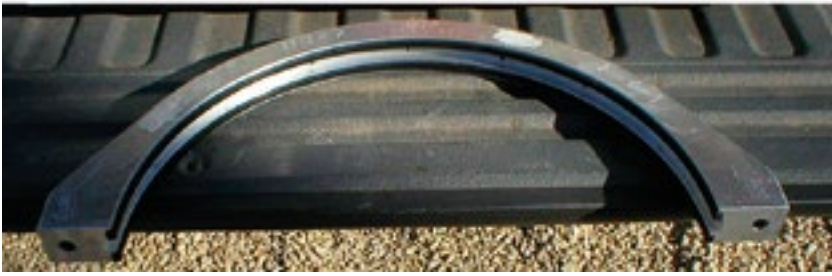
Figure 10. One half of a precision bolted aluminum clamp prior to mounting around a bushing

Figure 10 depicts one half of the aluminum clamp prior to mounting around the bushing.

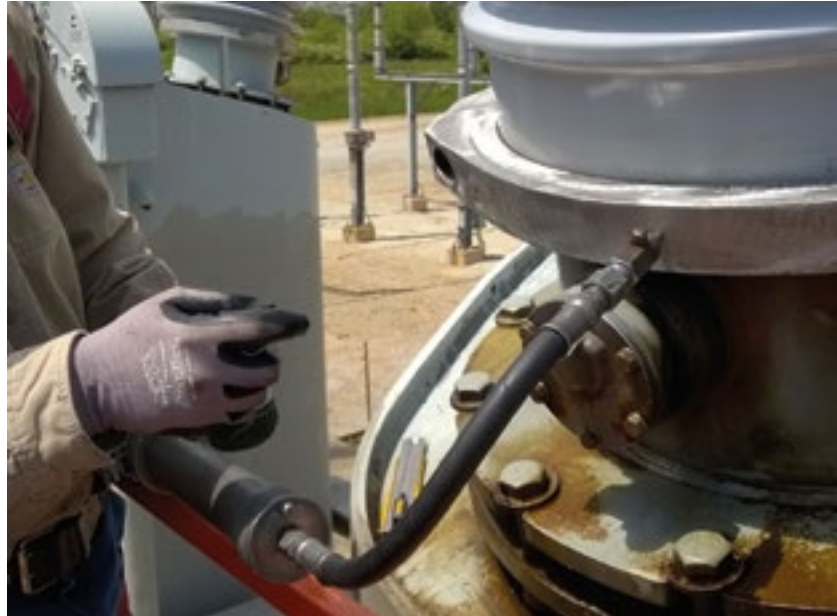
Figure 11. Technician pumping the leak seal compound into the clamp around the bushing

Figure 11 shows a technician pumping the leak seal compound into the clamp. These nozzle-looking valves are removed and threaded plugs are placed into the injection holes to contain the sealant in the cavity.

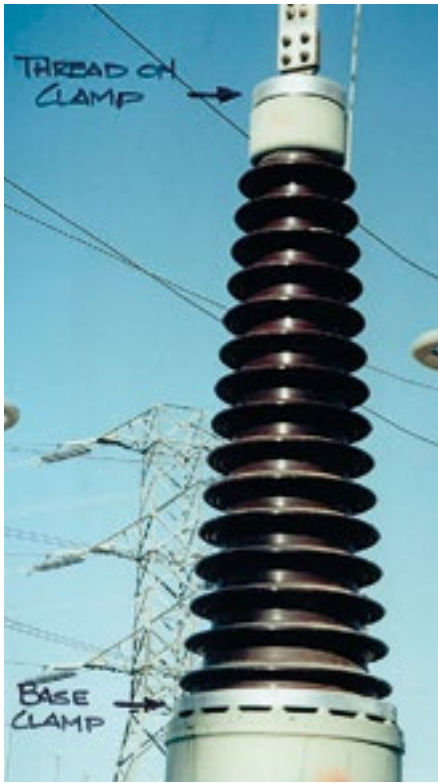
Figure 13. High voltage bushing with a precision aluminum split style clamp at the base as well as a threaded style clamp at the top of the bushing

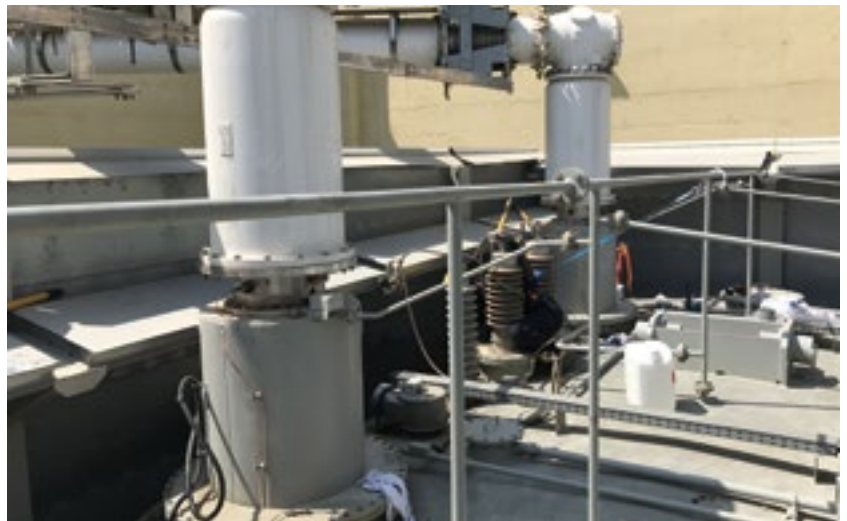
Figure 14a. SF<sub>6</sub> GIS bus connections to high voltage bushings on top of a transformer

interconnections with flanges between the switchgear and any transformer bushings required as part of the substation design. The overall view of a GIS to transformer interconnection is depicted in Figure 14a, with a close up image in Figure 14b. This interconnection is essentially a transformer bushing with an SF<sub>6</sub>-filled environment on the GIS bus side and an oil-immersed bushing on the transformer side.

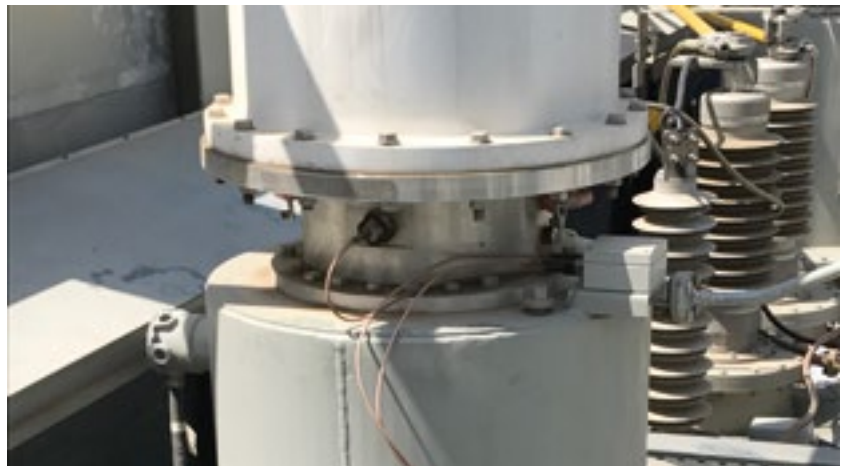
Figure 14b. Close up of the GIS to transformer connections

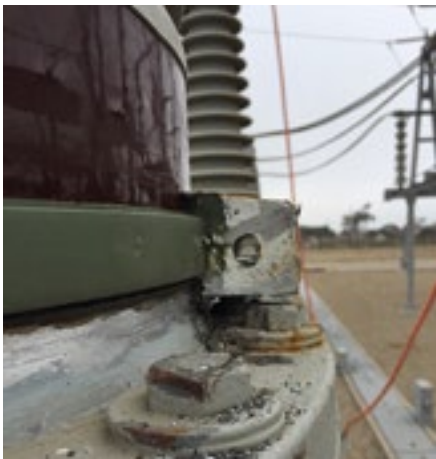
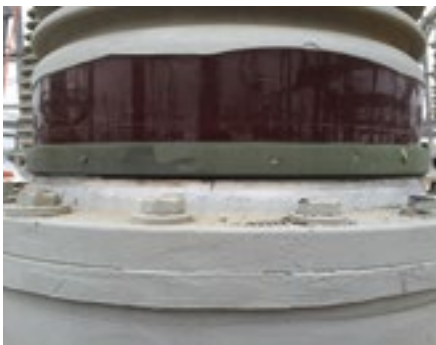
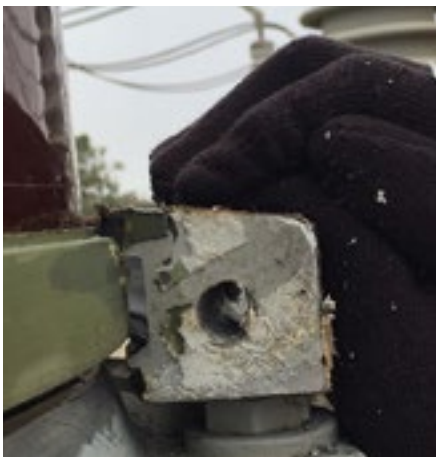
Figures 15a, 15b and 15c. Three views of a bushing with a portion of a previously installed bolted clamp removed

and if the repaired component requires disassembly or removal, the cured sealing compound is always soft and pliable. It never hardens. The containment clamp can be removed and the compound cut out with a knife allowing the component to be taken apart. Then upon the assembly the technicians can come back and reinstall the clamp or a new clamp and reseal the leak. The sealant does not stick to the metal surfaces of the transformer, nor leave a residue of any kind. Figures 15a, 15b and 15c show how the sealant compound appears in place around a bushing with the clamp removed. Figure 15d shows the sealing compound cut away from the

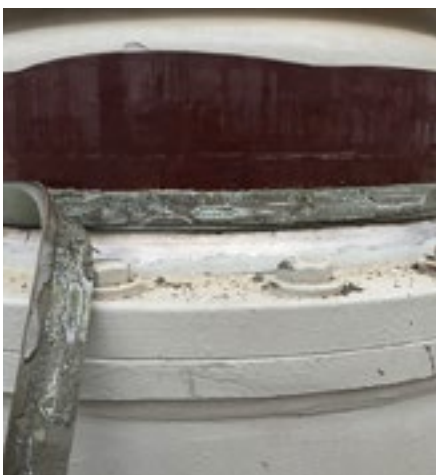
Figure 15d. Sealing compound cut away from the bushing

bushing, depicting how soft and pliable it is. The mesh material in this photo is what is commonly put in place around the porcelain of a bushing to (a) keep the clamp from creeping up the bushing as the sealant is pumped into the cavity in the clamp, and (b) to protect the porcelain from being scratched or chipped. Note that the sealing compound is soft and does not adhere to either the porcelain or the steel. The sealant, having similar properties to the gasket material it is formulated to replace, also has a similar life to that of the gasket materials. The potential benefit of the sealant compound installations is that when the sealant gasket begins to leak again it can be potentially replaced by the same technique as the original repair. The holes drilled, providing access to the gasket groove, can be opened again by removing the threaded plugs, and utilizing an injection valve and hydraulic sealant injection gun to pump sealant in again to stop the leak.
