# Monitoring the Structural Deformation of Davutpasa Barrack by Using Geodetic Methods

Ercenk ATA, Ramazan Gürsel HOŞBAŞ, Atinc PIRTI

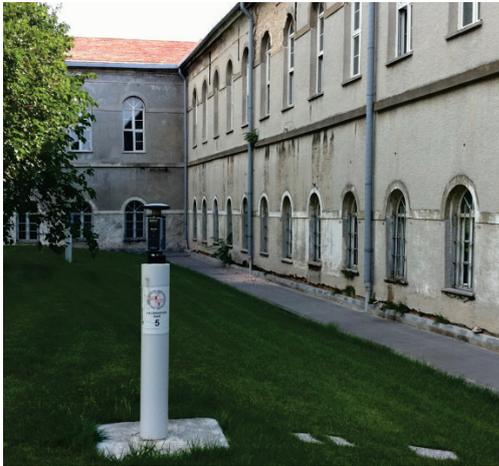
Figure 3 A reference point located as a pillar

The intense deformation of the Davutpasa barracks is observed towards the south-east part. For this reason the geodetic control network is formed in this part. The network consists of the fifteen fixed points and the fifty-four object points (Fig. 2). Five of the reference points are selected at suitable places for positioning with GPS (Fig. 3). Point number of 5003 and 5004 are located in the courtyard of the Davutpasa Barracks as triangulation points. Other reference points are selected on the concrete floor. The coordinates of these reference points (starting with 3000) were obtained by traversing using 5003 and 5004 points. The marks of these points are given in the form of bronze nails (Fig. 4). The object points in the corridor were selected between the upper and lower parts of the windows overlooking the courtyard. The object points on the south-east of barracks exterior are determined in the lower right corner of windows in the first floor and middle floor (Fig. 5). Starting with point 1000 in the object points are used foil prism (Fig. 6) [2, 3, 4, 6, 7, 8].
