# Application of geological strength index for characterization of weathering-induced failures

Professional paper

This study investigates weathering induced failures of the heterogeneous fissile rock mass consisting of sandstone and shale. Discontinuity data was collected and the geological strength index (GSI) value was determined immediately after excavation based on the quantified GSI chart. Slake durability tests were performed up to the fifth cycle. Samples were exposed to natural climatic conditions during a twelve-month period, in order to quantify slaking process by means of disintegration ratio. As a consequence of exposure, samples disintegrated into smaller fragments. On these bases, the model aimed at addressing delayed failure of cuts is proposed in the paper.

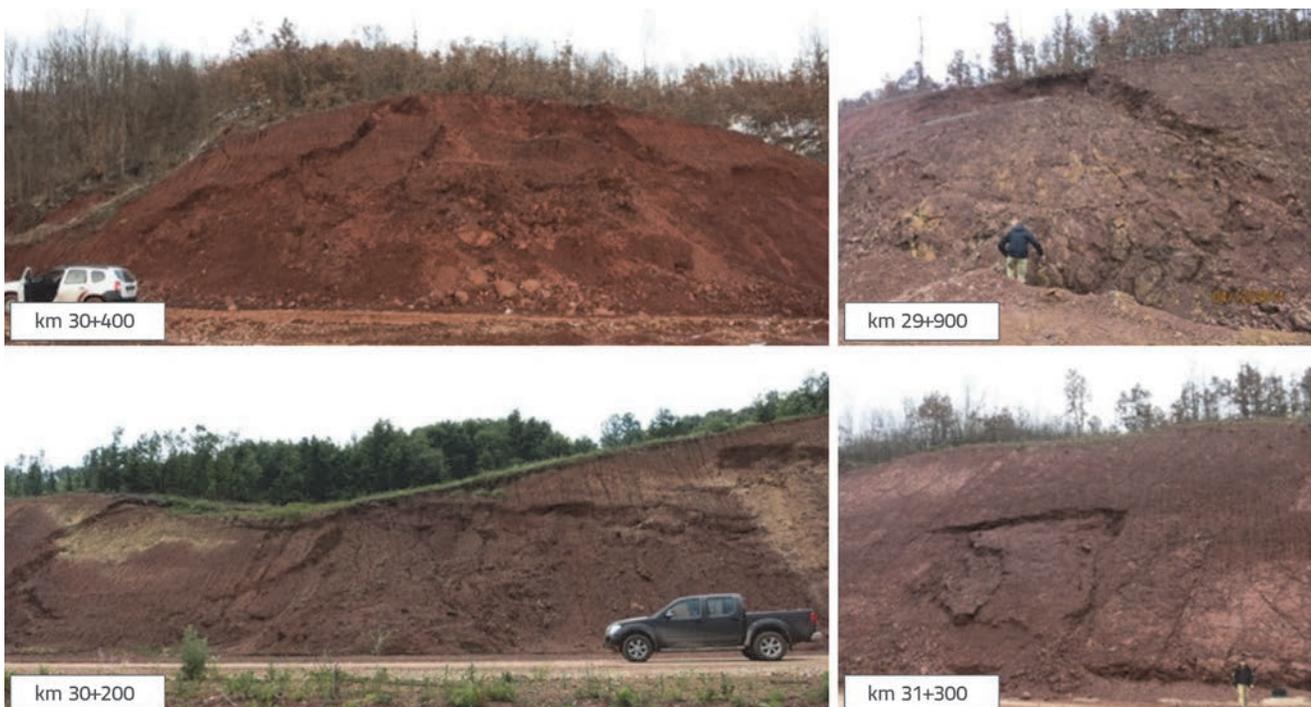
Typical failures induced by weathering are shown in Figure 2. Cuttings remained stable during the first several months after exposure. First signs of instabilities occurred when cracks parallel to the slope face developed at different heights along the slope, usually in the toe or at mid-height of the slope. Progression of cracks and deterioration of rock mass was monitored until the failure in three locations namely, at km 22+850, km

Figure 2. Typical failures in Permian shales and mudstones

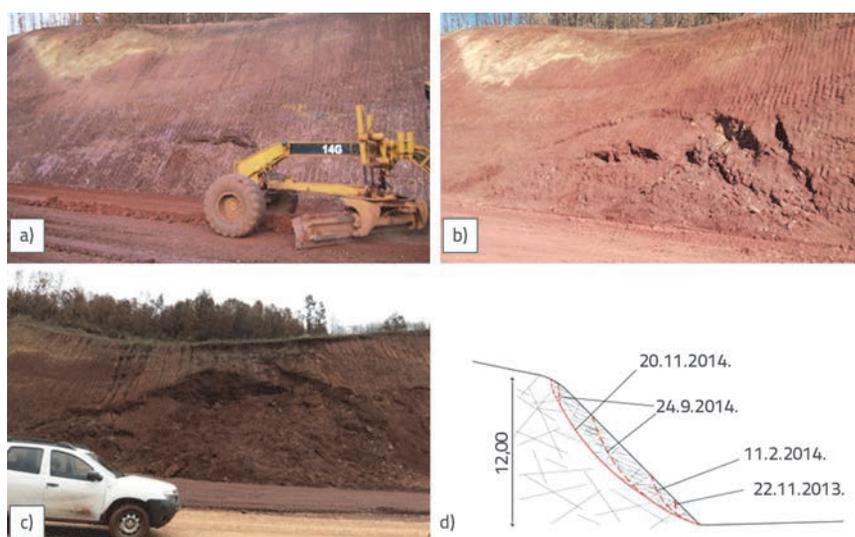
Excavation of cuttings between chainages 30+000 and 30+350 started in April 2013 and final geometry was obtained in October 2013. First cracks appeared on the slope face in late November and early December 2013, Figure 3.a. At the beginning of February 2014, the instability extended to the lower portion of the slope, Figure 3.b. By the end of September 2014, first cracks developed at the crest of the slope, and sliding surface was formed by November 2014, Figure 3.c. Further lateral progression of landslide is shown in Figure 2. Overall movements are not large and failed material serves as protective cover, which slows down disintegration of deeper layers.

Figure 3. Failure at KM 30+200: a) 22.11.2013; b) 11.02.2014; c) 20.11.2014; d) Model of failure progression

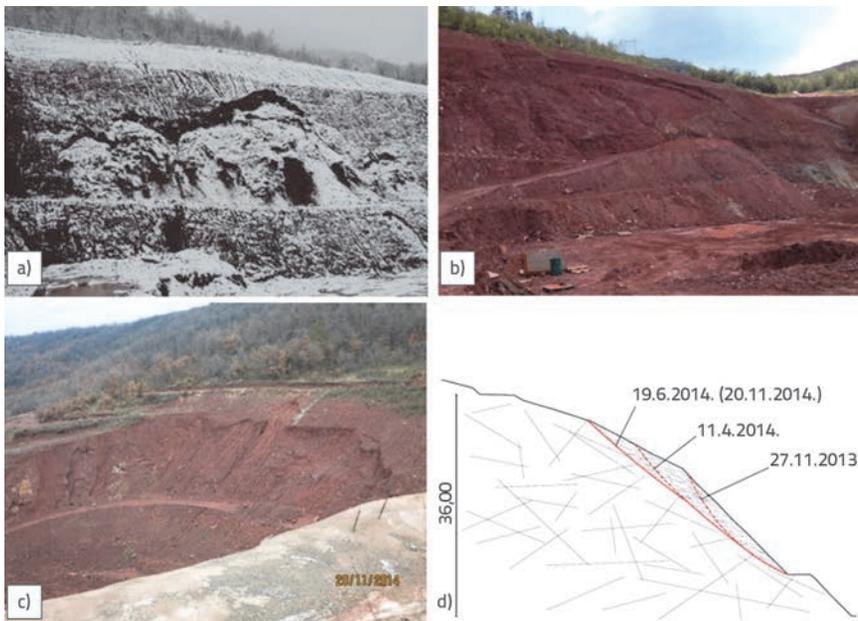
Construction of the left side slope of the Bancarevo Tunnel west portal ended in October 2013. It was planned to backfill 100 m long slope up to a certain height following construction of tunnel tubes by the cut and cover method. Previous failures at the east portal slope influenced the final slope geometry. The lower part of the cutting consists of a 4m wide berm with the slope inclination of 1 : 1, while the upper part is inclined to v : h = 1 : 2. The first failure was initiated in late November 2013 at the lower portion of the slope just above the berm, Figure 4a. Progression of the failure is shown in Figures 4.b and 4.c. No further extension of failure was noted during the site visit in June 2015. This

Figure 4. Failure at KM 28+650: a) 27.11.2013; b) 11.04.2014; c) 20.11.2014; d) Model of failure progression

is probably due to placement of backfill in the toe of the slope, which prevented further deterioration of the rock mass.

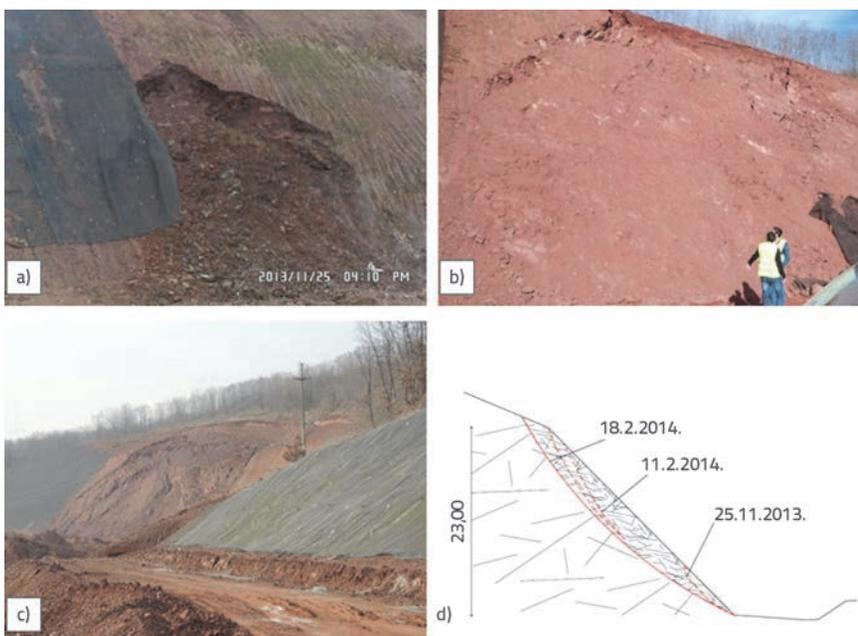
The cutting was constructed with designed slope inclination of 1 : 1 in October 2013. Maximum slope height was 25 m. First signs of instability occurred during November 2013, Figure, 5.a. In early January 2014 the crack was formed in the upper part of the slope with a trace that could be followed up to the

mid-height of the slope, Figure 5.b. In mid-January the sliding surface was formed, Figure 5.c. No signs of further deterioration of the rock mass were observed until the beginning of remedial works in August 2014. It is interesting to note that the first signs of instabilities at the studied cuttings occurred during the first month after construction. After detailed examination of all instabilities (as shown Table 1) it was noted that the failure could have been initiated at the toe of the slope where concentration of stresses is the highest, but cracks could have also been formed at mid-height of the slope. Due to this reason, it was not possible to establish the unique model of failure progression, which is probably closely related to the local heterogeneity of material at the slope face. Global failure surfaces in the first, second and third case were formed

Figure 5. Failure at KM 22+850: a) 25.11.2013; b) 11.02.2014; c) 18.02.2014; d) Model of failure progression

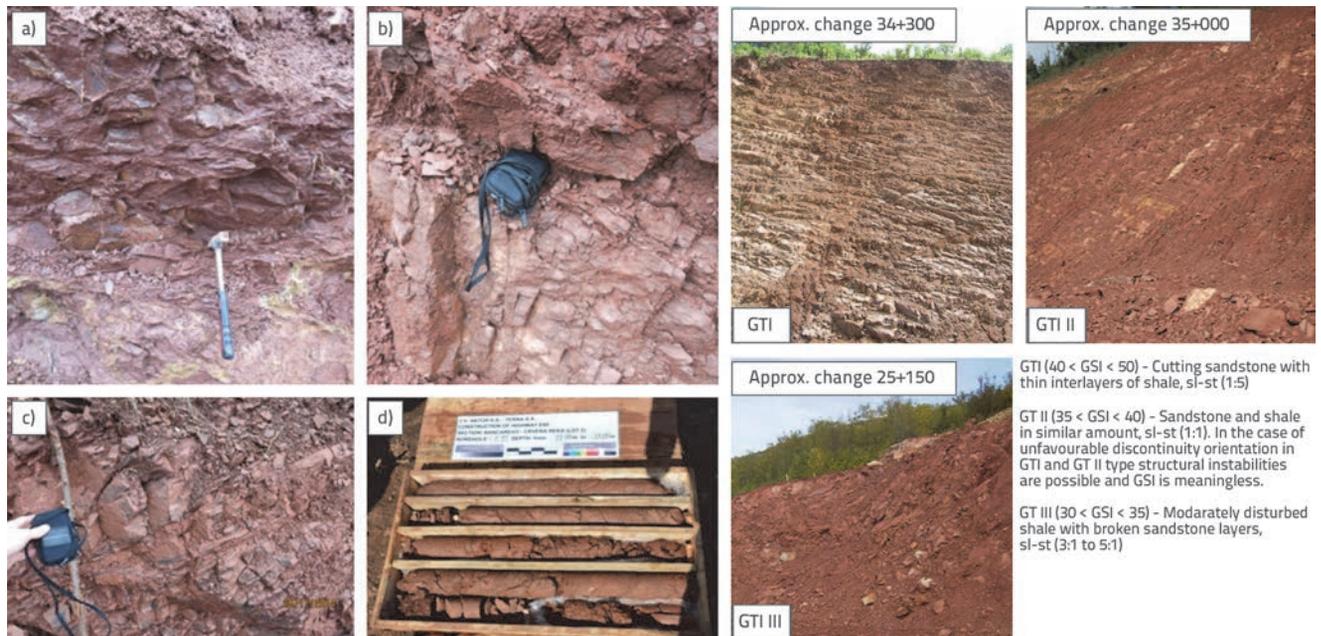
Figure 6. Unweathered rock mass in the main scarp of landslides: a) km 30+200; b) 28+650; c) 26+300; d) core recovered from borehole at km 30+200 and typical Permian representatives (to the right)

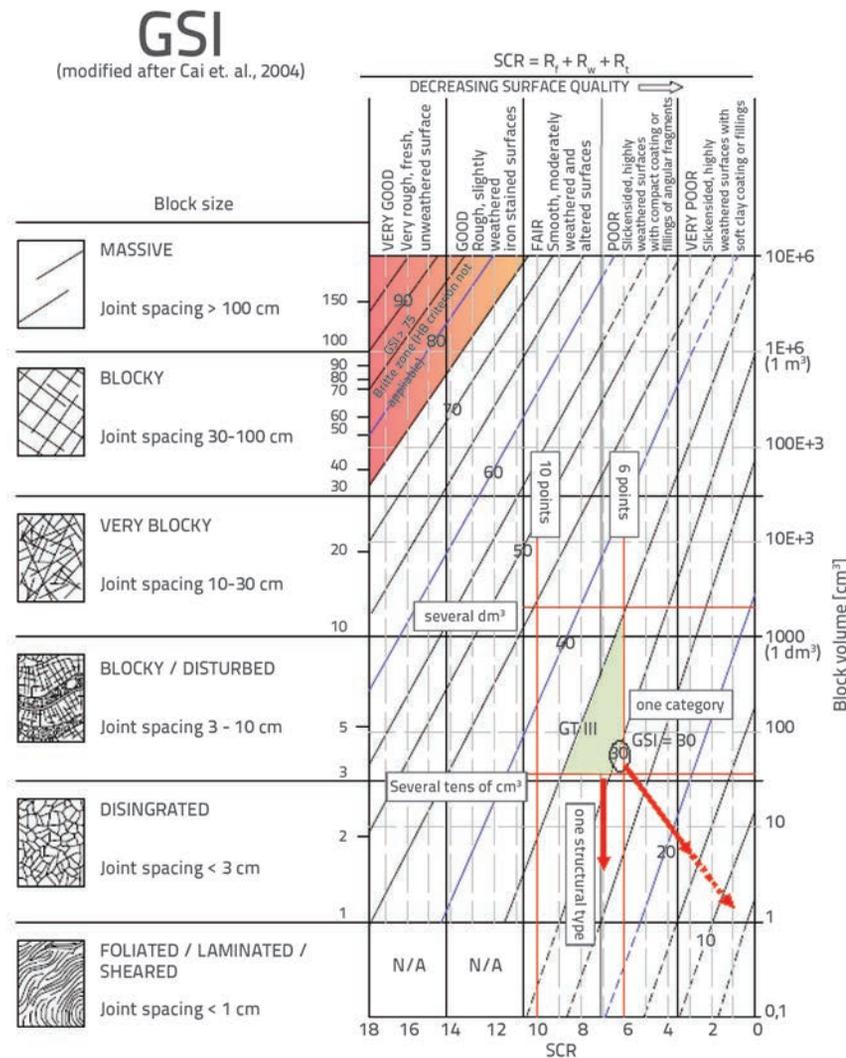
cubic centimetres to several cubic decimetres [25]. Shales are typical Hoek-Brown material. Propositions for flysch were used to determine geotechnical parameters of heterogeneous rock masses [26, 27]. Depending on the sandstone/siltstone ratio and joint surface conditions, three rock mass types (GT I–GT III) and GSI ranges were determined, Figure 6. Table 2 shows results of laboratory testing on intact samples and data collected for determination of surface quality conditions. Characteristics of rock discontinuities were determined either on unweathered surfaces immediately after excavation, or after inspection of scarps of newly formed instabilities. It was very important to collect structural data on fresh excavated surfaces in order to avoid negative influence of weathering. The intact uniaxial compressive strength  $\sigma_{ci}$  was determined for 25 laboratory prepared cylindrical samples (10 sandstone and 15 shale samples) according to the International Society for Rock Mechanics procedure [28]. The Hoek-Brown constant  $m_i$  was determined according to suggestions by Marinos and Hoek [26]. The values of 17 and 7 have been adopted for sandstone and shale, respectively. Table 3 shows values of initial geotechnical properties of Permian rock mass. Figure 7 shows quantified GSI chart to account for surface quality and block size.

Figure 7. Quantified general GSI chart (modified after Cai et al. [20])

As a consequence of disintegration, the GSI value reduces in both horizontal and vertical directions. Initial SCR coefficient rating, as well as the block volume, should be reduced on GSI chart, Figure 7.

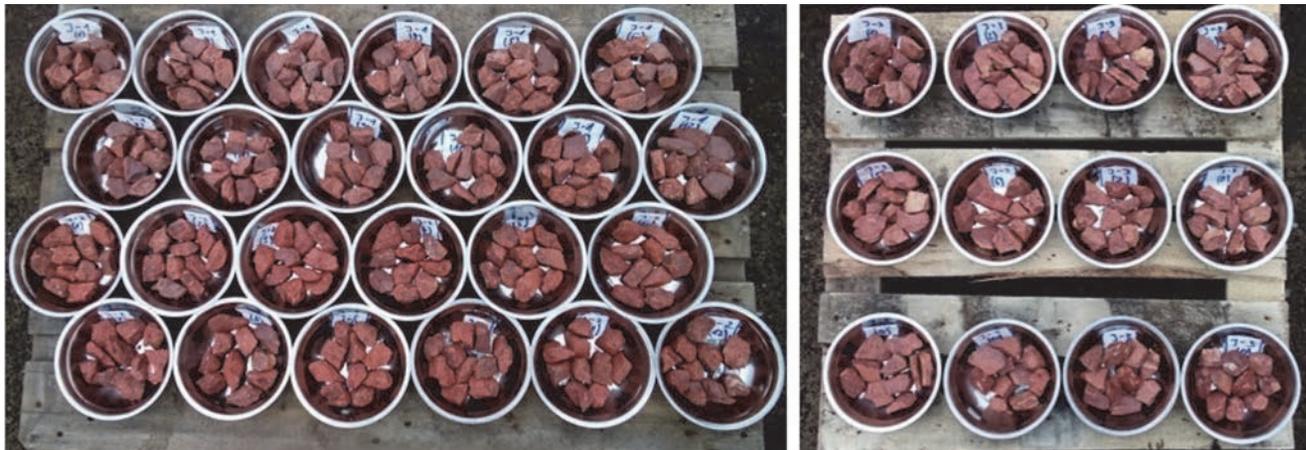
Figure 8. Samples exposed to natural climatic conditions

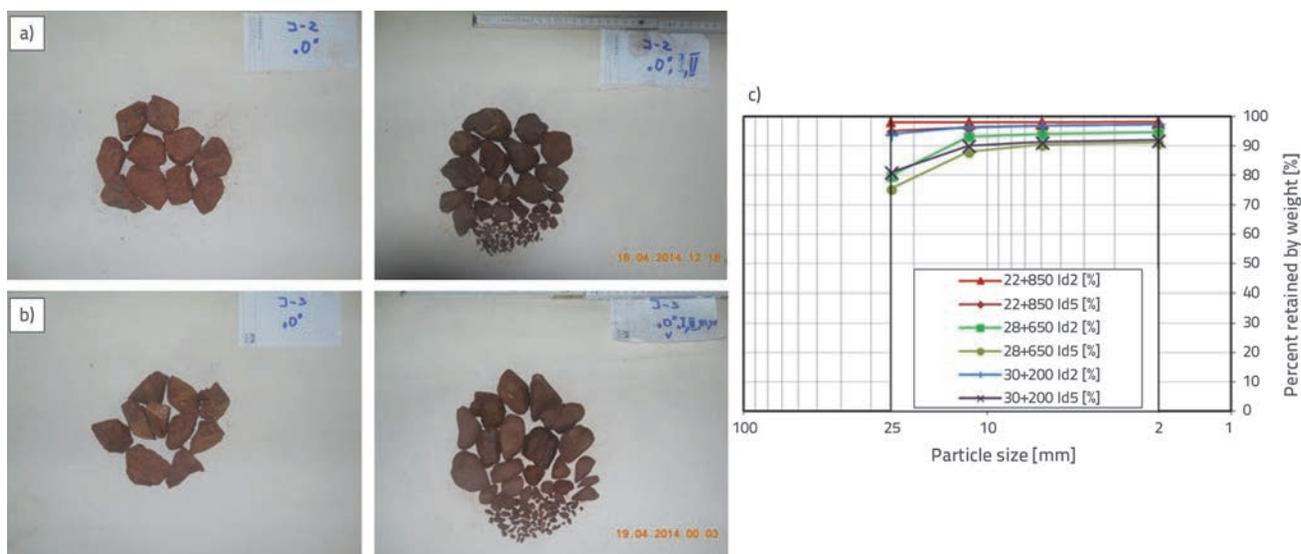
Results of slake durability tests are shown in Table 4. Figure 9.a and 9.b shows samples prior to testing and after the second and fifth cycles. The slake durability index ranges between 95 % < Id(2) < 98 %. In order to classify the degree of disintegration after the first and second test cycles, Gamble [45] proposed a classification, which was modified by Erguler and Shakoor [43],

Figure 9. a) Sample from km 28+650 before test and after second cycle, b) Sample from km 30+200 before test and after fifth cycle, c) Grain size curves after second and fifth cycles

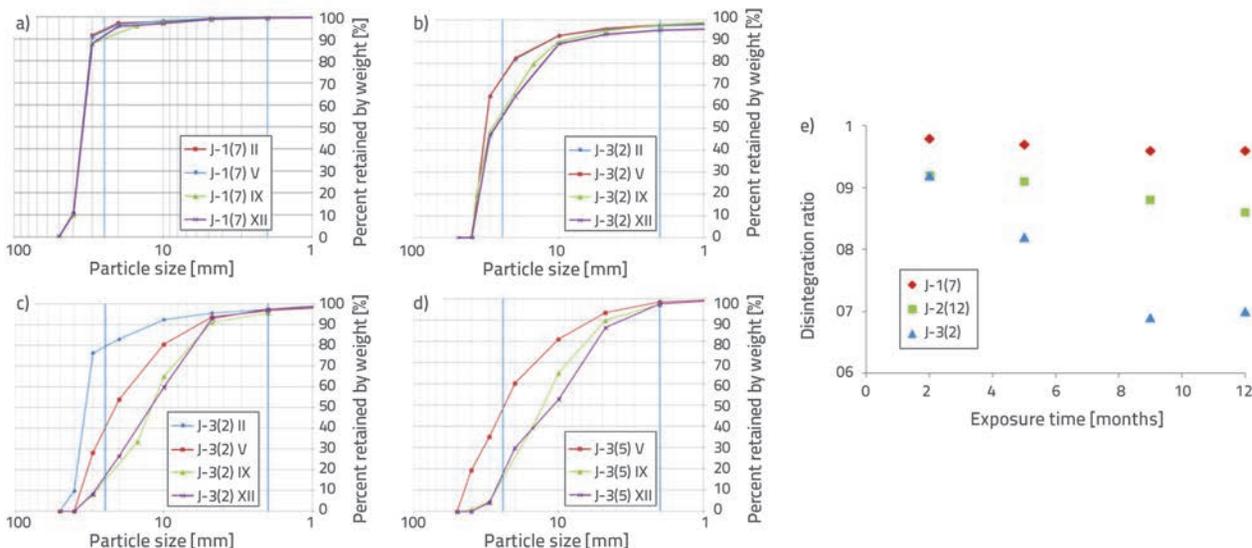
Figure 10. Grain size curves: a) J-1(7), b) J-2(12), c) J-3(2), d) J-3(5), e) disintegration ratio with exposure time

inspection so as to obtain an average degree of disintegration of all samples from one location. After sieving, samples were re-exposed to elements in order to monitor further disintegration. As shown in Table 6, samples from location at km 22+850 (designated J-1) are the least susceptible to disintegration, whereas samples from location at km 30+200 (designated J-3) exhibit the highest level of susceptibility to disintegration. Grain size curves for samples J-1(7), J-2(12), J-3(2), and J-3(5) are shown in Figure 10.a to 10.d. It can be seen that the highest rate of disintegration is achieved during the first five month of exposure, whereas disintegration between 9 and 12 months of exposure is insignificant. The results show that the rock mass is moderately resistant to weathering (except in the case of samples from location 22+850). Disintegration ratios with exposure time for samples from three locations are shown in Figure 10.e.

expected to be negligible between six and twelve months after exposure, whereas GSI value tends to an asymptotic value of 15. These findings are in general agreement with the rate of disintegration as represented by grain size distribution curves, Figure 10.

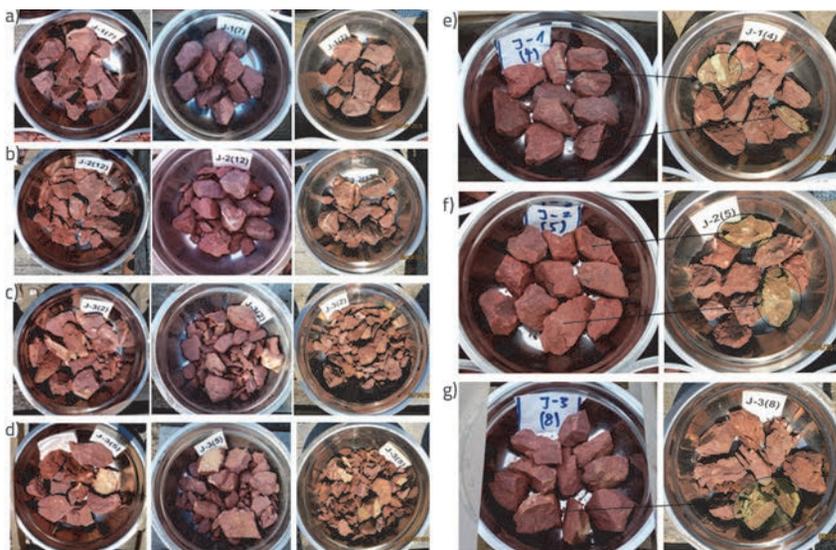
Figure 11. Samples after 2, 5, and 12 months a) J-1(7); b) J-2(12); c) J-3(2); d) J-3(5); and change in surface conditions for samples e) J-1(4); f) J-2(5); g) J-3(8)

Appearance of samples prior to and after exposure to atmospheric conditions is shown in Figure 11. Figure 11 shows that mechanical properties of Permian sediments are influenced by rock mass disintegration in two ways. At first, new cracks develop on intact pieces, pre-existing discontinuities become wider, and process of fragmentation is initiated. During further exposure, discontinuity surfaces are altered, and quality is reduced. Alteration of discontinuity surfaces cannot be obtained in short-term laboratory tests. Prior to exposure the samples were slightly to moderately weathered, thus surface conditions were of good to fair quality. After one year of exposure, the quality of surface conditions was on an average reduced by one category. These changes also influenced the surface roughness. If all exposed samples are

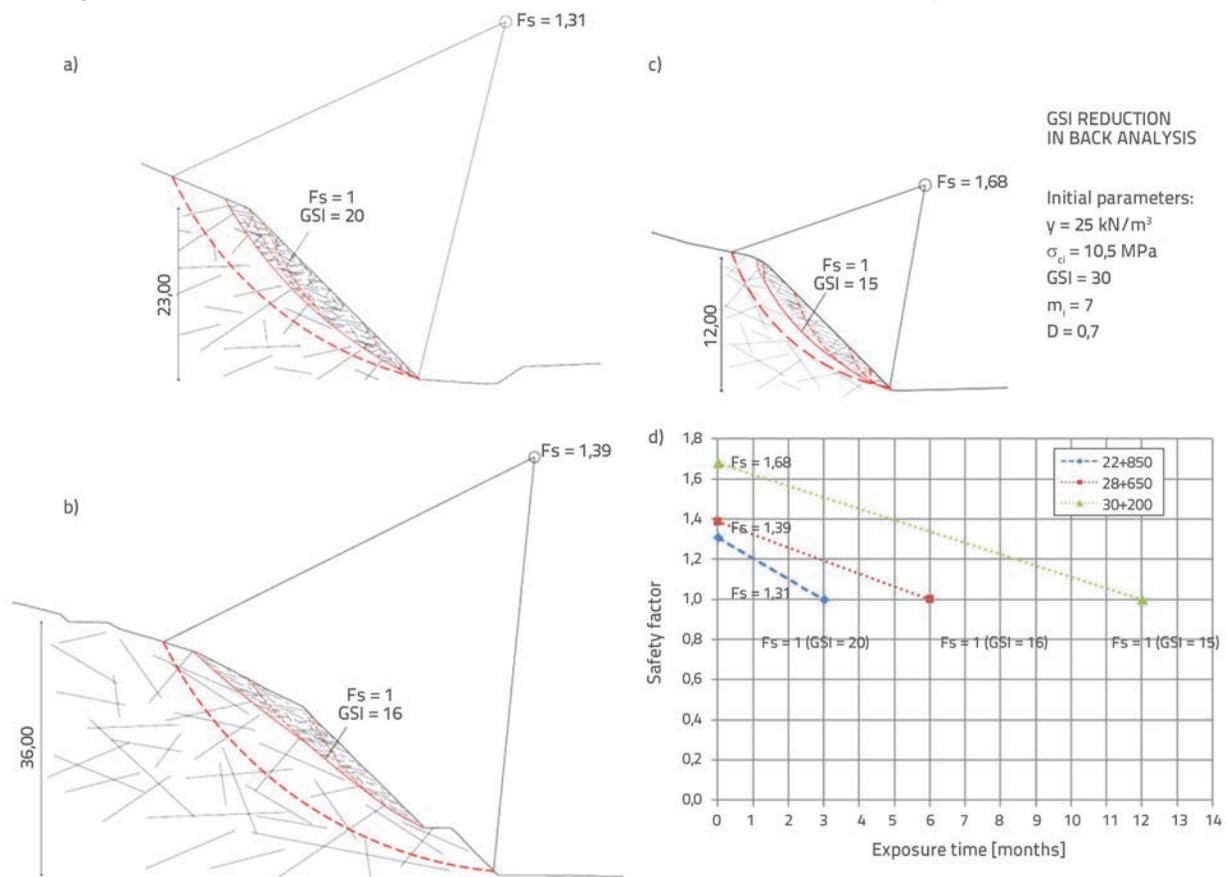
In order to analyse the influence of GSI reduction on the stability of the cuttings, the slope stability analyses were performed using the software package Slide, assuming plane strain conditions. Lower bound values of initial shear strength parameters of GT III material (Table 3) were used in forward analyses. Since Permian sediments are a typical HB material, appropriate calculations were performed using the Bishop's simplified method. Back analyses were performed on predefined failure surfaces where the state of failure was reached by reducing initial GSI value to the value for which FoS equals unity. Morgenstern-Price method, with an assumption of half-sine interslice force function  $f(x)$ , was used to perform back analyses since the failure surface observed at km 28+650 has a composite shape.

1.31, 1.39, and 1.68, respectively. The cutting at KM 22+850 exhibits the lowest FoS and an instability occurred three months following the exposure. An average critical GSI value at the time of failure is equal to 20. The global failure at km 28+650 occurred six months after excavation with an average GSI value of 16. The lowest slope at km 30+200 exhibits the lowest average GSI value equal to 15 at the time of failure. In other words, the slope with the lowest initial FoS will be the first to suffer from instability at the moment of reaching the highest critical GSI value. In order to become unstable, a lower cutting needs to disintegrate to a higher extent and reach a lower critical GSI value. Variation of FoS with exposure time is shown in Figure 12.d.

Figure 12. Slope stability analyses (not to scale): a) KM 22+850, b) KM 28+650, c) KM 30+200, d) safety factor with exposure time

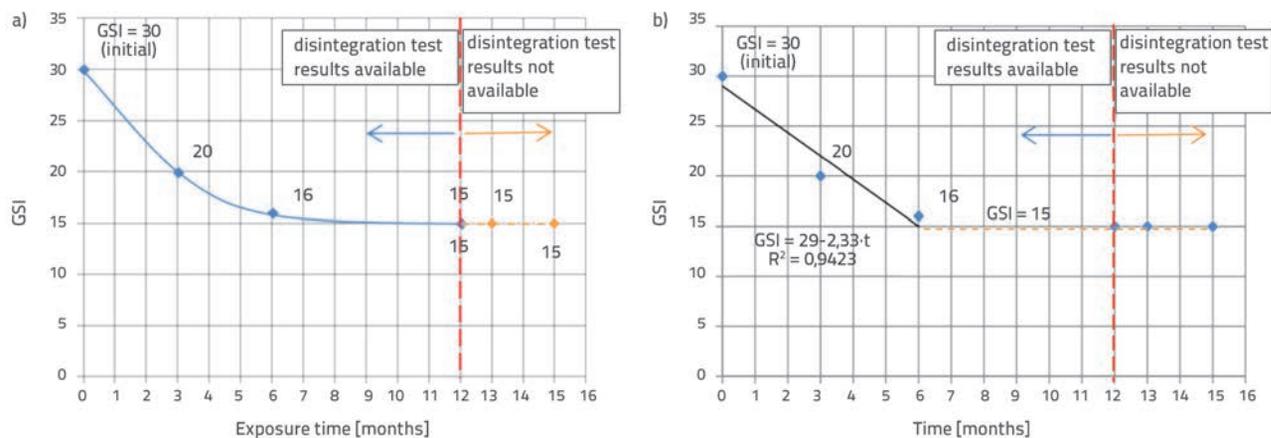
The GSI value reduces by one third during the first three months of exposure, whereas the initial GSI value reduces up to 50 % after one year, Figure 13. The critical GSI values for cuttings at KM 29+400, KM 29+900 and KM 30+050 are shown in Figure 12 along with GSI values obtained from three studied locations. These cuttings are all 12 m in height, with the slope inclination of 1 : 1. The state of failure is reached after 12, 13, and 15 months, respectively (Table 1). It can therefore be concluded that the largest decrease in GSI value should be expected during the first six months after exposure. The reduction in GSI value is

Figure 13. a) GSI value with exposure time for 1:1 slope geometry; b) GSI reduction as a bilinear function

The GSI reduction can be approximated by bilinear function with a relatively high accuracy, Figure 13b. It is suggested that the conservative GSI value of 15 be used for slope stability analyses if slope stays unprotected during the periods of more than 6 months. Bilinear equation can be expressed as :
