Spatial development of the St. Michael Castle on the island of Ugljan

Subject review

The paper is based on the conservation study prepared in 2015 by the same authors, and it constitutes its shorter version. The preparation of the conservation study was encouraged and funded by the Preko Municipality as a first stage of the systemic rehabilitation and revitalisation of St. Michael's Castle.

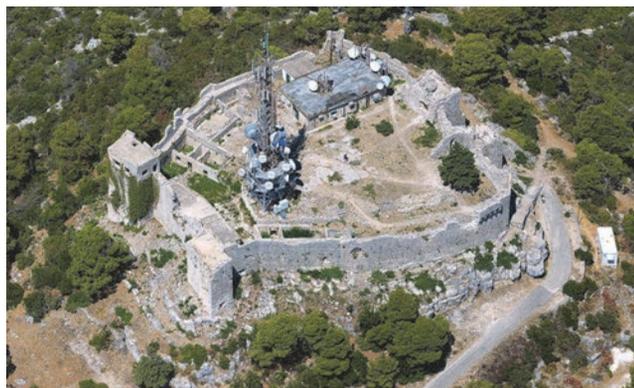
Figure 1. St. Michael's Castle on Ugljan (Photo: Boris Kačan)

With its 263 m in height, St. Michael's Mount is the second highest point on the island of Ugljan. It is situated opposite to the city of Zadar, above the town of Preko, only 600 m away from the outer coast of the island. It was named after St. Michael Church which was built there in the Middle Ages. It boasts an exceptional strategic position offering good view of a great part of the Zadar area and its hinterland. That is why a mighty castle was built on its top in the early 13th century (Figure 1).

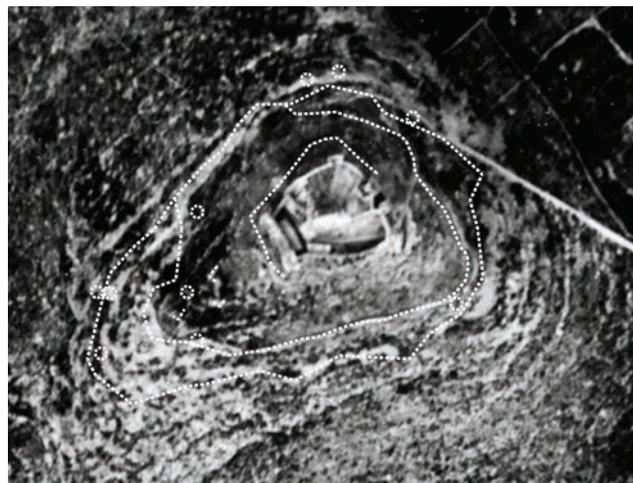
Figure 2. Dry stone defensive walls and structures at St. Michael's Mount (Vinko Madiraca) as shown on the photo taken in 1944 (Geodetski zavod d.o.o. Split)

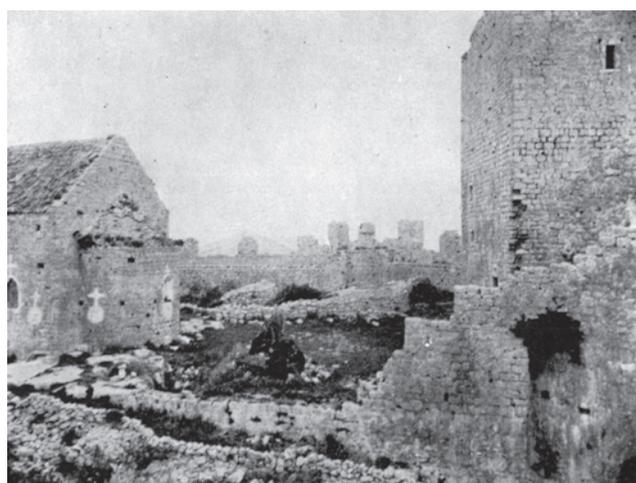
Figure 4. St. Michael's church and castle in the early 20th century [7]

Two photographs (Figures 4, 6) and the drawings made by Salghetti-Drioli in the mid 19th century (Figure 5) bear witness

m in height. Its accurate reconstruction is made possible thanks to drawings by F. Salghetti-Drioli from the mid 19th century [9], photographs of west façade from 1913 from Brunelli's book [19] (Figure 15), and the south-façade photograph from the Ostojić's book [7] (Figure 4).

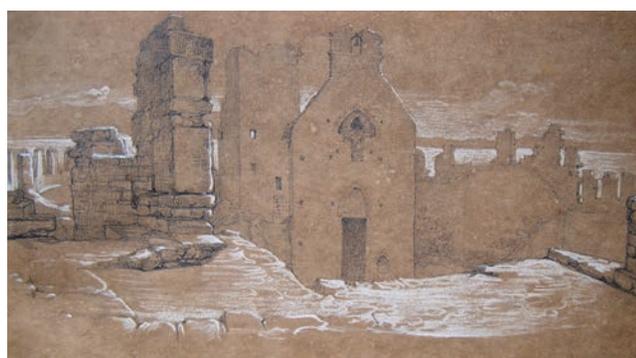
Figure 5. West façade of St. Michael's Church in the mid 19th century (Crtež: F. Salghetti-Drioli) [9]

of the appearance of the Romanesque-Gothic church. Traces of mortar on the cliffs at the central plateau enable determination of the position of walls, and hence definition of approximate size of the church: 13 x 7 m, with a semi-circular apse 6 m in diameter. According to Benevenia, the church measured 13 x 6 m in size [10], while according to Bianchi it measured 20 x 8 m [11].

The style of the openings and furniture was gothic, while the semi-circular apse is typical for Romanesque churches. The roof was double-pitched with gable walls, and the bell cote was situated on top of the main façade. T. G. Jackson described the vault above the nave as a waggon vault [8], while Petricioli considers that the church proportions, and the steep gable, actually point to the existence of a gothic blunt vault [9]. A confirmation of Petricioli's assumption can be found on the Salghetti-Drioli drawing of the west façade of the church (Figure 5) where the top of this gothic vault can be seen by looking through the caved-in opening above the portal. The second church entrance was probably situated at the south side, where the access was enabled via the ramp mentioned by Benevenia. This ramp was situated exactly opposite to the stairs leading to the south wall of the castle [10].

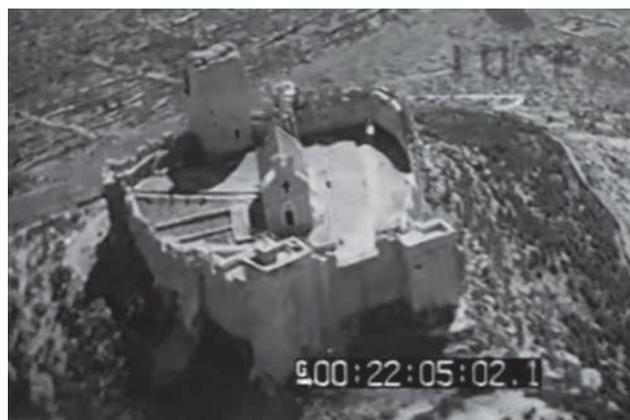
Figure 6. St. Michael's Castle, photo from 1941 [12]

At the very beginning of World War II, the castle and church were photographed from the air for the purposes of fascist propaganda [12] (Figure 6). The church was destroyed during an attack of Anglo-American airplanes in 1944, and its remains were razed to the ground by the Yugoslav navy in 1947 [9]. Its construction material now lies in a stone heap to the south of the plateau on which the church used to stand. Among other material, the heap contains numerous blocks of tufa from the former vault.

On the west side of the castle, there are two rectangular towers. They are positioned in the same plane and are parallel to the towers situated in the east. The second gate of the castle, smaller in size, is situated between the two towers. This gate probably served for evacuation in emergency situations and is today also walled up. The third gate, the only one that is presently in use, was probably built by cutting the wall in the period between the two world wars because the dilapidated donjon posed threat to the main entrance. This gate is not presented in the drawings by F. Salghetti-Drioli from the mid-nineteenth century (Figure 17), but can be seen on the photo from 1941 (Figure 6).

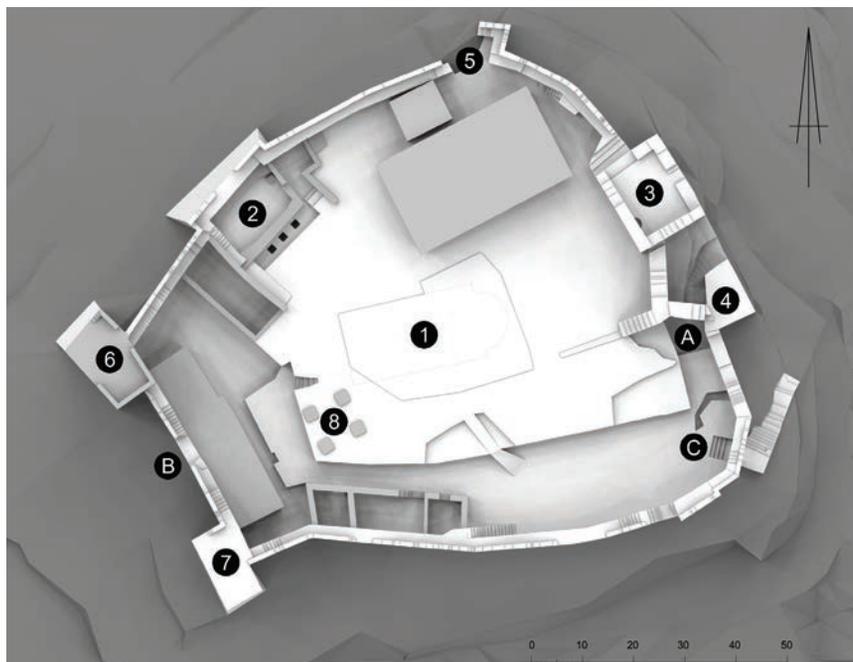
Figure 7. Plan view of St. Michael's Castle: 1. Position of St. Michael's Church, 2. Monastery cistern, 3. Donjon, 4. South-east tower, 5. North-east tower 6. North-west tower, 7. South-west tower, 8. Television aerial pedestal, A. Main gate of the castle, B. West gate, C. New gate (authors)

The position of the monastery can be assumed based on the plan view of St. Michael's Castle (Figure 7). In fact, the main east gate of the castle (currently walled up) is positioned in such a way to orient the main roadway to the south of the church, parallel with the south wall of the castle toward the west gate (currently also walled up). The space within the castle in front of the west gate, and the space in front of the donjon, was left free for defence purposes, and so it can only be assumed that the monastery was positioned to the north of the church. The monastery probably had the cistern which was situated along the northern wall of the castle. The fact that the castle wall leans onto the cistern is a proof that it existed before construction of the castle. The cistern remains that have been preserved to this day include peripheral walls and the beginning of the vault. This spot is currently also occupied by a cistern covered with a reinforced-concrete slab. Cisterns, bell tower, and monastery building, are mentioned in documents from 1347 [4, 13] and 1348 [4, 13] in which demolition of the castle is depicted. The bell tower is shown in the drawing of the castle made in 1716 by Cosmo Faventini. Bianchi considered that the abbey on Ugljan closed its doors in 1402 [7] and T.G. Jackson states that the monastery was abandoned in the period from 1453 to 1468 [8]. In 1421, the Venetian authorities ordered "that the military castellan be removed from St. Michael, and that the key of St. Michael be handed over to the abbot so that the divine service (mass) can be celebrated there" [7], which is a proof that by that time the monks no longer lived in the monastery.

The St. Michael's Castle is a stronghold of irregular, trapezoidal plan and its contours follows natural configuration of the terrain. It measures 58 x 52 m in size and is protected by strong walls and five towers. The main tower (donjon) is situated at the northeast side of the castle. Immediately next to donjon, on its south side, there is a smaller tower of trapezoidal plan, and between them the castle entrance where steep stone stairs lead to the main castle gate that is currently walled up.

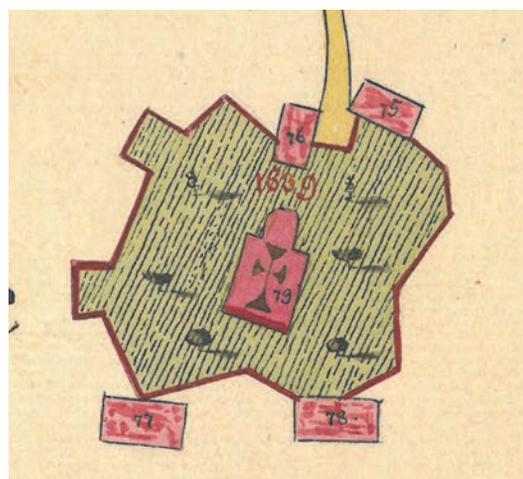
Figure 8. St. Michael's Castle on the cadastral plan from 1829 [20] (National Records Office in Split, Collection of maps for Dalmatia, Signature HR-DAST-152)

According to cadastral records from 1829, St. Michael's castle and church were state-owned during the Austrian rule (Figure 8). Towers were marked as rubble and, besides the church, there were no other structures in the castle. Its interior was used by yeoman Simeone Lantana as a vegetable garden with grapevines, olive trees and fruit trees. Later on, the place was used by an Austrian military reconnaissance unit [7] and, between the two world wars, the castle was used by Yugoslav army as an observation point toward Zadar, which was at that time under Italian rule [9]. After World War II and until 1960s the site hosted a Yugoslav navy unit and, after they abandoned the castle, it became a favoured destination, often visited by the locals and tourists [9]. Before the Homeland War, a TV aerial was installed in the castle, which is why an approach road leading all the way to the fort's east gate was built. During the same war, the south and north walls of the castle were heavily damaged by Yugoslav army planes targeting the TV aerial [9].

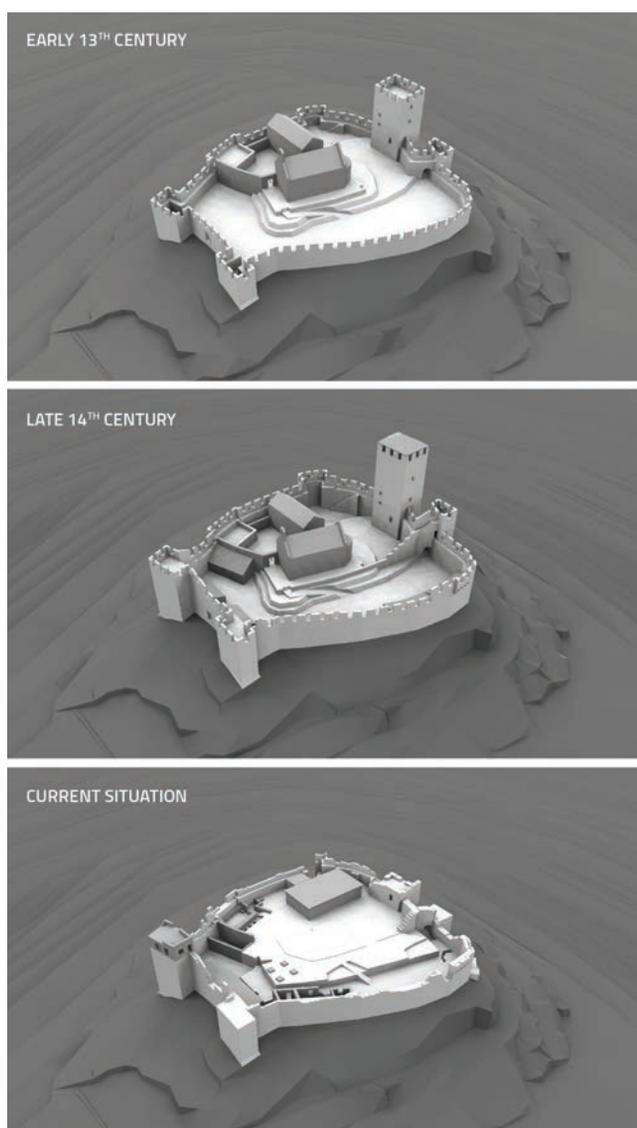
Figure 9. Assumed spatial development of St. Michael's Castle

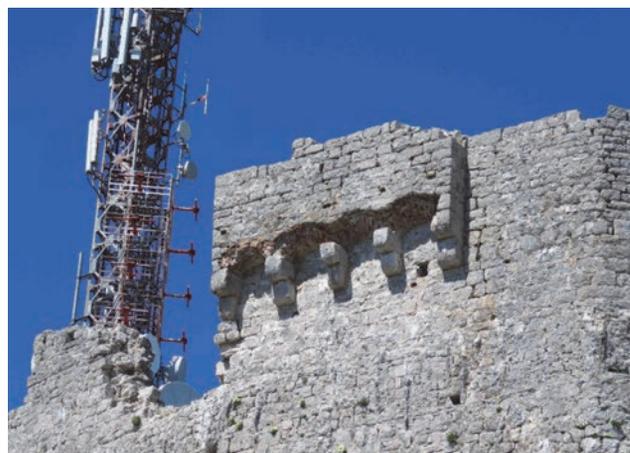
Figure 10. False brattice at the southeast side of the castle (authors)

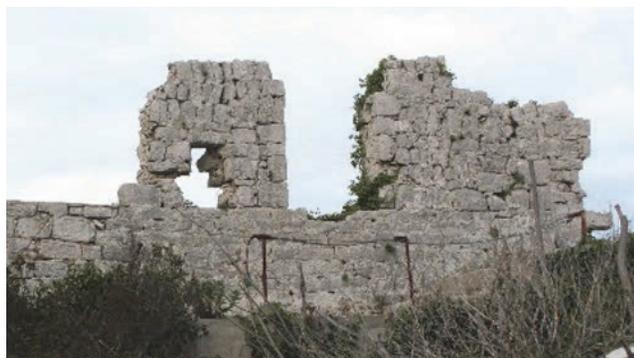
Figure 11. Opening and two merlons of the north-wall crenellation, damaged arrow loop is visible at the left-side merlon

The walls of the castle, measuring 135-145 cm in width, ended at the top part with the chemin-de-ronde and crenellation. The chemin-de-ronde and the parapet are almost fully preserved, while two merlons at the north wall under the north-west tower (Figure 11), and two merlons at the west wall, are the only remaining elements of the crenellation. However, thanks to old photos and drawings by F. Salghetti-Drioli, the disposition of openings of the entire crenellation can be reconstructed to a great extent. As was usually the case, there was a vertical arrow loop at every other merlon of the crenellation, such as the one that is partly preserved at the north wall, while stone-made perforated cantilevers (rechioni) that carried the wooden or leather-made shutter (mantelet), were situated on both sides of the crenellation opening. Only one of them, albeit cut out, is preserved to this day at the west façade of the castle. The railing of the chemin-de-ronde was made of wooden beams fixed to perforated stone cantilevers protruding from the wall under the floor of the chemin-de-ronde. Some such cantilevers with a square hole have been preserved at the south and west-side walls (Figure 12).

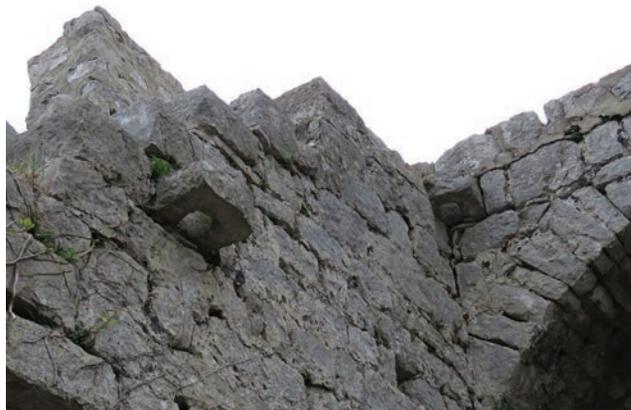
Figure 12. Perforated stone cantilevers – supports for the wooden railing (authors)

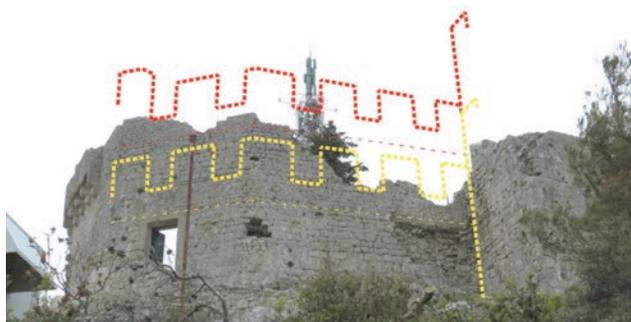
Figure 13. Two phases of crenellation at the south-east part of the castle

A detailed analysis of stone structure of the castle walls has revealed traces of an earlier lower chemin-de-ronde at the east wall, to the south of the south-east tower. This points to the existence of an older structural phase of the castle (Figure 13). The traces appear in form of joints or changes in the masonry work techniques. At the point of wall damage, immediately next to the south-east tower, the layers of material used to close the former crenellation and build the new one can clearly be seen. This vertical extension of defence walls can be dated to the second half of the 14th century when Zadrans conducted the mentioned castle rehabilitation works. At that time, the walls were raised by 3 to 4.5 m. Unlike the previous one, this new chemin-de-ronde was not horizontal but elevated at the south-east (at the point where the earlier mentioned false brattice was built), at the north-west and south-west towers, and at the wall connecting these two towers.

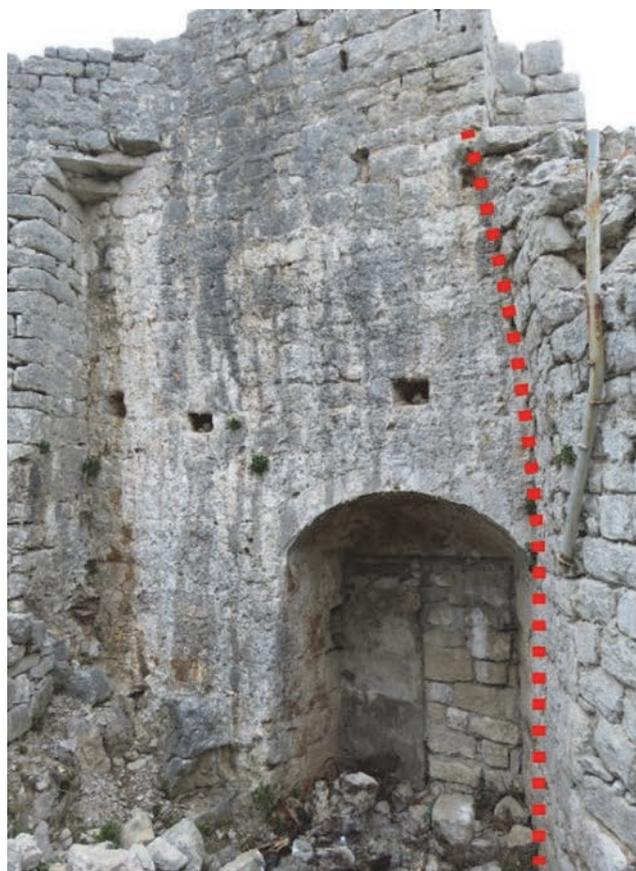
Figure 14. Cantilever part of the defence wall next to donjon and S-E tower

An interesting defence wall extension detail can be seen to the east and west of the south-east tower, and in the north-west and south-west tower. In fact, the wall from the interior was not extended vertically like in other parts of the castle, but protrudes slightly in form of a gently curving arch. This was probably done to obtain a greater width of the chemin-de-ronde. The same detail

can be seen in Split, on the medieval strengthening of the north wall of Diocletian's Palace, to the east of the north-west tower, above a medieval staircase leading to the chemin-de-ronde.

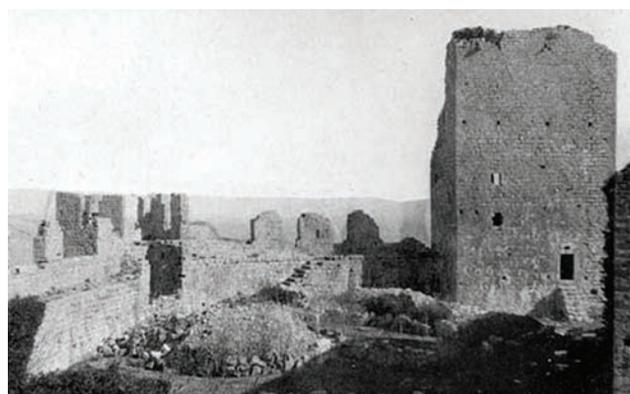
Figure 15. West façade of donjon in early 20th century [19]

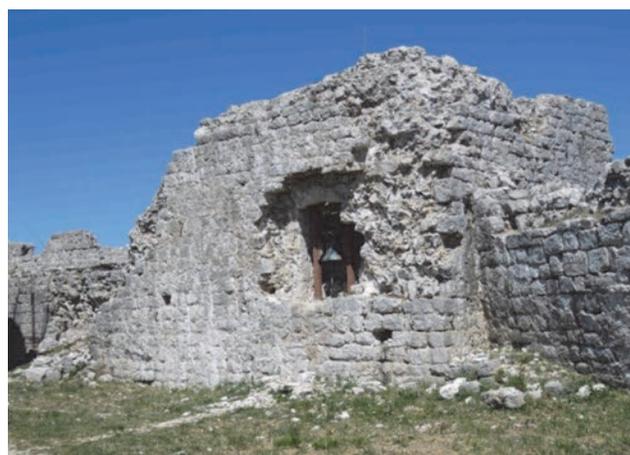
Figure 16. West façade of donjon (authors)

The interior of the tower is currently filled with rubble up the top of the opening at the west façade in which the bell is now situated (Figure 16). Stone cantilevers of the floor structure protrude from the wall at the height of this fill material. The fact that the cantilever is not placed at the very corner at the south-west side of the tower, as is the case at the opposite wall, points to the existence of staircase precisely at that corner. The frame of the opening at the west façade has not been preserved but its rectangular shape and the relieving opening above it can be seen in an old photograph. It can be determined by rectification of the photograph that this opening was no more than 145 cm in height. The opening is positioned precisely below the cantilever of the floor structure and, considering its small height, it can be concluded that it was positioned higher than the floor of the room.

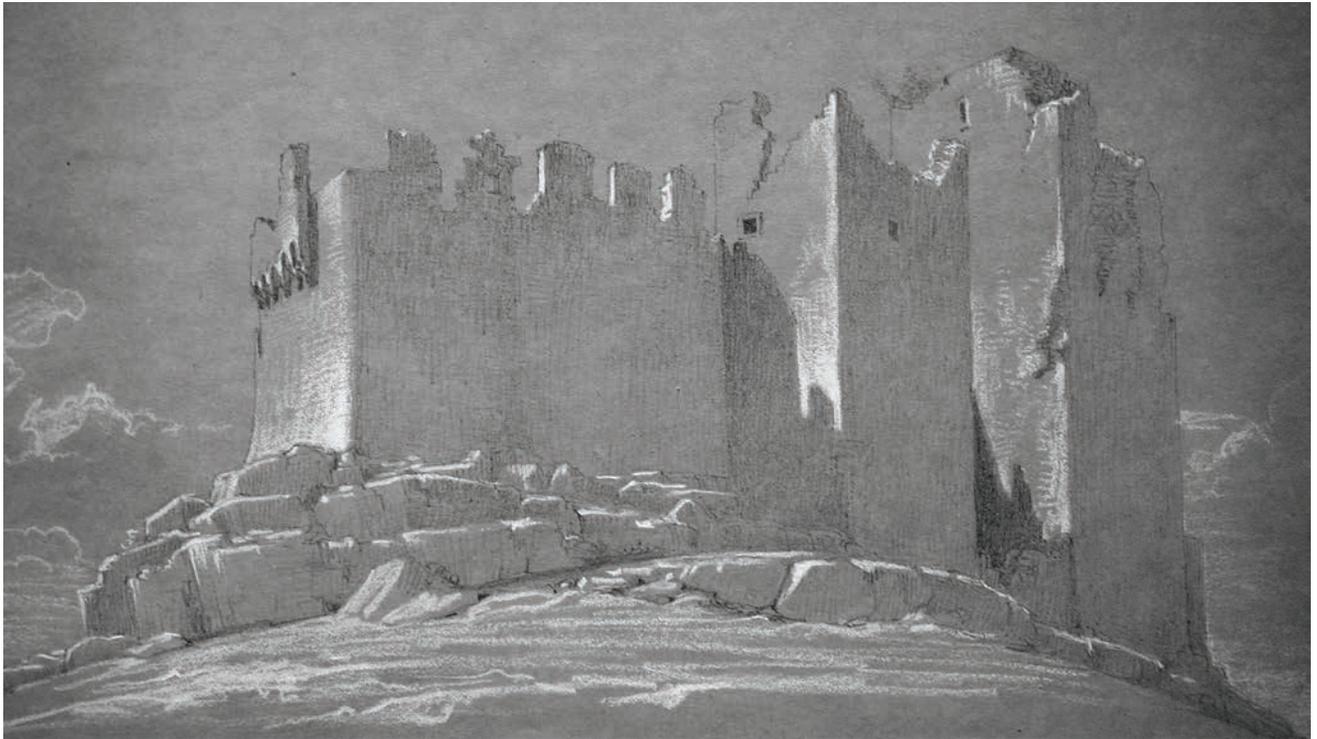
Figure 17. Eastern part of St. Michael's Castle in mid 19th century (crtež: F. Salghetti-Drioli) [9]

Small windows at the east façade and south façade of the tower, as shown in the drawings by Salghetti-Drioli (Figure 17) prove that an additional storey, topped by a terrace with crenellation, existed above the cistern vault (Figure 14). However, as the walls of this castle were built in two phases, it can be assumed that, in the first phase, the tower had only the crenellation above the terrace over cistern and that, later on, due to vertical extension of the castle, it was also elevated by one storey. This assumption is backed by the fact that the level of the first phase of the chemin-de-ronde to the north of the tower is the same as the level of the terrace above the cistern.

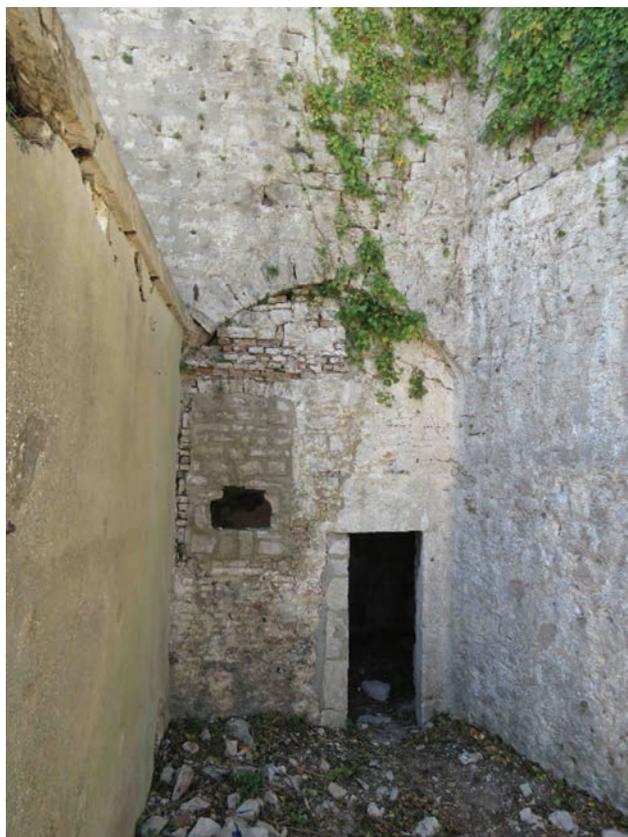
Figure 18. Walled up opening at the S-W tower

By its structure, the southwest tower is similar to - although a bit smaller than - the northwest tower. It measures about 3.8 by 7.4 meters in plan. In the first phase, this tower was as tall as the castle wall and was later extended by a protruding wall segment of curved section. In this case, it was topped with stone slabs forming a false ceiling (Figure 19). Just like in the northwest tower, the opening toward the castle interior was bridged with a blunt arch. Almost none of the crenellation at the terrace level has been preserved. The original cistern topped with barrel vault and situated below the ground floor has been preserved. It was probably converted in the 20th century to a septic tank, and was topped with lavatory for soldiers. The south wall of the castle was pierced to enable drainage of the septic tank content. The existence of a similar cistern can be assumed in the northwest tower as well.

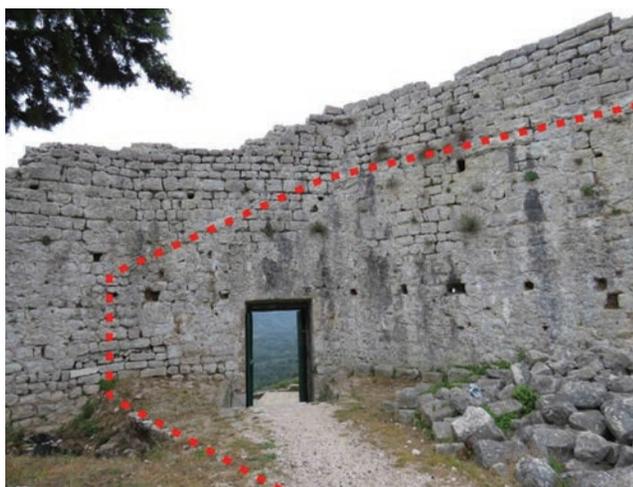
Figure 20. Captain house traces at the southeast part of the castle, in the zone where new castle gate was subsequently pierced

The traces of the first captain house next to the south wall of the castle, opposite the main entrance, were already observed by Petricioli, who assumed that the house was a two storey dwelling [17]. However, based on the holes for beams of the horizontal wooden structure in the south wall, and stone cantilevers that carried a single pitched roof, it can be concluded that this was a single storey house measuring 3.5 m in height up to the eaves of the roof (Figure 19). It extended all the way to the staircase leading to the south wall. This house was followed by the second house placed along the south wall. Its existence is

confirmed by the holes of the beams for the horizontal wooden structure in the south wall of the castle, within the rubble of structures that were built here during the second world war. This is probably the area in which the houses for soldiers, mentioned in the contract from 1400, were situated. According to the same contract [17], the house for the second captain was to be built more to the north, near the stove. It can be assumed that it was situated to the west of the medieval monastery cistern, at the very spot that is currently occupied by the debris of military structures.
