# DETERMINATION OF BALLISTIC PROPERTIES ON ARMOX 500T STEEL WELDED JOINT

### Abstract:

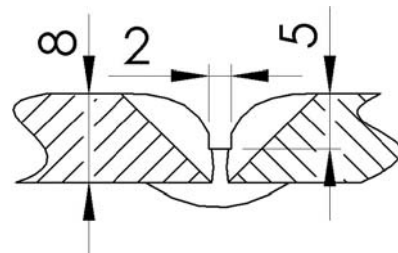
Figure 2. Buttering layer configuration.

Before welding of the plates, all of the bevelled edges of the V groove were buttered with a layer of ASS filler material. According to the literature [8] this layer provides the welded joint with improved ballistic performance. Buttering was carried out by positioning of the plates on copper backing and tilted for 45°. After applying the buttering layer, root pass was welded from the backside of the joint. Before continuing with the welding, other filler passes, root pass and buttering layer were grinded in the middle in order to eliminate possible slag inclusions and to achieve more favourable joint geometry (Fig. 2). Total of 4 different samples were welded all with different welding sequences and filler material combinations. The samples U1, U3 and U4 were welded in total of 6 welding passes and sample U2 was welded in 4 passes. The joints were welded as per the sequence shown in Fig 3 (a –

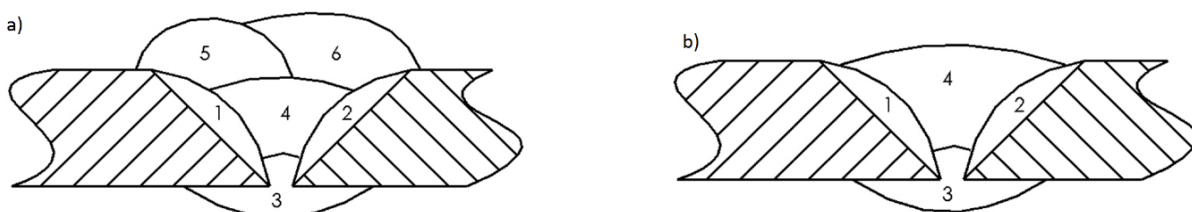
Figure 3. Welding sequences.

samples U1, U3 and U4; b – sample U2). Welding parameters used to produce all of the samples are presented in Table 2 and Table 3. All samples were welded using pulsed metal transfer and DCEP with no weaving motion. The inter-pass temperature was maintained under 100 °C during welding of all passes.

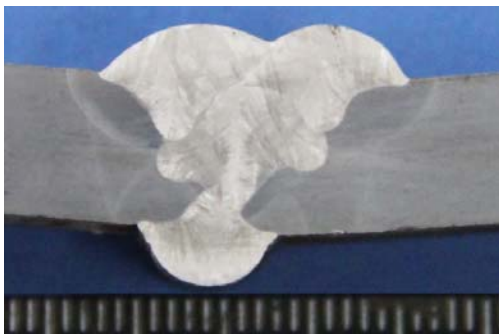
Figure 4. U1 macrograph.

Macrostructures of all the welded joints are shown in Fig. 4 to Fig. 7. As can be seen from the mentioned figures, all of the samples (except for sample U2) have a significant reinforcement due to the final two layers. These reinforcements were not grinded because that would affect the ballistic performance of the joints. The welded joints are all homogenous without occurrence of pores or inclusions. A penetration of all weld passes is sufficient and no lack of fusion was noticed. The only difference between the samples is between the sample U2 and all the other samples, and it lies in the deformation of the welded structure. It can be noticed that the sample U2 is less deformed compared to the other samples. This difference is due to smaller overall heat input and therefore less thermal deformations.

After evaluating all of the observed experiment results, discussion on the subject of the ballistic performance can be made. First of all, macrographs of all samples (Fig. 4 to Fig. 7) show that there was no occurrence of cracks, inclusions, or porosity indicating that the applied technology was adequately defined. Use of the ASS filler material in combination with the hardfacing filler material prevented the occurrence of hot cracks after welding providing the welded joint with excellent weld integrity. The main difference from standard welded joint is the higher reinforcement of the weld which was not grinded. The reason for keeping the high reinforcement lies in the fact that if it were to be grinded, properties of welded joint would be severely impaired leaving the joint with thinner capping layer which is especially important in the case of hardfacing capping layer.

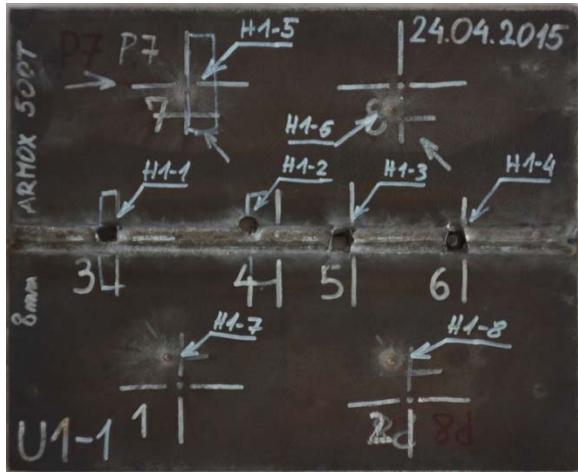
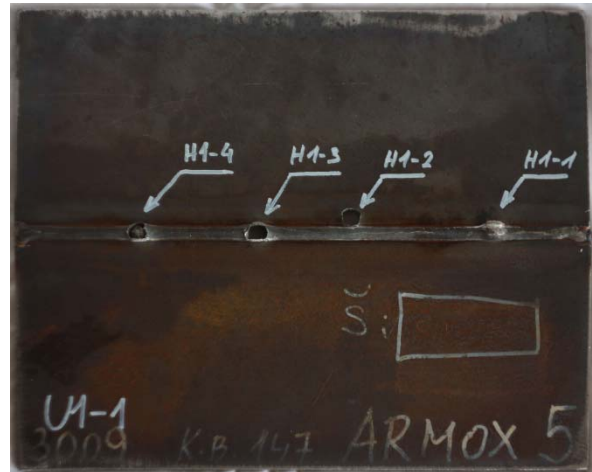
Figure 8. U1 sample after ballistic testing.

Figure 8 shows the U1 test sample after ballistic testing. Figure 8a is the front side and Fig. 8b is the rear side view. Pictures clearly show that the welded joint did not withstand the ballistic load of the projectiles being shot. Hits H1-2 and H1-3 resulted in total breach through the test sample. Hit H1-1 (Fig. 9) partially breached the weld metal zone. It can be seen on the rear side the occurrence of the smooth bulge. Also hit H1-4 (Fig. 10) resulted in partial breach of the weld metal with the bullet left

trapped in the weld metal zone. This sample shows no ballistic resistance in the area of the welded joint. Macrograph of hit H1-1 in Fig. 11 shows the appearance of three mechanisms. First of all, deformation of the “soft” austenitic material layer can be observed as a result of the kinetic energy delivered from the bullet which leads to formation of the crater. Secondly, occurrence of the crack at the end of the HAZ zone where very strong tension appeared. Thirdly, significant sliding of the material

The sample U1 showed very poor ballistic performance, as it was expected, because the filler material used was low hardness austenitic steel. Almost all of the breaches which occurred were "plugging" type. This type of breach results in extrusion of the material being hit in the form of a plug or cork (Fig. 13). Low ballistic performance was expected due to the use of only low hardness filler material which could not withstand the ballistic impact of the bullet. Only the base material showed good ballistic performance.

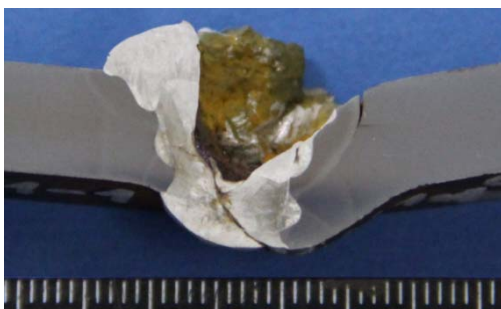
Figure 11. Macrograph of hit H1-1.

in the root pass fusion line area caused formation of the bulge on the rear side of the welded joint. Figure 12 shows macrograph of the hit H1-2 which was shot in the area of fusion line and HAZ. Elevation of

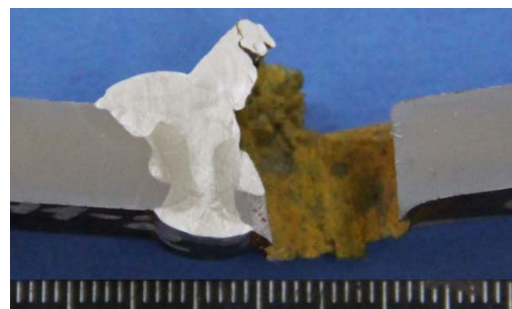
Figure 12. Macrograph of hit H1-2.

the weld metal as a consequence of the pressure waves created when a bullet hit the target can be noticed. This hit clearly shows the extremely low ballistic performance in the area of the HAZ.

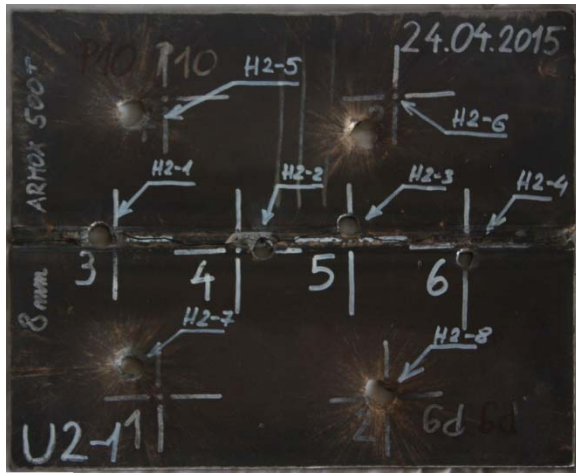
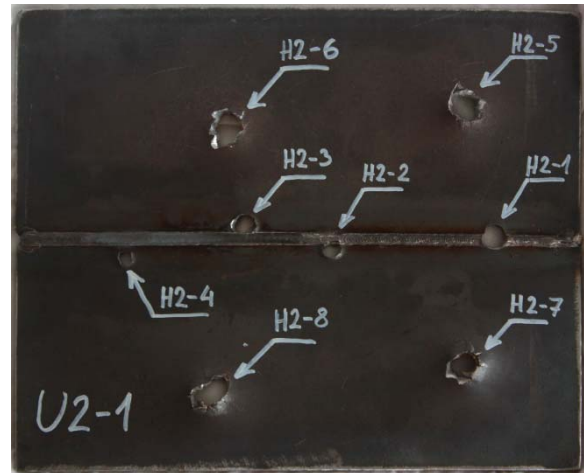
Figure 13. U2 sample after ballistic testing.

Figure 13 displays results of the ballistic testing on sample plate U2. Figure 13a shows the front and Fig. 13b shows the rear side of the test plate. As can be noticed, sample plate U2 did not withstand any of the hits shot at different weld joint zones including the base material. All of the breaches were total

breaches with occurrence of plugging. The crack that goes along the weld centre line is due to bullet impacts of hits H2-5, H2-6, H2-7 and H2-8 which were taken with 12.7 munitions type. Figure 14 shows in greater detail H2-2 hit which was shot at fusion line of the welded joint. Figure 14a shows in

Ballistic performance of the sample U2 was even worse than of the sample U1 even though the welded joint consisted of the austenitic steel and hardfacing filler material. The main difference between the sample U2 and other samples was that this sample consisted of fewer weld layers which would obviously contribute to the weld ballistic performance. Even though one might expect better weld characteristics because of the lower total heat input, which means less microstructural changes and mechanical properties deterioration, the results of the ballistic testing proved that it was not the case. It seems that the filler material used in weld metal could not compensate for the deterioration of the mechanical properties due to welding process – heat input.

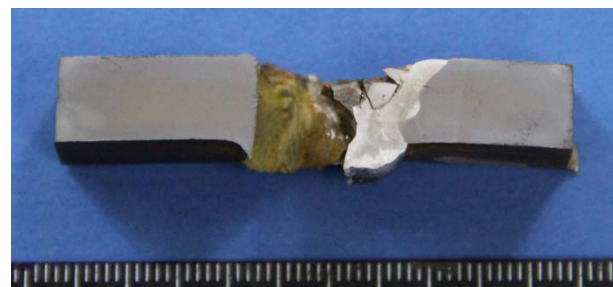
Figure 15. Macrograph of H2-2 hit.

more detail the front side of the hit being shot at the fusion line. The occurrence of the crack can also be noticed along the centre line of the weld metal and chipped off segment of the weld metal due to the H2-2 bullet hit. Macrograph of the H2-2 hit shown

on the Fig. 15 indicates that the bullet has devastated part of the base material with the left side of the welded joint. Observed crack of the hard filler material indicates the absorption of portion of the load, but not enough to stop the total breach.

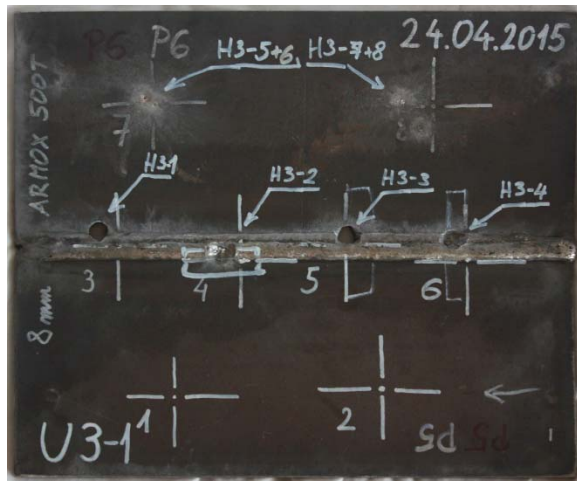
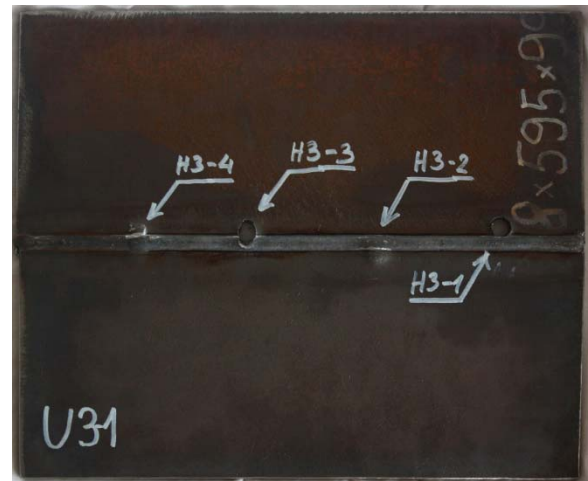
Figure 16. U3 sample after ballistic testing.

The sample U3 after ballistic testing is shown in Fig. 16. Both front (Fig. 16a) and rear (Fig. 16b) side of the test sample show better ballistic properties in comparison to the samples U1 and U2. Only shots hit to the fusion line and heat affected zone (H3-1 and H3-3) resulted in total breaches. Weld metal (H3-2 and H3-4) resulted in better ballistic performance as there were no breaches but only appearance of the bulges on the rear side. Base material (H3-5, H3-6, H3-7 and H3-8) showed excellent ballistic performance as no significant damage was observed on the front side and on the rear side of the test plate. Figure 17 shows in greater detail hit H3-2 which was made to the weld metal.

The sample U3 showed relatively satisfactory results after ballistic testing. Even though there were some signs of damage on the rear side of the welded sample, no breaches were detected. The ASS capping layer overtook some of the bullet impact

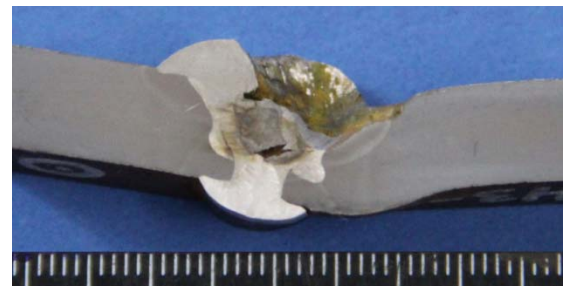
Figure 18. Macrograph of H3-2 hit.

Here it can be seen that the weld metal withstood the great ballistic load of the bullet. No breach was observed but an indent bigger than the bullet occurred. On the rear side only small bulge can be noticed. Macrograph of the H3-2 (Fig 18) shows the damage occurred as a result of the bullet impact wave. Due to the “soft” capping layer, the bullet impact energy has been dissipated blocking further path of the bullet with the “hard” middle layer. This hard layer not only stopped the breach of the bullet through the welded joint but also deflected the bullet to the side. Deflection of the bullet caused the separation of the welded joint in the root layer between the base and filler material.

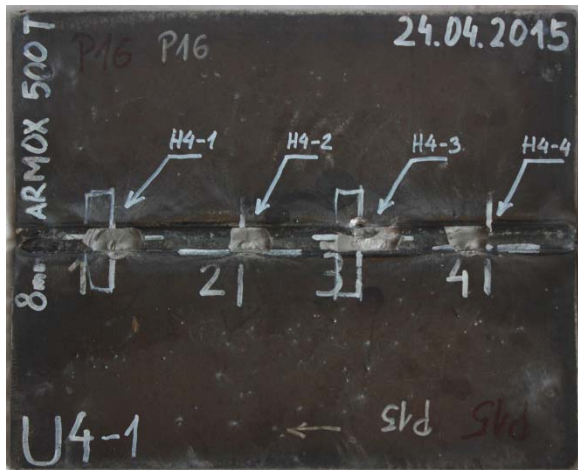
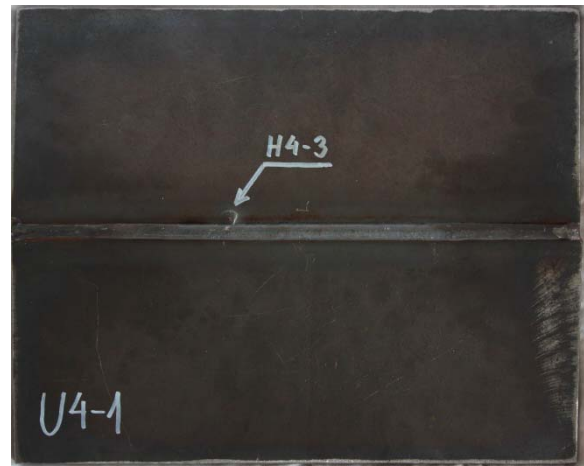
Figure 19. The U4 sample after ballistic test.

Last sample ballistically tested was the sample U4 shown in Fig. 19. As it can be seen from the Fig. 19a and Fig. 19b, this sample showed the best ballistic performance. No total breaches were observed, even in the critical weld area of HAZ. All hits fired to the weld metal (H4-1, H4-2 and H4-4) caused only chipping off the capping layer leaving the rest of the welded joint without significant damage. Hit shot at the weld metal and HAZ (H4-3) shown in the Fig. 20 resulted in chipping off a piece of capping layer and an occurrence of a small bulge in the rear side of the plate/joint. Figure 21 shows the macrograph of the hit H4-1 which was shot to the weld metal. The picture clearly shows the chipped off piece of capping layer with the intact rest of the welded joint. The role of the capping hard layer was in this case completely fulfilled as the layer took over most of the impact force from the bullet and distributed the rest onto the more elastic and softer austenitic steel filler material. The hard capping layer spent the majority of the impact force by breaking and detaching from the rest of the weld

metal and the austenitic filler material beneath the capping layer absorbed the rest of the stress. This kind of stress dissipation left the rest of the welded joint without cracks or any other damages.

The last sample tested was the sample U4. This sample showed the best ballistic performance even though the hardfacing filler material used in welding of this sample was also used in welding of the sample U2. The sample U4 even showed ballistic resistance in the heat affected zone area which was found to be the critical area of the tested welded joints. Hits shot into the weld metal zone and fusion line caused chipping off the pieces of the hardfacing layer. As a consequence of the impact, separation of the chipped off pieces along the fusion line with the weld pass beneath the capping layer occurred. Separation and breaking of the capping layer resulted in distribution of the bullet impact energy. This left the weld pass beneath it without occurrence of cracks providing the welded joint with great ballistic resistance.
