## The Austro-Hungarian hangars in Mostar - Part II

**Gottfried Holzschuh**

**Abstract:** The first part of the survey covers the history of the Austro-Hungarian "Air Base", "Aviation Park no. 4" and "Reserve Squadron 11", which were stationed in Mostar between 1913 and 1918. The airfield of Mostar-Rodoč, evaluated as early as in 1912, was one of the oldest in the Austro-Hungarian Monarchy. The Imperial and Royal Army Air Service used it for basic pilot training in World War I. The second part is an expertise for the salvage, conservation and restoration of the four still existing Austro-Hungarian hangars at the former Mostar-Rodoč airfield in view of protection of historical monuments. Erected in 1917/18, these hangars are the oldest witnesses of aviation in Bosnia and Hercegovina. Because of their genuine and very efficient construction, they should be preserved as unique examples of technical and engineering architecture. One hangar of exactly the same type, restored in 2013 in Krakow, is now part of Poland's cultural heritage. Structural calculations have shown that these Austro-Hungarian hangars comply with modern EU building regulations. All used documents and plans from th

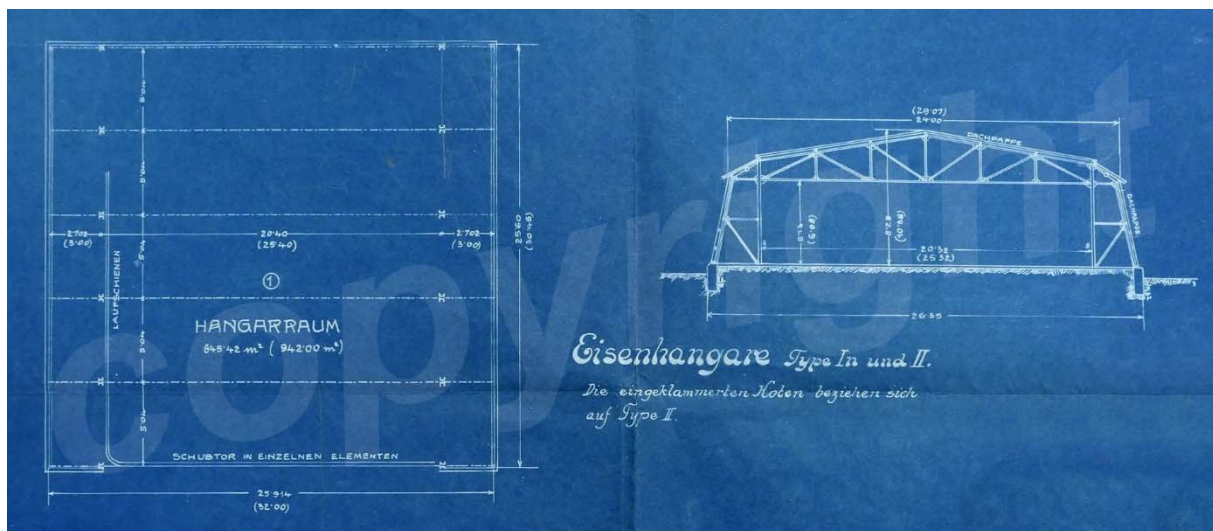
Figure 12. Waagner hangar, plan view and section with measurement data of types *In* and *II* (ÖStA/KA)

At the beginning of 1916, the army air service ordered 50 pieces of iron hangars *in sizes I* (no. 3223 - 3242), *II* (no. 3311 - 3330) and *III* (no. 3411 - 3420) from the Vienna bridge construction company Waagner, Biró & Kurz AG to equip their airfields (Figure 11). This type of hangar was already proven; the same number were even erected at the Aspern Aviation Authority, at the aviation depots in Aspern and Fischamend, the equipment supplier Strasshof as well as some reserve squadrons. It was a riveted truss frame structure made of iron, the individual elements connected by screws to make the parts transportable. The flat mansard roof with truss beams was equipped on both sides with skylights at full length. Admittedly, the internal supporting structure reduced the usable area for aircraft, but the space between the girders could be used for workshops and depots. The front of the hangar could be opened almost completely by means of sliding door panels that moved inwards on rails (Figure 12).

For its hangars, Waagner delivered only the iron framework to the Army Air Service. The necessary foundation works, carpentry and roofing works had to be advertised and assigned to local construction companies at each building site. The roof and walls were given wood panelling that was sealed with bituminous roofing felt on its outside. The wooden doors on lattice iron frames were impregnated instead. Additional windows, ventilation accessories, built-in storage spaces, heating, eaves or lightning rods were not part of the original catalogue of demands of the Austro-Hungarian Technical Committee but were a possible option. The complexity of construction and overall costs were considerably higher than for Lord wooden hangars of the same size, but resistance to wind pressure and snow load was greater.

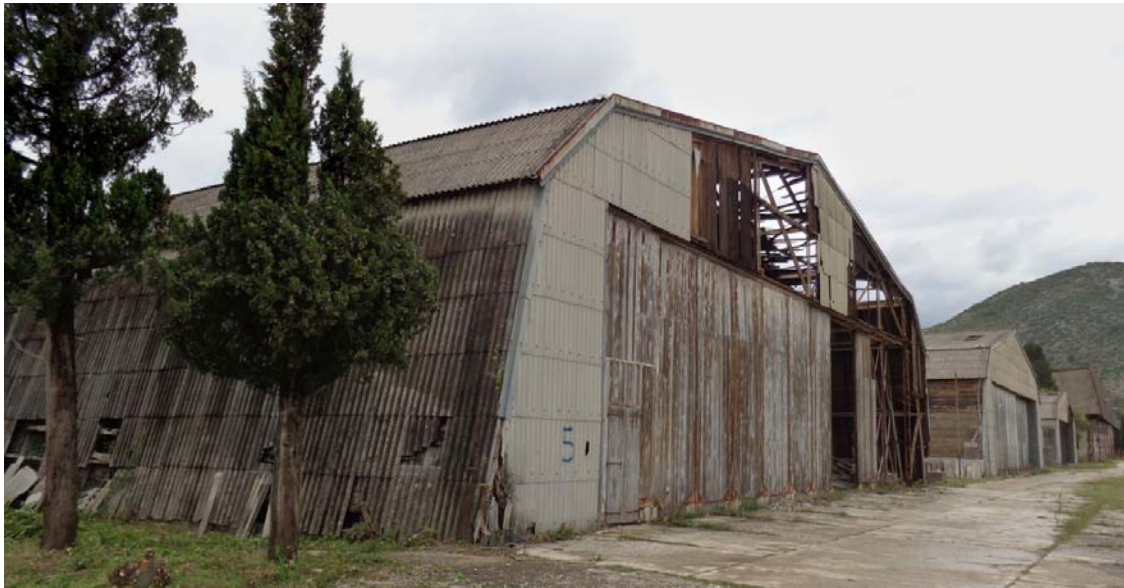
Figure 14. *Type II* Waagner hangar (no. 5) in Mostar (M. Martinović)

At first impression, the present condition of the four hangars is poor. There is damage from the Bosnian and Herzegovinian war primarily to the wooden panelling of roofs, walls and doors. But the iron truss structure appears to be still intact to a large extent (Figures 1, 14, 16). It was only supplemented by masonry walls on their backside (Figure 18). The typical skylights were covered at some point with wooden panels, and the whole buildings with corrugated sheets of cement fiber. Reconstruction of the wooden parts is easily possible, as from the identical Waagner hangars presently standing at the old airport in Innsbruck, Austria, detailed estimates with data on the dimensions of roof purlins and rafters, squared timber and panelling have been preserved.

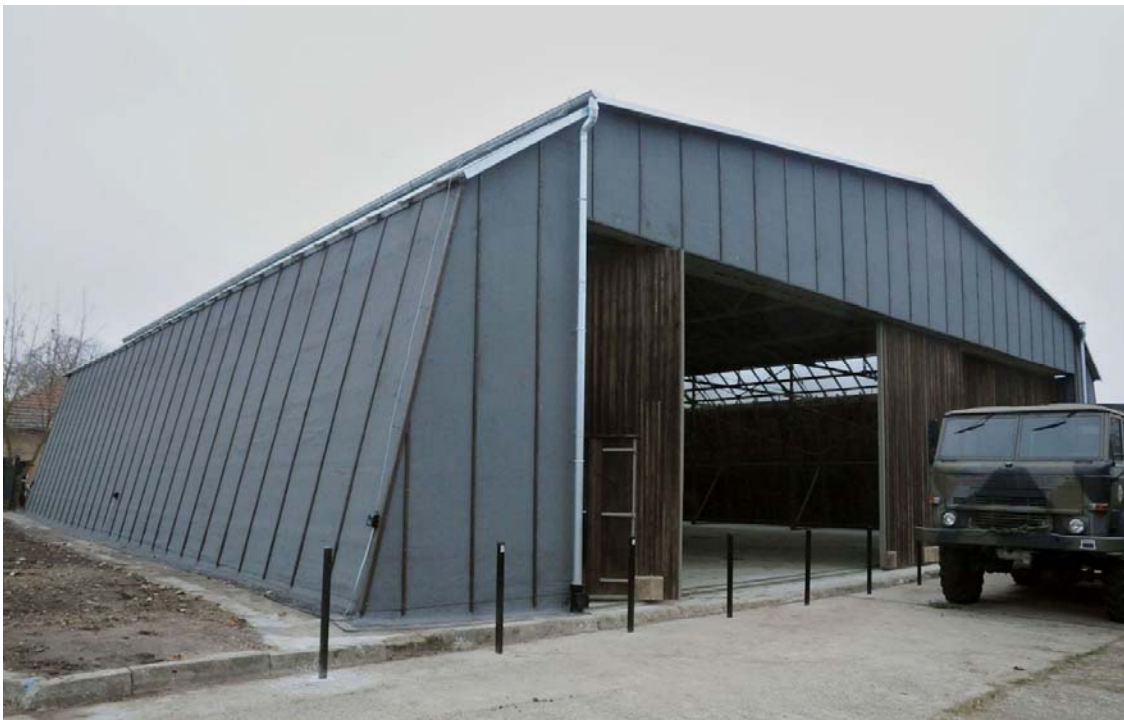
Figure 15. Immaculate restored *type In* specimen in Krakow. The eaves gutter with drainpipe and lightning rod are modern, but "accessories" that make sense

The model for proper restoration is beyond doubt the *type In* Waagner hangar in Krakow. It is located on a site of barracks of the former Krakow-Rakowice airfield, the original base of *Flek 10* in the northeast of the city. Its exceptional value as the last preserved on-site Austro-Hungarian hangar (Figures 15, 17) was recognized as part of a large survey of historic buildings (Figure 19) located there. According to the stamps on the iron support columns, the load-bearing structure was produced in 1916 in the Bohemian (Czech) steel plant Kladno (Kladno).

The restoration was financed from the resources of the Polish Ministry of Defense and the National Fund for Historical Monuments of the City of Krakow. The main works that were performed from July to November 2013 consisted in restoring the structure to its original technical condition and protecting it from microbiological risks and harmful environmental impacts. The iron parts were cleaned of corrosion and protected with anti-rust agent.

The structural calculation of truss girders proved to be completely sufficient according to present-day construction standards in terms of wind pressure and possible snow load, taking into account the prestressed structure. The restoration of the rope tensioning system could not only re-establish prestressing, but also the overall structure. This had completely lost shape when hit by a German air force bomb on 1 September 1939. The readjustment enabled the new setting of the valuable sliding door mechanism that allows efficient opening of the hangar doors, almost without effort.

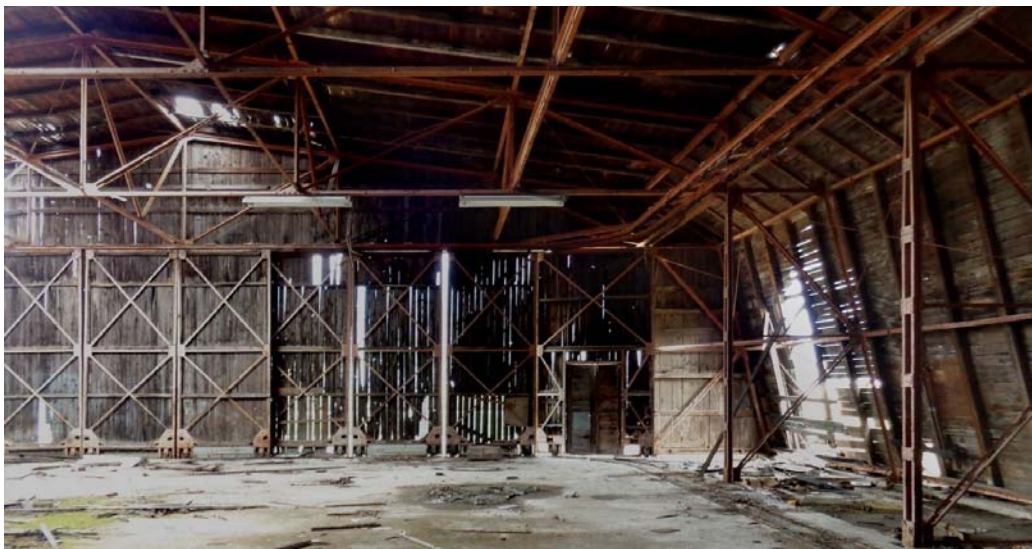
Figure 16. *Type In* hangar (no. 3) in Mostar: the iron frames and rails for the sliding door elements are intact (M. Martinović)

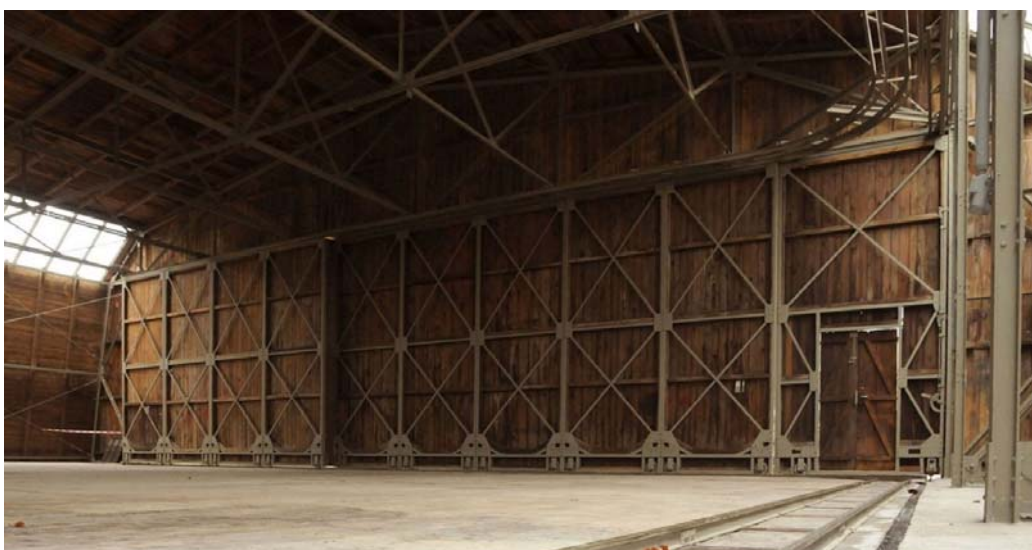
Figure 17. Vision for the re-establishment of the Mostar hangars. The Krakow hangar still lacks a wooden floor, so the door rails raise over the floor horizon

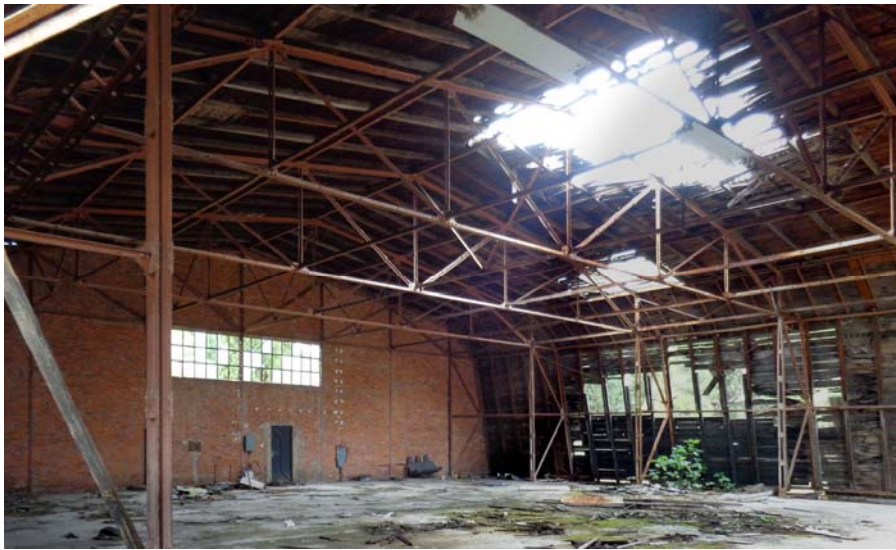
Figure 18. Hangar no. 3 with shell hit. The brick-built back wall does not belong to the original hangar construction (M. Martinović)

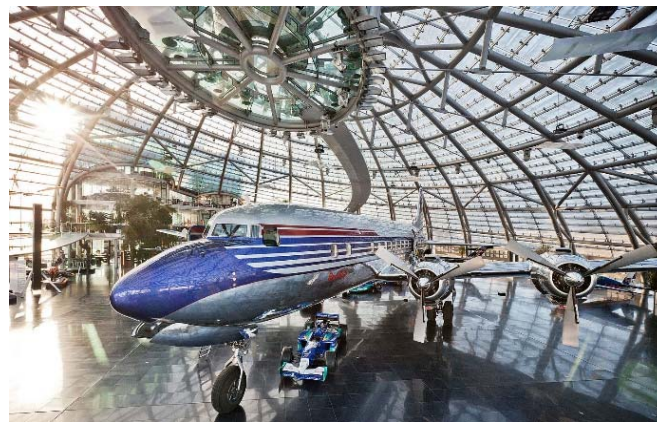
Figure 20. Waagner-Biro built the last hangars in 2003 for Red Bull in Salzburg. The reputable steel construction company that erected the domed roof of the Louvre Abu Dhabi went bankrupt in 2018 (Flying Bulls)

If the armed forces would withdraw from their site in Mostar, and the Waagner hangars would be threaten with demolition, then if they would be "available" or "tradeable", it would be necessary to consider "returning" one or the other specimen for museum purposes to Austria. The Austrian Air Force Museum in Zeltweg suffers from lack of space, and the Aviaticum in Wiener Neustadt, the most important collection of gliders in Europe, only recently had to move to a very small workshop. However, a possible sponsor for such a project - the Waagner-Biro Corp. - dropped out (Figure 20).
