# Durability and Mechanical Performance of Differently Treated Glulam Beams during Two Years of Outdoor Exposure

Original scientific paper • Izvorni znanstveni rad

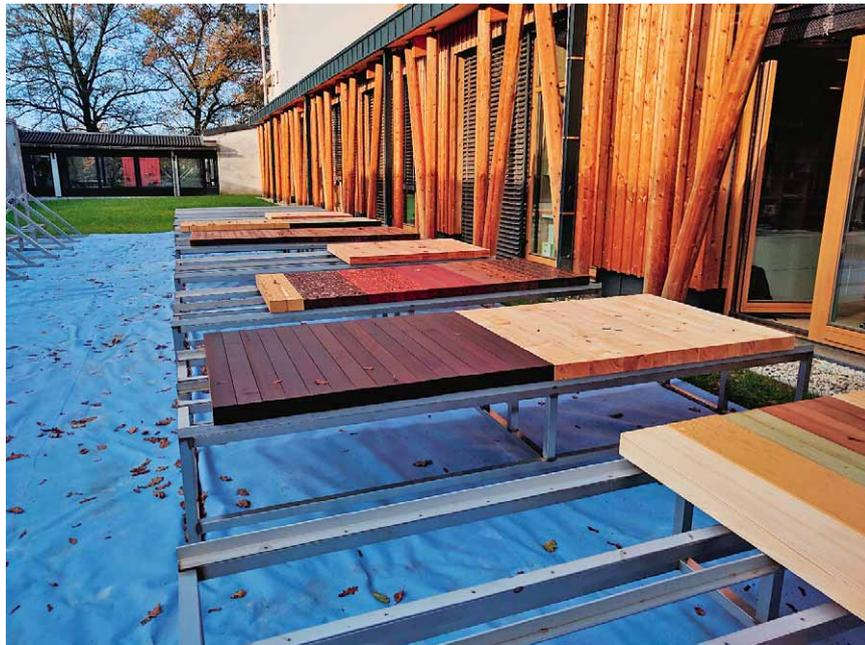
**Figure 1** Glulams at the beginning of the experiment on the test field of the University of Ljubljana, Biotechnical faculty  
**Slika 1.** Lamelirani nosači na početku izlaganja na izlagalištu Biotehničkog fakulteta Sveučilišta u Ljubljani

The running experiment started on 4<sup>th</sup> November 2016 and is based on the model glulam beams (83 mm × 68 mm × 1100 mm), exposed in use class 3.2 conditions, 500 mm above ground in a horizontal position on the test field of the University of Ljubljana, Biotechnical faculty (Figure 1) (46°02'55.7" N 14°28'47.3" E, elevation above sea level 293 m). The average temperature in Ljubljana is 10.4 °C, the annual precipitation is 1290 mm and the Scheffer Climate Index is 55.3 (Scheffer, 1971). The hazard potential of different climates was estimated by empirically determined decay intensity. Scheffer focused on the parameters temperature and distribution on rainfall as follows in Eq. 1:

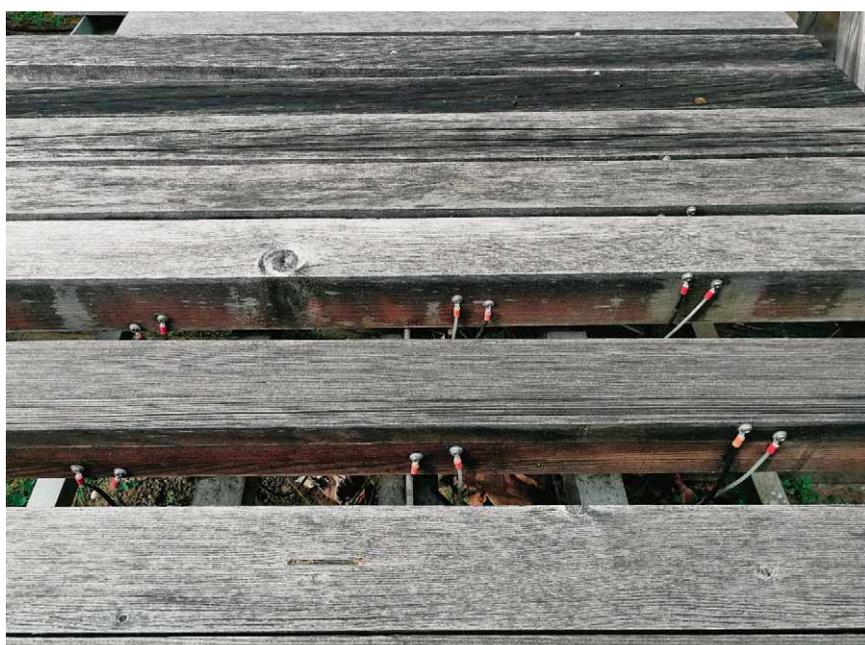
**Figure 2** Distribution of moisture content sensors in each layer of tested samples  
**Slika 2.** Raspored senzora za mjerenje sadržaja vode u svakom sloju ispitivanih uzoraka

Part of the specimens is equipped with moisture content sensors as shown in Figure 2. For moisture content (MC) measurements, resistance sensors were applied at 32 positions and linked to a signal amplifier (Gigamodule, Scantronik) that enabled wood MC measurements between 6 % and 60 %. Sensors were positioned in every lamella of three-layered glulam beams. In the top lamella, sensors were positioned approximately 10 mm below surface to avoid surface water-related phenomena. Similarly, in the two lower ones, approximately 10 mm from the glue line, the

electrical resistance of the wood was measured every twelve hours and these data were used for calculating the wood MC. Resistance characteristics for each material were determined as reported by (Brischke and Lampen, 2014) using the methodology described by (CEN, 2015).

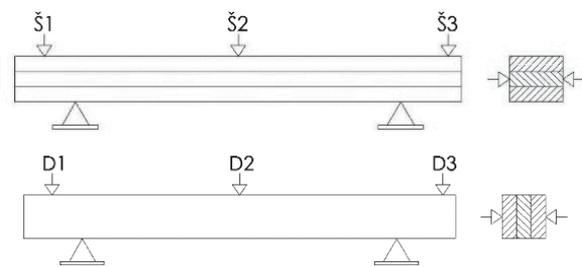
**Figure 3** Measuring the frequency response of glulams. Transverse vibration  $\parallel$  to the lamellas (top picture) and transverse vibration  $\perp$  to the lamellas (bottom picture). Š1-Š3 and D1-D2 mark the locations of measurements  
**Slika 3.** Mjerenje frekvencije odziva lameliranih nosača. Poprečna vibracija  $\parallel$  na lamele (gornja slika) i poprečna vibracija  $\perp$  na lamele (donja slika); Š1 – Š3 i D1 – D2 oznake su mjesta mjerenja

Non-destructive methods for testing wood are usually based on determining the speed of sound and damping sound oscillation. With the acoustic method, we can determine the mechanical properties and some anomalies of the wood (Bucur, 2006). The dynamic modulus of elasticity of the glulam specimens was determined from the frequency response of free-lying specimen vibration. The supports were placed at 0.224 lengths from each end of glulam specimens (Figure 3). With microphone (PCB-130D20) and the measuring

card (NI-9234), we determined the frequency response to transverse and longitudinal excitation of each glulam sample in the first vibration mode. In LabView 8.1 we determined, according to Bernoulli theory, the modulus of elasticity from the frequency response (Eq. 2) (Gorišek *et al.*, 2014).

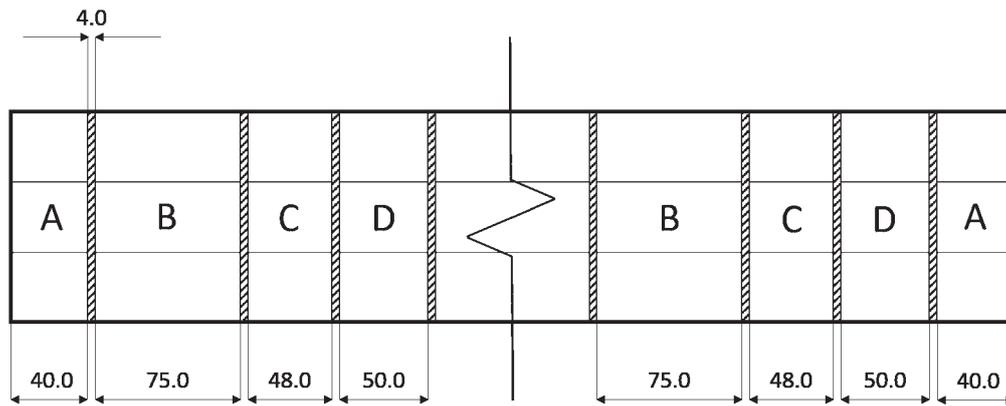
**Figure 4** Cutting scheme of three-layer glulams. A was cut off and saved, B sample was used for delamination test according to EN 14080, C samples were used for testing shear strength of glue lines, and D sample for compressive strength. The rest of glulams was stored. Prior to delamination test, mass and dimensions of B specimens in the oven-dried condition were determined and used in density ( $\rho_0$ ) calculation

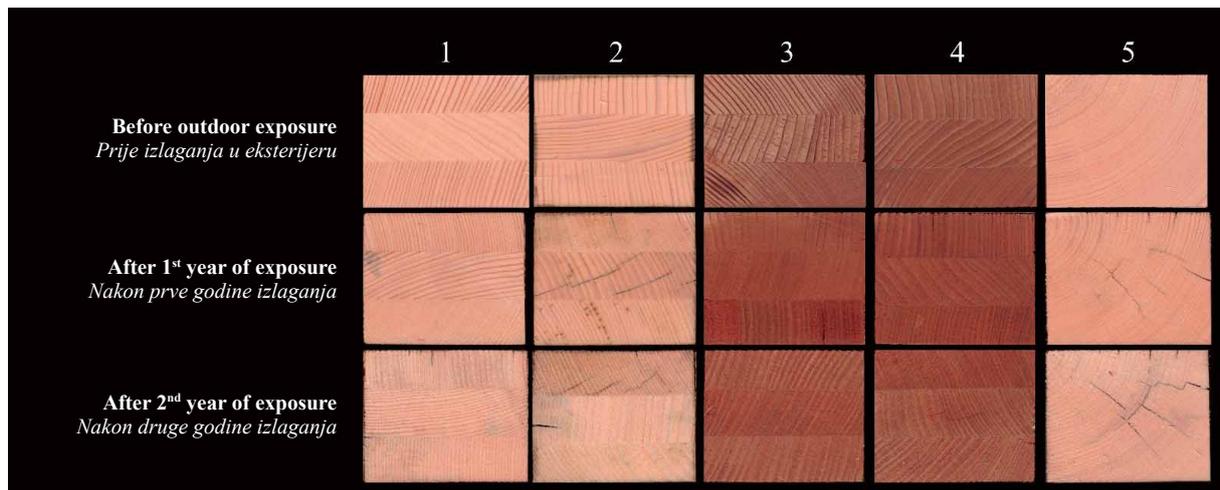
**Figure 5** Crosscuts of glulam beams before outdoor exposure and after the first and the second year of outdoor exposure  
**Slika 5.** Presjeci lameliranih nosača prije izlaganja u eksterijeru i nakon prve i druge godine izlaganja na otvorenom prostoru

Figure 5 gives the crosscuts of samples. Scanned crosscuts before outdoor exposure are presented in the top row; the second and third row show images after one and two years of weathering in 3.2 use class. From the pictures in the second row, it can be observed that the samples in columns 1, 2, and 5 show some signs of discolouration due to the presence of blue-stain fungi on the surface and in the vicinity of cracks and crack formation in different layers of glulam beams. Thermally modified samples (columns 3 and 4) look intact. This observation indicates that the higher dimensional stability and durability of TMT is reflected in less cracked glulam. Higher dimensional stability of thermally modified wood can be ascribed to lower equilibrium moisture content (EMC) associated to the chemical modification of organic functional end-groups (Willems *et al.*, 2015), and additionally to the fungal durability (Altgen *et al.*, 2014). This is also in line with previous observations of the performance of thermally modified wood in outdoor applications (Esteves and Pereira, 2009; Humar *et al.*, 2015).

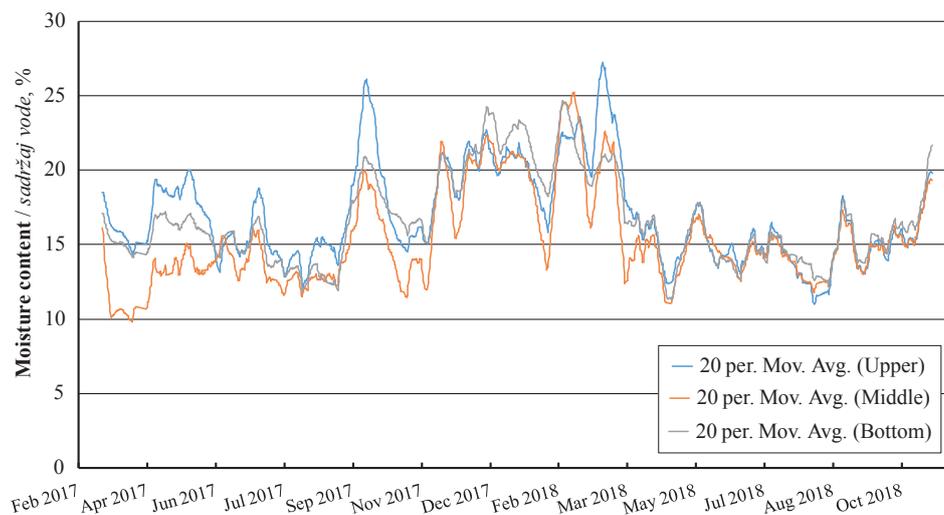
**Figure 6** Moisture content in three lamellas of Norway spruce glulam. The MCs of upper (blue line), middle (orange line), and bottom (grey line) lamella are displayed as twenty measurements moving average

Products like glued laminated timber (glulam) and other structural composite lumber all have different moisture dynamics to solid timber (Jones and Brischke, 2017). The main reasons for this originate in the possible surface treatment and the presence of glue lines. Glue lines act like barriers that considerably slow down water flows through different layers. Additionally, high daily variations of moisture, at high levels of relative humidity, can cause large moisture gradient close to external surfaces with the development of so-called moisture-induced stress (MIS) and possible increase of crack risk, because the MIS perpendicular to grain may exceed the tensile and compressive strength also in the absence of external mechanical loads (Angst and Malo, 2012; Fragiacomio *et al.*, 2011). Figure 6 illustrates the moisture content variations for all three lamellas in the glulam made from Norway spruce. From the beginning of monitoring in February 2017 until approximately July 2018, the differences between the lamellas can be seen (e.g. the upper lamella had higher MC than the other two, middle and bottom one). After July 2018, MCs in all three lamellas become much more similar due to the occurrence of deep cracks throughout the cross-section of the glulam. As can be seen from the respective plot, differences are more prominent in the wet part of the year. During summer months, MCs of respective lamellas are more uniform. In general, the upper lamella has the highest MC, with the exception of the period when the snow covered the samples (Dec 2017 – Jan 2018). The slow melting of the snow resulted in a slow diffusion of water into the samples. Snow coverage prevented drying, so water accumulated in the interior of the glulam. A similar effect was ob-

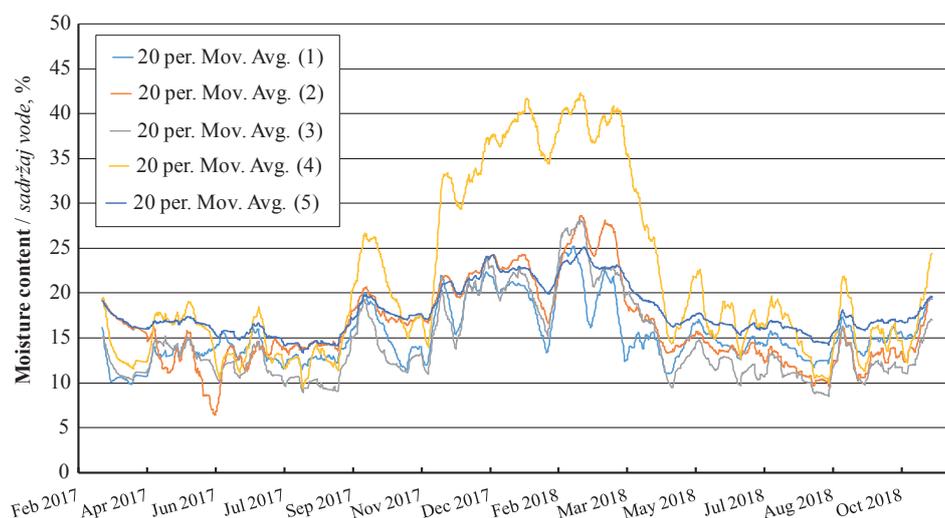
**Figure 7** Moisture contents of middle lamellas of all five presented glulams. Measured MCs are presented using twenty measurements moving average values. In brackets are numbers of test materials

served in other glulams. Similarly, MCs of the five samples are plotted in Figure 7. The poor moisture performance of thermally modified spruce is well known and it has been already reported. Reduced moisture performance is associated with degraded pit membranes during thermal modification and micro-cracks formed on the surface acting as capillaries that take up water (van Acker *et al.*, 2015; Žlahtič and Humar, 2016). Variations in MC dynamics are higher in all the glulams compared to the massive timber presented with dark blue line. On average, the highest MC was measured in thermally modified and wax treated glulam, while the lowest MCs were measured in thermally modified glulam. Despite the variety in the nature of different modification techniques, efficacy in improving decay resistance has often been linked with reduced amounts of moisture in the wood (Hill, 2002; Ibach and Rowell, 2000; Thybring *et al.*, 2018). Fungal attack can occur

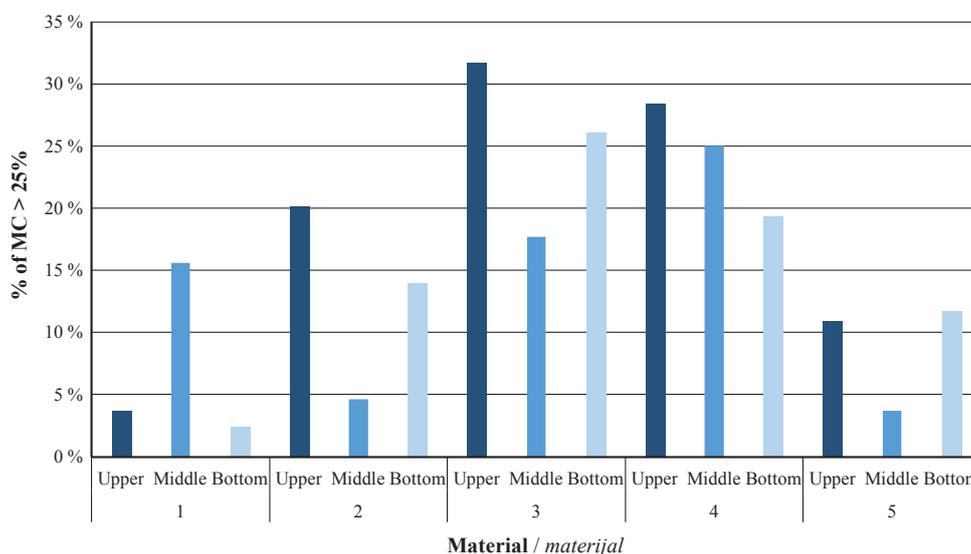
**Figure 8** Percentage of measurements ( $N = 1216$ ) when MC was equal or higher than 25 %. Results are presented for each lamella individually

on wood, if the substrate can be metabolised by the fungi and if the substrate moisture content is above a certain threshold level. Figure 8 presents the percentage of measurements exceeding the threshold level of 25 % for all glulams in all three lamellas (Meyer and Brischke, 2015). Commonly, this threshold can be reached for 15 % of measurements in at least one lamella with the exception of solid Norway spruce timber. The respective graph indicates that there were two general patterns. At glulam made of untreated spruce, the highest MC content was determined at the middle lamella. The prime reason for this is the development of cracks on the upper lamella, which opens voids for water through the glue line. As thermally modified wood is considerably more resistant to cracking, there were no cracks formed through the glue line, hence water stayed in the upper lamella. A similar effect was also determined in copper treated lamellas (material 2).
