# UAV, Digital Processing and Vectorization Techniques Applied to Building Condition Assessment and Follow-up

**Abstract:** The aim of the paper is to explain the basic principles of carrying out an inventory and follow-up of buildings and their condition assessment, by using the Full Interactive Visualization Method for Building Condition Assessment platform. It is a platform enabling the implementation of construction inventory based on the remote cooperation of many specialists in the field of, among others: building construction, architecture, civil engineering, photogrammetry, CAD, UAV. This type of cooperation is of particular importance especially in the context of the current epidemiological situation related to COVID-19. The idea of the presented platform fits into the broadly understanding of Building Information Modeling. After introducing the methodology, stages of the inventory and follow-up process carried out within the platform are illustrated and discussed on the basis of a case study. Based on the obtained results it can be concluded that the proposed methodology creates a convenient, efficient and inexpensive tool for massive inspection of building resources in

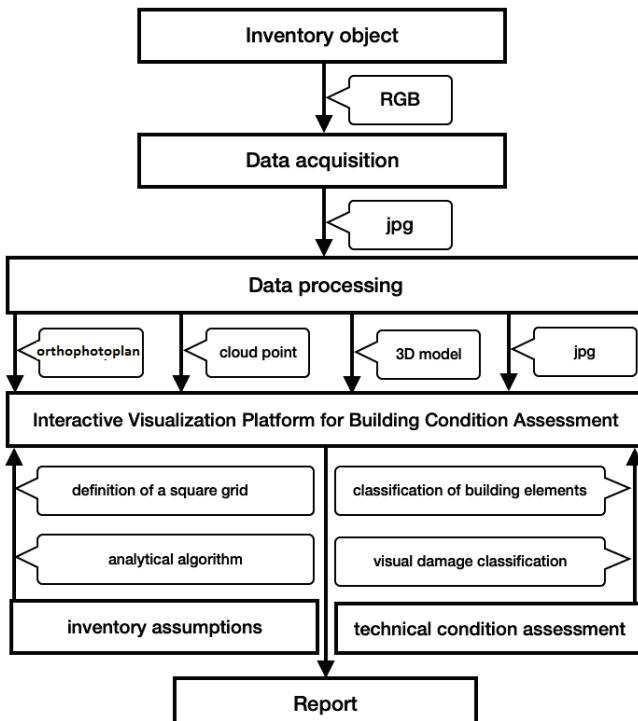
Figure 1 IVP4BCA Methodology

Fig. 1 illustrates in detail the IVP4BCA steps. The methodology is empowered by the results of processing data obtained from the board of the unmanned aerial vehicle. The data is acquired using an RGB sensor, and then, using the Pix4D class software, processed into orthophotos, point clouds and a 3D model. The processing is an iterative process, usually requires 2 to 4 iterations. The first iteration is performed in an unattended process. Materials that are created as a result become the basis of which the obtained data and its completeness are assessed. In the second iteration, the supervised process removes excess data and visible artifacts. After reprocessing, the geometry is analyzed, and the generated materials are visually assessed. If the results of the test are satisfactory, the materials are imported into IVP4BCA, otherwise an iterative process takes place in order to eliminate the observed errors in the geometry and the visual side of the materials.

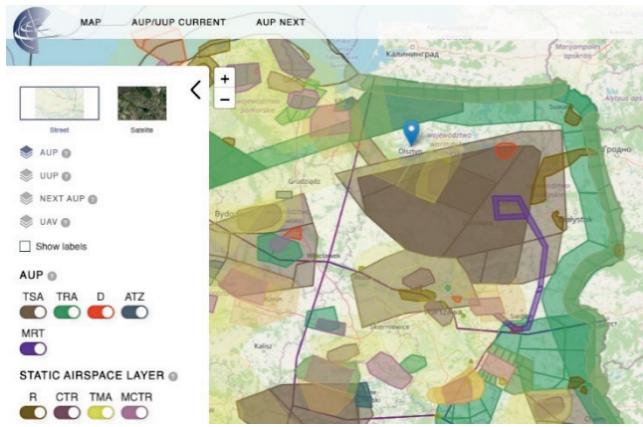
Figure 2 Visualization of the airspace in the area of planned flights

The analysis of the field situation in the area intended for the UAV raid showed that the inventoried object is located in a compact urban development, on both sides directly adjacent to the road lane. An additional obstacle is the narrow sidewalk adjacent to the building, about 1.5 m wide, and a two-way road, about 9 m wide, on which there is traffic, including public transport buses. In the off-peak hours, pedestrian traffic can be considered as low-intensity and vehicle traffic moderate.

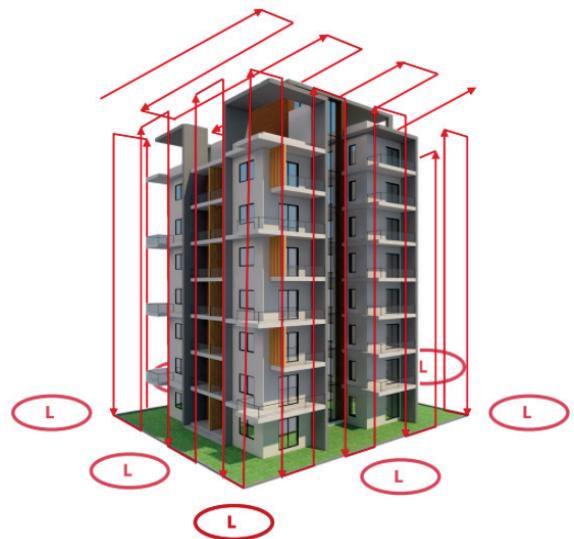
Figure 3 Design of a manual cubature raid for the building inventory (landing strip)

The take-off and landing sites are designated separately for each elevation. When planning the flight, attention was also paid to the difficult accessibility of one of the elevations. The flights were carried out using the DJI Inspire One drone. It is a drone with a weight not exceeding 3.5 kg MTOM, classified in the MR (multirotor) category in the so-called the X4 system. The camera installed on board the drone is X3 ZENMUSE with a 12 Mpix matrix with a size of 4000×3000 Pix. 7 flights (6 facades + roof) have been planned. Flights for the façade inventory were carried out in manual mode using the native DJI GO drone control application. The roof inventory was carried out in automatic mode, using the DJI GS application for photogrammetric flights. All flights are to be carried out as Visual Line of Sight (VLOS) flights, in accordance with the diagram shown in Fig. 3. Design coverage of min. 80/80%, distance from the facade approx. 2 m, height above the roof level approx. 10 m. Shutter release manually or with an interval - 2 seconds. GSD is planned at the level of <0.5 cm.

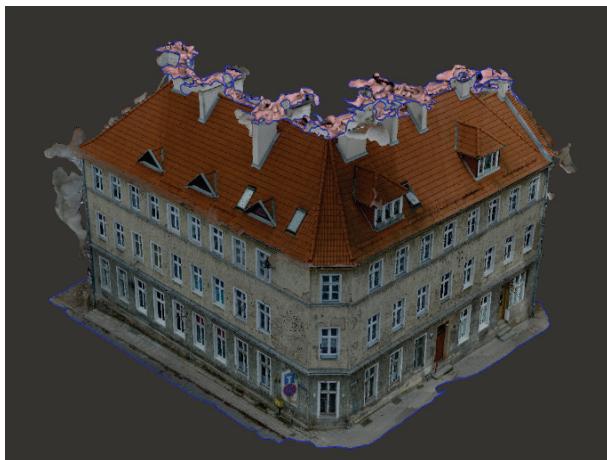
Figure 4 Visualization of the generated model in 3D space

the point cloud (Fig. 4 and Fig. 5). The process took almost 6 hours and resulted in the generation of a model practically free from contamination. The model allows it to be used for the visualization of selected, inventoried phenomena in 3D space in a natural way for the user. The carried-out process of cleaning the point cloud additionally influenced the quality of the generated orthophotoplanes of the facade and roof. As part of this stage, an orthophotoplan separation was generated for each of the elevations (Fig. 6).

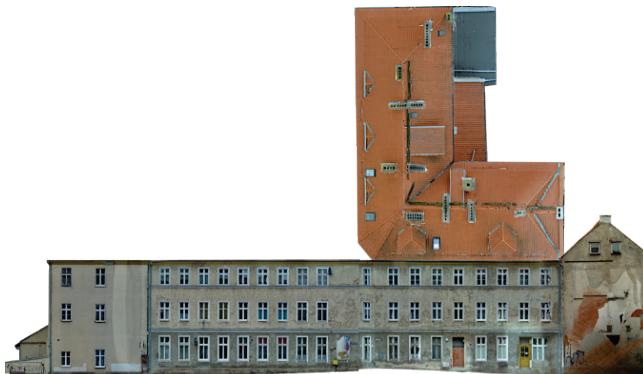
Figure 5 3D model of an inventoried building in a flat projection

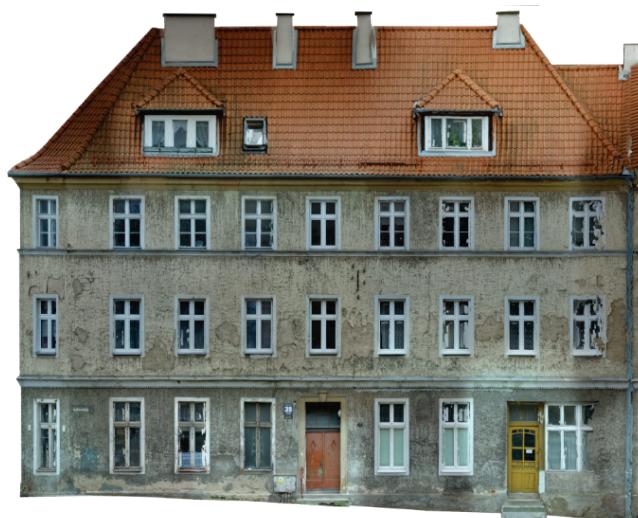
Figure 6 Orthophotoplan of North-East elevation

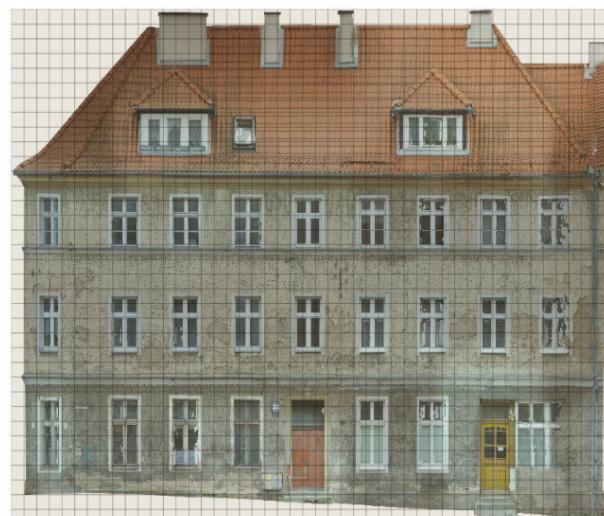
Figure 7 Orthophotoplan with a squared grid

Based on the conducted analyses, a matrix made of squares with a side of 0.4 m was considered optimal (Fig. 7).

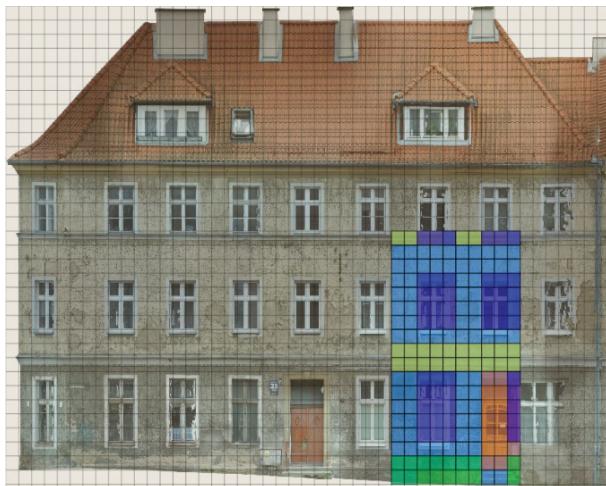
Figure 8 Orthophotoplans with completed qualification of inventoried elements

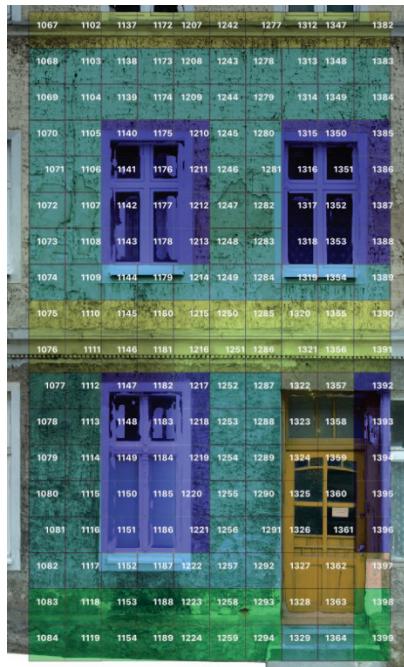
Figure 9 A fragment of the orthophoto plan with the performed qualification of the inventoried elements

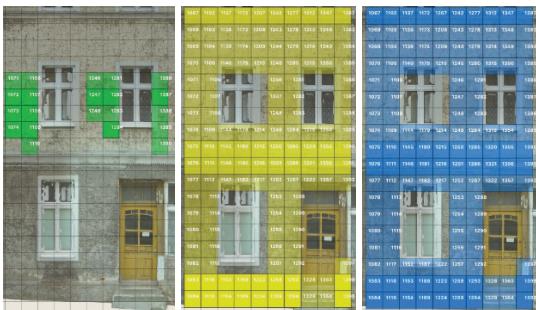
Figure 12 Visualization of a specific degree of wear, depending on the type found

The last step is to carry out a visual assessment of the technical condition of the facade by the inspector, determining the degree and type of wear on the basis of orthophotoplans based on a square grid and classification (Fig. 11). Its implementation enables the automatic visualization of wear in accordance with the indicated criteria and the determination of the area and position of each type of defects found (Fig. 12 and Fig. 13).

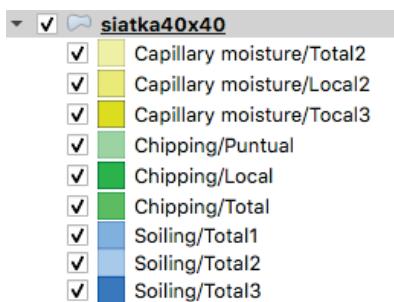
Figure 13 A fragment of the list of inventoried types of use
