## Elementi za arhitektonsku rekonstrukciju crkve sv. Sergija i Bakha (Kisha e Shirgjit) na rijeci Bojani (Buni) kraj Skadra u Albaniji

### Evidence for the architectural reconstruction of the church of Sts. Sergius and Bacchus (Kisha e Shirgjit) on the Bojana (Buna) River near Skhodra, Albania

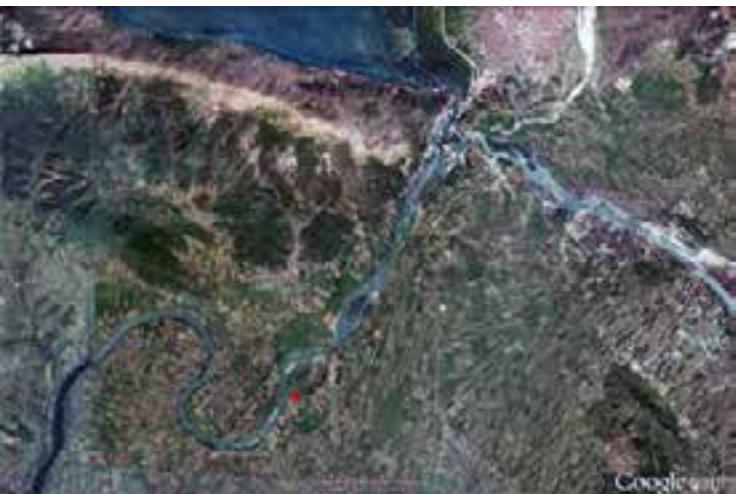
Sl. 1. Satelitski prikaz širega područja južno od Skadra. Na desnoj strani je rukavac Drina s označenom lokacijom crkve u Shirqu

*Fig. 1 Satellite view of a greater area south of Skadra. On the right, the distributary of Drin, with the location of the church in Shirq marked*

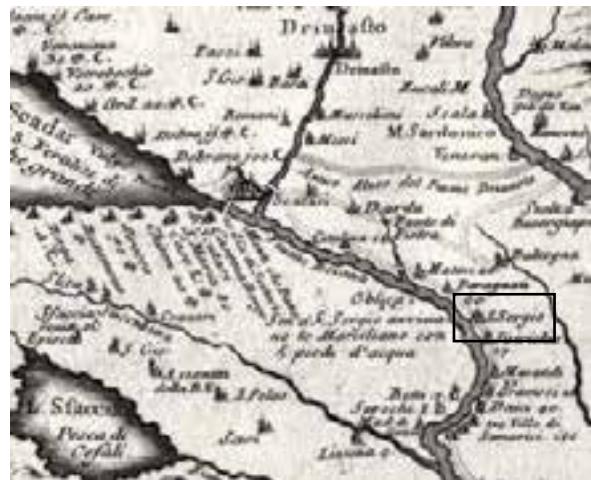
Sl. 2. Detalj stare Coronellijeve karte: Corso dell Fiumi Drino, e Boiana nella Dalmatia, 1690.  
Označena je lokacija crkve; nekadašnji rukavac Drina je sjeveroistočno od Skadra (Scutari). Zbirka Stanislava Živkova

*Fig. 2 Detail of the vintage map by Coronelli: Corso dell Fiumi Drino, e Boiana nella Dalmatia, 1690.  
The location of the church is marked; the ancient distributary of Drin is to the NE of Skadra (Scutari). Collection of Stanislav Živkov*

of St. Sergius, as well as of other numerous monuments along the Buna River. (**Fig. 2**)

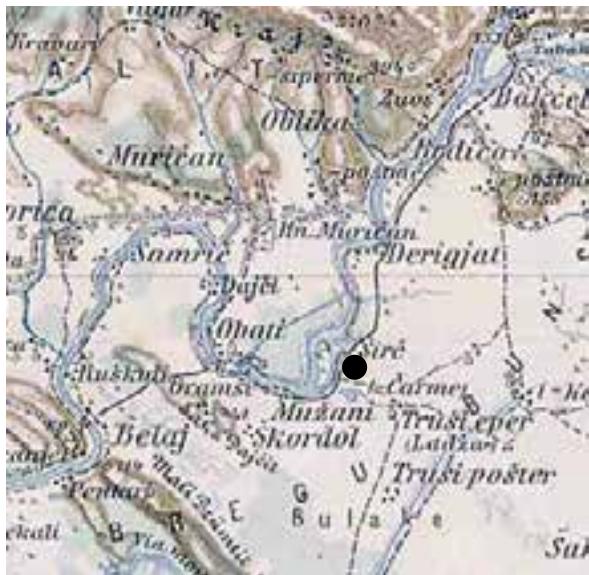
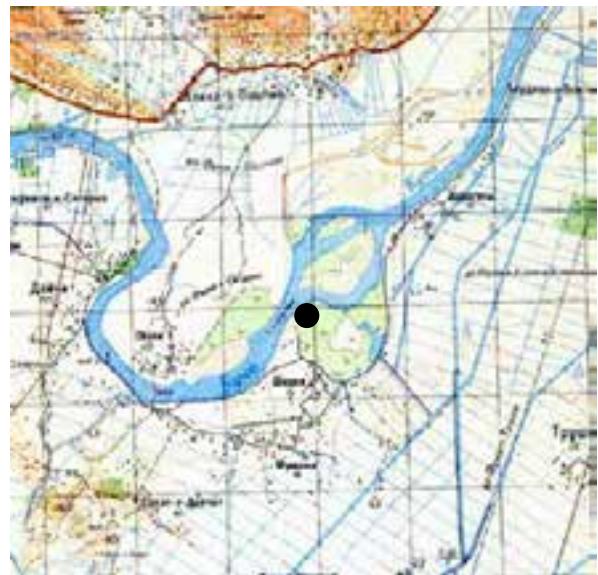
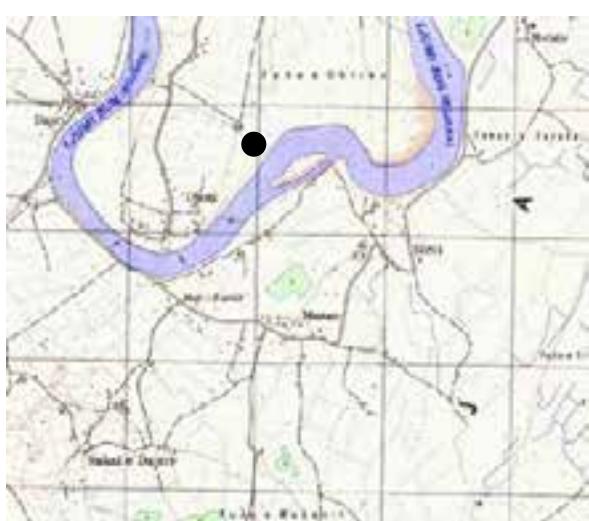
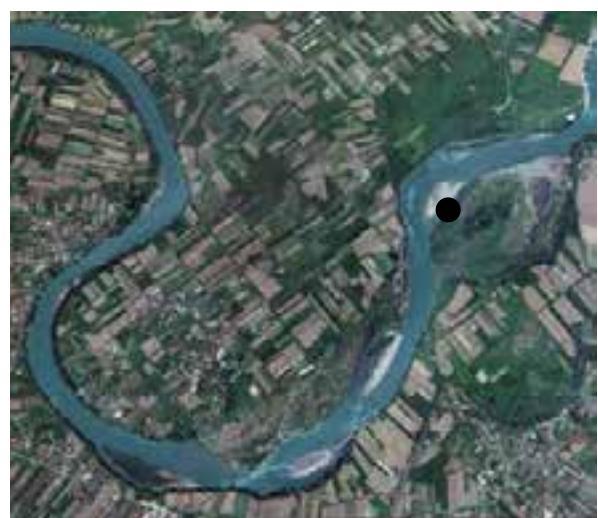
Sl. 3a. Detalj s austrougarske vojne topografske karte u mjerilu 1:75.000 III. Mjerni listovi 37–42. Zbirka Stanislava Živkova

*Fig. 3a Detail from an Austro-Hungarian military topographic map in the scale of 1:75000 III.*

Sl. 3b. Detalj s ruske vojne topografske karte u mjerilu 1:50000, list K 34-63-G. Zbirka Stanislava Živkova

*Fig. 3b Detail from a Russian military topographic map in the scale of 1:50000, sheet K 34-63-G.*

Sl. 3c. Detalj s jugoslavenske topografske karte u mjerilu 1:25000, list Fraskanje, 170-2.2. Zbirka Stanislava Živkova

*Sl. 3c Detail from a Yugoslav topographic map in the scale of 1:25000, sheet Fraskanje, 170-2.2.*

Sl. 3d. Sadašnja situacija, Google Earth

*Fig. 3d Present-day situation, Google Earth.*

i okolne ravnice. Budući da je cijelo područje duž korita Bune (Bojane) uglavnom aluvijalna ravnica koju pretežno čini riječni sediment, ne iznenađuje činjenica da se tok Bune (Bojane) uvelike mijenja, što se vidi na nizu topografski karti iz 20. stoljeća. (Sl. 3.)

in the Drin River, the Buna (Bojana) River shows a very torrential character and has been known to frequently change its course and flood its banks and the surrounding plains. Since the whole area along the waterbed of the Buna (Bojana) is mostly alluvial plain composed mainly of river sediments, it is no surprise that the Buna (Bojana) was heavily changing its course in the past, as shown in a series of topographic maps from the 20<sup>th</sup> century. (Fig. 3)

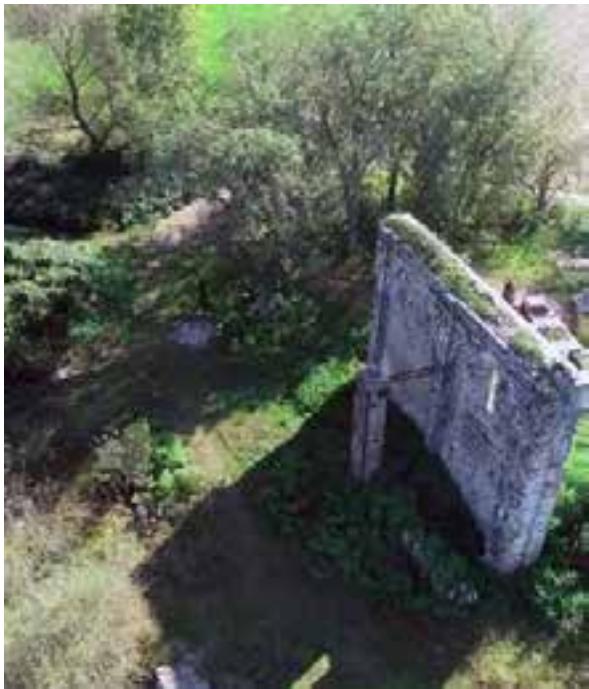
Sl. 4. Postojeće stanje crkve. Nekadašnji erodirani dijelovi sada su puni nanosa. Ispis slike iz snimke

*Fig. 4 Present condition of the church. Formerly eroded parts are now fully silted. Printscreens from Terenc Pepe's footage*

Although the riverbed is now partly flanked with dams, the area of the church is still occasionally flooded<sup>5</sup>. Immediately northeast of the church, the Buna (Bojana) River until recently used to flow into two separate riverbeds which surrounded a river island and these two main watercourses joined in a strong river stream east of the monastery complex. The force of the stream gradually eroded the site and destroyed the church itself, which is very well documented. However, even the earliest sources do not mention any remains of the monastic complex. The fact that the east, west and south façades were richly articulated indicates that other monastic buildings – the cloister, dormitory, dining room – could only have been placed to the north of the church, i.e. the area that was devastated first. The destruction of the church is very well documented in published material. The maximum erosion was reached sometime between 1947 and 1960, judging by a situation sketch by Mušić<sup>6</sup>. In the early 1960s, a greater part of the preserved section of the west façade collapsed, and one of the inscriptions was retrieved from the ruins and transferred to the Skhodra Historical Museum<sup>7</sup>. Meanwhile, the Buna (Bojana) River further changed its course, and the east watercourse was, for the most part, silted, whereas today the once eroded part of the church location is now again on dry land<sup>8</sup>. (Fig. 4)

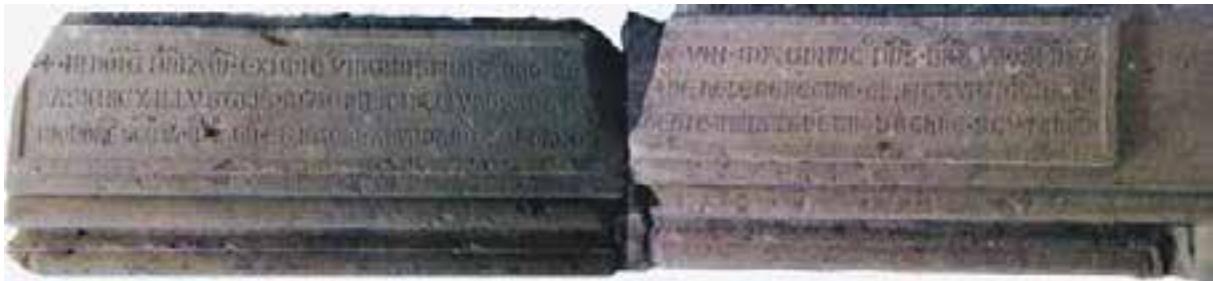
Sl. 5. Nadvoj zapadnoga pročelja s natpisom kralja Milutina (J. Erdeljan)  
Fig. 5 The lintel of the west portal with the inscription of King Milutin (J. Erdeljan)

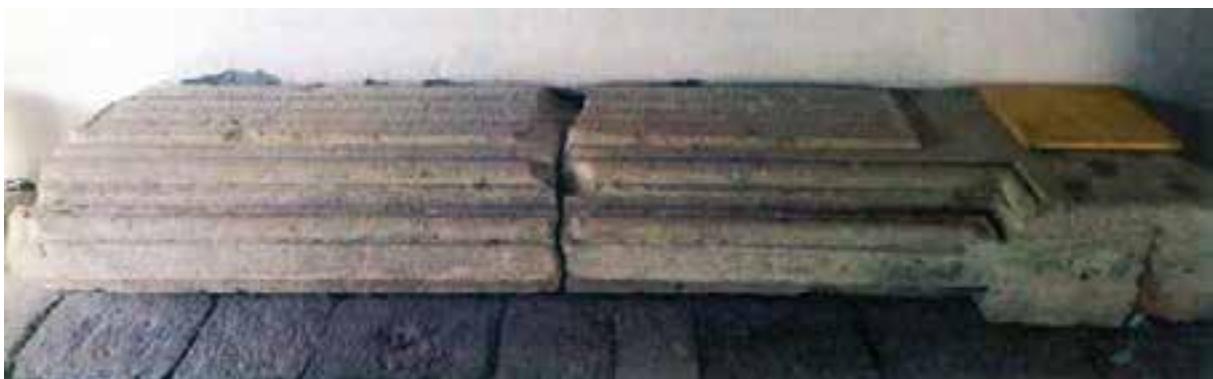
Sl. 6. Sačuvani ulomci zapadnoga portala (J. Erdeljan)  
Fig. 6 Preserved fragments of the west portal (J. Erdeljan)

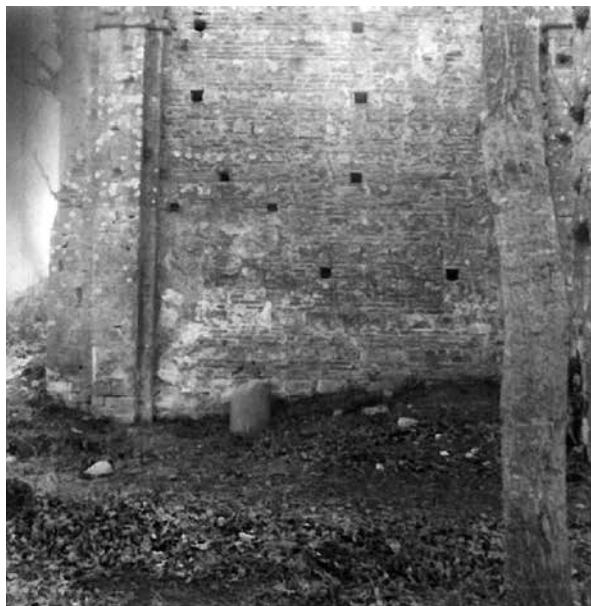
Sl. 7. Stara fotografija iz 1961. s prikazom patrljka granitnoga stupa. Negativ br. 34361, Služba za zaštitu spomenika u Tirani

the earlier structure was noted by Degrand<sup>13</sup> and Ippen<sup>14</sup>. Both mentioned that fragments of mosaics had been unearthed during grave digging. In 1961, a stump of a granite column still stood by the interior face of the southern wall. (Fig. 7)

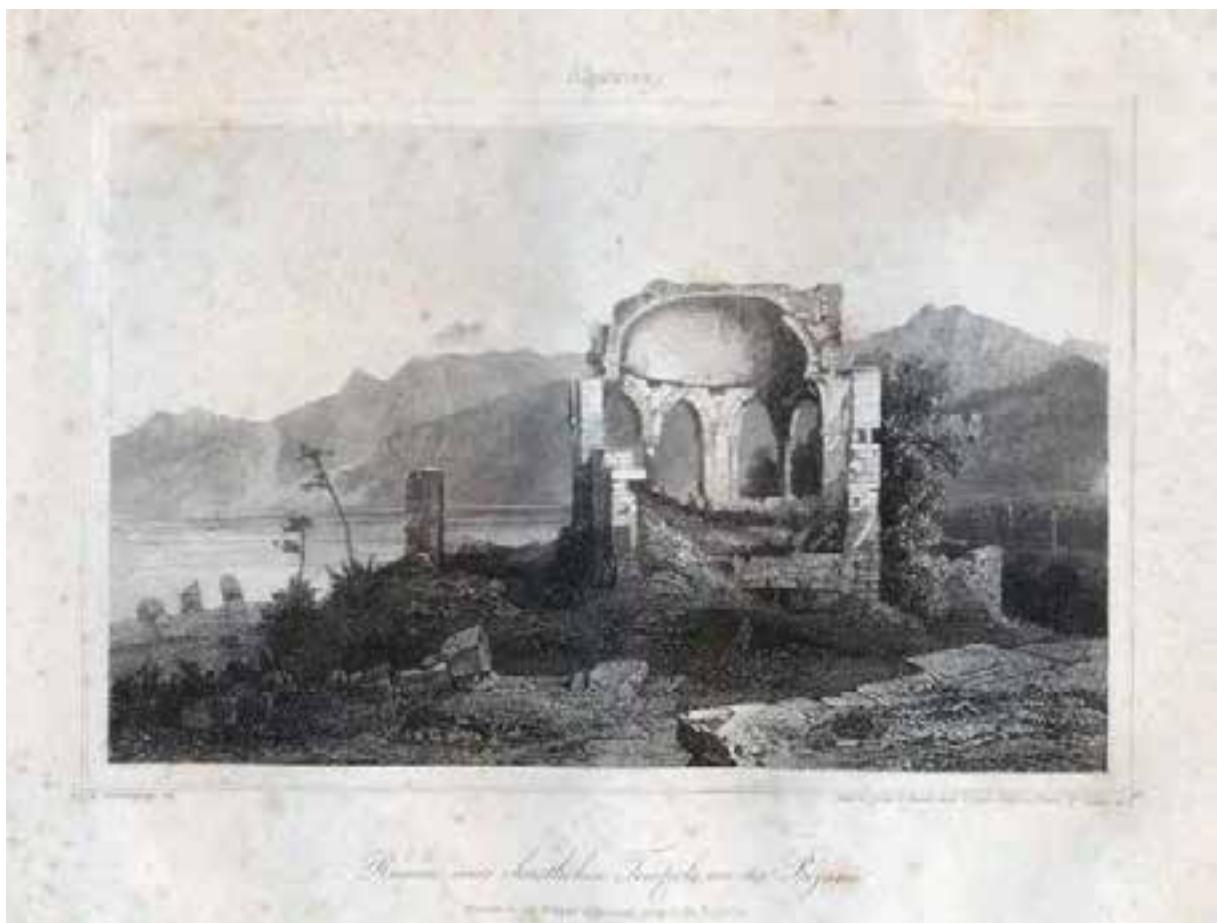
Sl. 8. Gravira C. Steinickena prema crtežu E. Schweinfurta: „Ruinens eines christlichen Tempel an der Bojana”, Album malerischer ansichten aus Dalmatien, br. 23, Trst, 1855. Zbirka Stanislava Živkova

usly depicts a view from an elevated position near the end of the preserved section of the west façade, because the north pilaster in the interior is visible in the first plan. Vintage photographs and Ippen's engraving reveal that an enormous beech tree stood by the western wall, and the drawings were possibly made from that position. The engraving is precious because it shows the state of preservation of the central apse, which was still standing in full height at the time. While the northern apse, as well as the southern wall, were already missing, a part of the southern apse was depicted, but the artist Schweinfurt deliberately omitted a section of it, as well as the southern wall and two pairs of interior pillars, in order to emphasize the most prominent part of the interior: the apse with two biforate windows and the rectangular column dividing them. The existence of

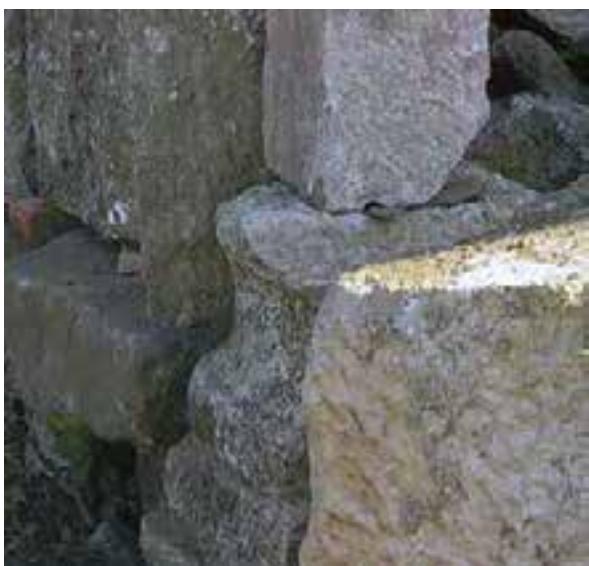
Sl. 9. Sačuvana baza stupa bifore središnje apside  
(foto: L. Bondarenko)

these biforate windows has been corroborated by a recent identification of one column base which has been preserved among the collected stone blocks in the SW corner of the church. (Fig. 9) Furthermore, several important details from this engraving were confirmed in the engravings published by Ippen<sup>31</sup>: the springing of the Gothic triumphal arch, the position of the eastern biforate window (shown by Ippen in the remaining south end of the central apse), and, finally, the existence of a somewhat thinner upper part of the pillars. Another very important detail, subsequently also published by Ippen, concerns the existence of the final (south-eastern) remains of the central nave superstructure. (Fig. 10)

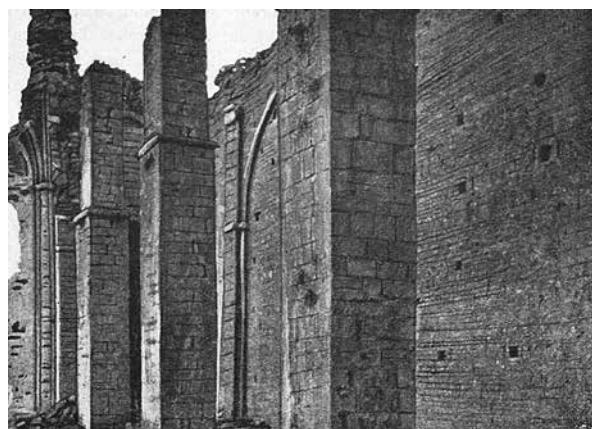
Sl. 10. Jugoistočni dio unutrašnjosti crkve; gravira prema Ippenovoj fotografiji (1899.). Vidljiv je četvrtstup kraj ostataka apside gornjega dijela srednjega broda te nagib krova na južnome brodu (30 stupnjeva)

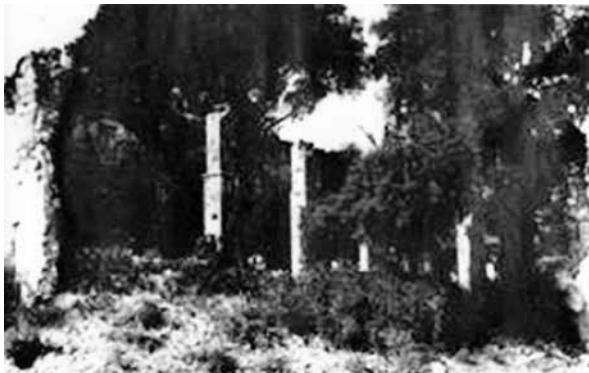
11. Stara fotografija snimljena s istoka. Vidljive su šupljine na gornjim dijelovima stupova gdje su prolazile drvene grede, freska u luneti jugoistočnoga traveja južnoga zida te ostaci središnje apside.

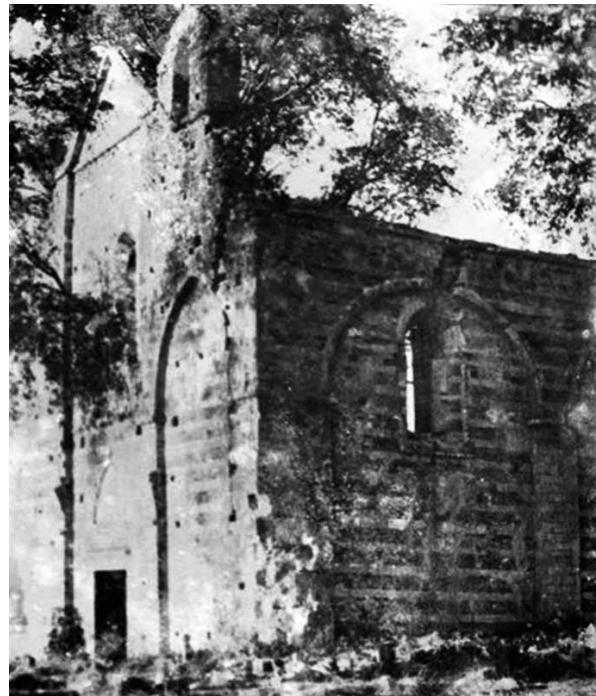
Sl. 12. Najstarija poznata fotografija snimljena s jugozapada. Jasno se vidi zabat na srednjemu brodu, kao i zvonik

Pored toga, jedna nekvalitetna fotografija na nekoliko albanskih internetskih stranica potvrđuje postojanje utora za drvene grede gornjega dijela razdjelnih lukova, vidljivih na graviri<sup>32</sup>. Njena sadašnja lokacija nije poznata. (**Sl. 11.**) Navedena fotografija važna je i zato što je na njoj prikazana velika hrpa ruševina djelomice urušene središnje apside; na njoj već nema sjeveroistočnoga stupa, dok se na istočnom traveju južnog zida izgleda nalazila golema freska – portret koji je opisao Degrand. Jedna druga fotografija iz istog izvora, malo kvalitetnija, glavna je podloga za točnu rekonstrukciju zapadnoga pročelja. (**Sl. 12.**) Razvidno je da ni Smirnov

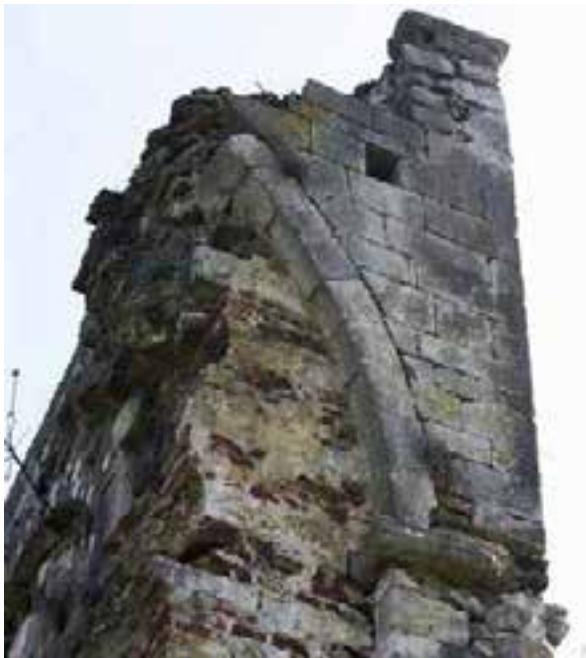
Sl. 13. Preostali dio zapadnoga pročelja s dijelom vodoravnoga vijenca *in situ* (foto: L. Bondarenko)  
*Fig. 13 Remaining part of the west façade with a part of the horizontal cornice in situ (photo: L. Bondarenko)*

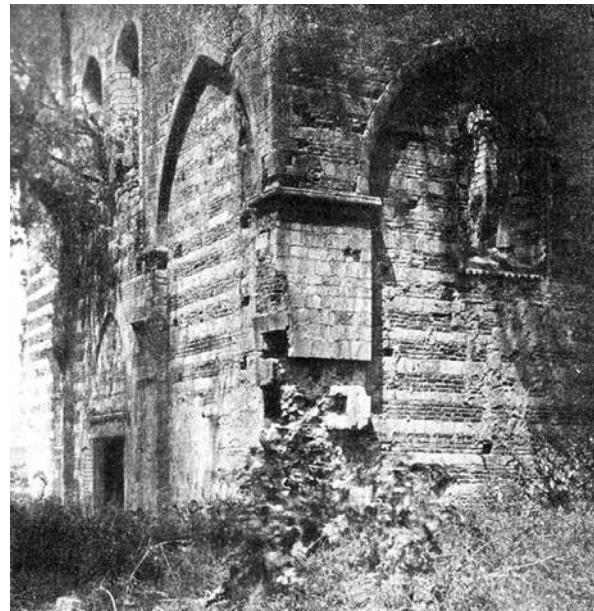
Sl. 14. Fotografija s jugozapada koju je objavio Degrand (Degrand 1901, str. 94–95)  
*Fig. 14 Photograph from the SW published by Degrand (Degrand 1901, pp. 94–95)*

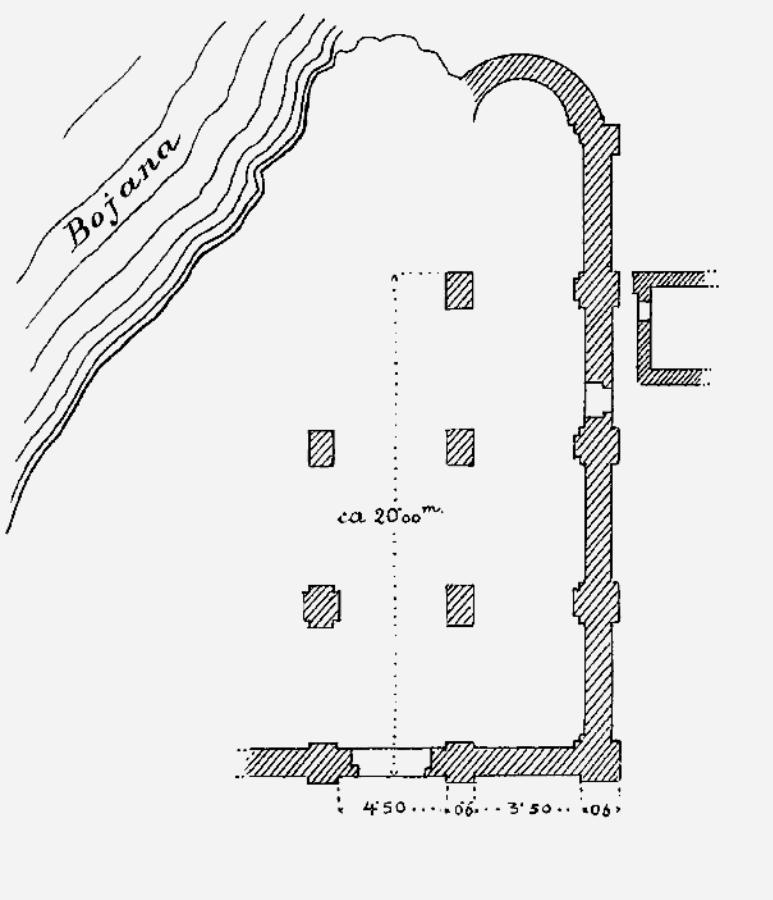
Sl. 15. Tlocrtni prikaz koji je objavio Ippen  
Fig. 15 Situation plan published by Ippen

zapadnoga pročelja, a nešto kasnije i tlocrt ruševina crkve<sup>40</sup>. (Sl. 15.) Na trima objavljenim gravirama prikazani su pogledi iz daljine na južno (sl. 16.) i zapadno pročelje (sl. 17.), kao i pogled na južnu polovicu unutrašnjosti crkve, uključujući južnu apsidu i ostatke središnje apside. Ippenova gravira južne fasade je dokaz da je svjetlo za jugozapadni dio unutrašnjosti crkve osiguravao samo prozor na južnom zidu. Vidljiv je i južni portal, kao i kasnija nadogradnja crkve, no najvažniji detalj odnosi se na ostatke istočnoga zida na južnoj apsidi, koji se bolje vidi na graviri s prikazom unutrašnjosti, što dokazuje da je nagib krova koji je nosio taj zid bio sasvim različit, mnogo manji od onoga na zapadnoj fasadi<sup>41</sup>. Nadalje, obje Ippenove gravire južnoga zida, kao i ona s prikazom unutrašnjosti, također dokazuju postojanje zidova gornjega dijela iznad kolonada u unutrašnjosti, što znači da je na vanjskoj konstrukciji crkve bila vidljiva struktura triju bro-

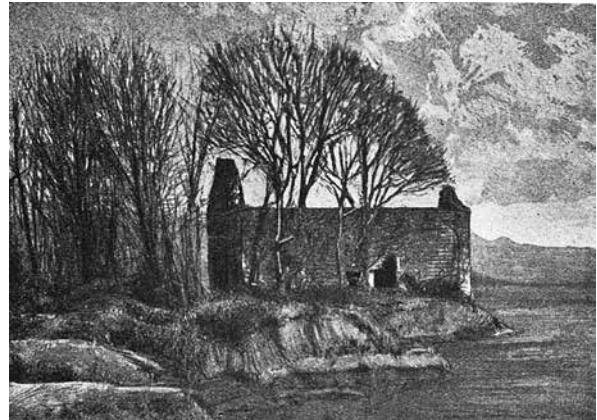
Sl. 16. Južno pročelje crkve. Gravira prema fotografiji koju je objavio Ippen (1899.)  
Fig. 16 South façade of the church. Engraving after the photograph published by Ippen (1899.)

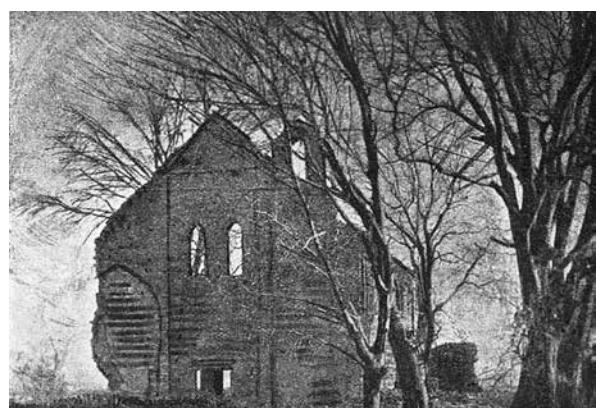
Sl. 17. Zapadno pročelje crkve. Vidljivi su različiti nagibi vijenaca središnjega zabata (55 stupnjeva) i sjevernoga dijela pročelja (45 stupnjeva), kao i trokutasti zabat na portalu i prozori. (Gravira prema fotografiji koju je objavio Ippen 1899.)  
Fig. 17 West façade of the church. Different inclinations of cornices of the central gable (55 degrees) and the northern part of the façade (45 degrees), as well as the triangular gable over the portal and windows are visible. (Engraving after the photograph published by Ippen in 1899.)

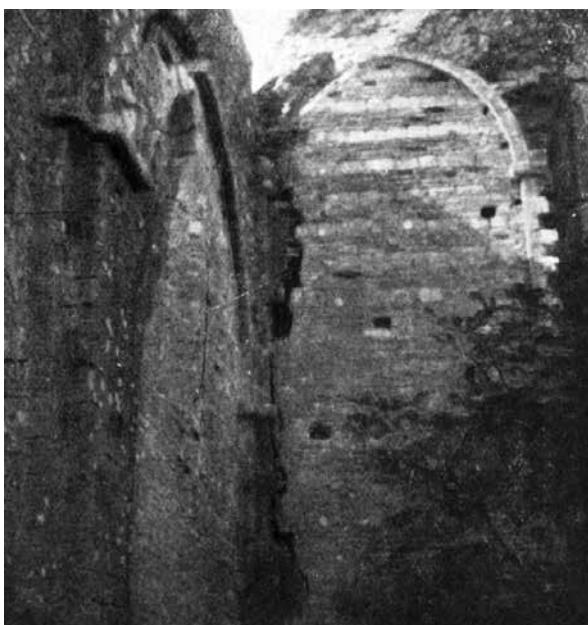
Sl. 18. Jugozapadni kut južnoga broda (foto: Sergio Bettini, 1937)

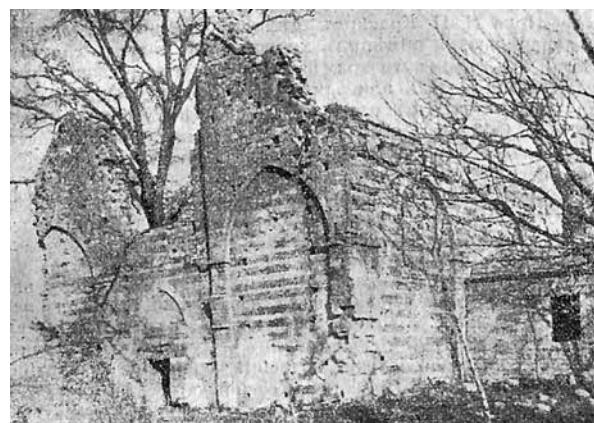
Sl. 19. Pogled s jugozapada. Već se urušio veći dio zapadnoga pročelja sa zabatom i prozorima. Vidljiv je i objekt povezan s drugim travejem južnoga zida

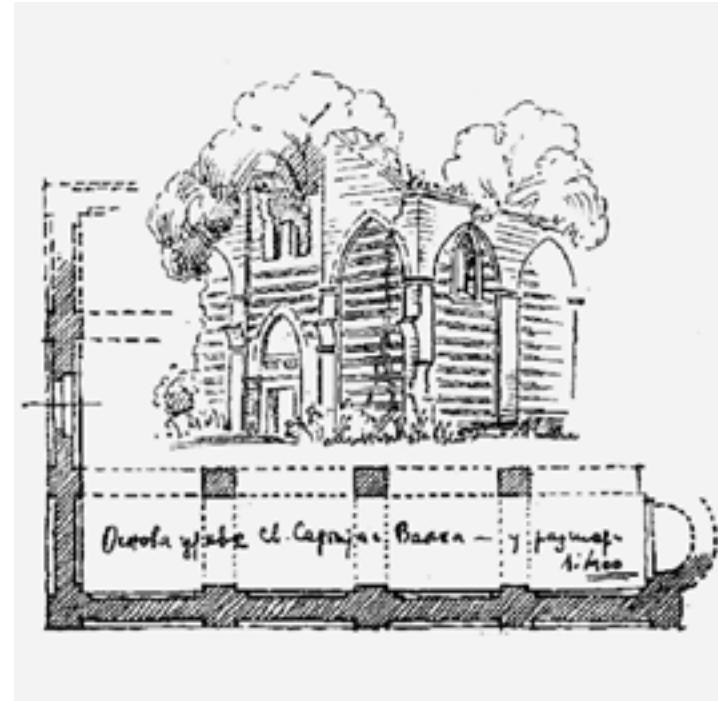
Sl. 21. Derokova skica tlocrta i pogleda  
 (izvor: Deroko 1930.)  
*Fig. 21 Plan and view sketched by Deroko  
 (source: Deroko 1930.)*

(**Sl. 21.**) Također je objavio kombinirani crtež s prikazom crkve s jugozapada i djelomičnim tlocrtom na kojemu je još bila čitava južna unutarnja kolonada južnoga zida i većina zapadnoga zida, dok južne apside i južnoga kraja trijumfalnoga luka očito već tada više nije bilo. Važno je napomenuti da

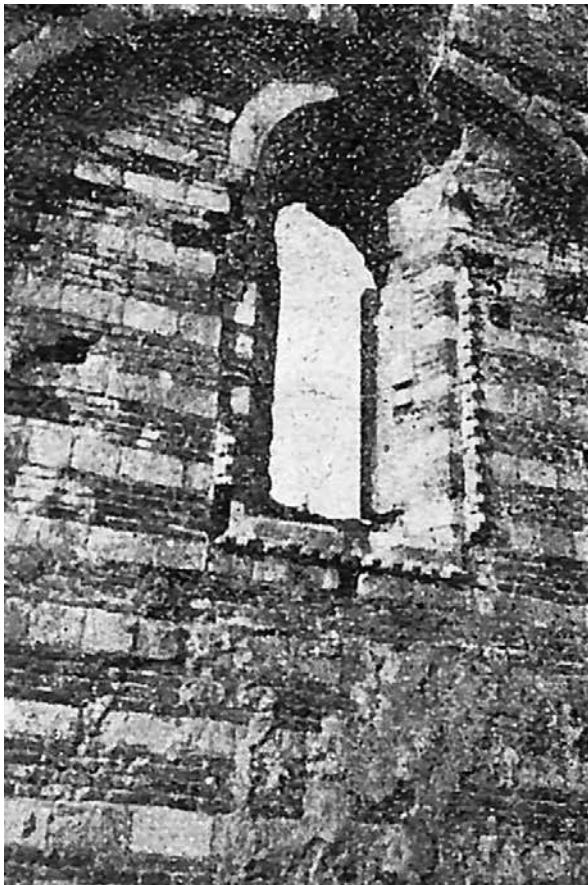
Sl. 22. Fotografija gotičkoga prozora na južnome zidu  
(izvor: Smirnov 1927.)

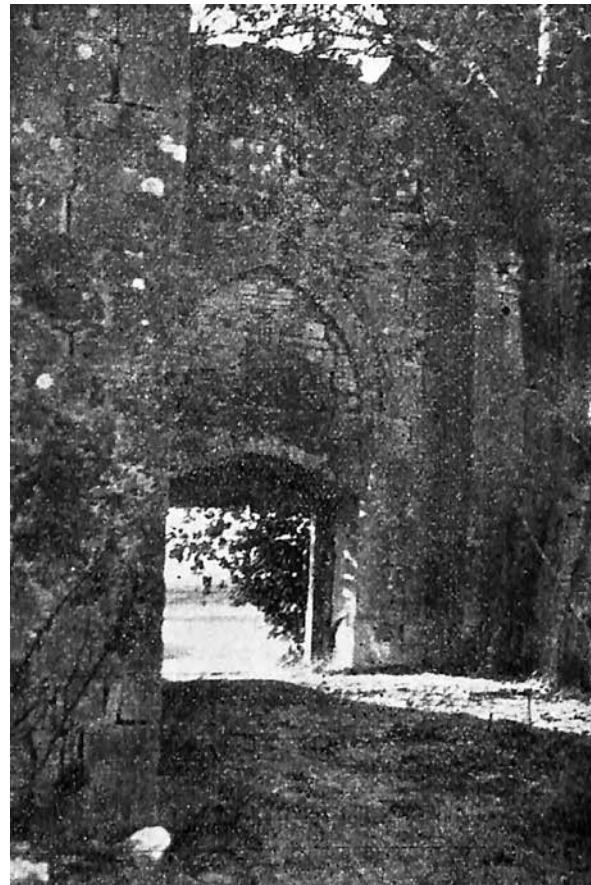
Sl. 23. Unutarnja strana zapadnoga pročelja. Vidljiva je stražnja strana lunete portala i rasteretni luk iza nadvoja s natpisom (izvor: Smirnov 1927.)

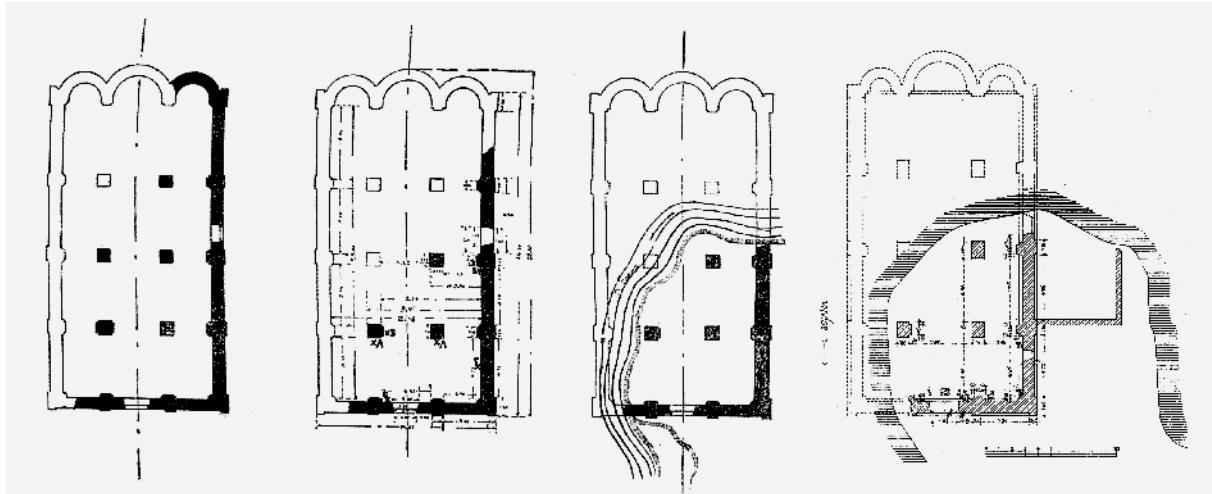
Sl. 24. Razaranje crkve. Slijeva nadesno (Ippen, prije 1899; Novicki, Smirnov, Mušić 1947.)

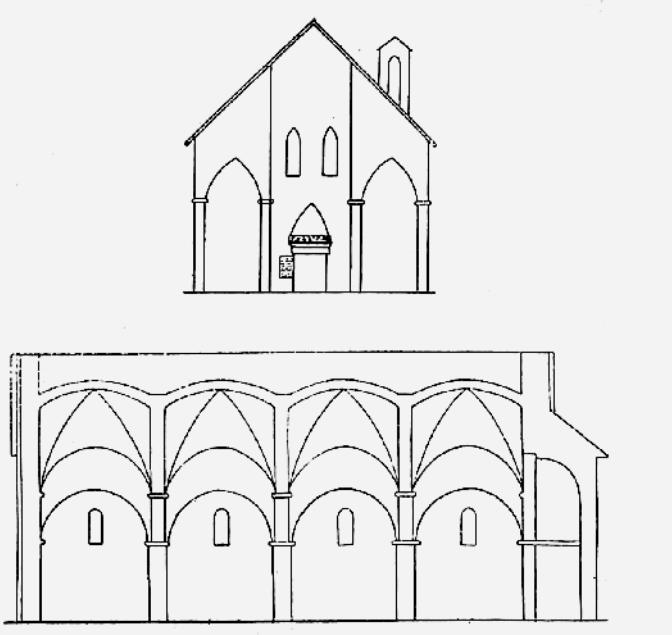
Sl. 25. Smirnovljeva rekonstrukcija zapadnoga pročelja i presjek (izvor: Smirnov 1927.)

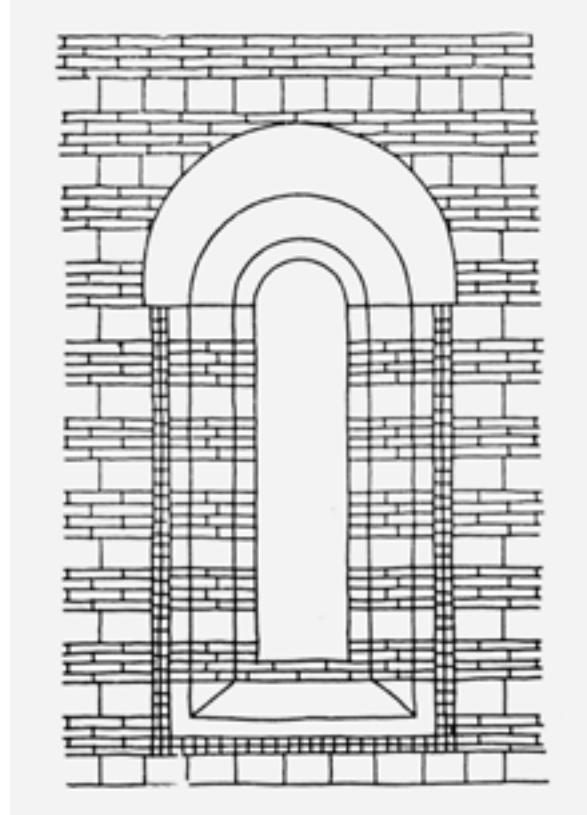
Sl. 26. Koraćev crtež prozora na južnome zidu (izvor: Korać 1965)

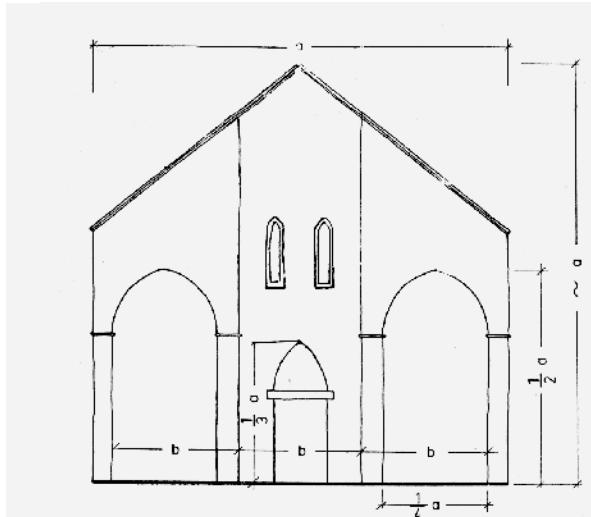
Sl. 27. Koraćeva rekonstrukcija zapadnoga pročelja.  
(izvor: Korać 1965, T. XXV, br. 2.)

Fig. 27 Reconstruction of the west façade by Korać.  
(source: Korać 1965, Pl. XXV, No. 2.)

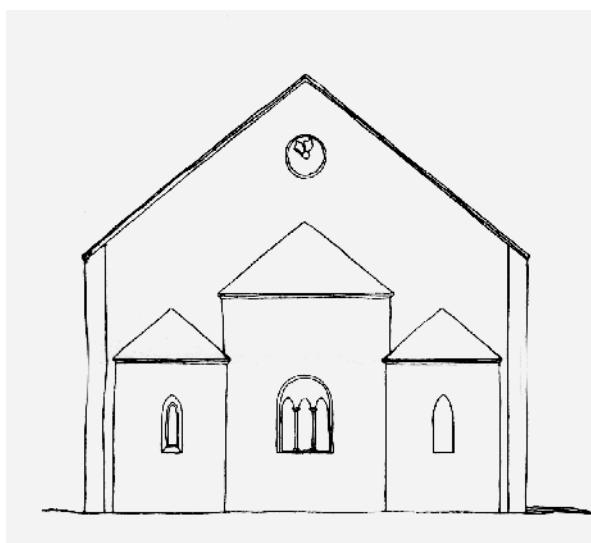
Sl. 28. Koraćeva rekonstrukcija istočnoga pročelja  
(izvor: Korać 1965, T. XXXV, br. 4.)

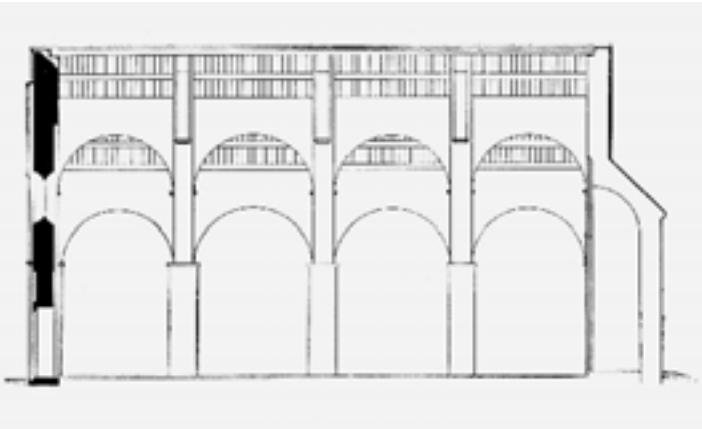
Sl. 29. Koraćeva rekonstrukcija presjeka  
(izvor: Korać 1965, T. I.)

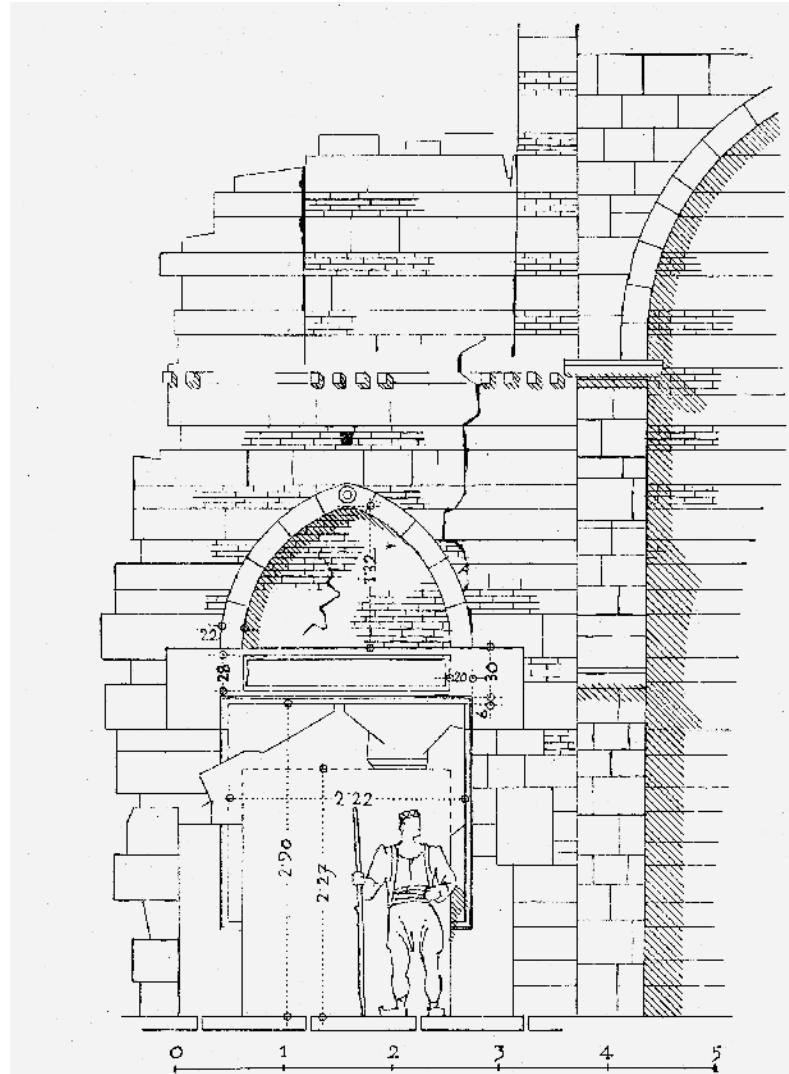
Sl. 30. Mušićev kotirani nacrt zapadnoga pročelja iz 1947. godine (izvor: Mušić 1952, sl. 7.)

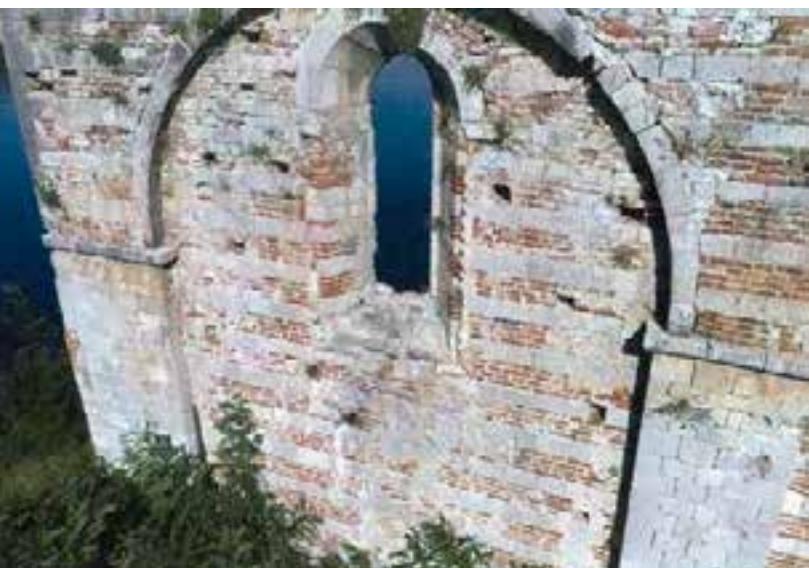
Sl. 31. Pogled na restaurirani prozor na južnome zidu  
(ispis slike iz snimke Terenca Pepe)

*Fig. 31 View of the restored window on the south wall  
(printscreens from Terenc Pepa's footage)*

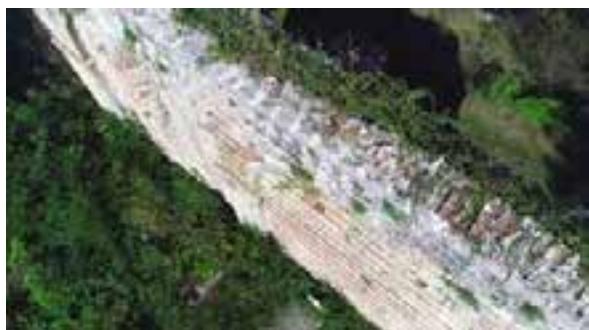
Sl. 32. Pogled na ostatke izvornih crepova na vrhu sačuvanoga dijela južnoga zida (ispis slike iz snimke Terenca Pepe)

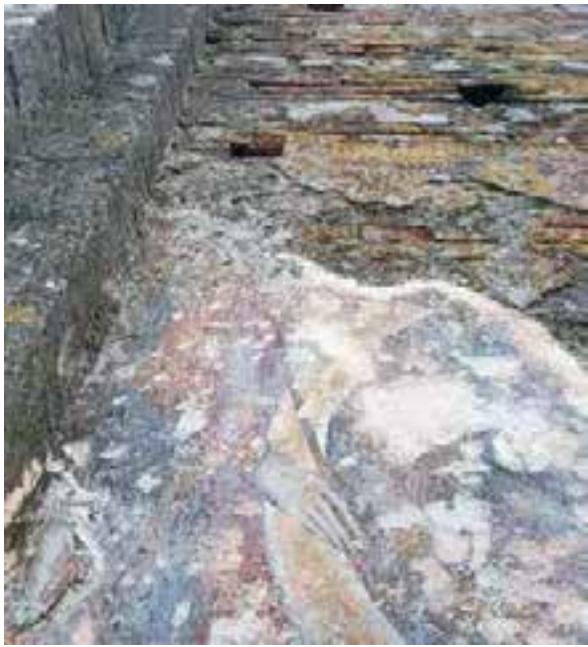
Sl. 34. Oчишћене и консолидиране фреске на јуžном зиду (Helidon Sokoli)

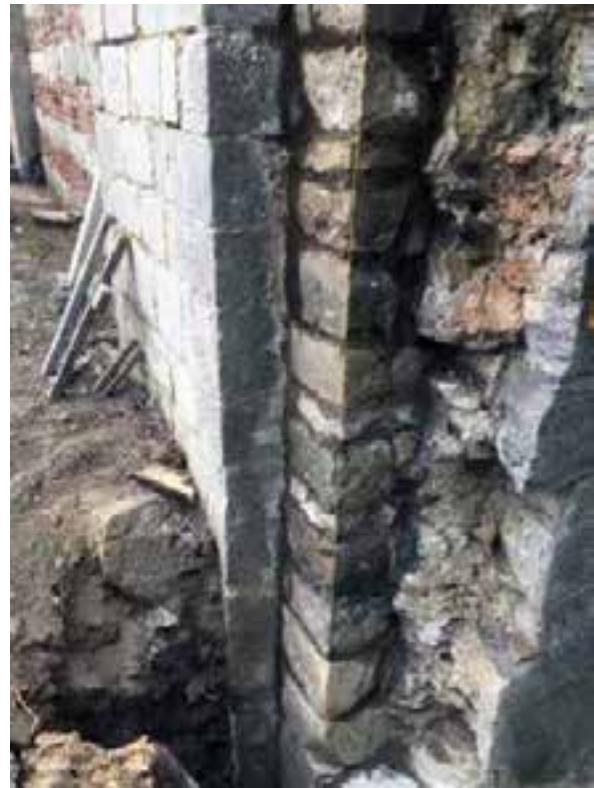
Sl. 35. Iskop rova uz južni portal (Helidon Sokoli)

in the position of the south portal. During the recent conservation works, a small trench was excavated by the south portal to determine the original height of the walls<sup>72</sup>. (**Fig. 35**) Furthermore, the interior of the SW part of the church has never been archaeologically excavated, which leaves the possibility that archaeological stratigraphy and the foundations of the two pillars and a part of the west façade which collapsed between 1947 and 1960 could be preserved.

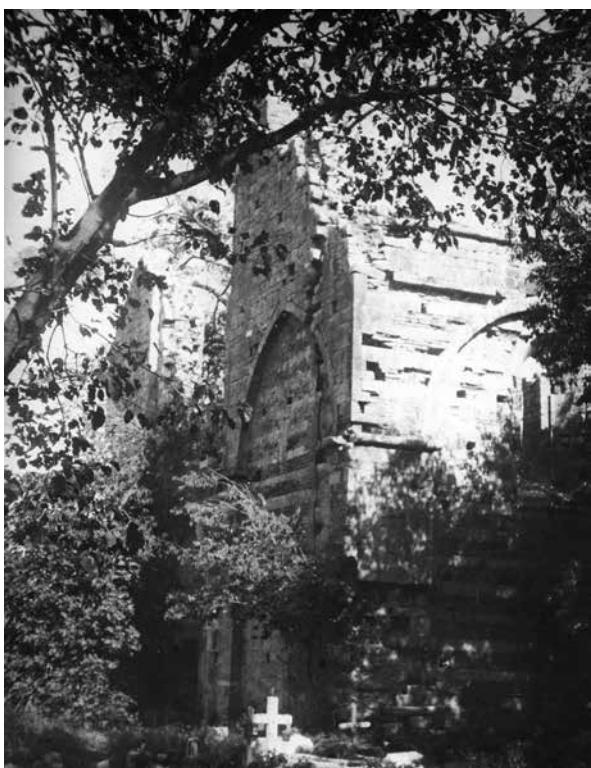
Sl. 36. Pogled na crkvu s jugozapada 1937. godine  
(Sergio Bettini)

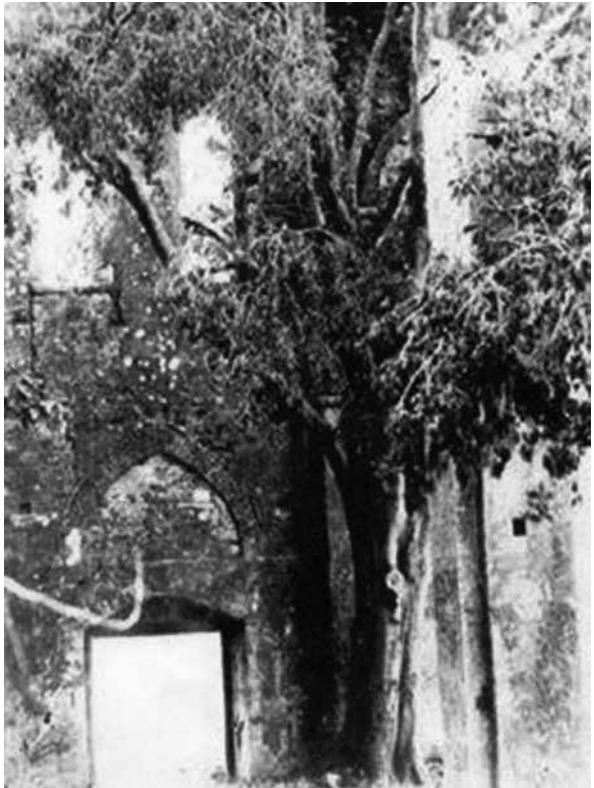
Sl. 37. Najstarija poznata fotografija unutarnjega dijela zapadnoga pročelja s prozorima i pilastrom na sjeverozapadnome stupu

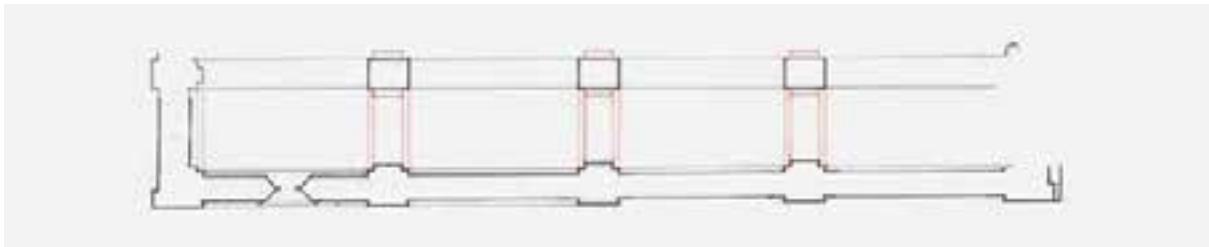
Sl. 38. Tlocrt izvedenih elemenata južnoga broda crkve; izvorni tlocrt označen crvenom bojom  
(Stanislav Živkov)

gradnje, a sve je natkriveno trostrešnim krovom. (Sl. 38.) Glavni ulaz u crkvu nalazio se u središnjem traveju zapadnoga pročelja, a taj je portal relativno dobro dokumentiran. Ispred portala nalazio se trijem, koji su najvjerojatnije nosili stupovi, jer u sačuvanome jugozapadnom kutu crkve nema nikakvih vidljivih ostataka zidova prema zapadu. Pete spojnih lukova između zapadnoga pročelja crkve i trijema bile su u ravnini gornjega nadvoja zapadnoga portala, što ukazuje da je središnji luk trijema bio nešto viši od lunete portala te da je taj luk bio širi od bočnih, što pak znači da su tri svoda trijema nosili stupovi, jer to je bio najjednostavniji način držanja lukova različitih visina. Što se tiče lukova, bočni na zapadnome portalu oblikom su bili u skladu s onima bočnih traveja samoga pročelja i bili su šiljati, dok je središnji luk bio viši i širi te je oblikom održavao lunetu portala. Luk na južnoj strani je mogao biti izgrađen kao nastavak polukružnih lukova na južnome pročelju, dok je na sjevernome mogao stati luk sličan onome južnome, no postoji mogućnost da je bio spojen s južnim zidom zapadnoga krila samostanskog kompleksa. Pete svih lukova najvjerojatnije su bile u ravnini središnjega para, no za to nema definitivnoga dokaza. Glavni zapadni portal je danas poznat s nekoliko starih fotografija, među kojima su najznačajnije one koje je snimio Bettini<sup>81</sup> 1937. godine, dok je Mušić 1947. izradio tehničku dokumentaciju s mjerama i objavio je 1952. godine<sup>82</sup>. Vratnice portala činile su tri glavne sastavnice: profilirani blokovi u donjem dijelu, šrine cijelokupne vratnice sa svake strane. Gornji dio vratnice bio je drugačiji: gornji dio bio je izrađen od

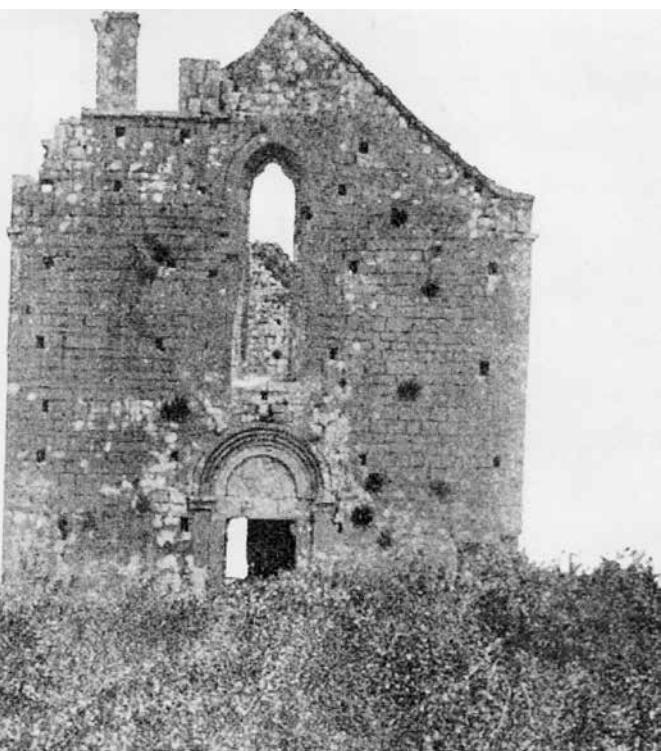
Sl. 39. Pročelje crkve sv. Marije u Svaču (zbirka Stanislava Živkova)

*Fig. 39 Façade of the church of St. Mary in Svac  
(collection of Stanislav Živkov)*

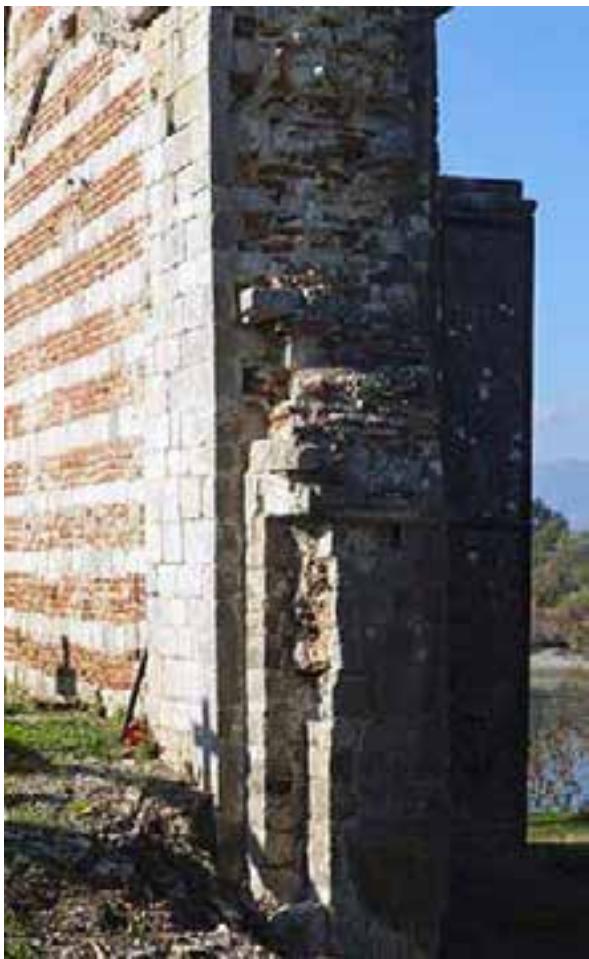
Sl. 40. Zapadni dio južnoga portala (zbirka Stanislava Živkova)

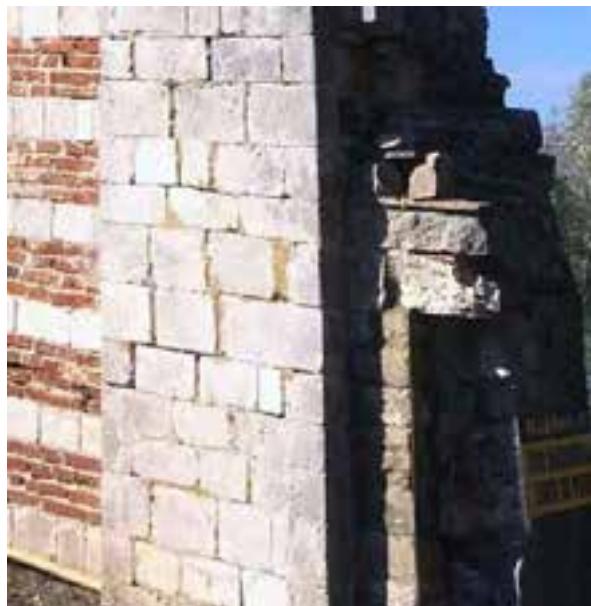
Sl. 41 Sačuvani dio nadvoja južnoga portala (zbirka Stanislava Živkova)

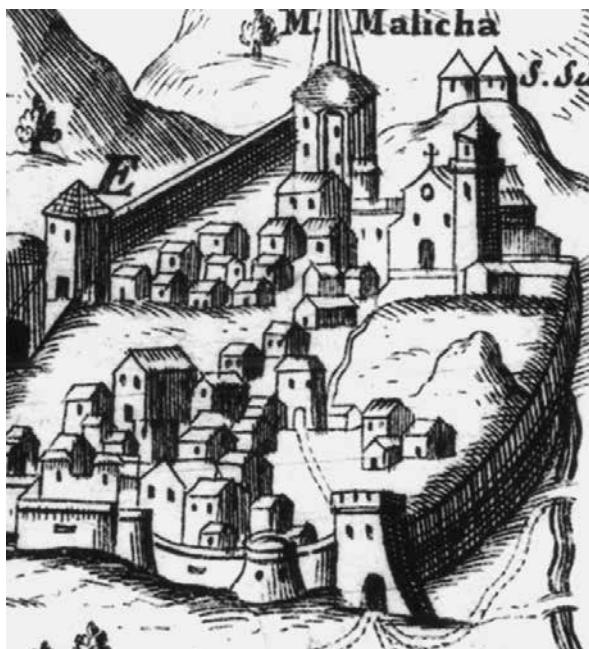
Sl. 42. Katedrala u Baru, detalj Coronellijeve gravire: Antivari, Vincenzo Coronelli – Repubblica di Venezia p. IV. Citta, Fortezze, ed altri Luoghi principali dell' Albania, Epiro e Livadia, e particolarmente i posseduti da Veneti descritti e delineati dal p. Coronelli, Venezia, 1688.

*Fig. 42 The cathedral in Bar, a detail of an engraving by Coronelli: Antivari, Vincenzo Coronelli – Repubblica di Venezia p. IV. Citta, Fortezze, ed altri Luoghi principali dell' Albania, Epiro e Livadia, e particolarmente i posseduti da Veneti descritti e delineati dal p. Coronelli, Venezia, 1688.*

effect the visually dominant element of this façade. Another contribution to the Gothic tendency for verticality on the east façade concerns the construction of two Gothic biforate windows in the upper section of the central apse. The plan of the church is very similar to that of the cathedral in Bar, also a three-aisled basilica built of alternating courses of polished stone. (Fig. 42) They were erected under the building programme of the Benedictine and, later, Franciscan monastic orders in the province of Praevalis. Some basic elements are common to all such basilicas: a nave consisting of four bays in length, with the aisles separated by rectangular piers bearing the vaults (Bar) or a wooden roof. All such basilicas were built of local stone or in combination with bricks; their central naves were much higher and lit through the windows placed on the clerestory. There were no domes above the central naves. The Cathedral of St. George in Stari Bar, of which only the foundations have remained, had the same architectural composition. Fortunately, the appearance of the cathedral in Bar is known from old drawings and photographs, and the discovered elements of its superstructure give enough evidence as to the original appearance of the church. Apart from the plan, very little is known about the superstructure of the cathedral in Ulcinj. Notwithstanding, the fact that it was built over an earlier church opens the possibility that the church of Sts. Sergius and Bacchus might have been erected over the remains of an earlier church memoria from the early Middle Ages. The unfinished basilica "B" in the Franciscan convent at Ratac should also be added to this group. This is another building founded by Queen Helen of Anjou. This church was also planned as a true three-aisled basilica. Its outer walls had been begun with alternating courses of red and white polished stone, but due to subsequent problems, the basilica was never finished and only the crypt and the lowest parts of perimeter walls were built. The articulation of the façades with pilasters and pointed arches has its counterpart in the architecture of the now demolished church in Danj. (Fig. 44) The off-centre placing of the belfry over the west façade also has its counterpart in the church in Svač. The same applies to the horizontal ending of the façade cornices, also used on the cathedral in Bar. Finally, it must be said that the church of Sts. Sergius and Bacchus on the Buna (Bojana) River was one of the most important architectural monuments on the east coast of the
