## Elementi za arhitektonsku rekonstrukciju crkve sv. Sergija i Bakha (Kisha e Shirgjit) na rijeci Bojani (Buni) kraj Skadra u Albaniji

### Evidence for the architectural reconstruction of the church of Sts. Sergius and Bacchus (Kisha e Shirgjit) on the Bojana (Buna) River near Skhodra, Albania

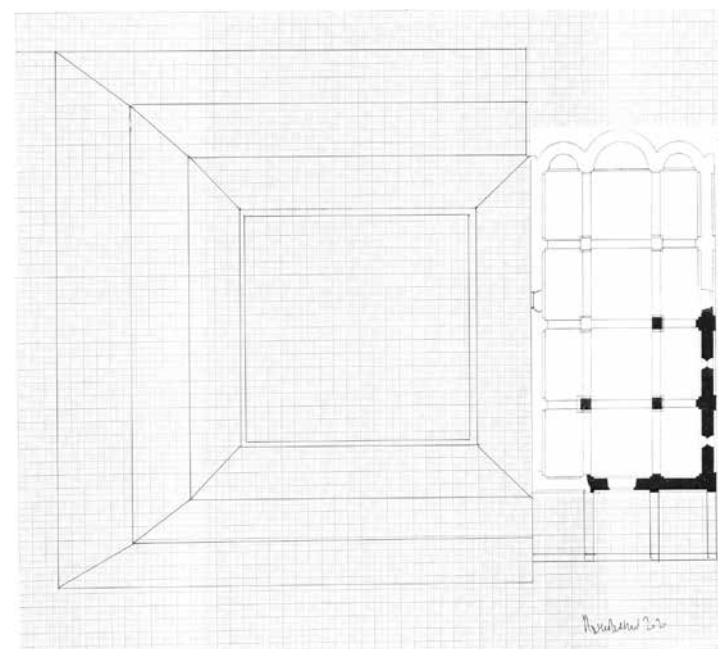
Sl. 43. Rekonstrukcija tlocrtnoga prikaza samostanskoga kompleksa (Stanislav Živkov)  
Fig. 43 Reconstruction of the situation plan of the monastic complex (Stanislav Živkov)

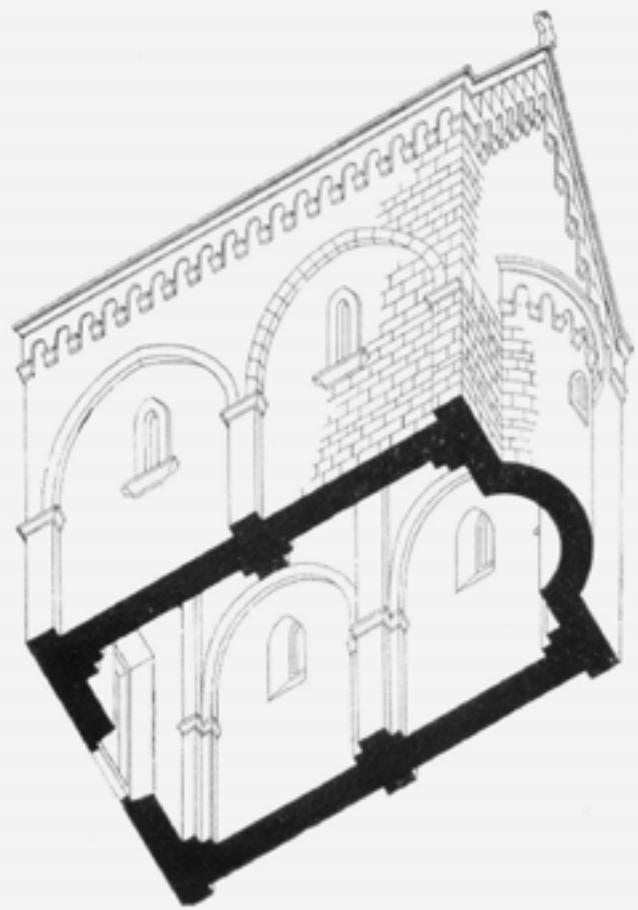
Sl. 44. Aksonometrijski crtež danas razorene crkve u Danju (Živkov 2001.)

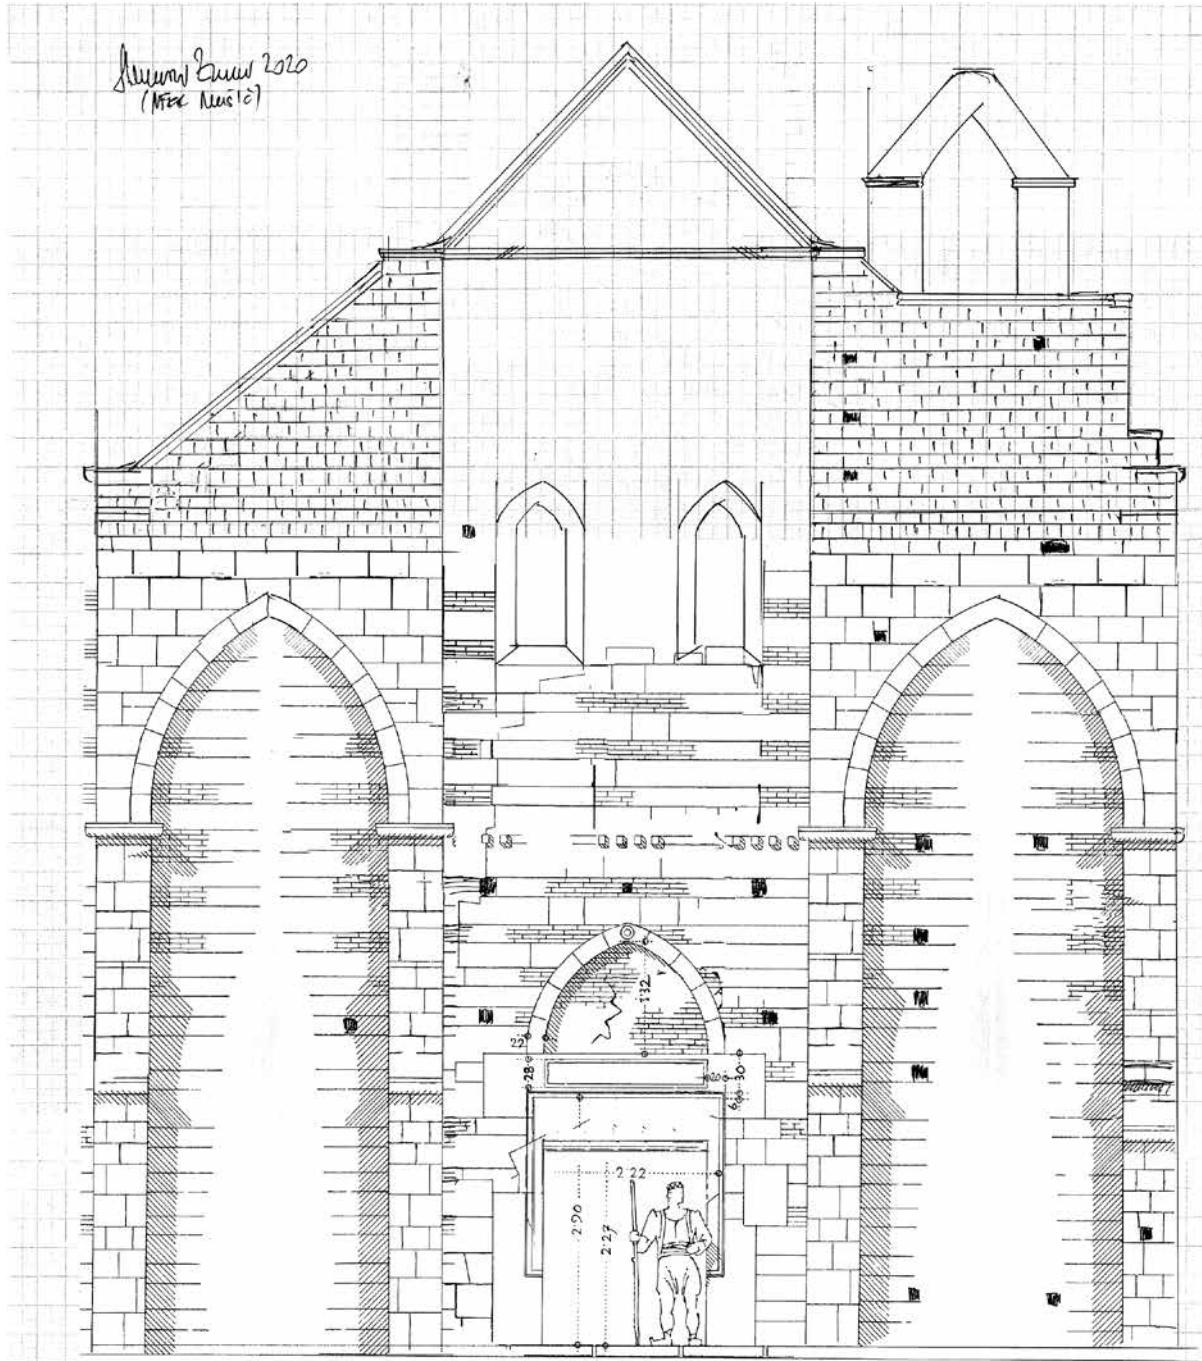
T. I. Rekonstrukcija zapadnoga pročelja crkve na temelju Mušičevih fotografija i crteža (Stanislav Živkov)  
Pl. I Reconstruction of the west façade of the church based on Mušić's vintage photographs and drawing  
(Stanislav Živkov)

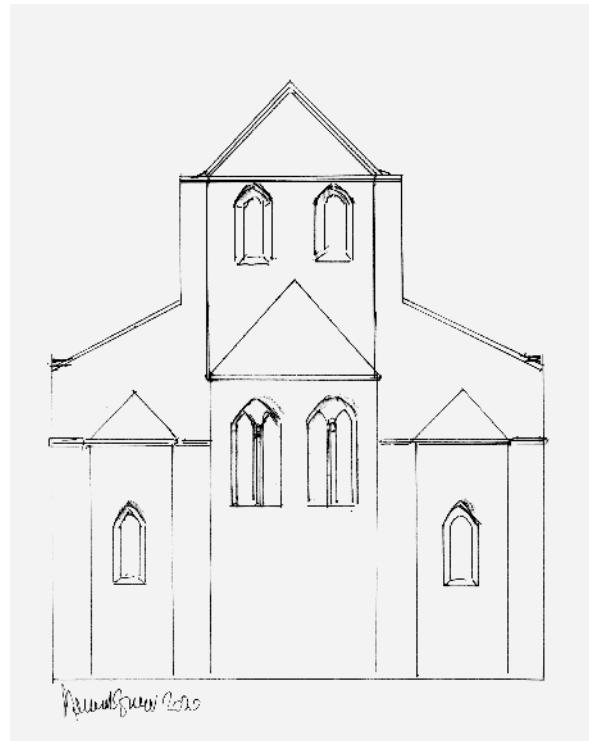
T. II. Rekonstrukcija istočnoga pročelja crkve na temelju gravira iz 1855. godine, Ippen (1899.) i starih fotografija zapadnoga pročelja *per analogiam* za gornji dio iznad središnje apside (Stanislav Živkov)

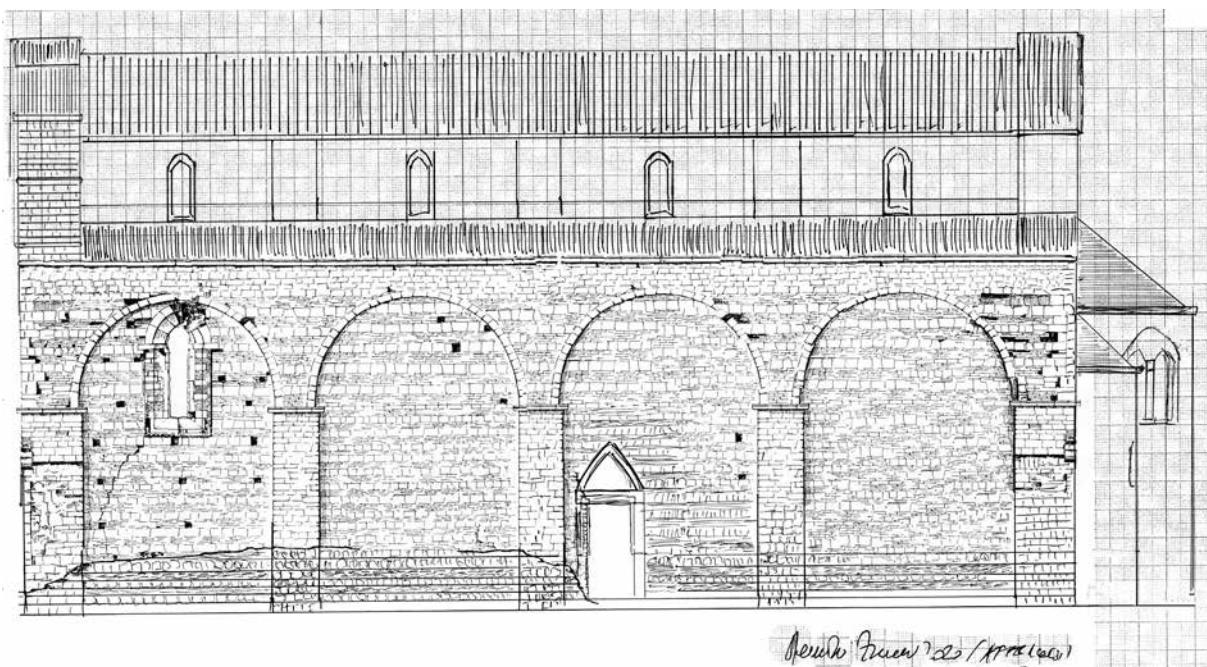
T. III. Rekonstrukcija južnoga pročelja na temelju objavljene Meksijeve izmjere i Ippenove gravire (Stanislav Živkov)

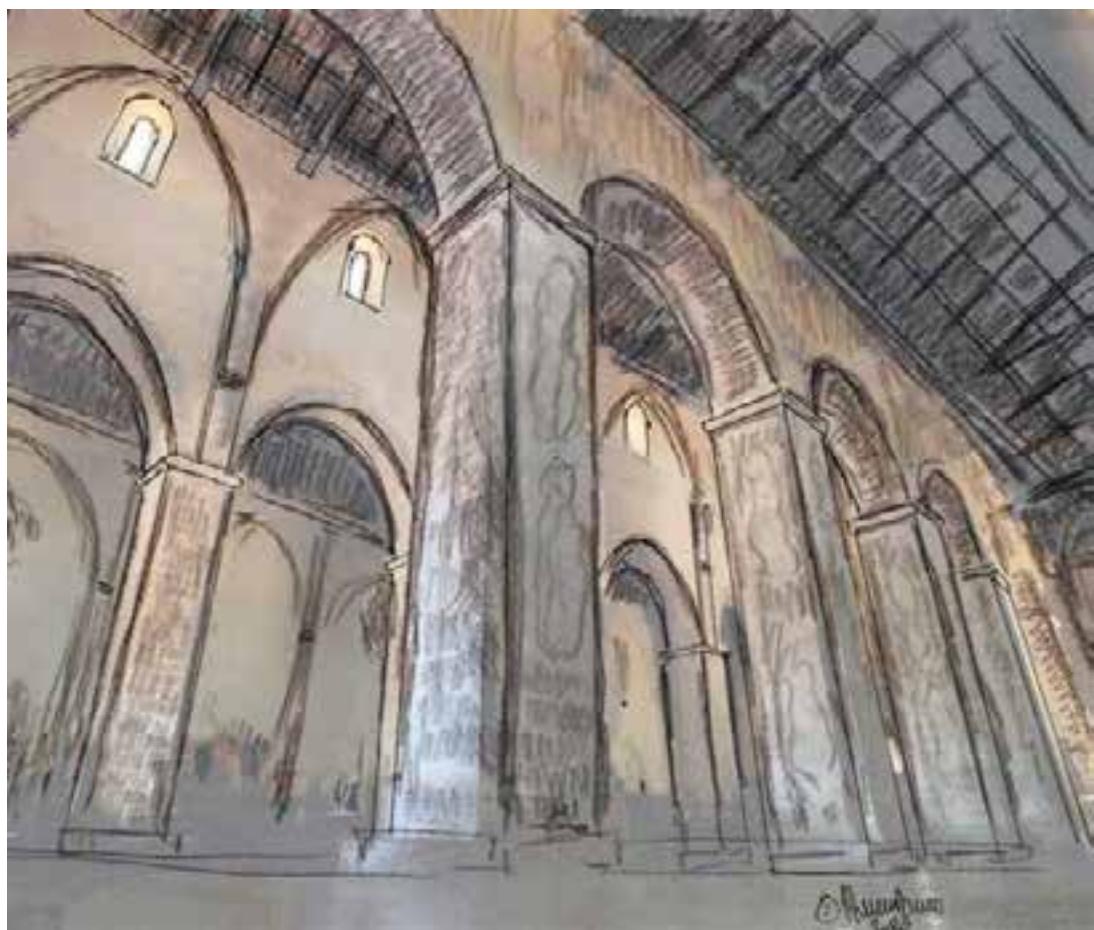
T. V. Perspektivna rekonstrukcija unutrašnjosti crkve (Stanislav Živkov)  
Pl. V Perspective reconstruction of the church interior (Stanislav Živkov)

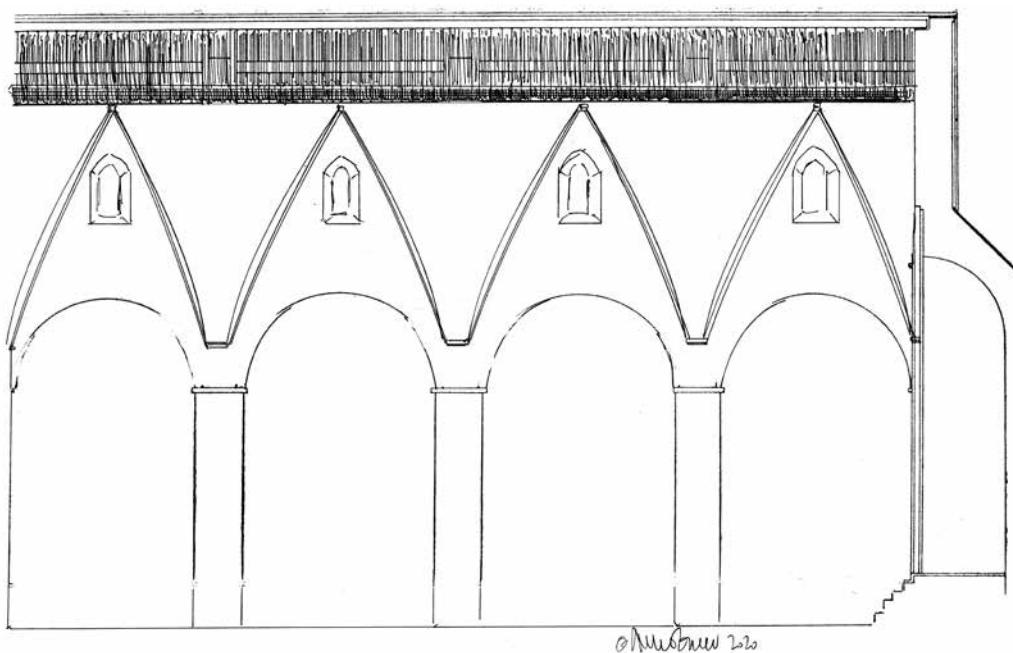
T. VI. Rekonstrukcija presjeka crkve na temelju Ippenove gravire i  
Smirnovljeve rekonstrukcije (Stanislav Živkov)  
Pl. VI Reconstruction of the church's cross-section based on Ippen's engraving  
and Smirnov's reconstruction (Stanislav Živkov)
