Installation of stainless metal reinforcements in stone cultural monuments

Objective: To provide examples of the installation of stainless-steel reinforcements in a stone cultural monument as part of conservation and restoration work.

Results: The presented examples of stone monuments (an ancient stone sarcophagus, two ancient sculptures, one medieval portal, two baroque baptismal fonts and a baroque bell gable) were reinforced with stainless steel. A reinforcing mesh was utilized to connect fragments of the sarcophagus and reconstruct the missing parts. The sculptures were found in fragments and required steel reinforcement to be set up in a free-standing position. The baptismal fonts were also found in fragments due to the corrosion of their iron clamps; they were furnished with a detachable, externally invisible steel reinforcement. The medieval portal was at risk of collapse due to the static instability caused by the rupture of its load-bearing lintel. The lintel was reinforced with a steel bar, which absorbs compression forces acting on the stone superstructure. The baroque bell gable was a prime example of a monument damaged by its iron clamps. These were completely remove

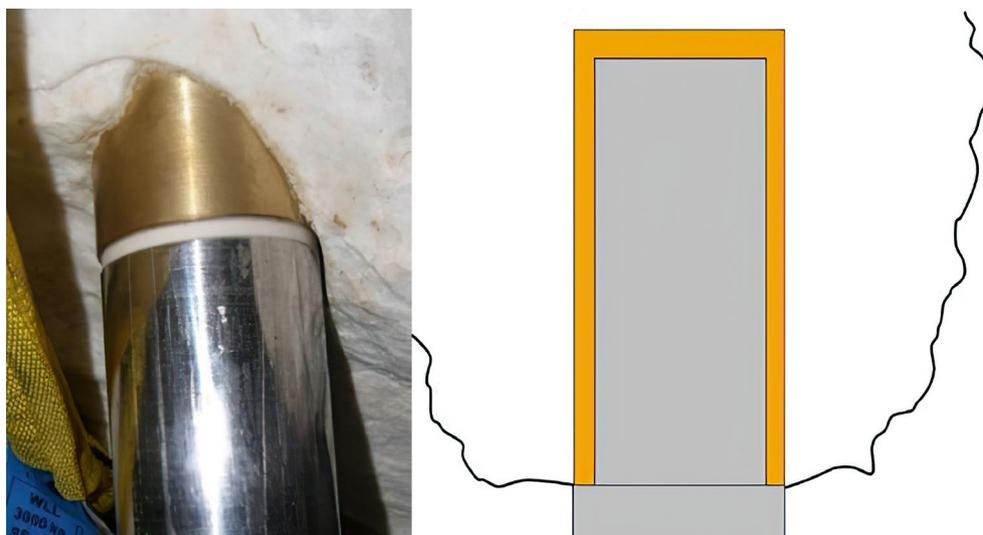
Figure 1. A rod embedded in a bronze cup; the cross-section of the bronze cup is shown in yellow, and the stainless-steel member embedded in the cup is grey. The white ring in the left photo is just a plastic distancer placed due to the fine height adjustment of the sculpture. Later it was removed (photo and drawing by Siniša Bizjak, 2016).

If possible, the embedding should be reversible; detachable metalwork is used to this end (Crnković & Šarić, 2003). Detachable structural reinforcement for stone monuments may be divided into two types. The first involves turning a steel rod so its diameter is narrower than the bronze metal cup into which it is to be inserted (Figure 1). The reason for opt-

ing for different materials is their different hardness, which prevents wedging between metals (Čorić, 2017), because identical metals can easily get jammed between each other when mounting or dismantling the parts of the monument. We must keep in mind that it is generally always advisable to use only one type of metal and not combinations of two or more metals. The reason for this is what is called contact corrosion, which rests on the different corrosion potentials of the various metals (Zhang, 2011). Two different metals become electrodes in a liquid medium, such as water with salts dissolved in it. However, we use this combination of metals only in highly controlled climatic ambientes such as museum interiors.

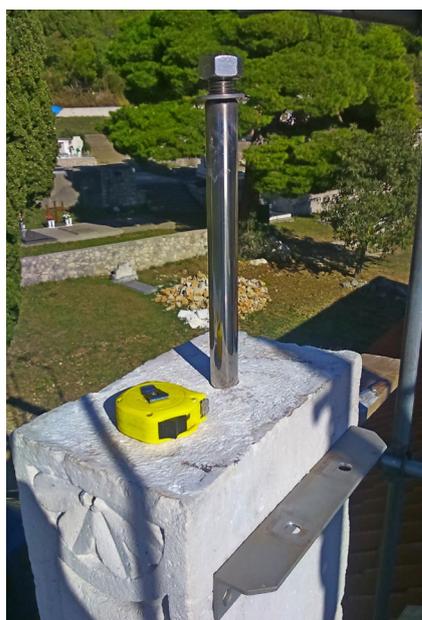
Figure 2. An embedded threaded rod with a tightening nut (photo by Duje Ordulj, 2016, reproduced with permission).

The second type uses rods with turned threads and tightening nuts. The advantage of this solution is that, unlike the first type, it can be arranged both vertically or horizontally and remain equally easy to disassemble. We use these structures to connect cracked fragments by the controlled tightening of nuts to buffer compression and tensile forces that may have a destructive effect on the stone cultural monument (**Figure 2**).

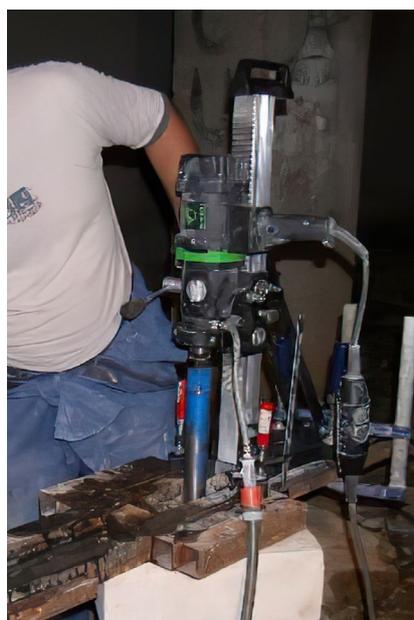
Figure 3. Drilling a hole in a stone monument with an anti-vibration drill (photo by Ivo Donelli, 2006, reproduced with permission).

After precisely gauging the integration of the construction zones, machine drills are used to drill holes in the stone. A drilling method is selected based on the state of the stone monument and the size of the structure. For example, hammer drills with SDS bits or anti-vibration drills with water-cooled bits may be used (**Figure 3**). Cooling is used when drilling deeper holes or working with monuments in poor condition, as these may sustain damage due to vibrations from hammer drills. After removing stone dust from the holes, the prepared stainless-steel reinforcements are glued to the stone (**Figure 4**). Two-component epoxy adhesives are most commonly used. Sometimes, structural elements cannot be pre-arranged into their desired position and need to be welded together on the spot (**Figure 5**). It is important to note that in certain cases, the stainless-steel should not be glued to the stone due to its physical property – thermal expansion. This is especially important when dealing with outdoor monuments, which may crack due to heating and varying thermal expansion coefficients of applied materials (**Donelli & Malinar, 2015**).

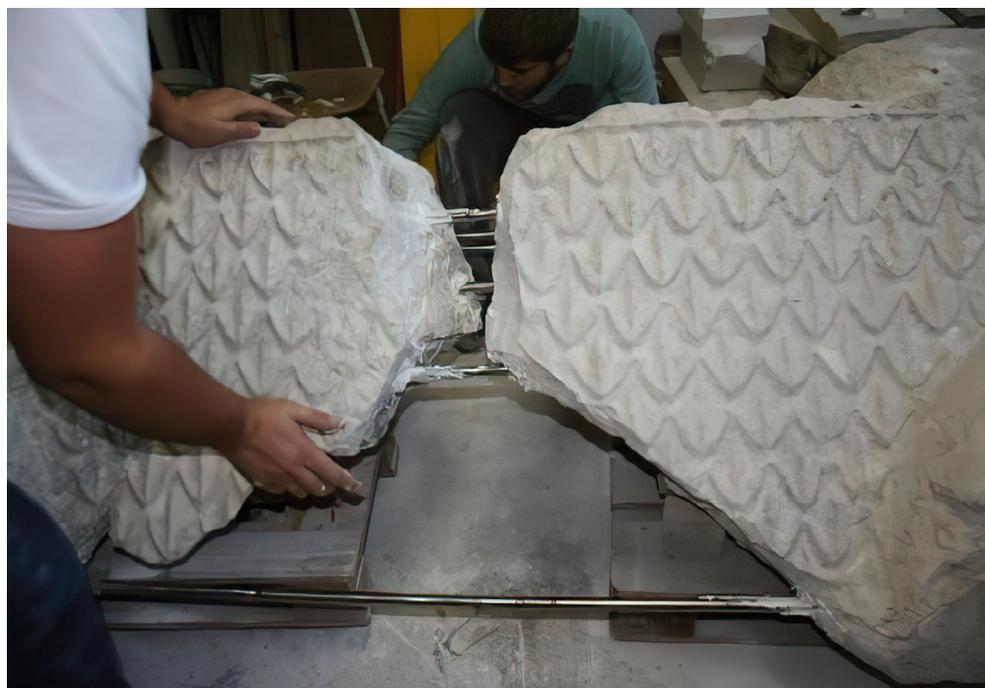
Figure 4. Stainless steel members are glued to the stone to join fragments with no shared point of contact (photo by Siniša Bizjak, 2019).

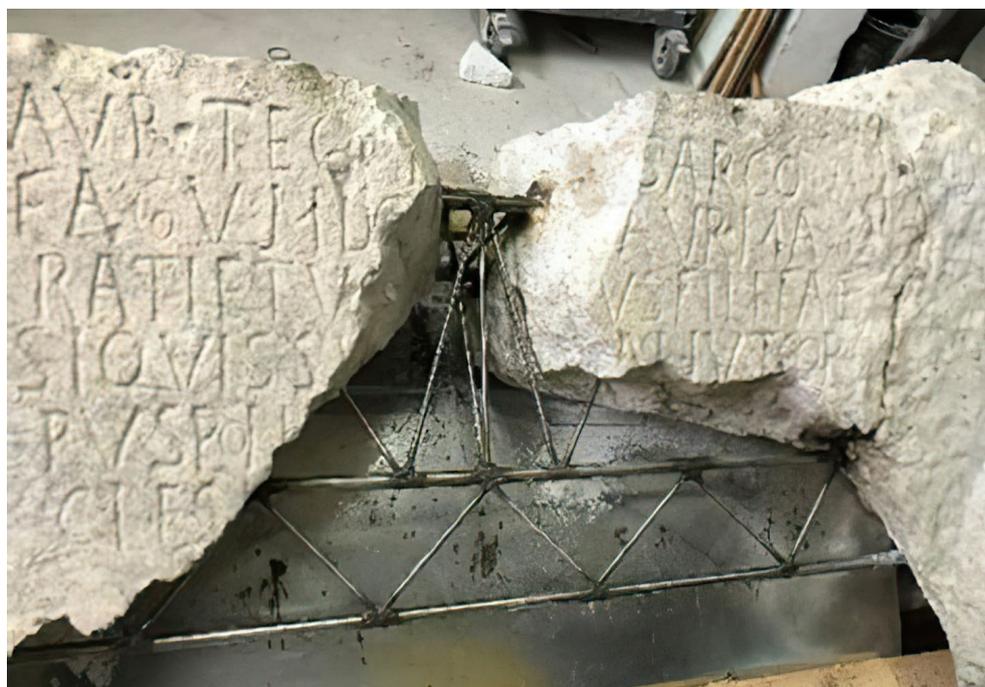
Figure 5. An example of a welded load-bearing stainless steel metal grid (photo by Siniša Bizjak, 2019).

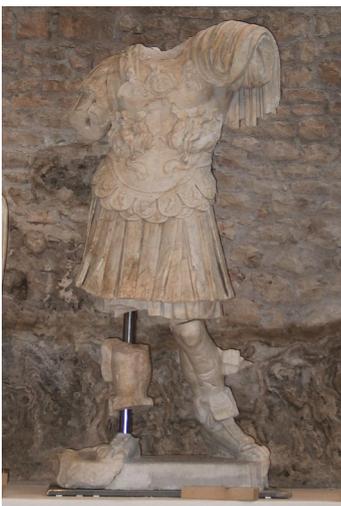
Figure 6. The ancient sculpture of Emperor Augustus with visible load-bearing reinforcement of the right leg (photo by Siniša Bizjak, 2016).

The installation of metalwork in the ancient sculpture of Emperor Augustus from the Narona Archaeological Museum (**Marinković, 2014**), resembled the intervention on the marble sculpture of Venus Pudica described later in the text. A detachable structure consisting of a bronze cup and stainless-steel bar was embedded in the marblework. The bar follows the anatomy of the statue's leg and attaches to a stainless-steel metal base that keeps the sculpture upright (**Figure 6**). As the load-bearing bar was visually distracting, we opted for reconstructing the missing pieces to cover the metal structure. After moulding

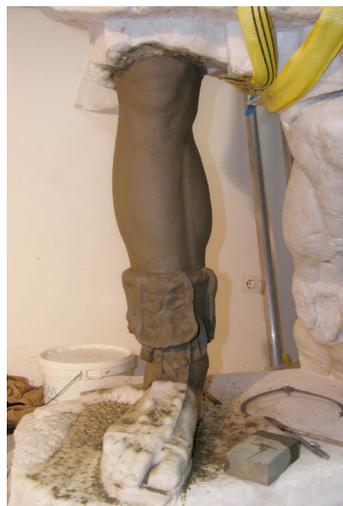
Figure 7. Moulding the missing portions of the right leg of the Emperor Augustus sculpture to facilitate the visualization of the sculpture's integrity (photo by Ivo Donelli, 2016, reproduced with permission).

and casting, artificial marble casts were installed in the sculpture and then retouched and patinated to fit into the whole (Figure 7, Figure 8). Note that this structure is modifiable and can be completely removed.

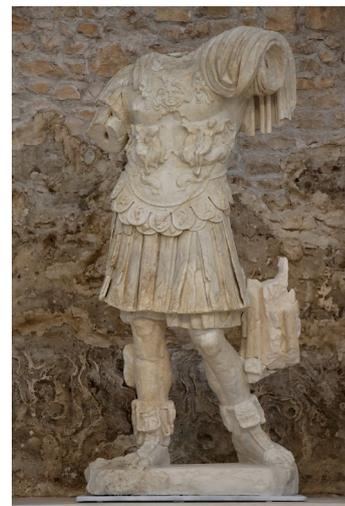
Figure 8. The sculpture of Emperor Augustus after the intervention, with adapted parts of the right leg, reconstructed using artificial marble to hide the load-bearing steel reinforcement (photo by Siniša Bizjak, 2017).

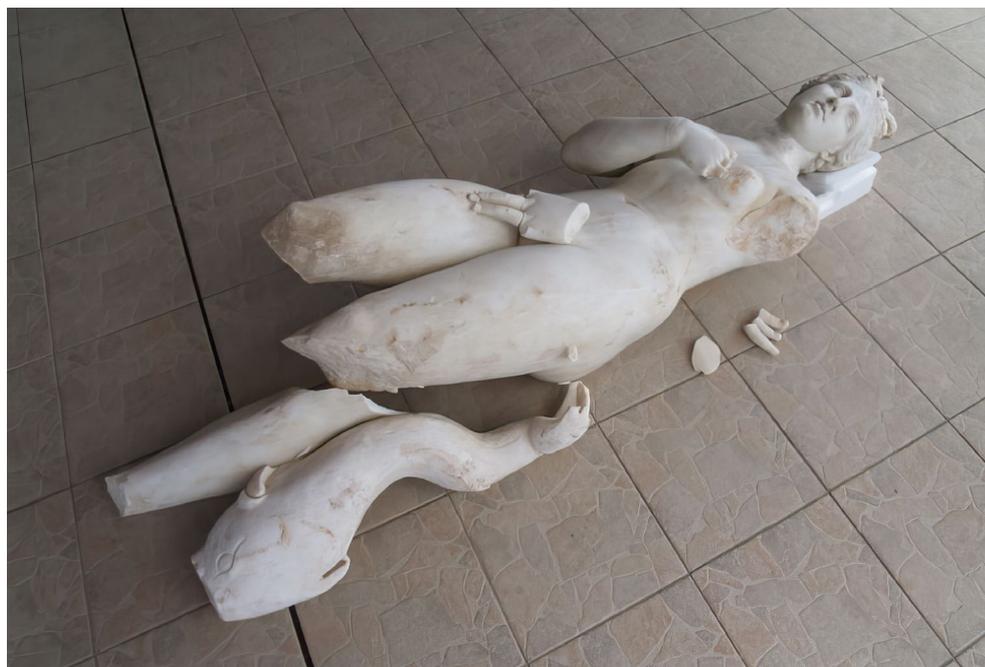
“Venus Pudica”, a marble sculpture of the Roman goddess of love, was discovered at the Skupi site near the city of Skopje in Macedonia, in 2008 (Ončevska Todorovska, 2011). The sculpture, made from white Greek marble, was found in 16 fragments, with parts of the legs and feet missing (Figure 9). After running analyses of the type of marble and harmful water-soluble salts, the joints between the fragments were cleaned. After the cleaning, drilling points were defined for the installation of stainless-steel dowels. Once the fragments were joined, a stainless-steel metal structure needed to be designed to hold the sculpture in the optimal vertical position, in the contrapposto pose. Drilling was done with an anti-vibration drill with a 32 mm bit. The method of embedding a detachable metal reinforcement was chosen in this case as well. Firstly, turned bronze cups were inserted into drilled holes to hold the bars, which in turn follow the anatomy of the leg and foot and keep the sculpture in the optimal position. Initially, the bars that carry the entire sculpture and follow the position and anatomy of the legs were made of wood and appropriately positioned. Based on the wooden model, a stainless-steel reinforcement with a base was produced to stabilize the whole sculpture (Figure 10). Missing parts were reconstructed over the metalwork using artificial marble to completely conceal the steel reinforcement (Figure 11). It is important to note that this structure is completely detachable and can be adjusted or completely removed if the original fragments of the legs are ever discovered.

Figure 9. The state of the sculpture after archaeological research. It was discovered in 16 fragments. Pieces of the right shank and left foot with the base are clearly missing (photo by Marina Ončevska Todorovska, 2010, reproduced with permission).

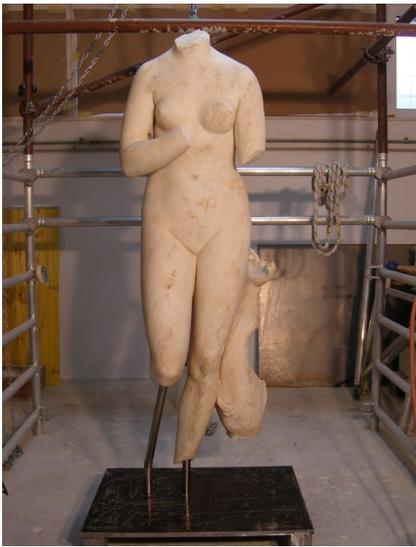
Figure 10. The stainless-steel metal reinforcement ensures the stability of the sculpture missing parts of the legs conceal the load (photo by Siniša Bizjak, 2011).

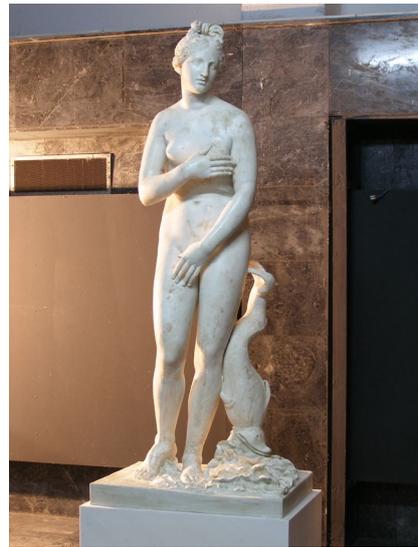
Figure 11. The sculpture after installation at the Skopje City Museum. Reconstructed bearing metal structure (photo by Siniša Bizjak, 2011).

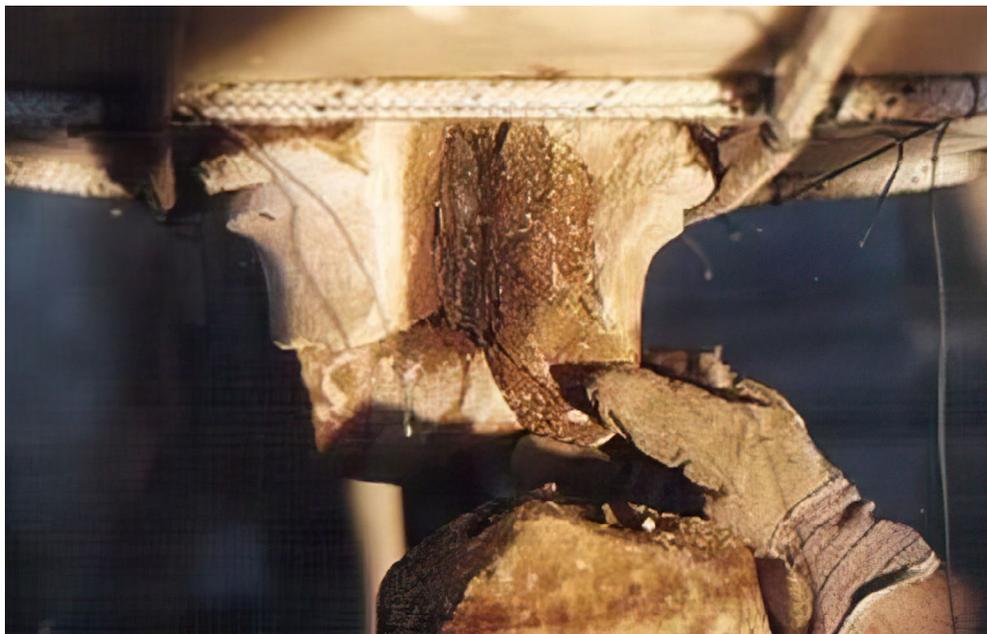
Two baroque marble baptismal fonts from the church of St. Euphemia in Rovinj (Marković, 1996), experienced significant structural disintegration due to the corrosion of iron members and their expansion into the marble structure (Figure 12). The baptismal fonts were initially in a very poor condition, held in one piece by copper and iron clamps and steel hoops installed preventively in an attempt to secure them. During the conservation and restoration works, many of the marble fragments were glued back, but the integrity of the monument was severely impaired. As the base and column could no longer bear the enormous weight of the basin, an innovative stainless-steel member was embedded in the stonework to fully absorb the compression forces from the monument and transfer them to the foundation (Figure 13 and Figure 14). When dimensioning the steel column, we started from the assumption that the baptismal font was loaded with a 500 N force (roughly corresponding to 50 kg of vertically suspended mass). This assumption was based on the fact that children would often grab and swing off the edge of baptismal fonts during the Eucharist. A vertical force of 500 N, acting on the edge of the basin (520 mm radius) causes a 260 Nm moment. It is assumed that the moment is transferred to the column via contact forces occurring at the upper and lower edge of the hole in the basin. These forces cause a couple equivalent to a 260 Nm moment and amount to 866.67 N (Krstulović Opara, 2003). This force couple is received by the base, which was originally a stone block at the foundation of the monument. This concept, based on just one hole in the ground with a diameter of about 50 mm, is the most favourable, given the possibility of cracks in the stone floor and breakage of the floor itself. The steel column, therefore, needs to meet the strength requirement of over 17.44 MPa, which is true of every steel alloy. In places where one stone member stacks onto the other, lime mortar was used as a kind of cushion between the two stone members. The same structure was utilized for both baptismal fonts. The advantage of this structure is that it allows for the disassembling of the monument into its constituent elements at any time (Figure 15).

Figure 12. Cracked marble of the St. Euphemia baptismal font caused by the corrosion of an iron dowel (photo by Siniša Bizjak, 2003).

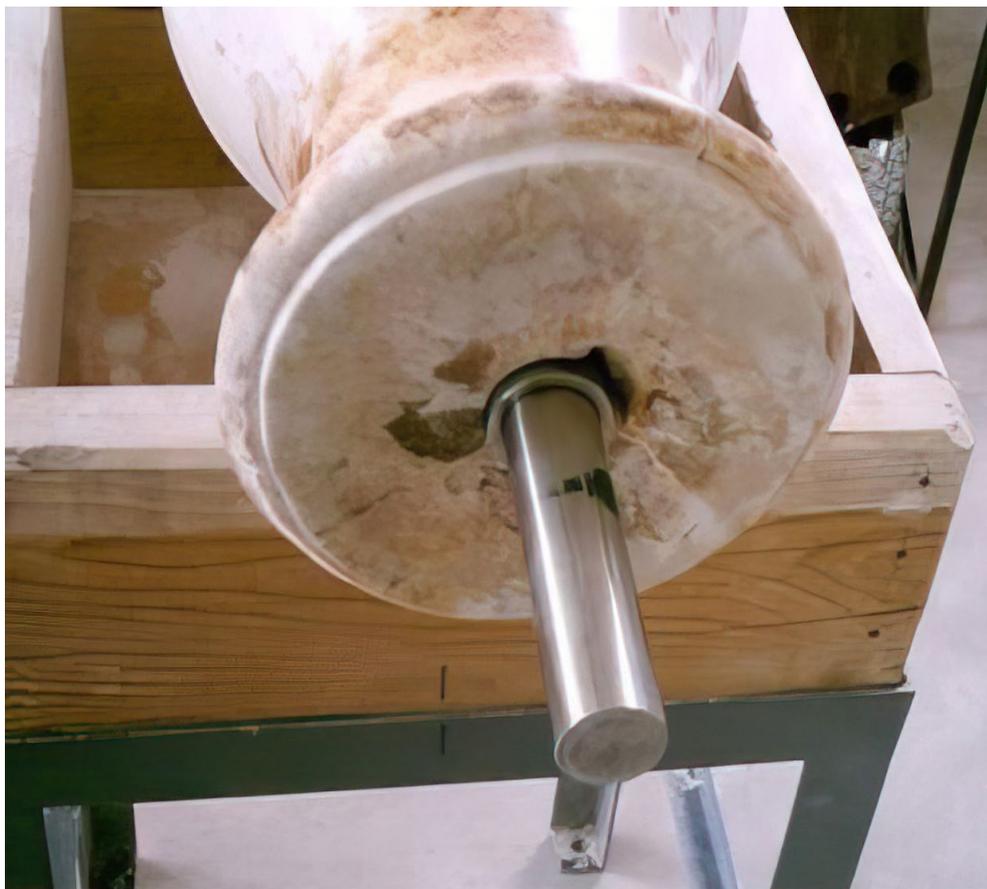
Figure 13. A detail of the installed internal structure. Part of the detachable internal structure is visible inside the marblework of the baptismal font. The same model was applied to both monuments (photo by Siniša Bizjak, 2003).

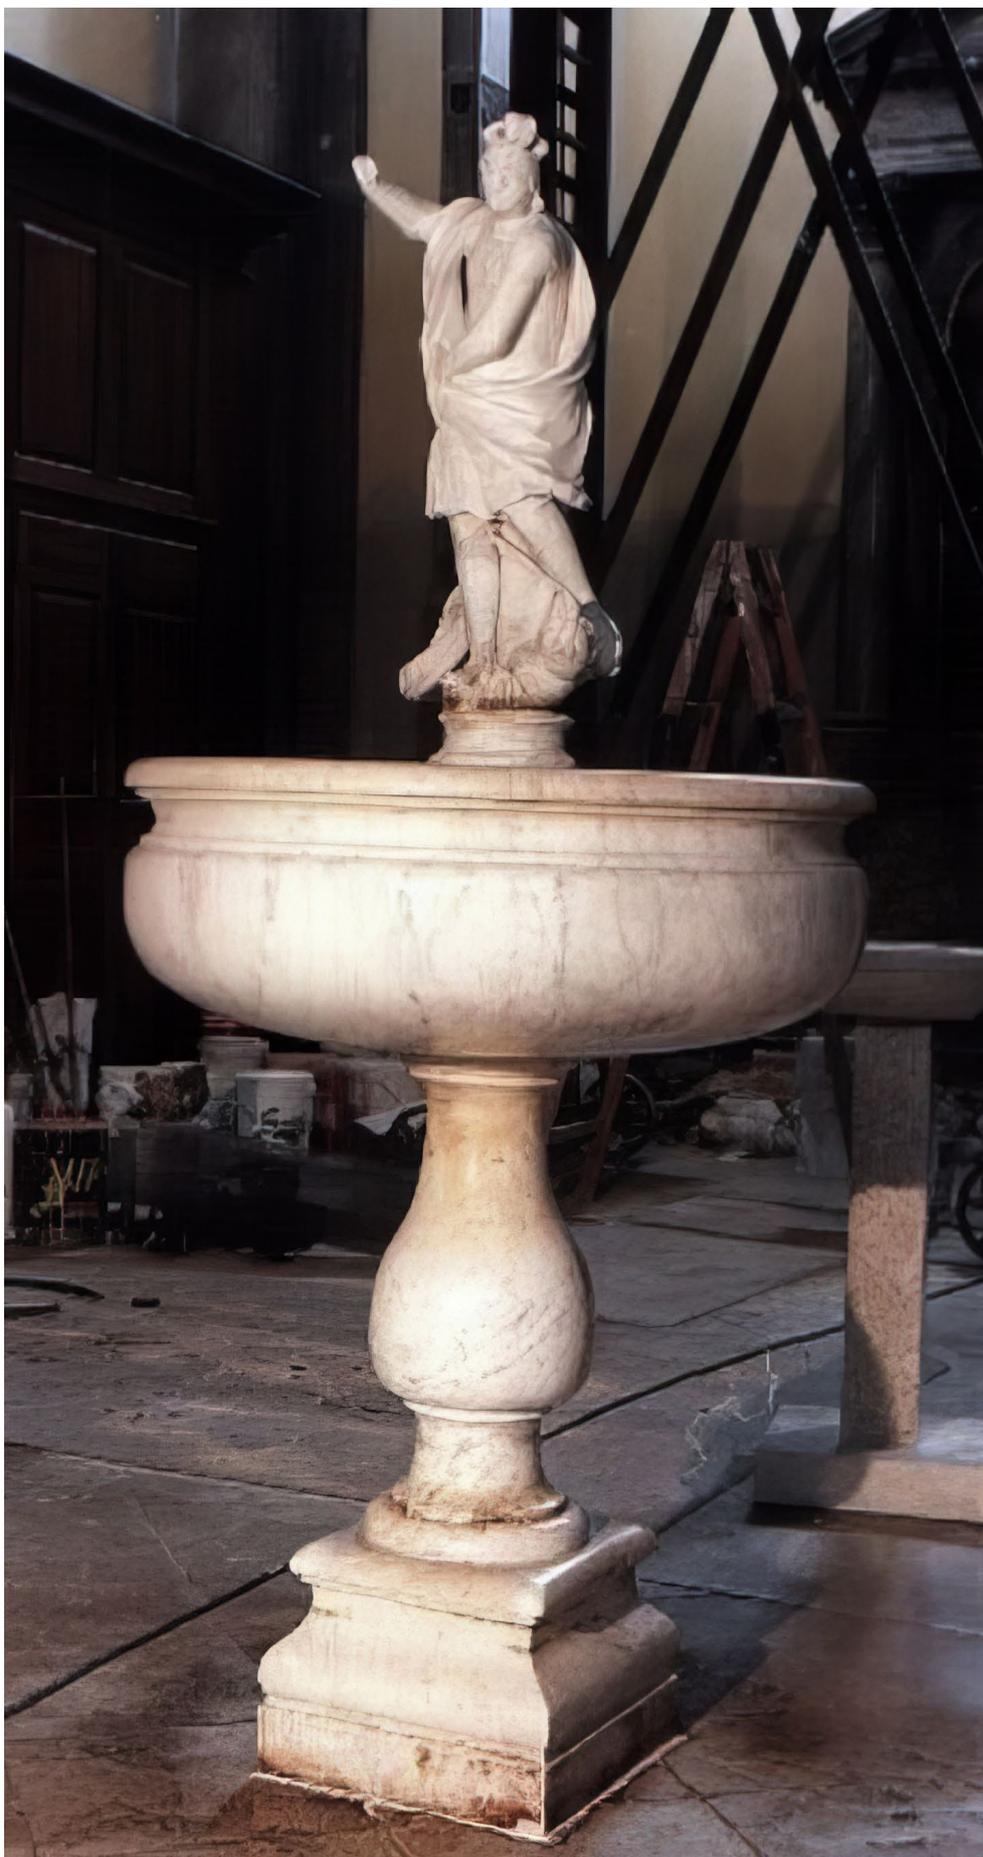
Figure 14. The St. George baroque baptismal font after the installation of “invisible” reinforcement (photo by Siniša Bizjak, 2003).

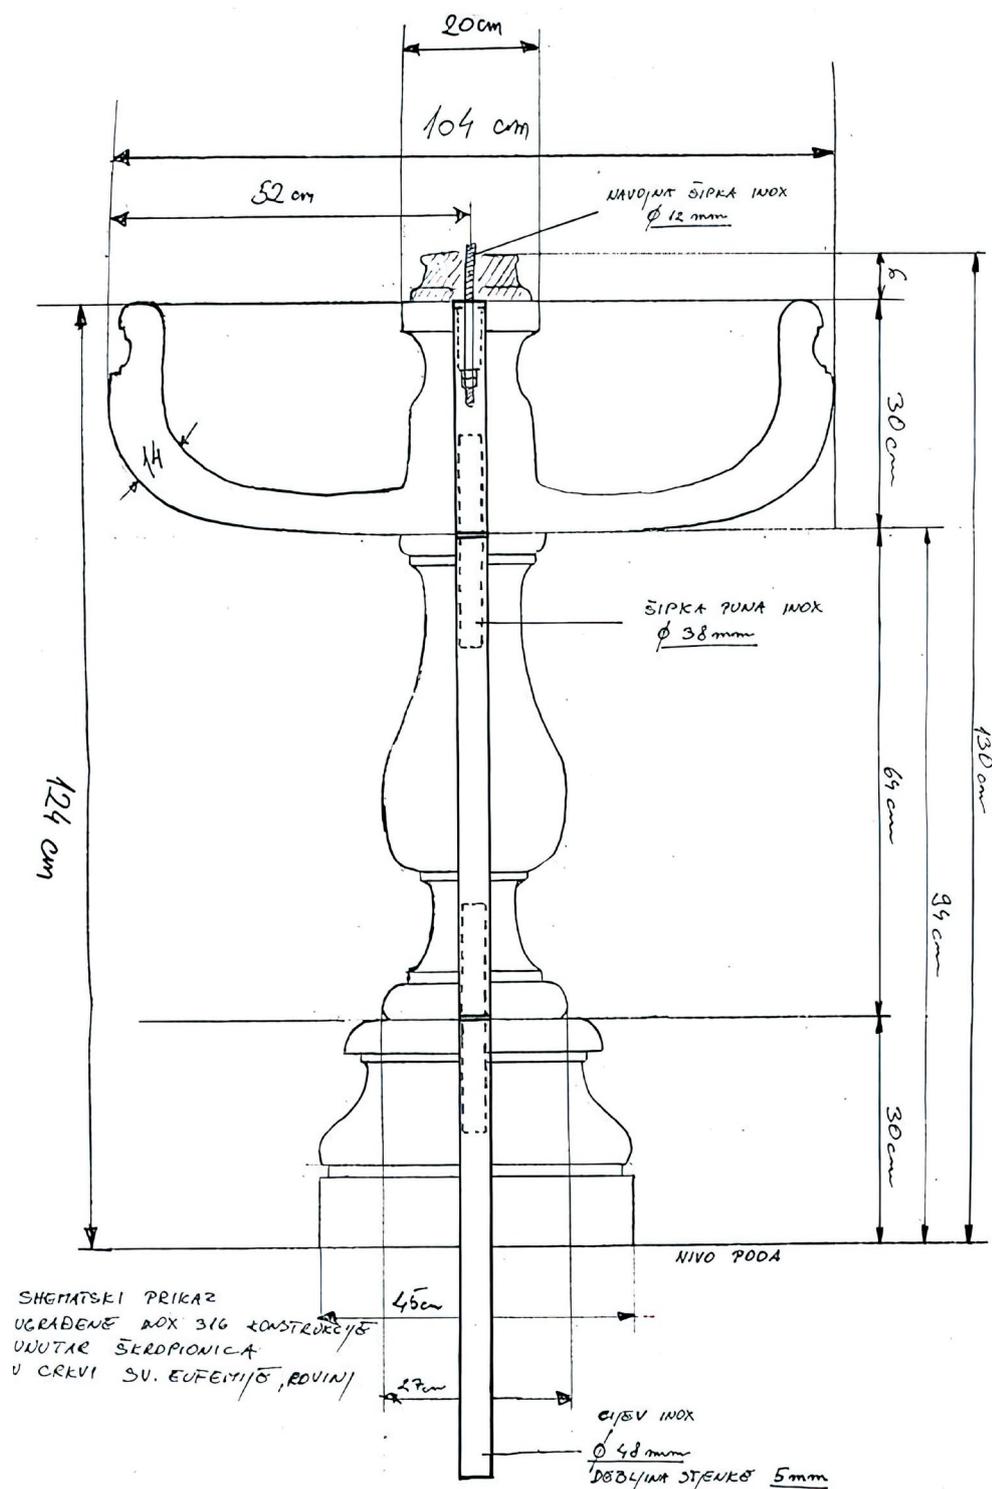
Figure 15. The cross-section of the baptismal font showing the detachable internal stainless-steel structure (drawing by Siniša Bizjak, 2003).

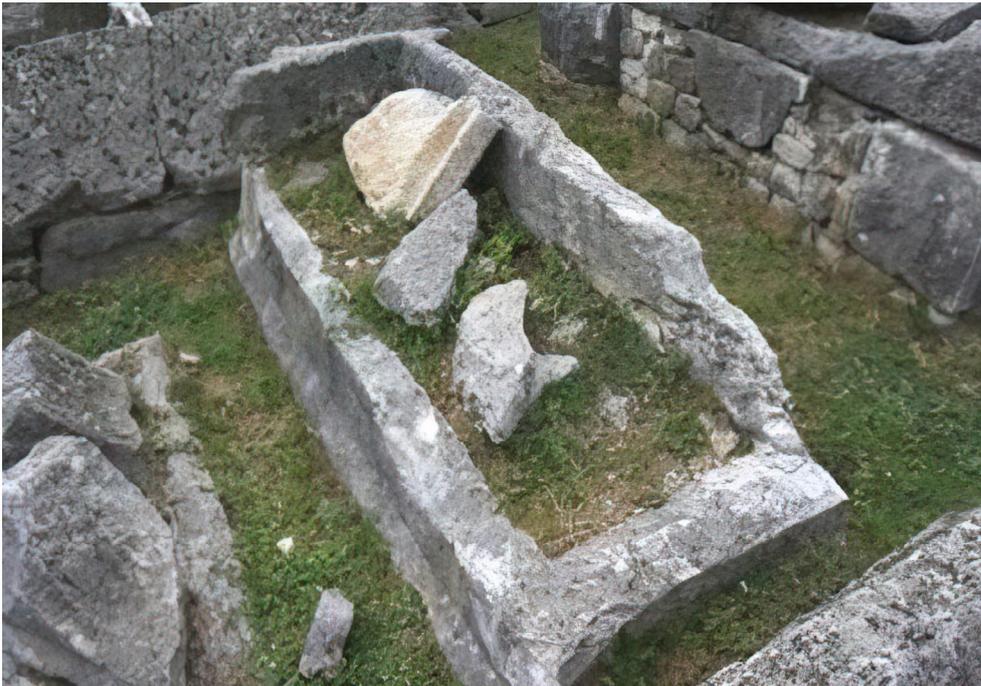
The sarcophagus of Quintia is located at the Manastirine archaeological site in Solin (Bulić, 1904; Matijević, 2019). The sarcophagus was in a very poor condition and the loss of its original structural elements was visible at a glance (Figure 16). The sarcophagus was full of earth and stones, overgrown with vegetation and covered in dark crusts, lichen and other deposits. Several missing fragments were discovered while clearing the earth out of the sarcophagus. These were cleaned and transferred to the workshop with the rest

Figure 16. The initial condition of the sarcophagus of Quintia in Manastirine (photo by Siniša Bizjak, 2017).

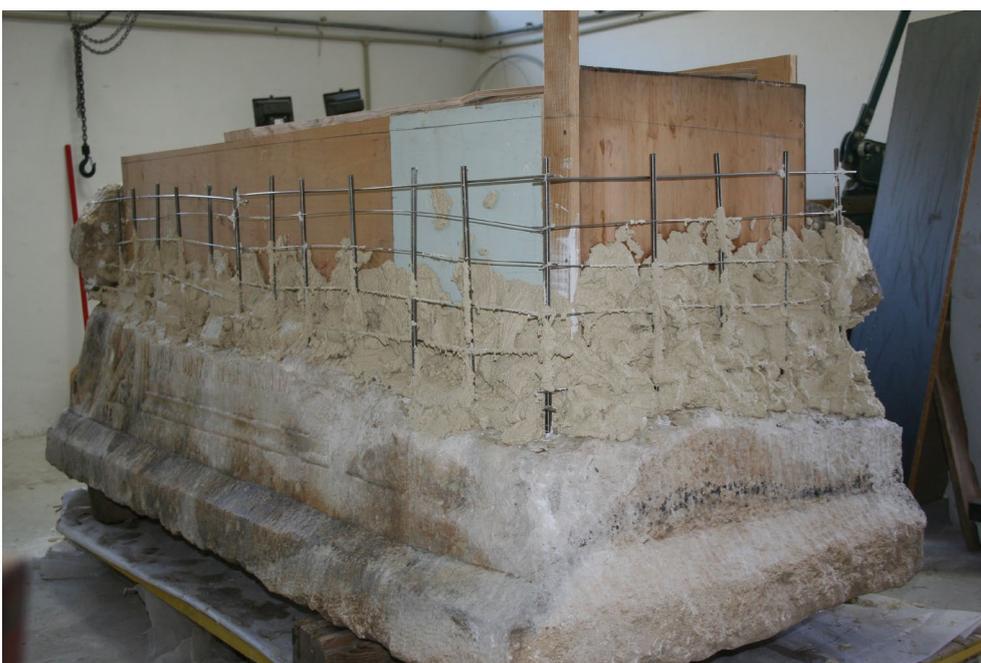
Figure 17. The installation of the reinforcement and application of reconstruction material (photo by Martin Zohil, 2017, reproduced with permission).

of the sarcophagus. After consolidating, gluing, and bonding the collected fragments of the sarcophagus, the installation of stainless-steel metalwork began. 24 holes were drilled into the sides of the sarcophagus to hold the 10 mm diameter stainless steel bars (**Figure 17**). One end of the bar was used to fasten the glued fragments and the other as a skeleton for pieces reconstructed in synthetic stone (**Zohil, 2018**). In areas holding the skeleton for reconstruction, horizontal 4 mm diameter stainless steel bars were weaved into the vertical lattice. This type of meshwork is used in synthetic stone reconstructions (in this case, mineral plaster) (**Figure 18**) to absorb tensile forces, as synthetic stone is more susceptible to these and might cracks easily without the mesh.

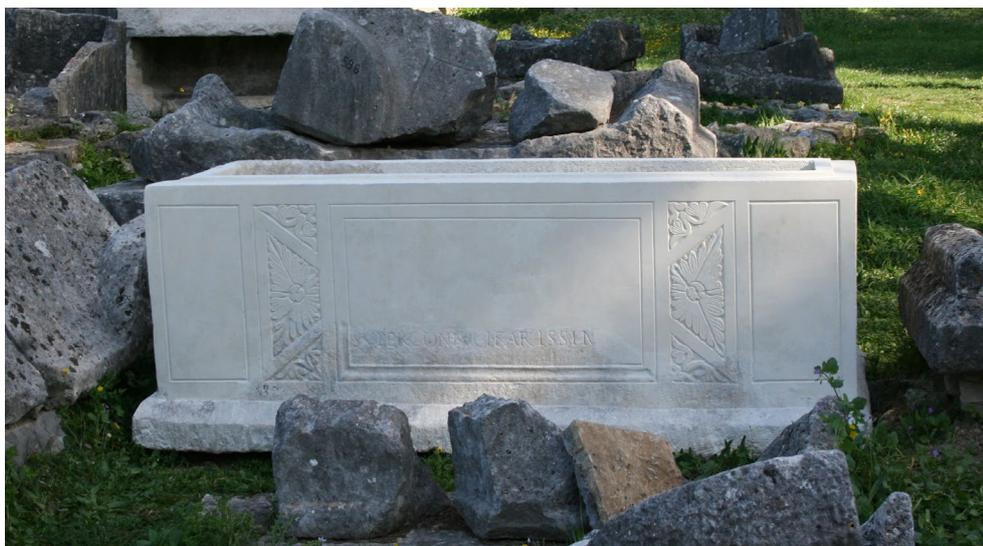
Figure 18. The sarcophagus after works (photo by Martin Zohil, 2019, reproduced with permission).

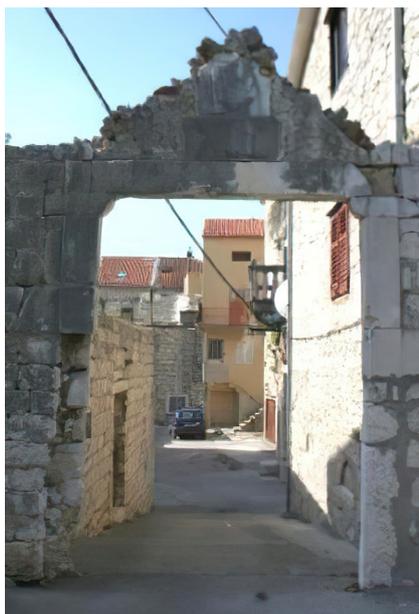
The only preserved medieval entrance to the Town of Kaštela (Bego, 1911) was initially in such a poor condition that it required complete conservation and restoration (Bizjak & Duvnjak, 2017). The whole portal had to be dismantled. We will not deal here with the restoration of the elements of the portal; instead, we will focus on the installation of a stainless-steel metal bar into the load-bearing lintel. The cracked portion on the right side of the lintel was worn-out and required replacing. The worn-out portion was reconstructed using natural stone and affixed to the lintel in the appropriate position. After bonding, a 30 mm wide and 2200 mm long opening was drilled through the centre of the lintel with an anti-vibration drill. A stainless-steel bar thread on both sides was embedded through the entire length of the lintel. Tightening nuts were placed on both ends of the embedded

Figure 19. The initial condition of the portal with a visibly damaged lintel and missing parts in the left doorjamb (photo by Siniša Bizjak, 2015).

metal bar to secure the stone lintel in place. The bar was installed without adhesives to avoid heat damage to the stone. The reinforcement bar in the lintel absorbs a large portion of the load that used to act on the lintel itself and thus provides necessary structural stability to the portal (**Figure 19**, **Figure 20**, **Figure 21**).

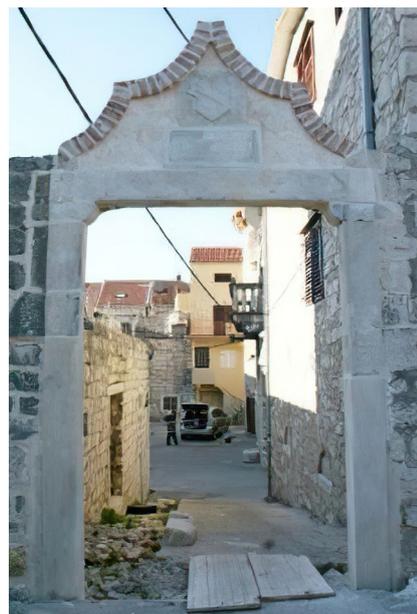
Figure 20. The portal after conservation and restoration works (photo by Siniša Bizjak, 2015).

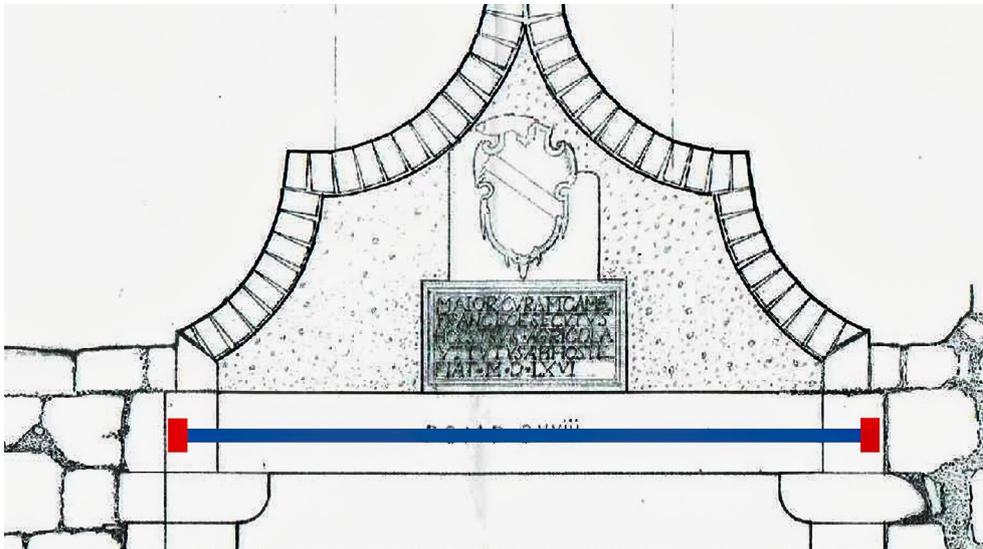
Figure 21. A schematic diagram of the reinforcement embedded in the portal lintel. The direction of the stainless-steel bar is shown in blue and the tightening nut in brown (drawing by Vinka Marinković, 2015, reproduced with permission).

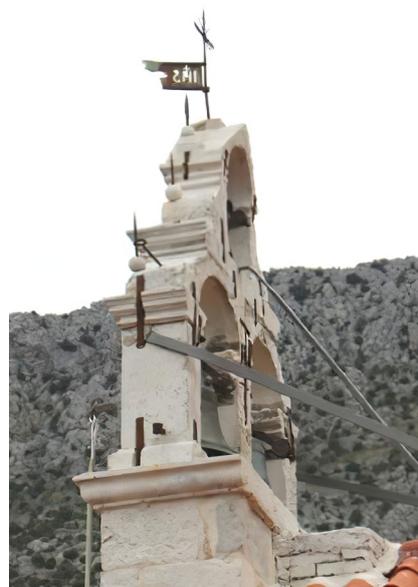
According to the markings engraved in the capital above the central column, the baroque bell gable was built in 1789 (Tomasović, 2007). Initially, the bell gable was statically unstable, as indicated by the several iron joints and clamps that were used to fixate it (**Figure 22**). Although installed in good faith, the number of iron joints in the bell gable seriously jeopardized the integrity of the monument so they needed to be removed and the entire bell tower dismantled. Following the removal of the iron members, an internal stainless-steel structure was constructed to secure the structural integrity of the bell gable. It is detachable and invisible to preserve the visual appearance of the monument. The reinforcement consists of 30 mm diameter pipes, which are anchored in the gable and extend vertically through the columns to the beam above the arches of the bell gable (**Figure 23**). In order to define verticals and drilling points, the bell gable was assembled in the workshop. The verticals were precisely defined with a laser. After the preparations in the workshop, the bell tower was transported to site in pieces. This was followed by the anchoring of the gable, using a 30 mm crown

Figure 22. A detail of the initial condition of the bell gable with several poorly placed iron tie-beams (photo by Siniša Bizjak, 2016).

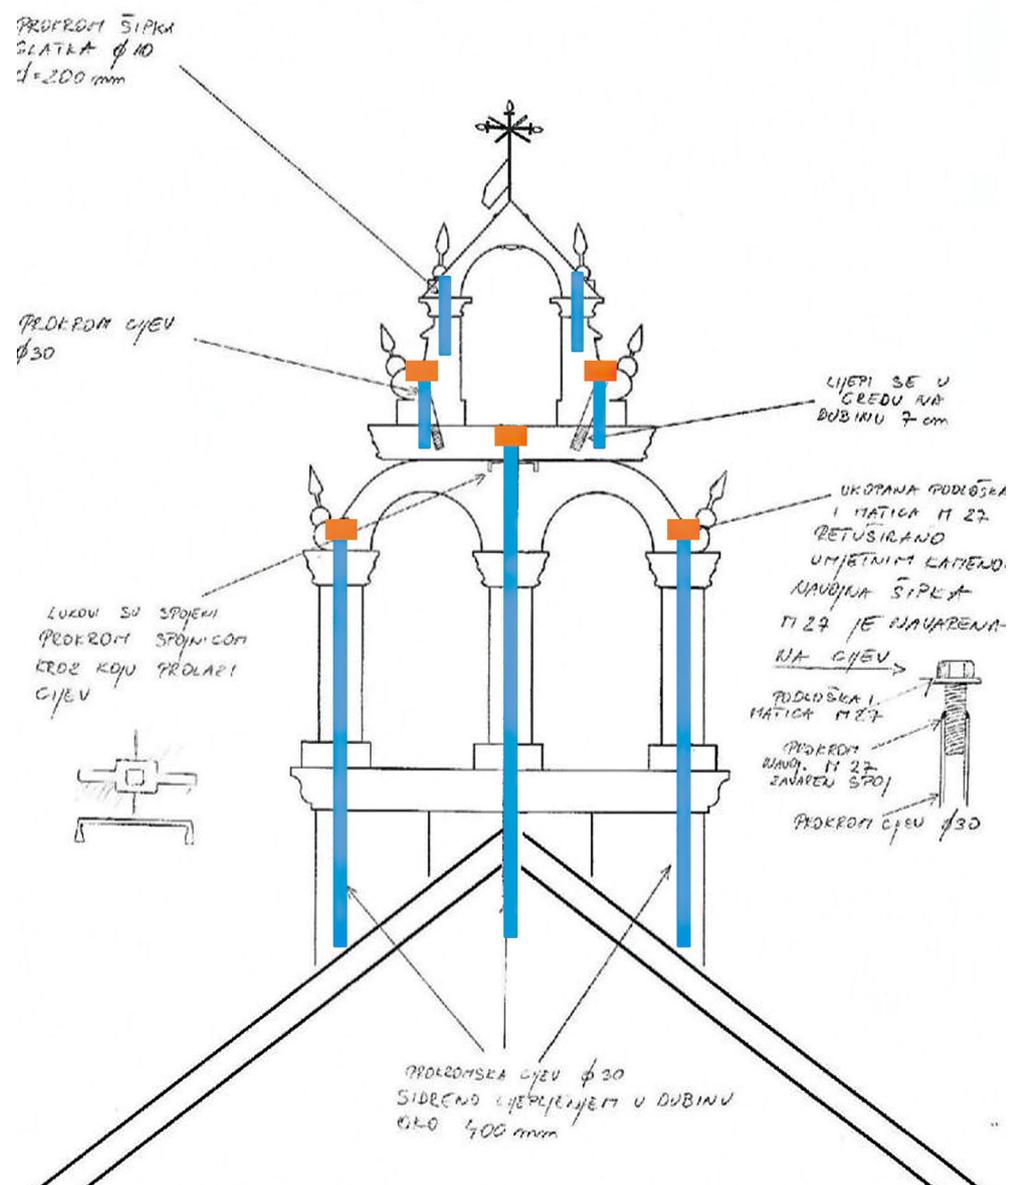
Figure 23. A schematic of a reversible steel structure embedded in the bell gable of the Church of St. George the Martyr. The direction of stainless-steel bars is shown in blue and tightening nuts in brown (drawing by Siniša Bizjak, 2016).

drill bit at the depth of 40 cm. Pipes were glued to the anchor holes and the structural elements of the bell tower were threaded onto them (Figure 24). Lime mortar was applied between the stone pieces to cushion the contact.

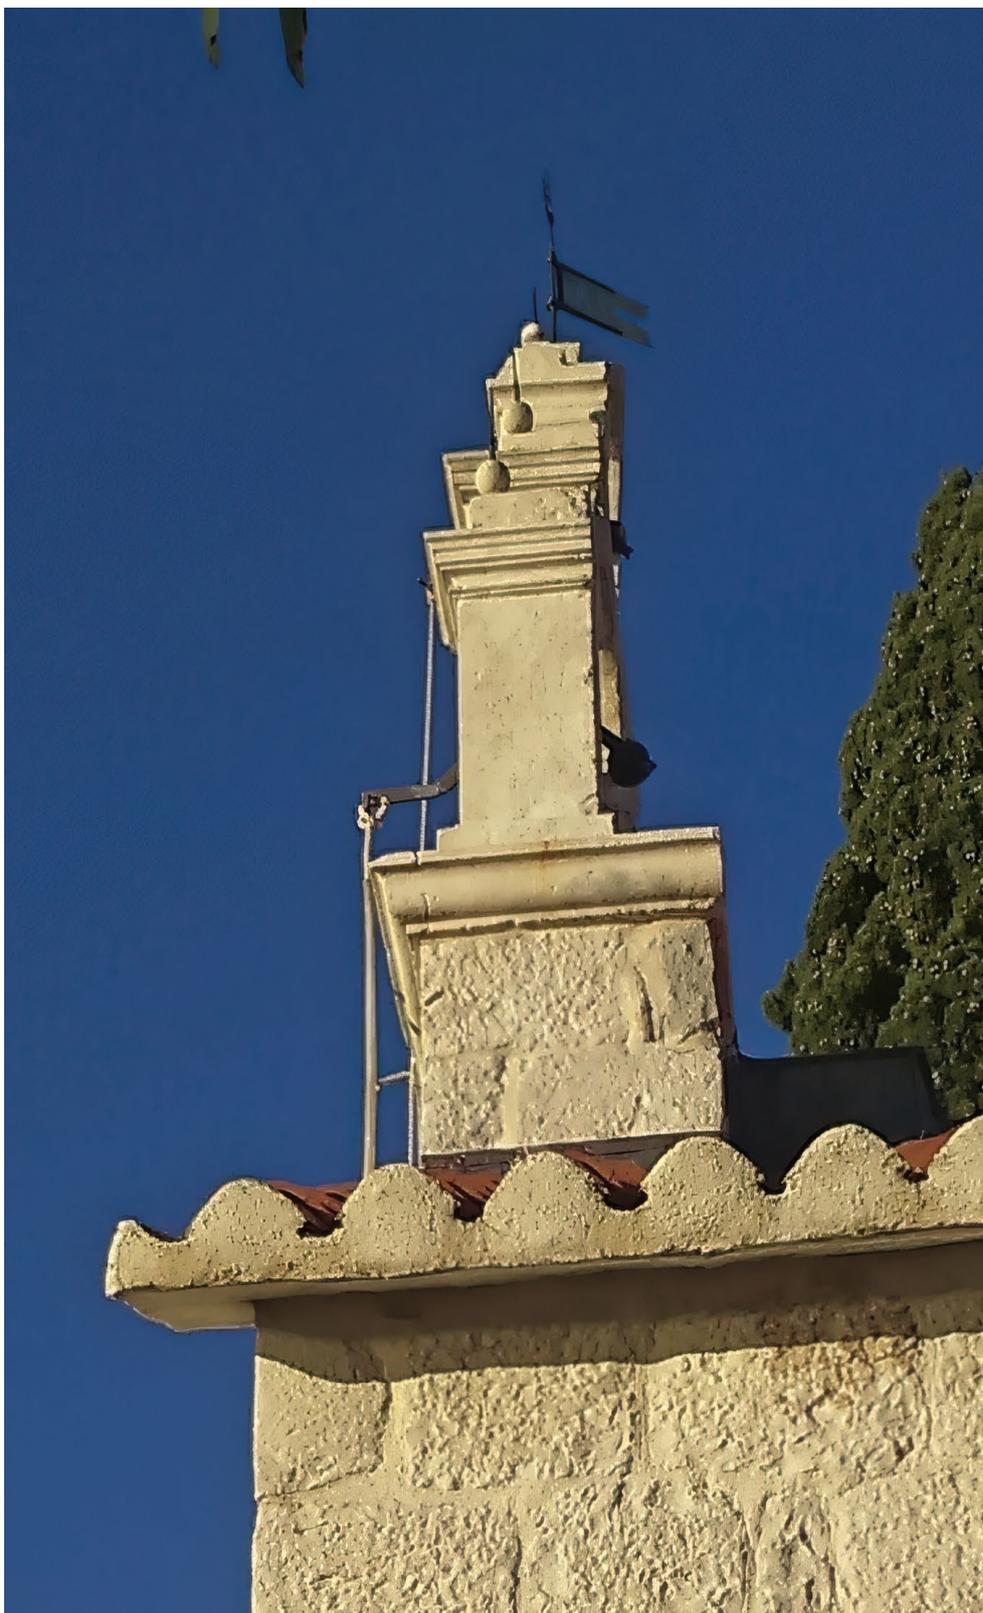
Figure 24. Church of St. George the Martyr in Drvenik, the same detail of the bell gable after the installation of stonework with no visible stainless-steel elements (photo by Siniša Bizjak, 2016).
