## ABSTRACT

On observation of deterioration of  $\tan\delta$  value to 1.08 %, i.e., surpassing the limiting value of 0.7 % as defined in IEC60137 for the 420 kV OIP bushing for a 315 MVA, 400 / 220 / 33 kV transformer located at substation Katni (India), a decision was made to replace the bushing. The replacement was risky, and it was a threat of causing the catastrophic failure for the transformer itself and the colossal loss to the neighbouring equipment and structures.

# Retrofitting of a 420 kV draw-lead type bushing with a draw-rod type - Part I

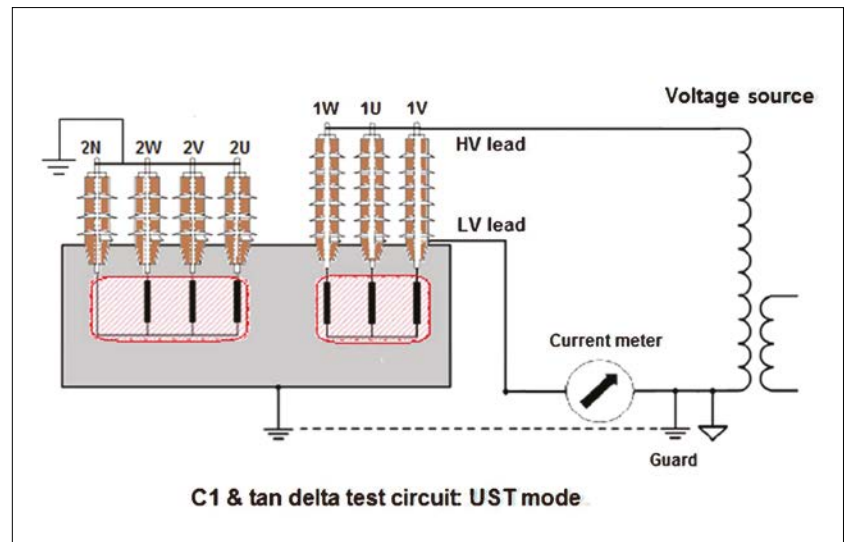
a) The value of  $\tan \delta$  is measured offline with 10 kV, utilising UST mode (ungrounded specimen test mode) (Fig. 7). The limiting value of  $\tan \delta$  for new OIP bushings is 0.007 or 0.7 % as per IEC-60137 [1].

Figure 7. Offline testing arrangement / schematic diagram for  $\tan \delta$  measurement of power transformer bushing in UST mode (ungrounded specimen test mode)

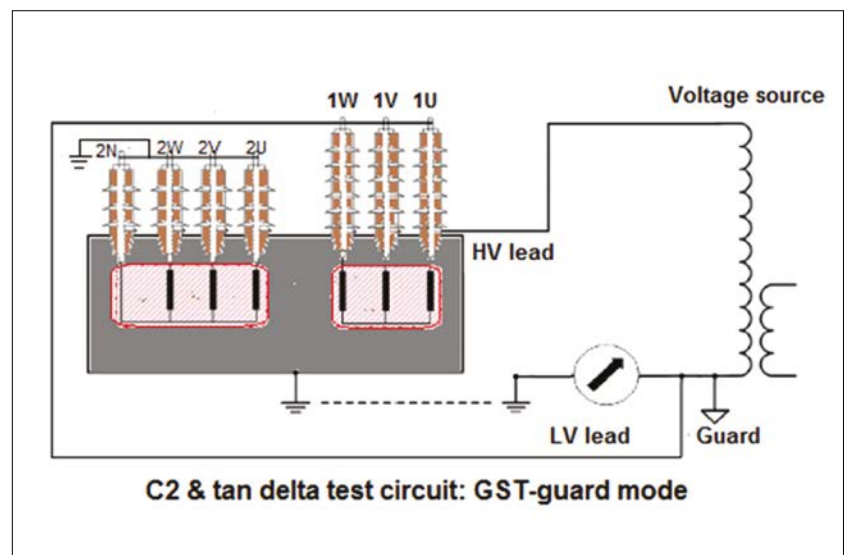
Figure 8. Circuit showing test kit connection for measurement of C2 and  $\tan \delta$

Guarded LV lead should be connected to the central conductor, and HV lead should be connected to the test tap. However, the test voltage should not exceed 1 kV. The connection circuit diagram is shown in Fig. 8.

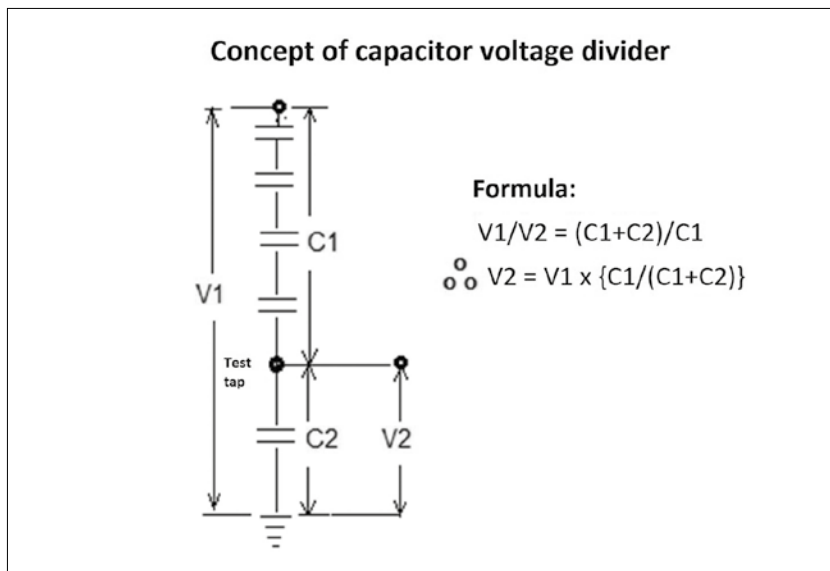
In a capacitor voltage divider, if capacitors are in series, say C1 and C2, and the tapping point is defined between C1 and C2 and if a voltage is applied across the whole series capacitor, then a voltage shall develop at the tapping point between the capacitors with respect to the common point, which is known as open secondary voltage. With reference to Fig. 10, a voltage of V1 is applied between terminal A and the Earth E, which gives rise to a secondary voltage designated as V2. Such capacitor voltage divider is used in the CVTs (capacitor voltage transformers) which are used in the CVTs lieu of PTs (potential transformers).

Figure 10. Concept of a capacitor voltage divider

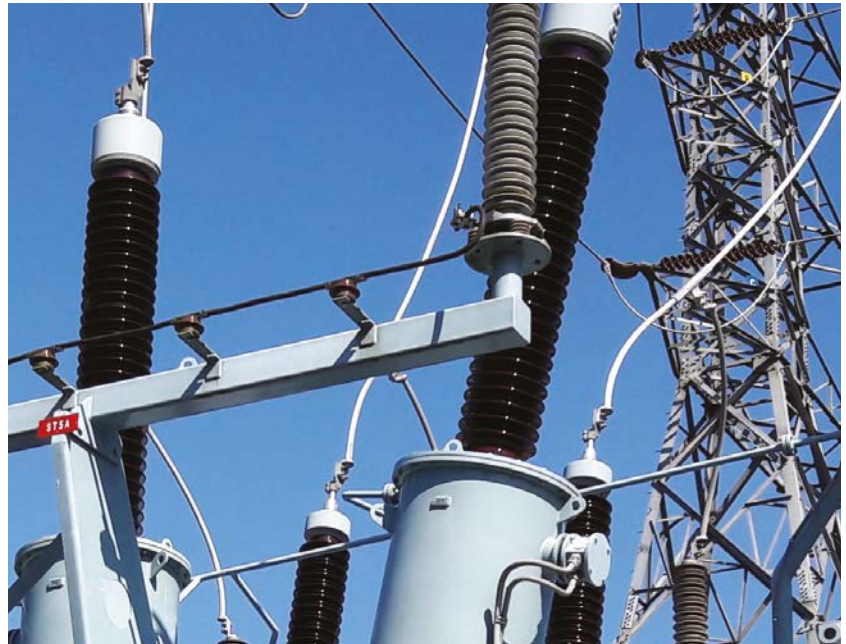
Figure 12. Components of OIP bushing

The OIP bushing is designed with multiple layers of grading condensers wound concentrically over the central tube of the bushing, using alternate layers of aluminium foil and kraft paper
