Pollution with Cr⁶⁺ of Groundwater and Surface Water from the Industrial Dump Jugohrom - Jegunovce – the Republic of North Macedonia

Rudarsko-geološko-naftni zbornik
(The Mining-Geology-Petroleum Engineering Bulletin)
UDC: 622.8
DOI: 10.17794/rgn.2021.5.11

Preliminary communication

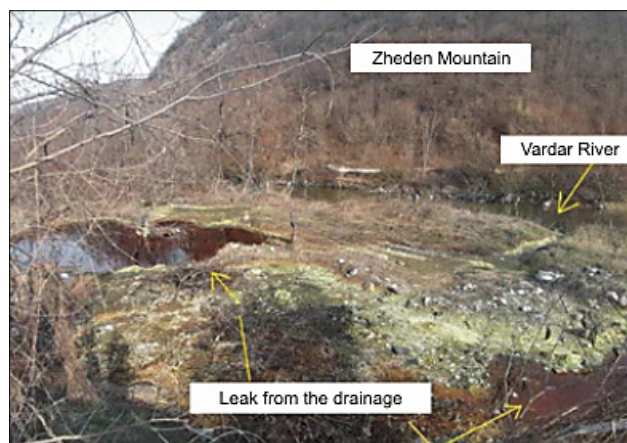
Figure 1: Drainage discharge, 2019

The enormously high concentration of Cr^{6+} (725 mg/l) 72500 times higher in relation to the allowed are determined in the water sample **no. 16** which is taken as spillway after from the drainage of contaminated waters from the dump (see **Figure 1**).

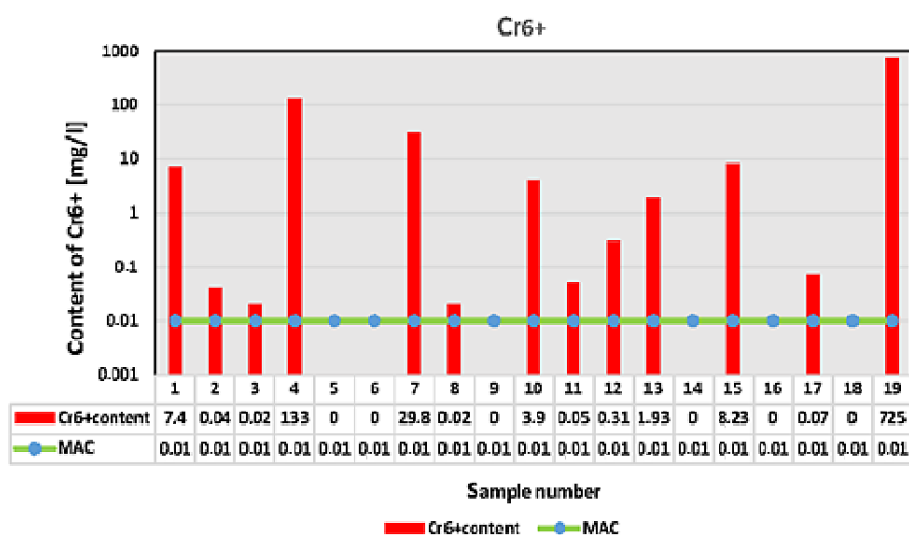
Figure 7: Graphic review of Cr⁶⁺ contents from taken water samples, 2019. MAC limit for Cr⁶⁺ is also shown

The contents of Cr⁶⁺ are shown graphically in **Figure 7**, and their comparison with MAC of Cr⁶⁺ (0.01mg/l) according to the Macedonian standard for drinking water. From the diagram it can be seen that increased concentration of Cr⁶⁺ are determined within a large number of samples in comparison to the MAC.
