REZULTATI ARHEOLOŠKOG NADZORA NAD GRAĐEVINSKIM RADOVIMA NA PODRUČJU LOKALITETA SAN LORENZO - ŠIŠAN, OPĆINA LIŽNJAN, I NALAZ RIMSKE RURALNE ARHITEKTURE

ARCHAEOLOGICAL SUPERVISION OF CONSTRUCTION WORKS AT THE SAN LORENZO SITE IN ŠIŠAN IN THE LIŽNJAN MUNICIPALITY AND THE FIND OF A ROMAN PERIOD RURAL STRUCTURE

Stručni članak

Professional paper

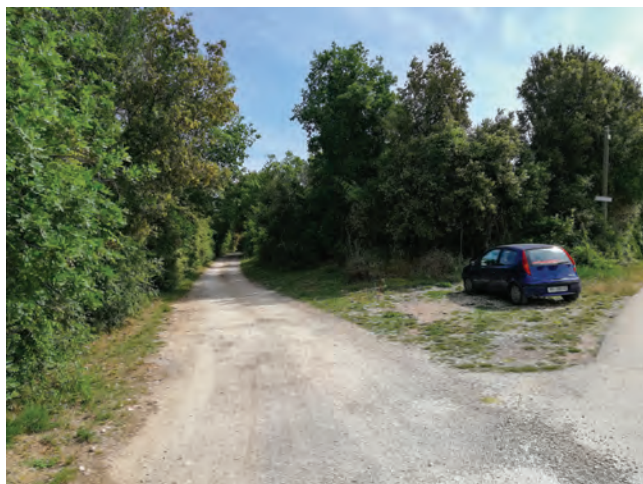
Sl. 1 Pogled na mjesto prije izvedbe građevinskih radova (fotografija: R. Zlatunić).

Fig. 1 View of the site prior to construction work (photo by: R. Zlatunić).

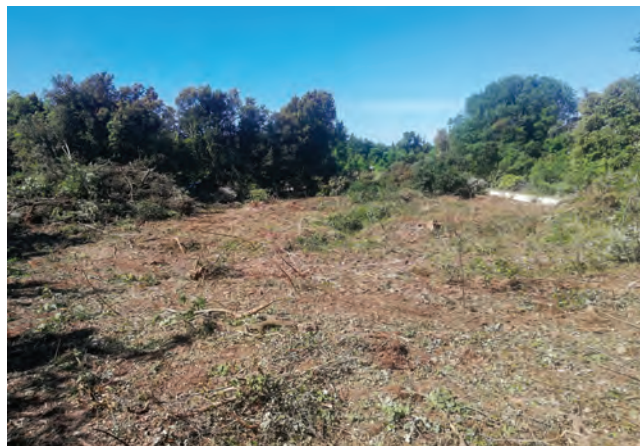
Sl. 2 Pogled na mjesto nakon skidanja i čišćenja zelene površine. Vidljiva je trasa rova JNA (fotografija: R. Zlatunić).

Fig. 2 View of the site following the clearing of vegetation. The line of the Yugoslav People's Army firing trench is visible (photo by: R. Zlatunić).

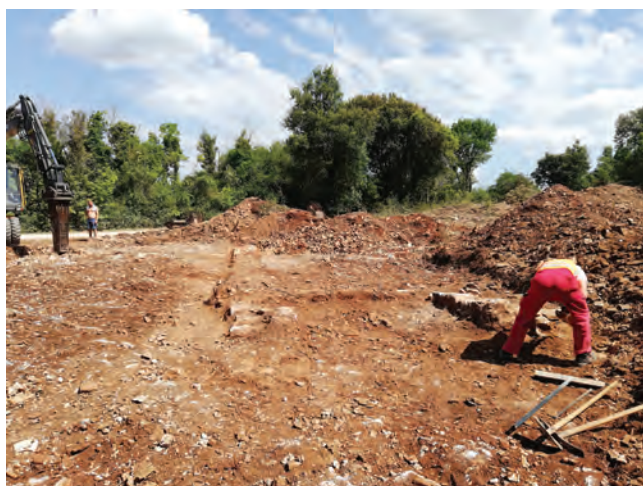
Sl. 3 Ručni iskop te čišćenje vidljivih ostataka zidova, koji predstavljaju temeljnu osnovu rimskog i kasnoantičkog ruralnog objekta ili vile (fotografija: R. Zlatunić).

Fig. 3 Manual excavation and the cleaning of the visible remains of walls that are the foundation structures of the Roman and late antique period rural building or villa (photo by: R. Zlatunić).

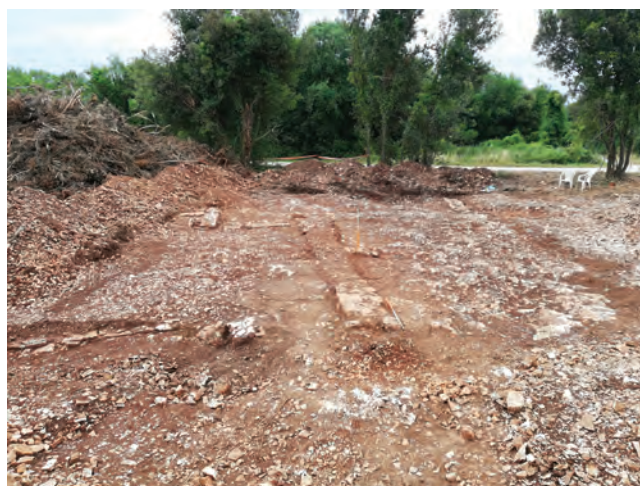
Sl. 4 Pogled na ostatke temeljnih zidova, prostorija rimskog i kasnoantičkog ruralnog objekta ili vile, nakon ručnog iskopa i čišćenja (fotografija: R. Zlatunić).

Fig. 4 View of the remains of the foundation walls and rooms of the Roman and late antique period rural building or villa following manual excavation and cleaning (photo by: R. Zlatunić).

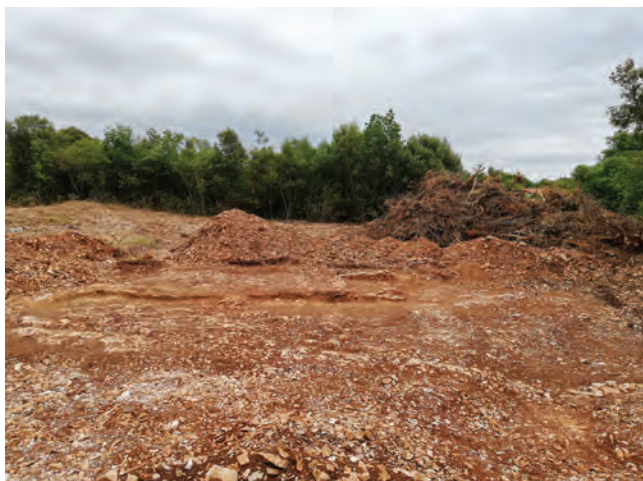
Sl. 5 Pogled na ostatke temeljnih zidova, prostorija i ulaza u rimski i kasnoantički ruralni objekt ili vilu, nakon ručnog iskopa i čišćenja (fotografija: R. Zlatunić).

Fig. 5 View of the remains of the foundation walls, rooms, and entrances to the Roman and late antique period rural building or villa after manual excavation and cleaning (photo by: R. Zlatunić).

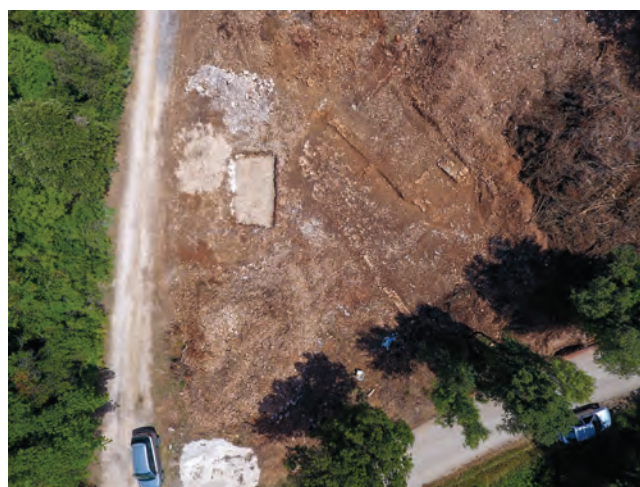
Sl. 6 Zračni snimak dronom na iskopanu arhitekturu rimskog i kasnoantičkog ruralnog objekta ili vile (fotografija: I. Juričić).

Fig. 6 Drone assisted aerial image of the excavated Roman and late antique period rural building or villa (photo by: I. Juričić).

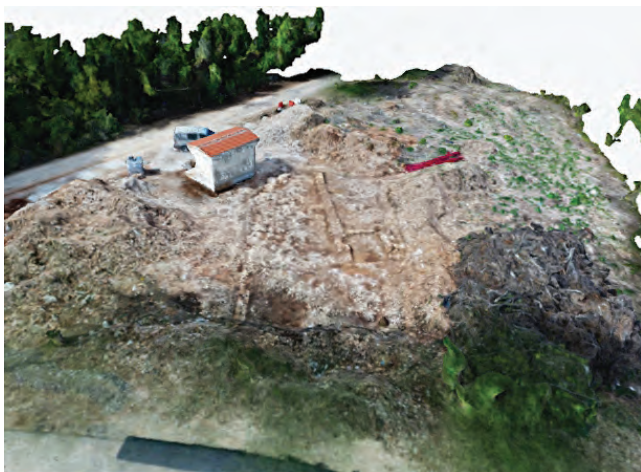
Sl. 7 Zračni 3d snimak otkrivene arhitekture rimskog i kasnoantičkog ruralnog objekta - vile (Geoline d.o.o.).

Fig. 7 Aerial 3D image of the uncovered Roman and late antique period rural building or villa (Geoline d.o.o.).

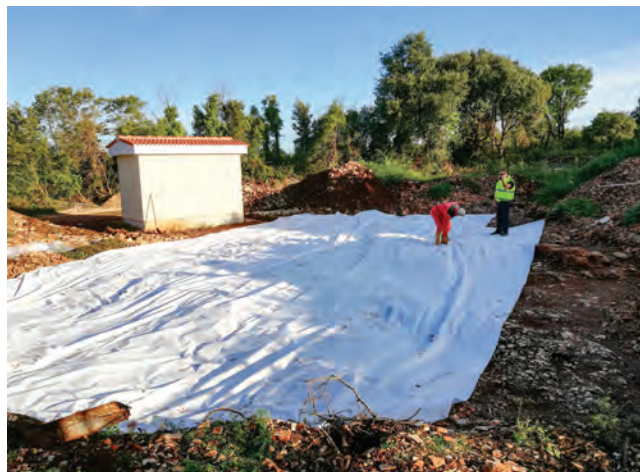
Sl. 8 Prekrivanje terena i arheološkog objekta geotekstilom (fotografija: R. Zlatunić).

Fig. 8 Covering the terrain and archaeological structure with geotextile (photo by: R. Zlatunić).

structure (Fig. 17) the conditions were achieved for the protection of the structure. The first step involved covering the foundations of the masonry structure, and then the entire archaeological zone, with geotextile (Fig. 18). The next step involved backfilling the site with fine to medium graded gravel to a thickness of about 0.20 m, followed by an additional backfill layer of rubble stone and earth to a thickness of about 0.50 m.

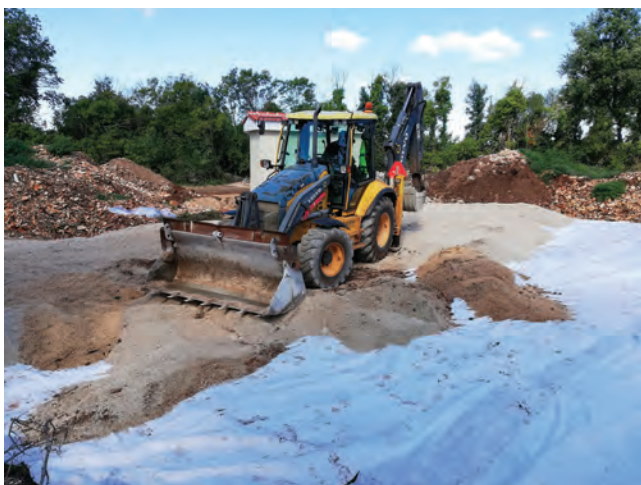
Sl. 9 Strojno zatrpavanje geotekstila zaštitnim slojem građevinskog materijala pijeskom i rizlom (fotografija: R. Zlatunić).

Fig. 9 Machine backfilling with sand and fine to medium graded gravel over the protective layer of geotextile (photo by: R. Zlatunić).

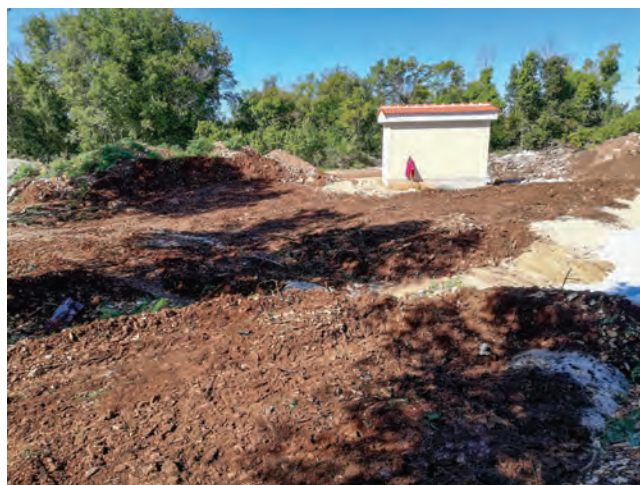
Sl. 10 Strojno nasipavanje dodatnim zaštitnim slojem zemlje (fotografija: R. Zlatunić).

Fig. 10 Machine backfilling with an additional protective layer of soil (photo by: R. Zlatunić).

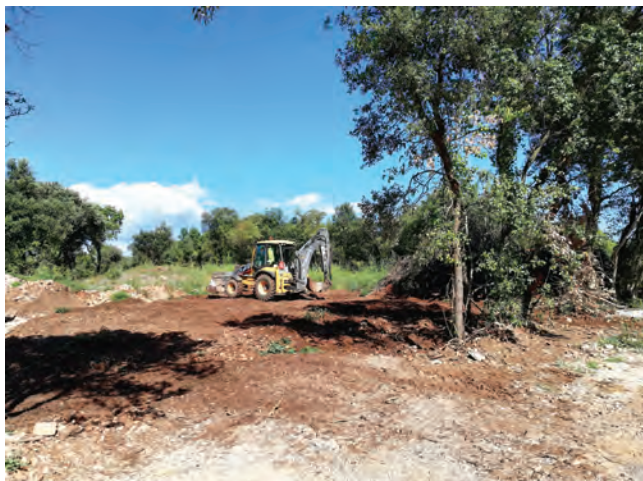
Sl. 11 Poravnavanje i nabijanje zemljom prekrivenog arheološkog lokaliteta (fotografija: R. Zlatunić).

Fig. 11 Flattening and compacting the soil covering the archaeological site (photo by: R. Zlatunić).

Additional backfilling with mixed earth and rubble was done at the remaining perimetral areas of the construction site on plot 60 to a thickness of about 0.50 m. The entire area was then flattened and compacted (Figs. 9-11). The archaeological supervision and site protection was concluded with the performance of these works.

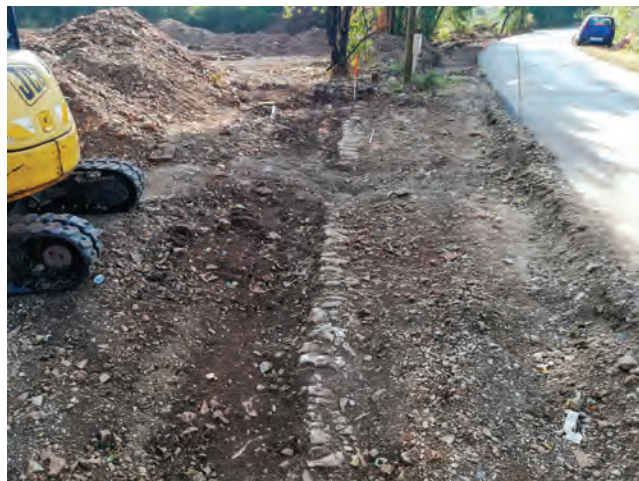
Sl. 12 Pogled na rubnike austrougarskog puta tijekom strojnog iskopavanja na području ceste prema Svetici ili Monte Madonni, koja se nalazi u blizini otkrivenog rimskog i kasnoantičkog ruralnog objekta (fotografija: R. Zlatunić).

Fig. 12 View of the kerbs of the Austro-Hungarian period road during machine excavation in the area of the road towards Svetica (Monte Madonna) near the uncovered Roman and late antique period rural structure (photo by: R. Zlatunić).

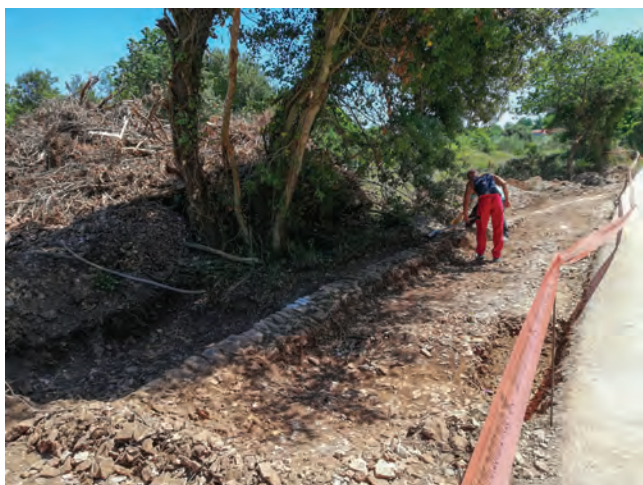
Sl. 13 Rubnici austrougarskog nabijenog puta nakon grubog ručnog čišćenja (fotografija: R. Zlatunić).

Fig. 13 The kerbs of the Austro-Hungarian period compacted gravel road following preliminary manual cleaning (photo by: R. Zlatunić).

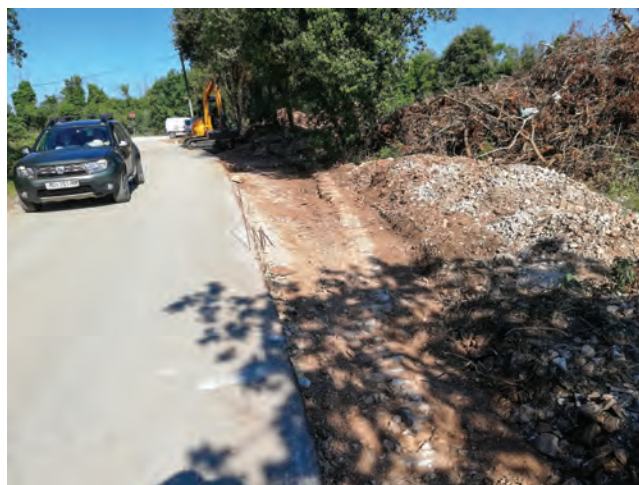
Sl. 14 Pogled na veći dio iskopane trase, gdje je otkriven austrougarski put s očuvanim rubnicima od finog lomljenog kamena (fotografija: R. Zlatunić).

Fig. 14 View of most of the excavated route where the Austro-Hungarian period road was found with preserved dressed stone kerbs (photo by: R. Zlatunić).

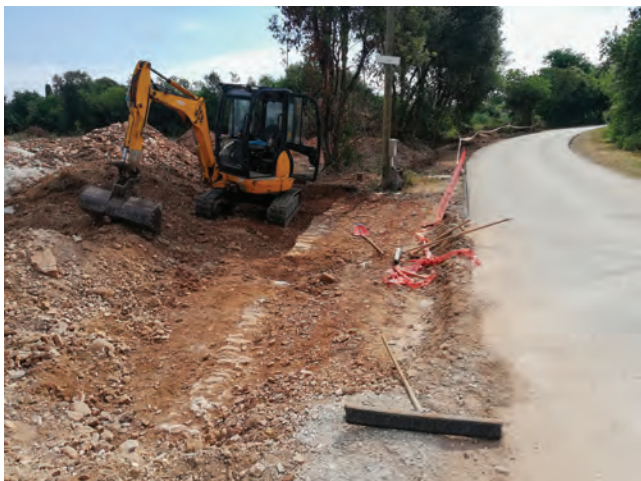
Sl. 15 Pogled na iskopanu trasu, gdje je registriran austrougarski nabijeni put s fino oblikovanim rubnim dijelovima od lomljenog kamena (fotografija: R. Zlatunić).

Fig. 15 View of the excavated route where the Austro-Hungarian period compacted gravel road was found with dressed stone kerbs (photo by: R. Zlatunić).

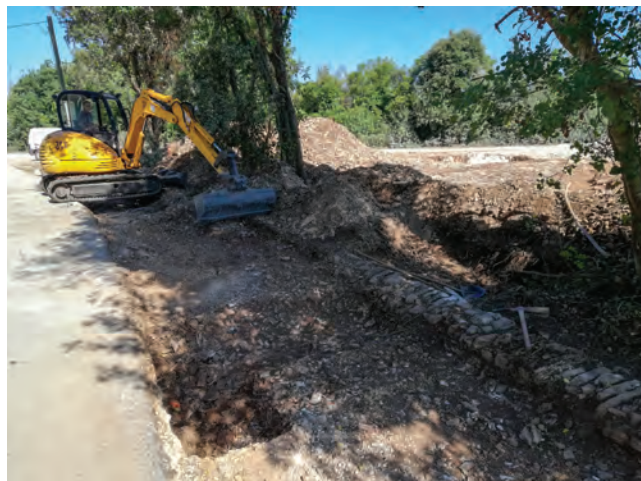
Sl. 16 Pogled na mjesto gdje austrougarski nabijeni put presjeca rimski ili kasnoantički temeljni zid br. 1 (fotografija: R. Zlatunić).

Fig. 16 View of the place where the Austro-Hungarian period compacted gravel road cuts across the Roman or late antique period foundation wall 1 (photo by: R. Zlatunić).

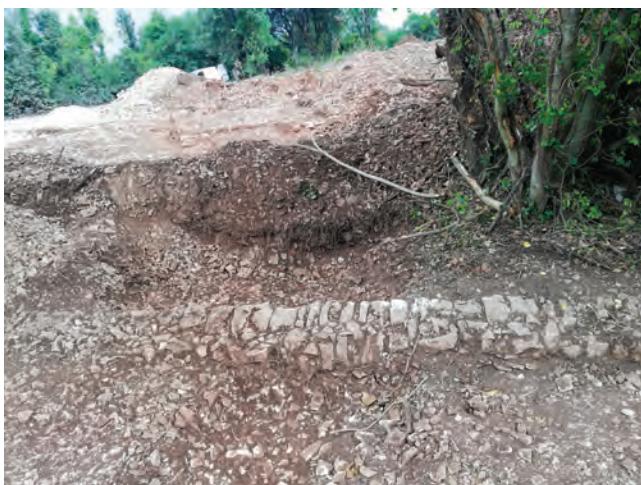
Sl. 17 Pogled iz drugog kuta na mjesto gdje austrougarski nabijeni put presjeca rimski ili kasnoantički temeljni zid br. 1 (fotografija: R. Zlatunić).

Fig. 17 View from a different angle of the place where the Austro-Hungarian period compacted gravel road cuts across the Roman or late antique period foundation wall 1 (photo by: R. Zlatunić).

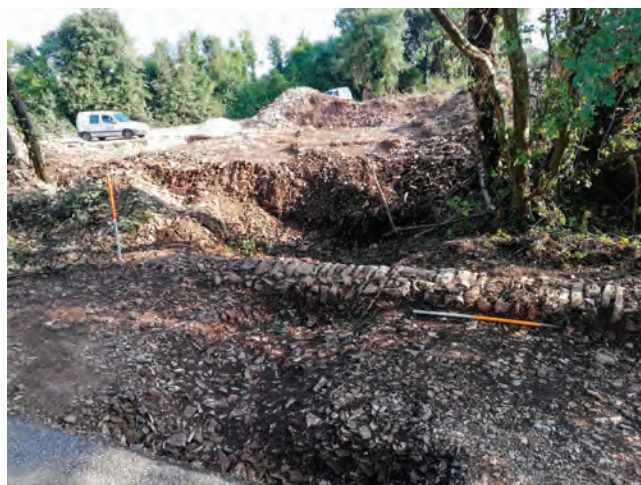
Sl. 18 Pogled na isto mjesto (fotografija: R. Zlatunić).

Fig. 18 Another view of the same detail (photo by: R. Zlatunić).

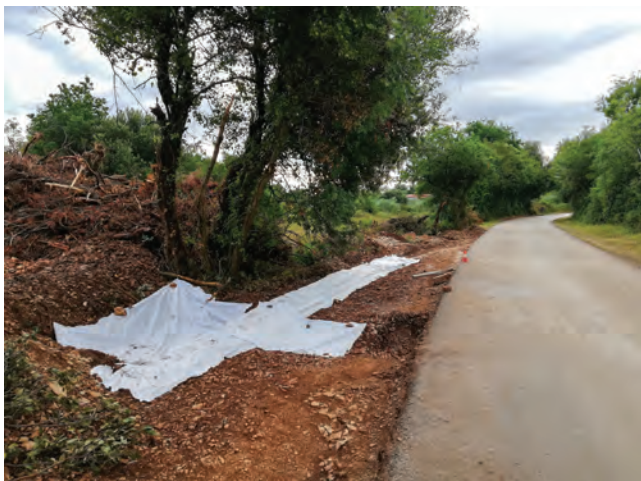
Sl. 19 Prekrivanje geotekstilom područje otkrivenog nabijenog austrougarskog puta s rubnjacima od fino lomljenog kamena (fotografija: R. Zlatunić).

Fig. 19 Geotextile is placed over the area where the Austro-Hungarian period compacted gravel road with dressed stone kerbs was uncovered (photo by: R. Zlatunić).

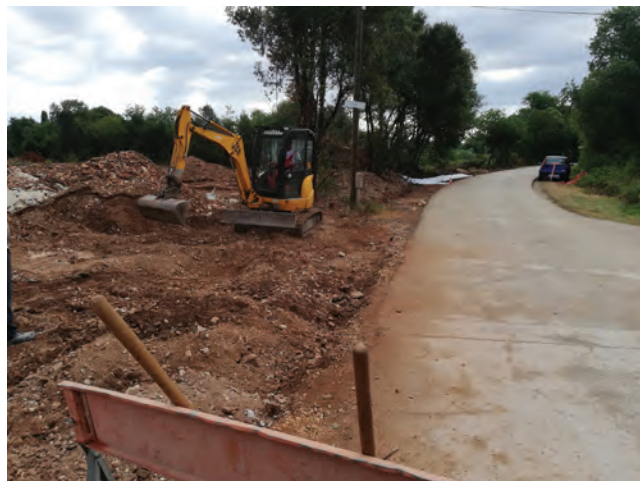
Sl. 20 Zatrpavanje austrougarskog nabijenog puta prekrivenog geotekstilom zaštitnim slojem građevinskog materijala (fotografija: R. Zlatunić).

Fig. 20 Machine backfilling of a protective layer over the geotextile covering on the Austro-Hungarian period compacted gravel road (photo by: R. Zlatunić).

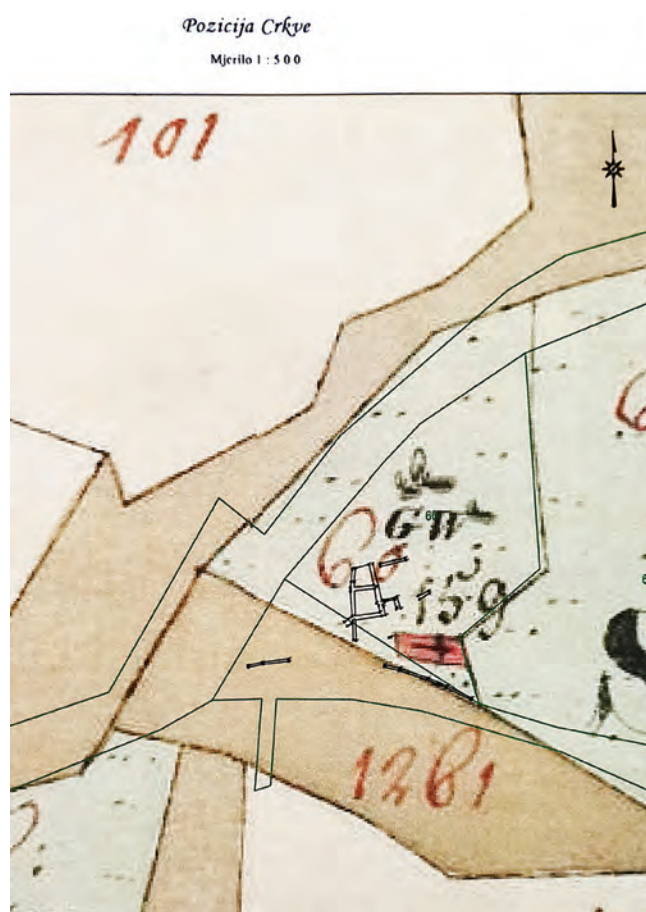
Plan 4 Geodetska skica položaja crkve San Lorenzo u odnosu na otkriveni dio rimskog ruralnog objekta na k. č. 60. Podloga za izradu plana pozicije crkve stara je katastarska karta iz 1820. godine (crtež: Domagoj Čiganović, geod. Geoline d.o.o.).

Plan 4 Geodetic plan indicating the position of the church at the San Lorenzo site as it relates to the uncovered part of the Roman period rural structure at cadastral plot 60. The position of the church is indicated using the 1820 cadastral map as the basis (drawing by: Domagoj Čiganović, Geoline d.o.o.).
