Simple ageless methods for field testing power transformers of no-load condition at the low induced voltage

(Analytical review with the aid of transformer field service technicians) - Part II

3. IEEE practice (excitation current test)

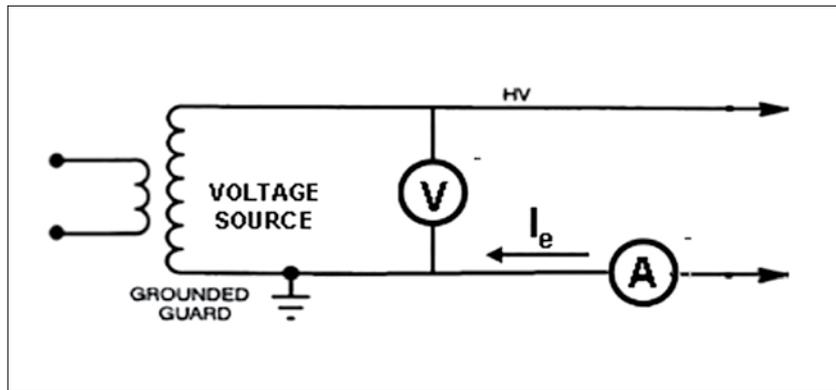
Figure 6. Basic measurement excitation circuit [1, 17]

The basic measurement scheme is shown in Fig. 6.

The excitation current test consists of a simple open-circuit measurement of the current magnitude and loss, typically on the HV side of the transformer, with the terminals of the other windings are left to float (with the exception of a grounded neutral). The excitation current is measured at rated frequency and usually at voltages up to 10 kV, which is more than an order of magnitude more than in the

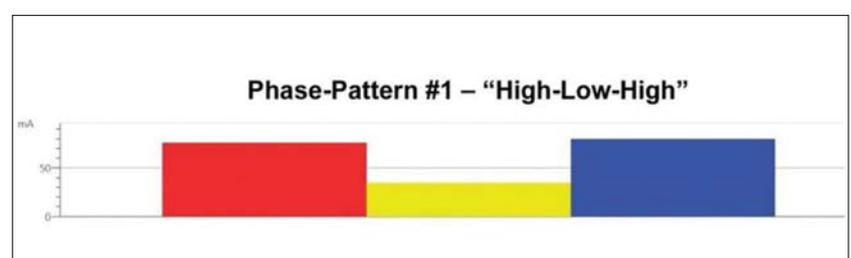
Figure 8. Example of an excitation current phase pattern

According to the standard [1], the usual approach to the analysis of the excitation current test results is to compare the results with previous tests or with similar single-phase transformers, or with phases of a given three-phase transformer. For the great majority of three-phase transformers, the pattern is two similar high readings on the outer phases and one lower reading on the center phase (Fig. 8).

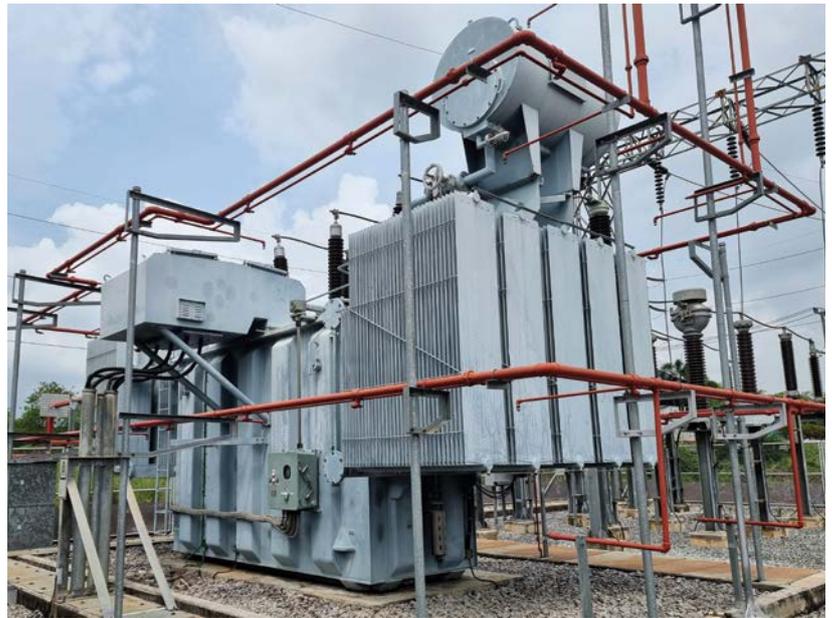
Figure 7. Excitation current test Doble for delta connected winding transformer (scan from [18])

Figure 5.20 Measurement of I_e in a Delta-Connected Transformer Winding (Routine Method)

Place the high voltage cable on the bushing in the Energize column, and place a low voltage lead on each of the other two bushings. One will be measured, one grounded. If using DTA, follow the prompts. For example, if you are testing the B phase (generally denoted as H1-H2) with the high voltage cable on H1 and the red lead on H2, blue on H3, you want to measure red, ground blue. You therefore choose the UST-R circuit from the choice list. In DTA, the three phases (H1-H2, H2-H3, H3-H1) are tested in the same row, across the screen. The order of the connections labels dictates the order in which the tests will be found in the three mA columns.

example, Fig. 7 illustrates the test procedure for one of these options. The reader can find other options in those available in the public domain [17].

Reference [17] details the measurement circuit and test procedure for: single-phase transformer, single-phase autotransformer, three-phase wye connected winding, three-phase wye connected winding with no accessible neutral, delta connected winding (Fig.7), wye connected winding with the reverse method, delta connected winding with the reverse method, delta winding with the alternate method. As an

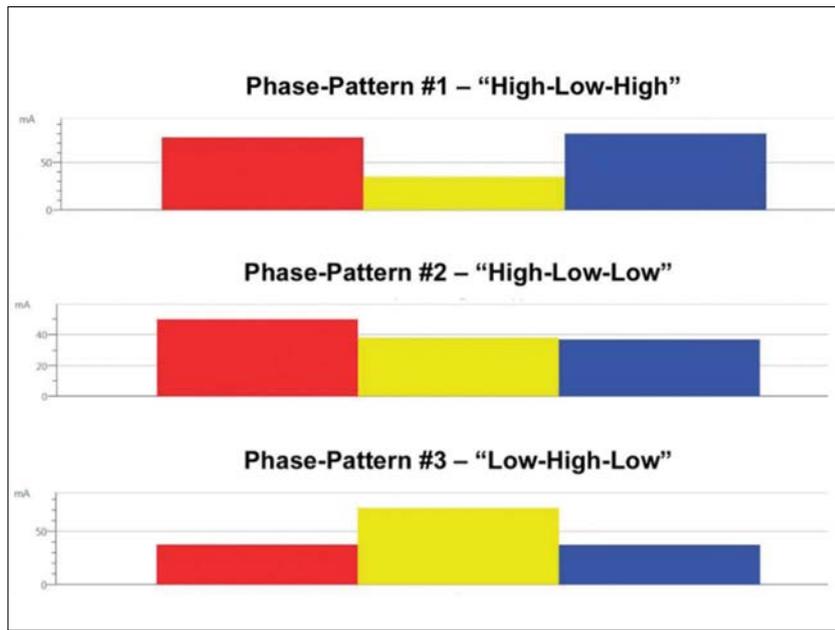
Figure 1. Example of an excitation current phase pattern (figure from OMICRON, explanations in the text)

common. This pattern is also characteristic of a transformer with a five-limb core-form (or shell) with a delta-connected secondary winding (Fig. 1). “High-Low-Low” phase pattern #2 is expected for transformers with a 3-limb core-form design and wye (without accessible neutral) HV winding and with. “Low-High-Low” phase pattern #3 is expected in the following cases: when the power transformer is damaged; when the third terminal on a delta-connect-

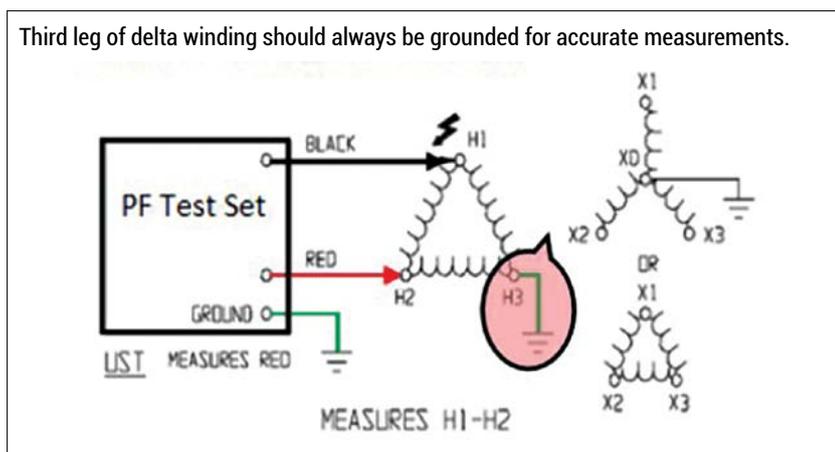
Wdg H1-H2	With third leg grounded	Without third leg grounded
Voltage (kV)	Excitation current (mA)	Excitation current (mA)
6	82.35	114.46
7	94.49	132.06

Pending the inductance and resistance of each winding, if third leg is not grounded, the results would be approximately 30-50 % higher than true readings.

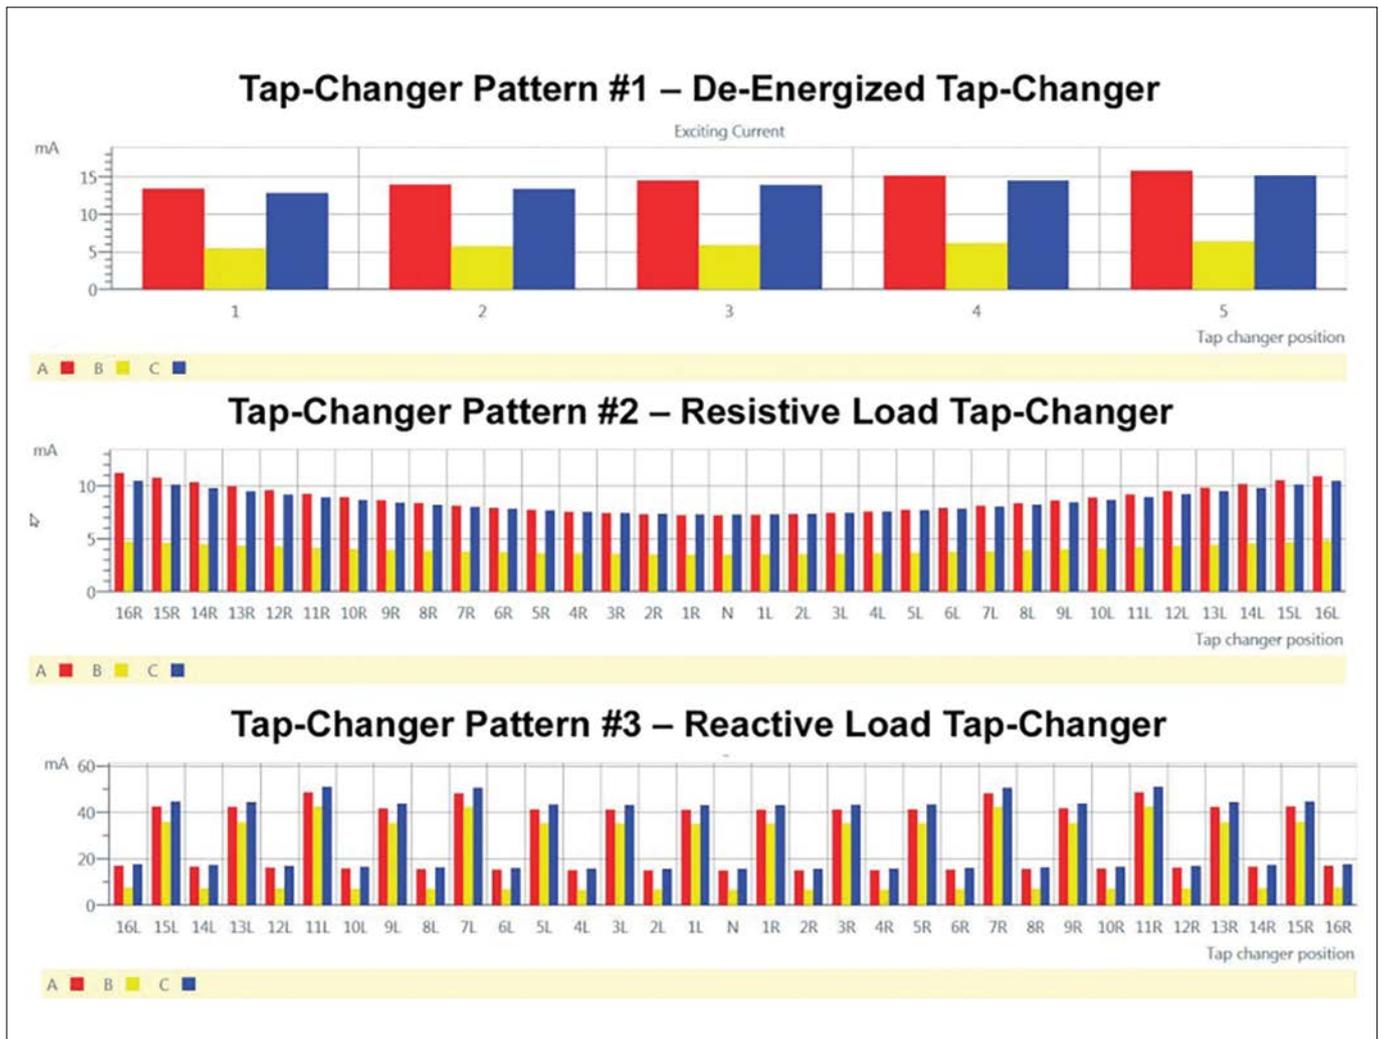
Figure 3. Example of the three tap-changer patterns (figure from OMICRON).

1. De-energized tap-changer (DETC) pattern: the measured exciting current typically increases or decreases linearly versus tap-position.
2. Resistive load tap-changer pattern: the measured exciting current typically increases or decreases linearly versus tap-position.
3. Reactive load-tap changer pattern: the measured exciting current typically fluctuates versus tap-position due to the excitation of the preventative autotransformer. It is expected that the bridging tap-positions produce higher currents for all three phases relative to the non-bridging tap-positions.

Fig. 3 provides an example of these three tap-changer patterns.
