# 1 Hz dissipation factor - The new trend for insulation condition assessment

NB DFR tests spectrum provides valuable pieces of information that can be used for the diagnostics of high voltage equipment. A case study has been conducted for a 10 MVA, 69/13.09 kV Dyn1 two-winding transformer that is

tested in the field after OLTC repairs and before re-energization.

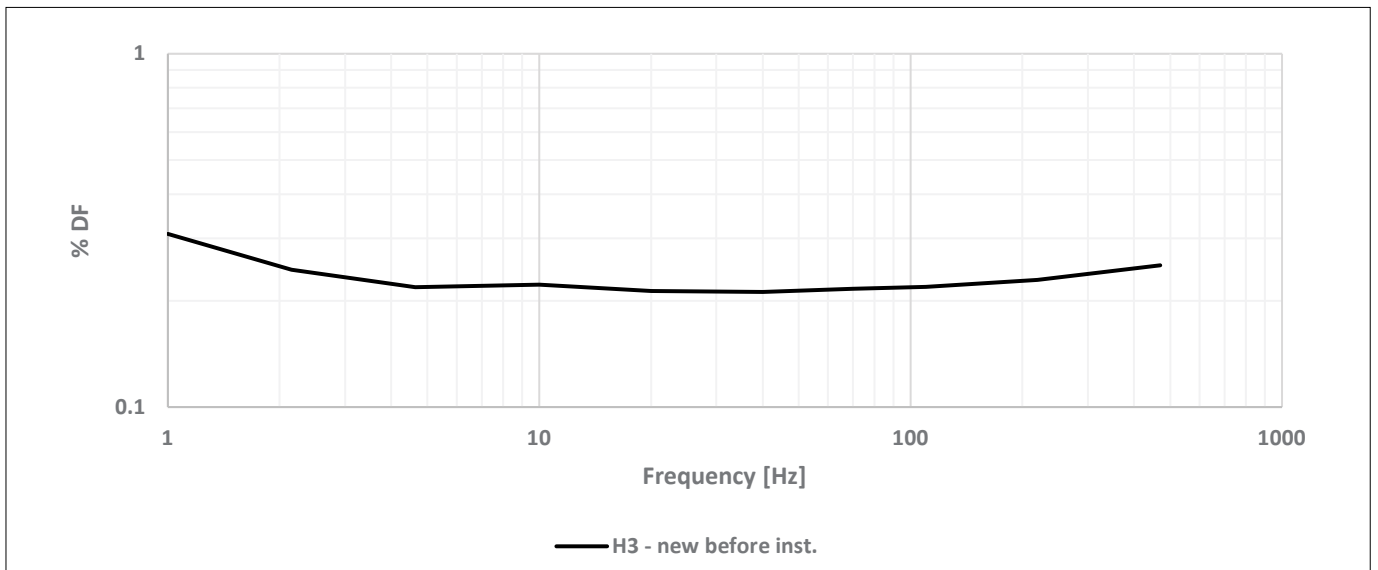
Figure 2. Pre-installation NB DFR test results for H3 replacement bushing

Before installing in the transformer, LF DF and NB DFR testing were performed on the H3 replacement bushing to confirm its integrity. LF DF and NB DFR test results indicated the bushing's good (G)

condition (Table 3) (Fig. 2). The response in the 1 to 505 Hz spectrum is quite a linear, showing no degradation of the insulation.
