Grada za arhitektonsku rekonstrukciju romaničko- gotičke katedrale sv. Tripuna u Kotoru

U radu je prikazana grada za novu arhitektonsku rekonstrukciju katedrale u Kotoru na temelju nove detaljne analize objavljenih materijala. Prvi su put objašnjene topografske i hidrološke promjene položaja katedrale, kao i štete nastale djelovanjem potresa, što je pak izazvalo naknadne preobrazbe crkve. Objavljena je različita kronologija postupka izgradnje na temelju nove analize poznatih grafičkih izvora. Novo tumačenje postojećih grafičkih izvora omogućilo je novu arhitektonsku rekonstrukciju crkve i njezinog položaja u regionalnoj arhitektonskoj skupini.

Evidence for the architectural Reconstruction of romano – gothic Cathedral of St Triphon in Kotor, Montenegro

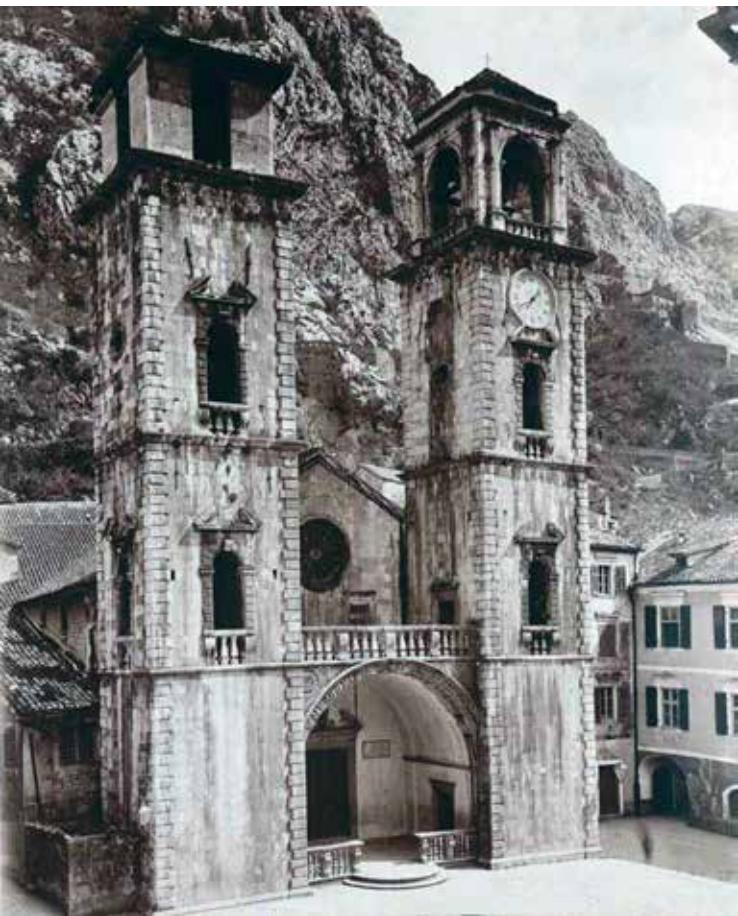
Sl. 1. Katedrala sv. Tripuna prije Hauserove restauracije (izvor: Zbirka S. O. Živkova)

Fig. 1 St Triphon Cathedral before the Hauser restoration (source: Collection of S. O. Živkov)

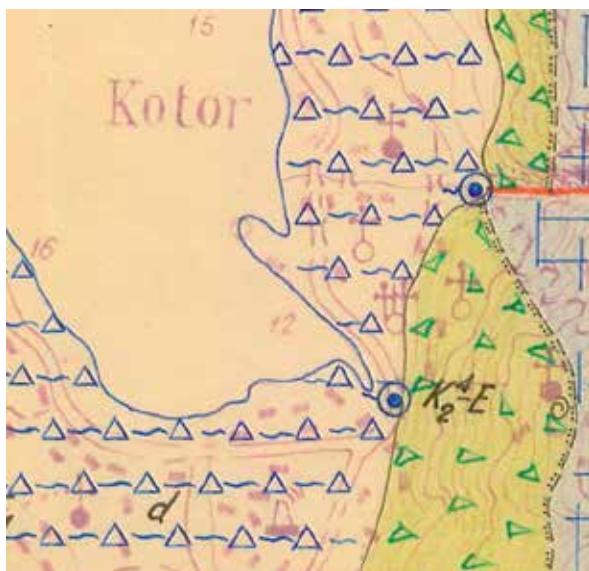
Sl. 2. Geološka mapa Kotora u mjerilu 1 : 25.000.
Aluvijalna ravnica (plavi trokuti) u kontaktu s
vapnencem (žuto) (izvor: Zbirka S. O. Živkova)
Fig. 2 Geological map of Kotor in scale 1 : 25.000.
*Alluvial plane (blue triangles) in contact with
limestone (yellow) (source: Collection of S. O. Živkov)*

sni i vodopropusnih slojeva duž jadranske obale široko je rasprostranjena slatka voda. Ovo je potvrđeno tijekom kartiranja geomehaničkih karakteristika lokacije i okolice, kada je otkriveno da prosječna razina podzemnih voda oscilira između 120 i 150 cm ispod površine terena (Milivojević 1933, str. 130–132; Grujić 1963, str. 10–11).

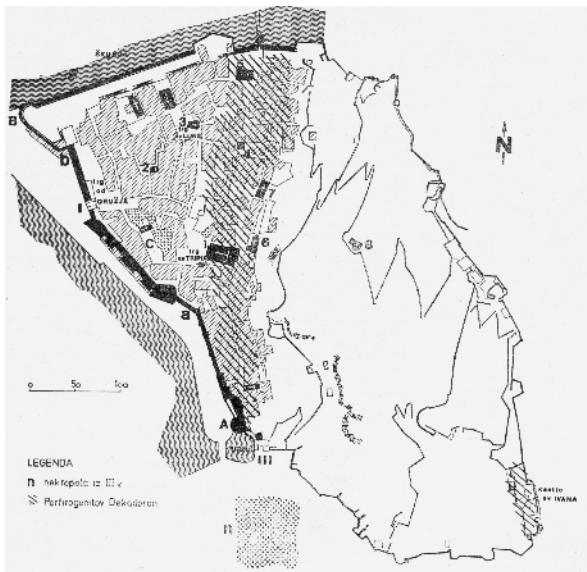
Sl. 4. Plan grada s naznačenim povišenim istočnim dijelom, sjedištem nekadašnjeg Dekadrona (izvor. Mijović 1975)

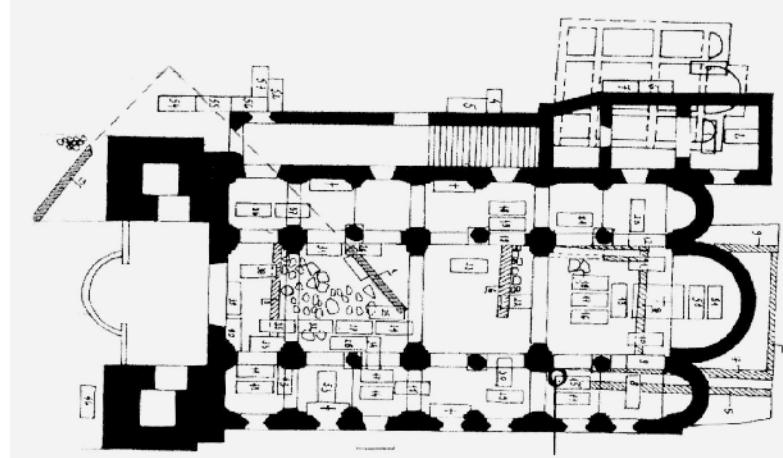
Sl. 5. Tlocrt iskopanih ostataka ispod katedrale sv. Tripuna (izvor: Križanac 1995)

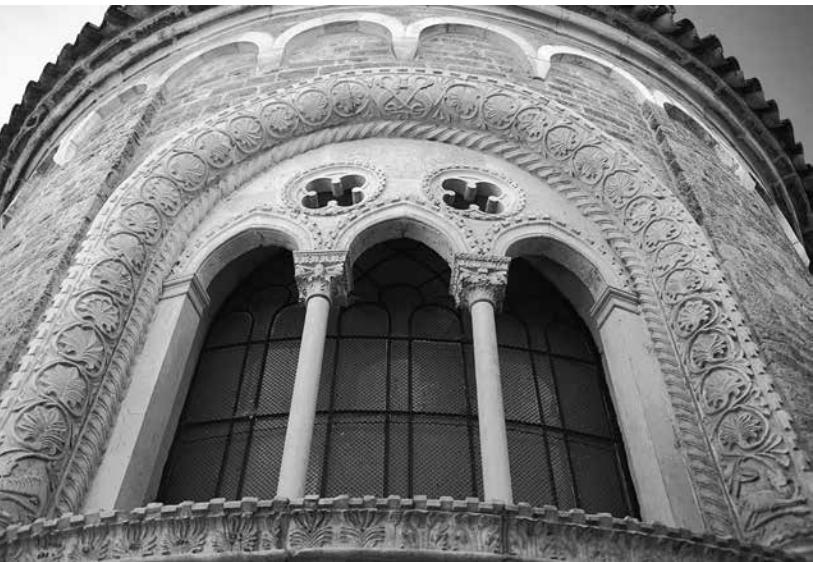
Sl. 6. Trifora na glavnoj apsidi katedrale
(izvor: zbirka I. Tomića)

Fig. 6 Trifora on the main apse of the Cathedral
(source: collection of I. Tomić)

Regarding the altar trifora it was earlier noticed that there is a discrepancy between the style character of its outer frame and the columns, arches and lunette.²² Although the window frame is clearly Romanesque, the columns capitols, and arches are similar in style with those from the superstructure of the central nave. This clearly indicates the possibility of the somewhat later replacement of the original components of the original altar window which was part of the altered project which also included the replacement of the original Romanesque small windows with the larger gothic ones. These interpolations of the windows could have been done either as a part of the second phase of church construction when it was decided that the windows over the lateral naves either should replace some earlier, or more probably, as a part of the rebuilding which became necessary after some kind of damage. It is well known that the complete east coast of Adriatic is seismically very active area, and various catastrophic earthquakes were documented during the last two millennia. Although the earthquake chronicle of Adriatic has significant gaps in the archival sources, the very strong earthquake in Durres (Drač) which destroyed that city in March 1273, is well documented.²³ If the aerial distance between Durres and Kotor is taken into account (135 km) it is obvious that Kotor was heavily damaged in this earthquake, and the nature and the extent of the damages on the Cathedral required the heavy rebuilding and alterations before the construction process could be resumed. All this, in turn, indicates that the building process of the cathedral lasted much longer after the dedication of the altars in 1166, and that this process was continued well into XIV century when the Cathedral was finally completed. The duration of the construction process was recently acknowledged and the sculptural decoration of some windows, as well as the superstructure of the main nave were attributed to the later part of the construction process.²⁴ As judged by the presence of gothic

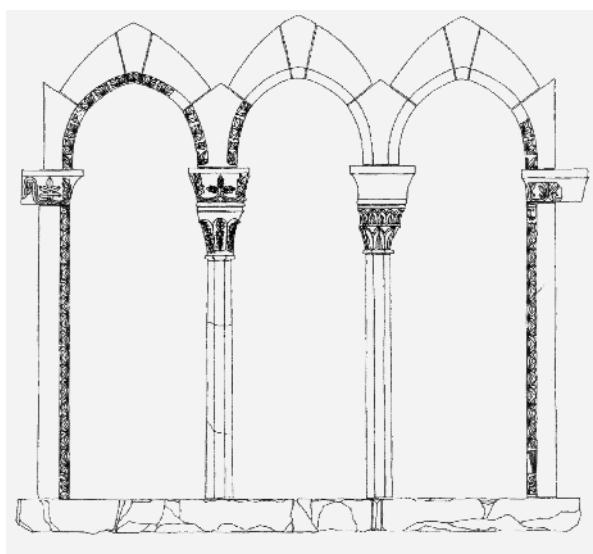
Sl. 7. Jedna od trifora nadgradnje glavnog broda
(izvor: Čanak Medić 1997)

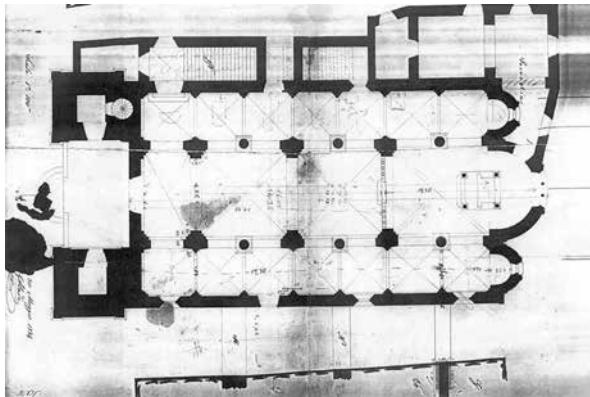
Sl. 8. Hauserov tlocrt katedrale
(izvor: Čanak Medić, Čubrović 2010)
Fig. 8 Plan of the Cathedral drawn by Hauser
(source: Čanak Medić, Čubrović 2010)

²⁰ Although the plan drawn by Hauser was known, Stjepčević wrongly interprets the great amount of burned lime as a proof that the south wall was rebuilt in 1591. (Stjepčević 1940, p. 8). However the south portal of the Cathedral was reconsecrated in 1613, as judged by the inscription which stood over the portal.

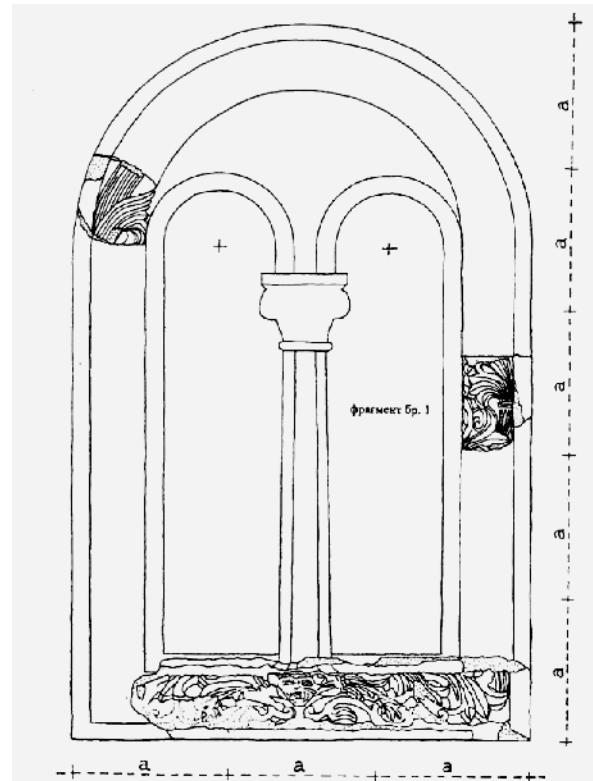
Sl. 9. Crtež bifore koja se vjerojatno nalazila na bočnoj apsidi (izvor: Čubrović 1999-2001)
Fig. 9 Drawing of the bifora, possibly on lateral apse
(source: Čubrović 1999-2001)

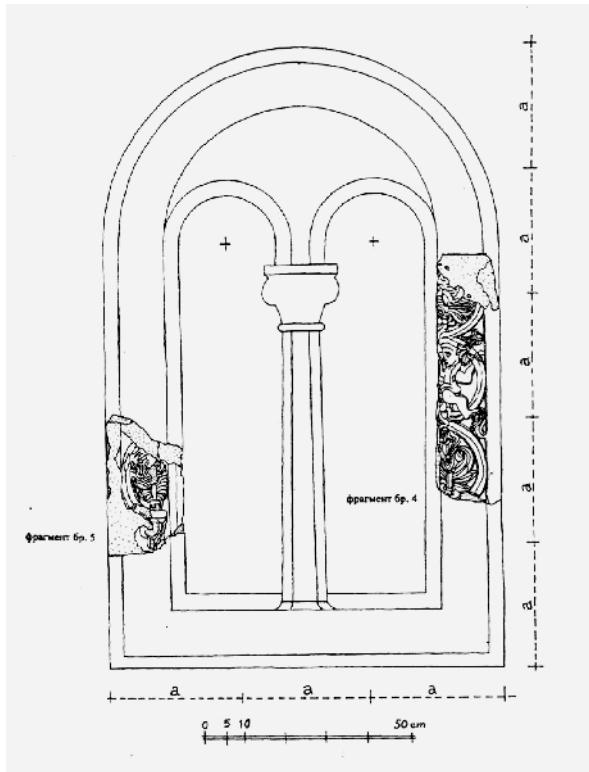
Sl. 10. Crtež bifora koja se vjerojatno nalazila na bočnoj apsidi (izvor: Čubrović 1999-2001)
Fig. 10 Drawing of the bifora, possibly on lateral apse
(source: Čubrović 1999-2001)

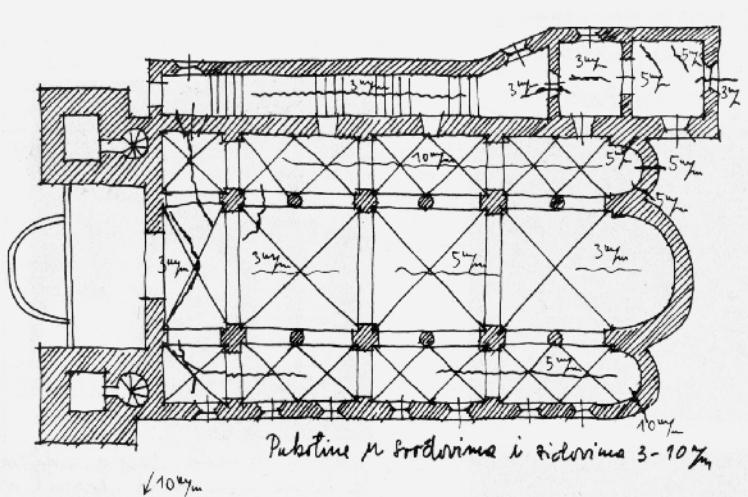
Sl. 12. Skica oštećenja nastalih u potresu 1979:
(izvor: Kotor 1981)

*Fig. 12 Sketch of the damages in 1979 earthquake
(source: Kotor 1981)*

Heavy cracks appeared on the contacts of the original Romanesque structures with the baroque walls chiefly in the NW corner of north nave, as well as on the contact of baroque replacement vaults with the replacement vault from the reconstruction after 1563 over the west semi bay; as well as with Hauser walls (contact of Hauser's south wall with south apse). Although the western wall of the nave as well as the central portal somehow partially survived the earthquake,³⁸ and although there were attempts for their consolidation, this eventually became unsuccessful, and after that, it was finally decided that the portal had to be dismantled together with the remainder of the west wall.³⁹ This work required the dismantlement of the vaults over the two western bays of the main nave as well as what remained of the westernmost vault which corresponds with the present day western half bay together with

Na spojevima izvornih romaničkih građevina s baroknim zidovima pojavile su se velike pukotine, uglavnom u sjeverozapadnom kutu sjevernoga broda, kao i na spoju baroknih zamjenskih svodova i zamjenskoga svoda iz obnove nakon 1563. godine iznad zapadnoga polutradeva te s Hauserovim zidovima (spoj Hauserova južnog zida s južnom apsidom). Iako zapadni zid broda i središnji portal dijelom nisu razrušeni u potresu³⁸ i premda je bilo pokušaja da ih se popravi, na koncu od toga nije bilo ništa pa je konačno odlučeno da portal valja razgraditi zajedno s ostatkom zapadnoga zida.³⁹ Za te je radove bila potrebna razgradnja svodova iznad dvaju zapadnih traveja glavnoga broda, kao i ostataka najzapadnijega svoda, što odgovara današnjem zapadnom polutradevu zajedno s prostorom atrija.⁴⁰ Prije početka izgradnje novih zapadnih građevina trebalo je ukloniti sve ostatke srušenih zvonika, kao i njihovu temeljnju ploču, zajedno sa zapadnim zidom i portalom.⁴¹ To ukazuje da su stari temelji bili u lošem stanju, najvjerojatnije kako oslabljeni djelovanjem podzemnih voda i brojnim pukotinama koje su se pojavile zbog torzije urušenih gornjih dijelova građevina. Zvonici su zamijenjeni novim parom, tako da je rekonstruirano zapadno pročelje približno nalikovalo arhitekturi izvorne crkve.

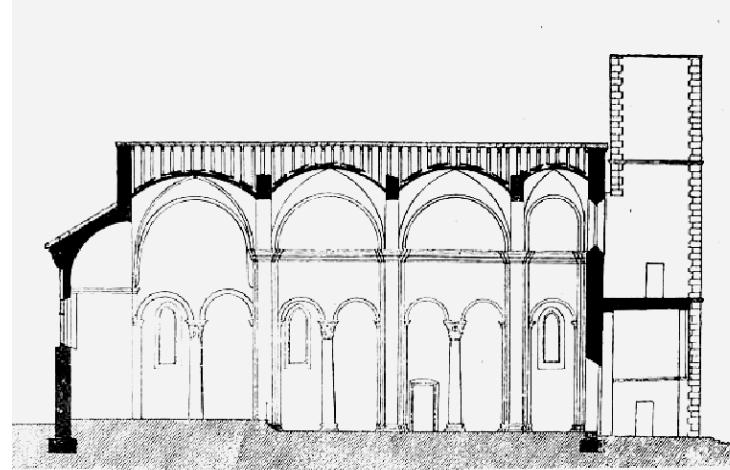
Sl. 13. Presjek katedrale prije Hauserove rekonstrukcije gledajući s juga; vidljivi su originalni gotički prozori (izvor: Stratimirović 1895)

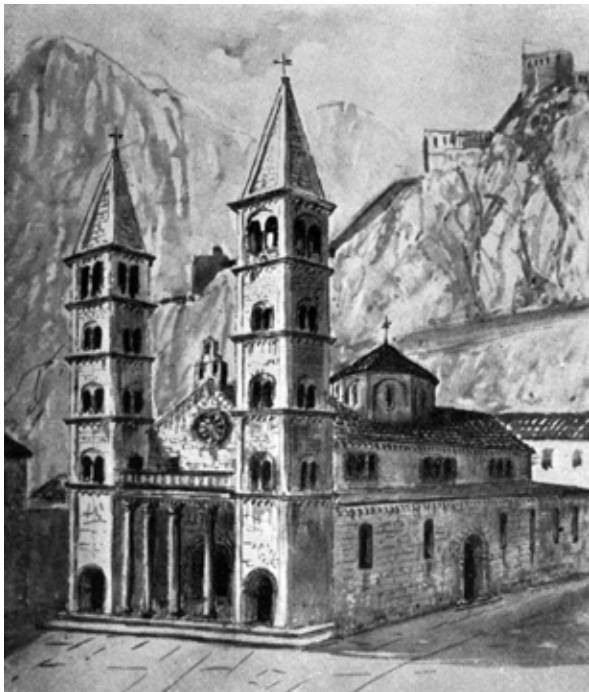
Sl. 14. Rekonstrukcija katedrale koju je načinio Tripo Raffaelli (izvor: Stjepčević 1938)

Fig. 14 Reconstruction of the Cathedral by Tripo Raffaelli (source: Stjepčević 1938)

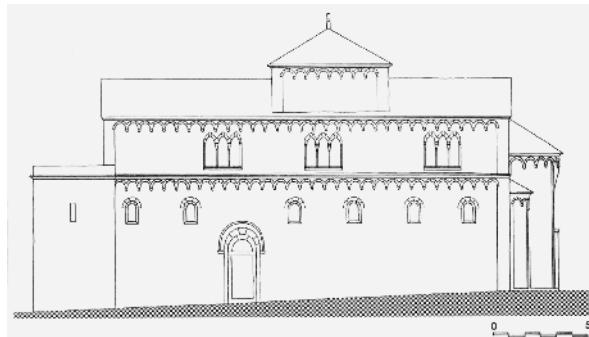
Sl. 15. Rekonstrukcija navodne prve faze katedrale prema M. Čanak Medić
(izvor: Čanak Medić, Čubrović 2010)

Fig. 15 Reconstruction of alledged first phase of the Cathedral by M. Čanak Medić (source: Čanak Medić, Čubrović 2010)

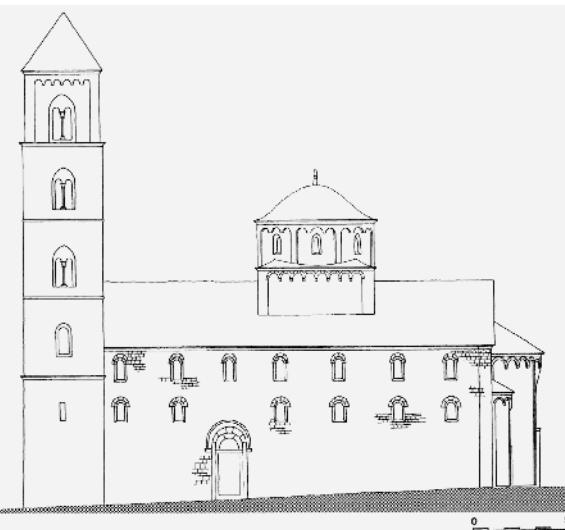
Sl. 16. Rekonstrukcija navodne druge faze katedrale prema M. Čanak Medić (izvor: Čanak Medić, Čubrović 2010)

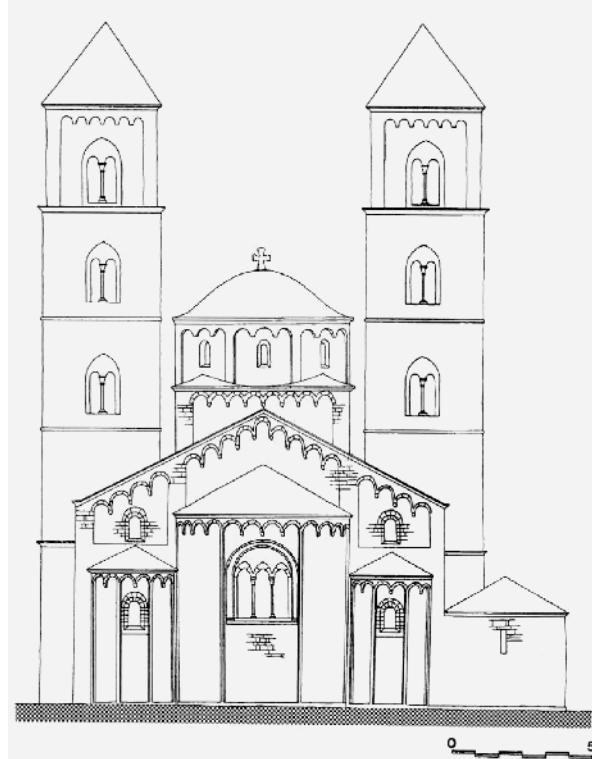
Sl. 18. Rekonstrukcija katedrale s istočne strane prema M. Čanak Medić

(izvor: Čanak Medić, Čubrović 2010)

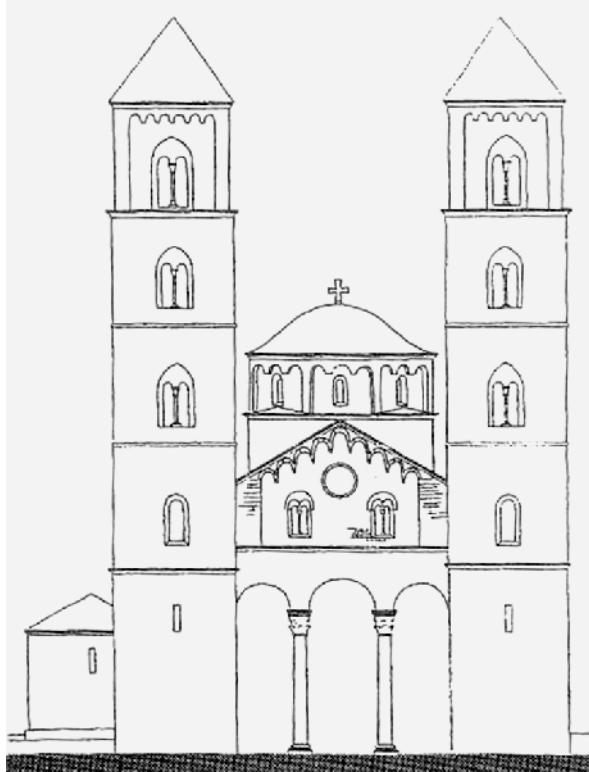
Sl. 19. Prva rekonstrukcija zapadnog pročelja prema M. Čanak Medić (izvor: Čanak Medić 2000)

Fig. 19 First reconstruction of the west facade by M. Čanak Medić (source: Čanak Medić 2000)

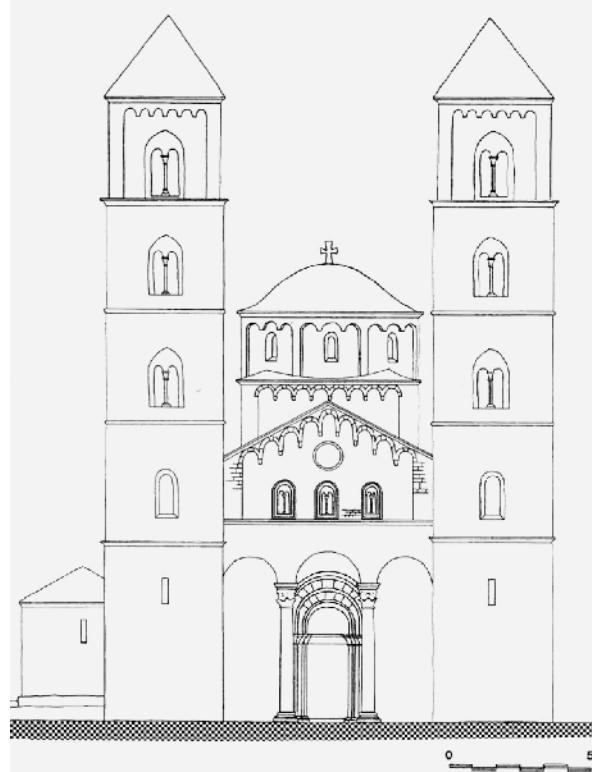
Sl. 20. Druga rekonstrukcija zapadnog pročelja prema M. Čanak Medić (izvor: Čanak Medić, Čubrović 2010)

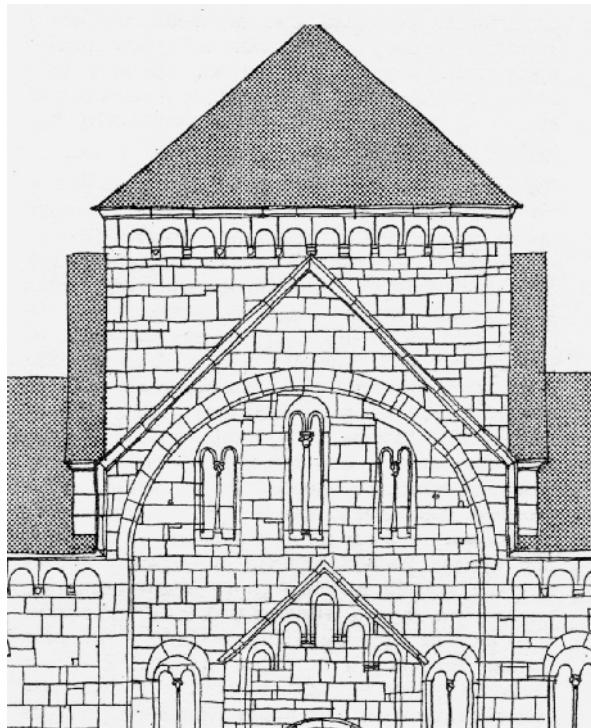
Sl. 21. Hipotetska rekonstrukcija originalnog projekta kupole crkve Blažene Djevice Marije u Studenici
(izvor: Čanak Medić 1985)

Fig. 21 Hypothetical reconstruction of the original project for the dome of Virgin Mary's church in Studenica
(source: Čanak Medić 1985)

⁷⁰ This cubic lower part is actually derived from previously published hypothetical and never executed original architectural project for the dome of Virgins church in Studenica monastery, which is allegedly modeled after the square dome of the church of St Mary on Mljet Island which the author connects with the architecture of byzantine church of St Nicholas near Kuršumlija and finds the origin of the cubic domes in the church of St Peter in Priko near Omiš!!! Čanak Medić 1989, pp. 37, 39-41.

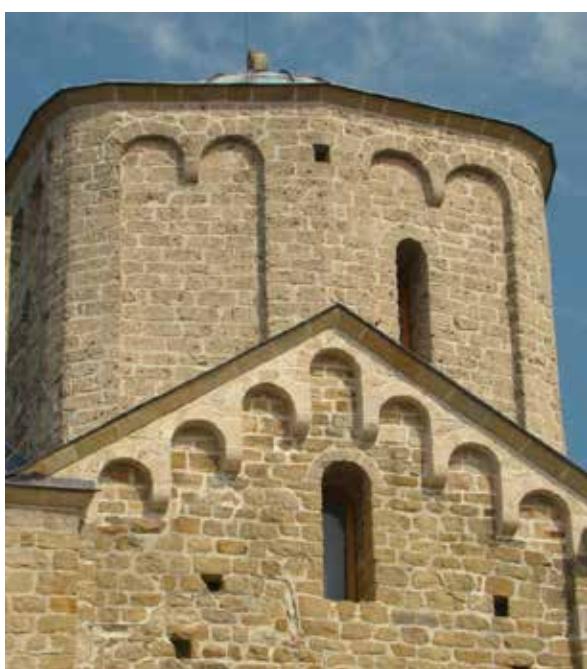
Fig. 23. Kupola crkve sv. Đordja u manastiru Đurđevi stupovi (izvor: Zbirka S. O. Živkova)

Fig. 23 The dome of St George church in Đurđevi Stupovi monastery (source: Collection of S. O. Živkov)

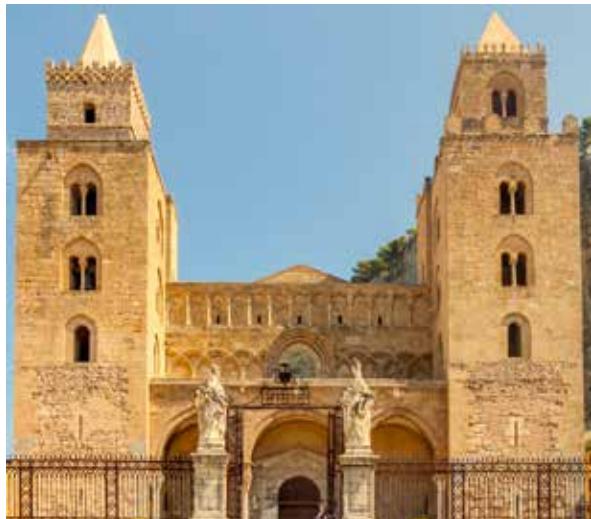
Sl. 25. Zapadno pročelje katedrale u Cefalu
(izvor: Zbirka S. O. Živkova)

Fig. 25 West facade of the cathedral in Cefalu
(source: Collection of S. O. Živkov)

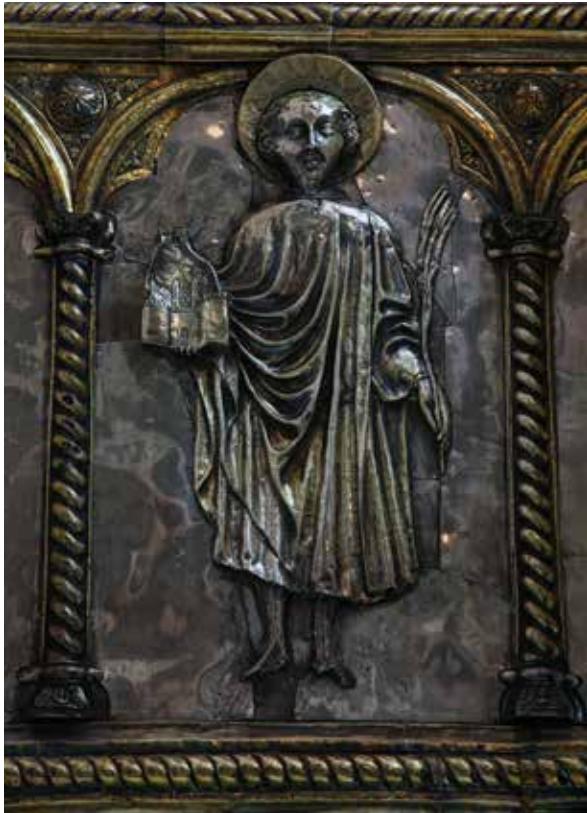
Sl. 26. Dio zlatne pale; ploča sa stojećom figurom sveca koji drži model grada Kotora (foto: S. Kordić, ljubaznošću don Roberta Tonsatija)

Fig. 26 Golden altarpiece; panel with the standing figure of saint holding a model of the city of Kotor (photo S. Kordić, courtesy of don Robert Tonsati)

⁸⁶ Published several times in context of the theoretical reconstruction of the Cathedral: Stjepčević 1938, Pl. IV, 1; Čanak Medić, Čubrović 2010, p. 125, Fig. 84.

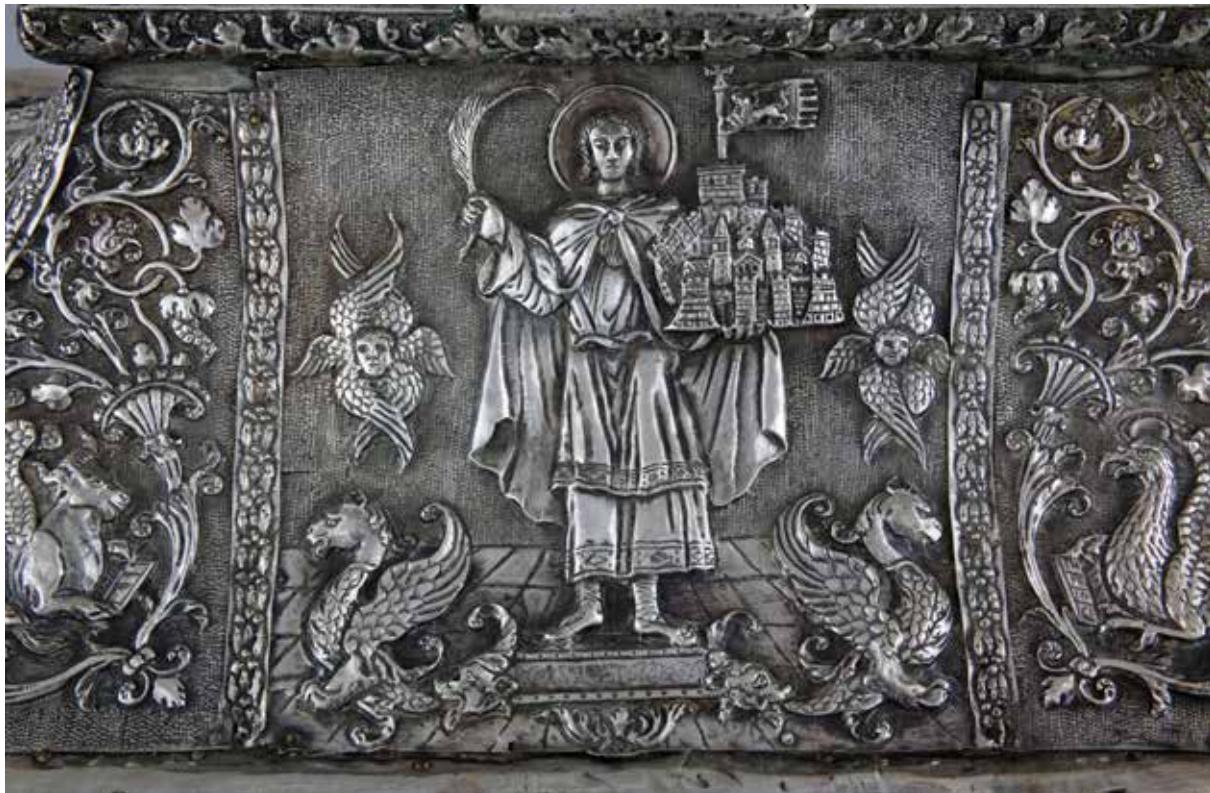
Sl. 28. Srebrni kovčeg; ploča poklopca; stojeća figura s modelom grada Kotora
(foto: S. Kordić, ljubaznošću don Roberta Tonsatija)

⁸⁸ Published several times in connection with the reconstruction of the original architecture of the Cathedral Stjepčević 1938, Pl. IV, 2; Čanak Medić, Čubrović 2010, p. 125, Fig. 85.

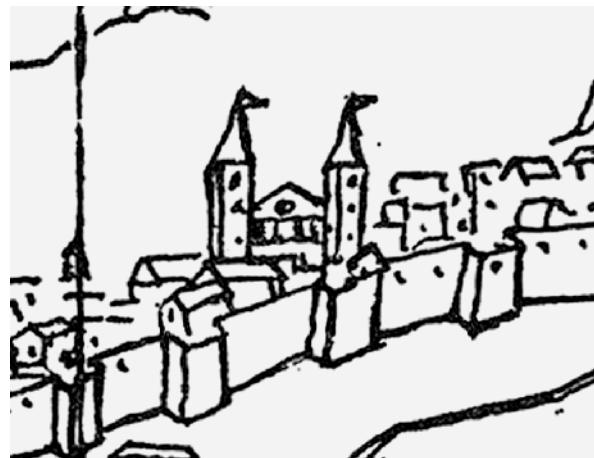
Sl. 34. Enrico Caterino Davila, detalj s katedralom sv. Tripuna (izvor: Novak 1972)

Fig. 34. Enrico Caterino Davila, detail with the Cathedral of St Triphon (source: Novak 1972)

Grafika je najvjerojatnije nastala u razdoblju iz-među 1618. i 1621. g., kada je Davila služio kao providur u Kotoru. Zasad nije poznato gdje je izvor-no objavljena. Koliko je poznato, grafika je objav-ljena dva puta.⁹⁶ Utvrde su vrlo detaljno prikazane, a građevine unutar donjega grada s manje detalja, osim katedrale. Crtež je napravljen na povиеноj lo-kaciji izravno nasuprot povijesnoj gradskoj jezgri Kotora. Topografija zidina donjega grada prikazana je sa svim pojedinostima zajedno s rijekom Škur-dom i izvorom Gurdićem. Katedrala je vidljiva iza gradskih zidina, zajedno s kućama između bedema i trga ispred katedrale. Jasno je vidljiva cijela prva

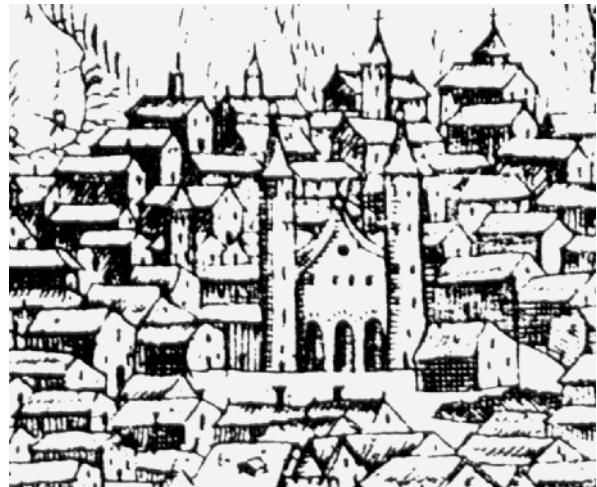
Sl. 36. Giacomo Franco, detalj s katedralom
sv. Tripuna (izvor: Kozličić 1995)

Fig. 36 Giacomo Franco, detail with the Cathedral of
St Triphon (source: Kozličić 1995)

¹⁸ U literaturi su ti trostruki prozori bez ikakva temelja uvijek opisivani kao triforiji, premda su oba bočna zida katedrale nadograđena znatno kasnije, odnosno tijekom obnove katedrale nakon potresa 1667. godine. To potvrđuje grafički prikaz katedrale Giacoma Franca iz 1575.

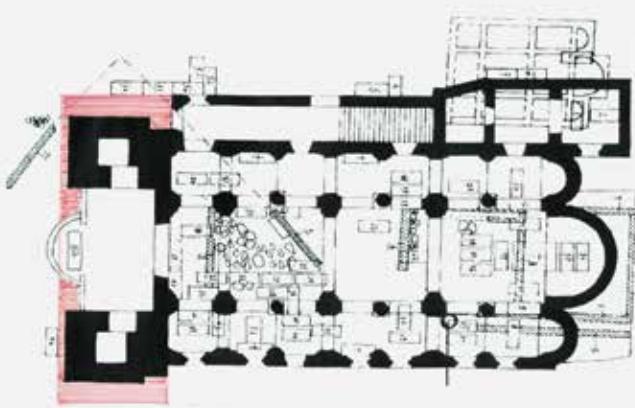
Sl. 37. Tlocrt arheoloških nalaza ispod katedrale s označenim područjem temeljne platforme originalnih zvonika prema Križanac 1995
(izradili: S. O. Živkov & Ivan Tomić)
Fig. 37 Plan of the archaeological finds under the Cathedral with marked area of the foundation platform of the original bell towers after Križanac 1995 (made by: S. O. Živkov & Ivan Tomić)

je niz grobnica u unutrašnjosti katedrale i uz njen sjeverni zid. Dispozicija tih grobnica ponudila je tragove za rekonstrukciju izvornoga prostornog rasporeda zvonikā i narteksa katedrale.

Grobnica br. 56 orijentirana je u smjeru sjever-zapad i nalazi se uz sjeverni zid, dok su grobnice 55 i 54 iste orijentacije i slično su postavljene te nastavljaju crtu sjevernoga zida dalje prema zapadu, što ukazuje na to da je razmak između izvornih zvonika bio znatno veći. Nagli prekid starijega zida 2 ukazuje na najzapadniji položaj izvornoga temelja zapadnoga dijela katedrale, kao i na prostorni raspored toga dijela crkve. Grobnice 63 i 64, otkrivenе neposredno zapadno od južnoga zvonika, označavaju izvornu granicu temelja ranijih zvonika. Očito je da je cijela izvorna temeljna ploča morala biti potpuno uklonjena da bi mogla biti započeta izgradnja baroknih zvonika. Tijekom arheoloških istraživanja otkriveno je da su današnji najzapadniji zvonici podignuti na temeljima izgrađenim od razli-

er span between the original bell towers. The abrupt break of the earlier wall 2 indicates the westernmost position of the original foundation of the western part of the cathedral and also gives the indications for the spatial disposition of this part of the church. The tombs No 63 and 64, which were discovered immediately to the west of the south bell tower marks the original limit of the foundations of the earlier bell towers. It is obvious that the complete original foundation platform had to be completely removed in order to start the building of the baroque bell towers. During the archaeological excavations it was discovered the the present bell towers were built over the foundations which were constructed with the use of various spolia of the earlier superstructure.¹⁰⁰ During the static consolidation of the baroque bell towers, it was discovered that they were also constructed with the extensive use of the earlier spolia.¹⁰¹ Furthermore the ossuary (tomb 67) was constructed between the foundation of the baroque bell towers. The wider span between the bell towers allows the construction of separate entrances into the lateral naves. Regarding the reconstruction of the architectural composition of the bell towers, the evidence was provided on the representation on the Golden altarpiece, Silver Casket, fresco in Stoliv and engravings. The published reconstruction of the windows on the original bell towers of the Cathedral of St Triphon is highly controversial because the proposed windows, biforas are actually copy pasted, without any logic, from the cathedral of Cefalu . Regarding the original appearance of the top floor, it is clearly visible on the model executed on the Silver Casket that the top floor had two windows on each side, decorated with the profilated cornice at the levels of the window floors and springing of the window arches, without any inward indentation of this floor, and without any pilasters and arcaded frieze, it was reconstructed as a exact copy of the executed architectural reconstruction of the upper floor of the bell tower in Žiča, which in turn was realised practically without any proof.¹⁰²

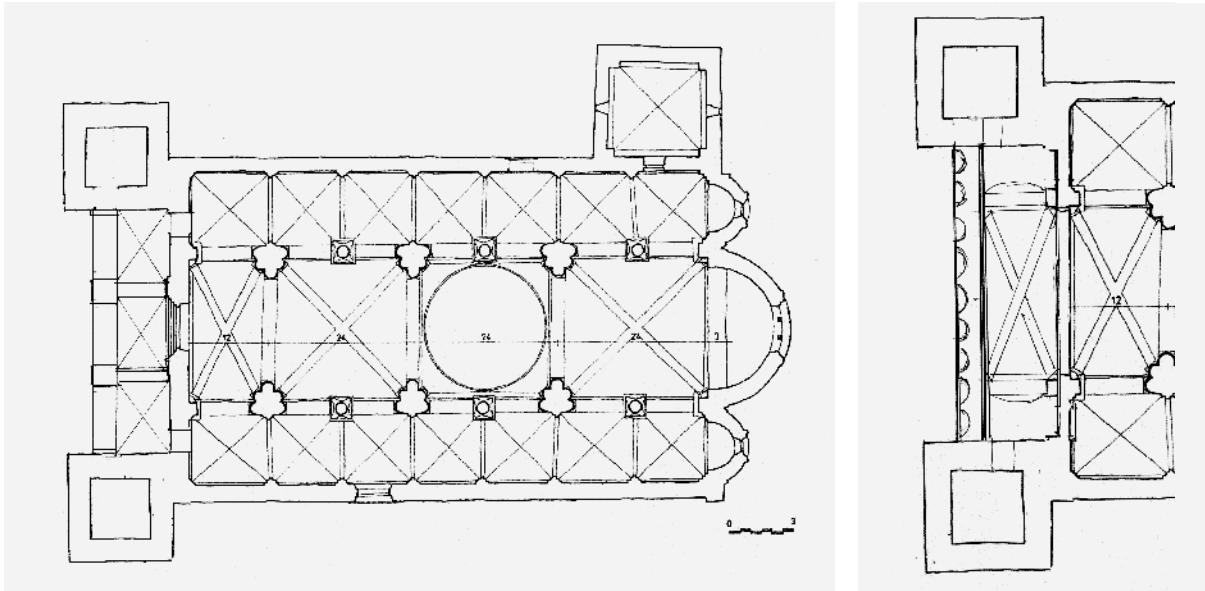
Sl. 38. i 38. a. Rekonstruirani tlocrt prizemlja katedrale, razina atrija i razina galerije
(izradili: S. O. Živkov & Ivan Tomić)

Tlocrt katedrale obično je tumačen na sljedeći način: glavni brod s tri traveja i jednim polutravejem na zapadu. Stup koji nosi dva luka dijeli travej glavnoga broda od dva manja traveja bočnih brodova, čijih se sedam traveja veličine $\frac{1}{4}$ od onih u središnjem brodu nalaze na sjevernoj i južnoj strani glavnoga broda. Nije bilo zadovoljavajućeg objašnjenja za polutravej glavnoga broda na zapadu. Analiza integriranoga tlocrta katedrale s dodanom arheološkom podlogom pružila je dokaz o kompletno novoj arhitektonskoj kompoziciji izvornog arhitektonskog tlocrta katedrale. Već je zabilježeno da je 1976. objavljeno jedno tumačenje prostorne kompozicije, a tlocrt katedrale prvi je put protumačen s četiri traveja u glavnome brodu sa zapadnim polutravejem i četvrtim travejem na istoku, koji zapravo uključuje i središnju apsidu. Analiza dostupne arheološke dokumentacije, kao i poznatih vizualnih izvora (reljefi i grafički prikazi), omogućili su nam da predložimo još noviju rekonstrukciju izvornoga prostornog rasporeda katedrale, koja se temelji na koncepciji s pet kvadratnih traveja (A) koji odgovaraju glavnoj apsidi (A1), tri postojeća traveja glavnoga broda (A 2, 3, 4), dok je peti smješten na zapadu, što odgovara zapadnome polutraveju i atriju (A5a, A5b) u prizemlju, koji se nalazio zapadno od sačuvanoga polutraveja, te unutarnjoj galeriji iznad njega koja odgovara današnjemu balonu iznad svoda. Nadalje, arheološka istraživanja pokazala su da se izvorna temeljna ploča zvonika pružala dalje prema sjeveru i jugu.

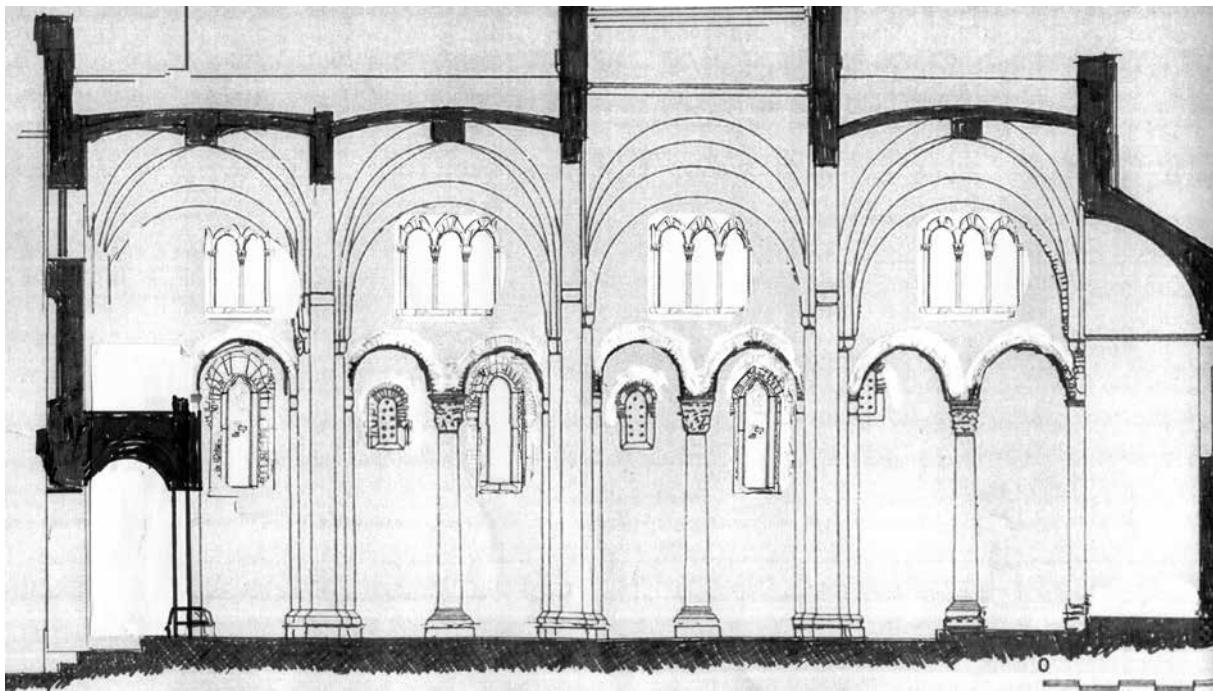
Sl. 39. Rekonstrukcija uzdužnog presjeka katedrale nakon njezina dovršetka 1331. gledajući prema sjeveru
(izradili: S. O. Živkov & Ivan Tomić)

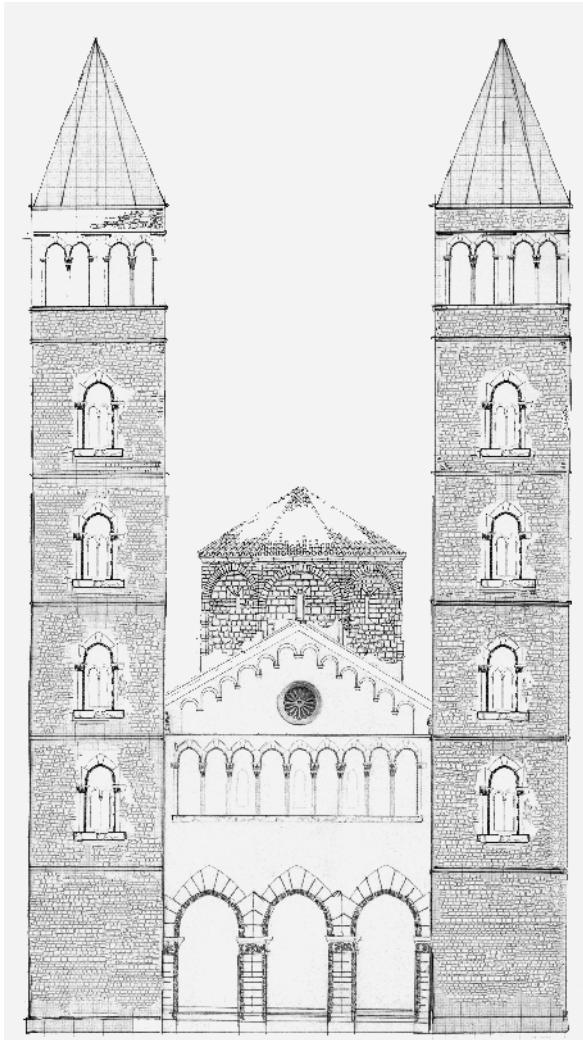
Sl. 40. Rekonstrukcija zapadnog pročelja katedrale sv. Tripuna (izradili: S. O. Živkov & Ivan Tomić)
Fig. 40 Reconstruction of the west facade of the Cathedral of St Triphon (made by: S. O. Živkov & Ivan Tomić)

kutnim tamburom s prozorom na svakoj strani, slično kupoli crkve sv. Marije, ali viša, u skladu s prikazom na zlatnoj pali. Viša kupola bila je nužna radi otvaranja prozora na svih njezinih osam strana, jer je istočni i zapadni prozor na kupoli crkve sv. Marije morao biti izostavljen zbog dodira s istočnim i zapadnim dijelovima krova. Općenito uzevši, nova rekonstrukcija kupole u skladu je s onom koju je objavio Raffaelli,¹⁰⁵ a precrtao i objavio Mijović,¹⁰⁶ uglavnom na temelju sačuvane arhitekture crkve sv. Marije, ali s određenom razlikom u proporcijama.

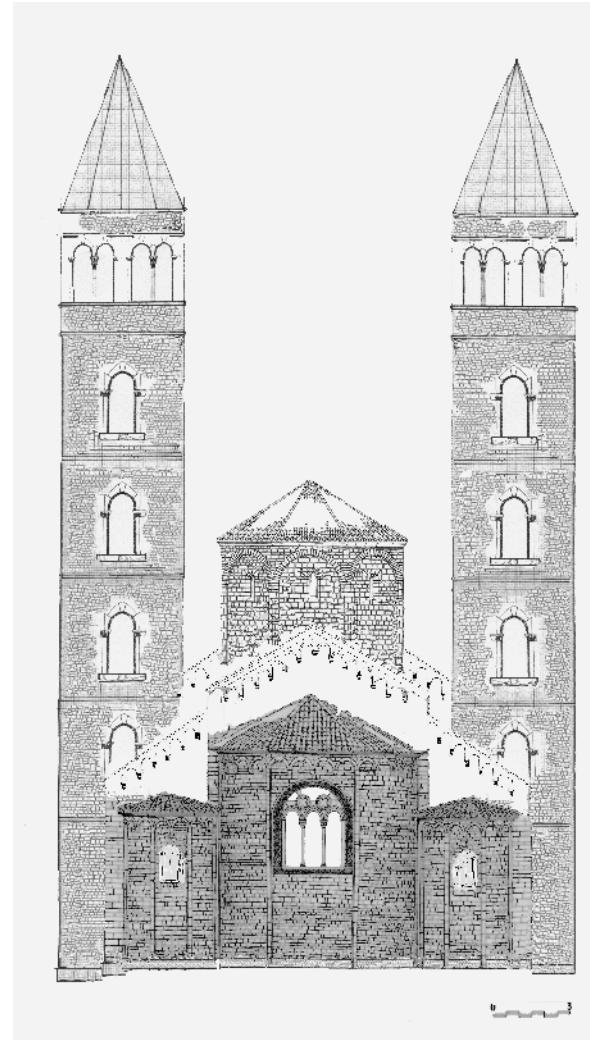
Sl. 41. Rekonstrukcija istočnog pročelja katedrale sv. Tripuna (izradili: S. O. Živkov & Ivan Tomić)
Fig. 41 Reconstruction of the east facade of the Cathedral of St Triphon (made by: S. O. Živkov & Ivan Tomić)

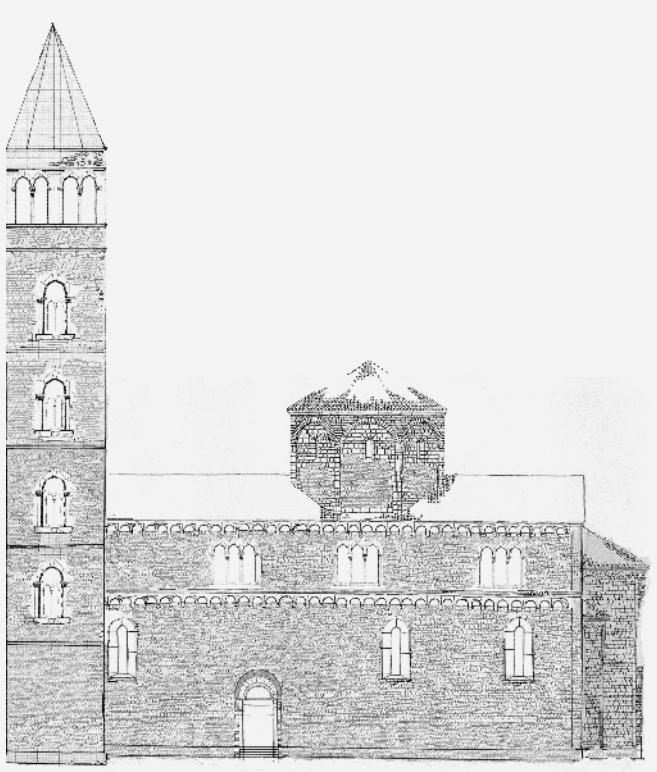
Sl. 42. Rekonstrukcija južnog pročelja katedrale sv. Tripuna (izradili: S. O. Živkov & Ivan Tomić)
Fig. 42 Reconstruction of the south facade of the Cathedral of St Triphon (made by: S. O. Živkov & Ivan Tomić)

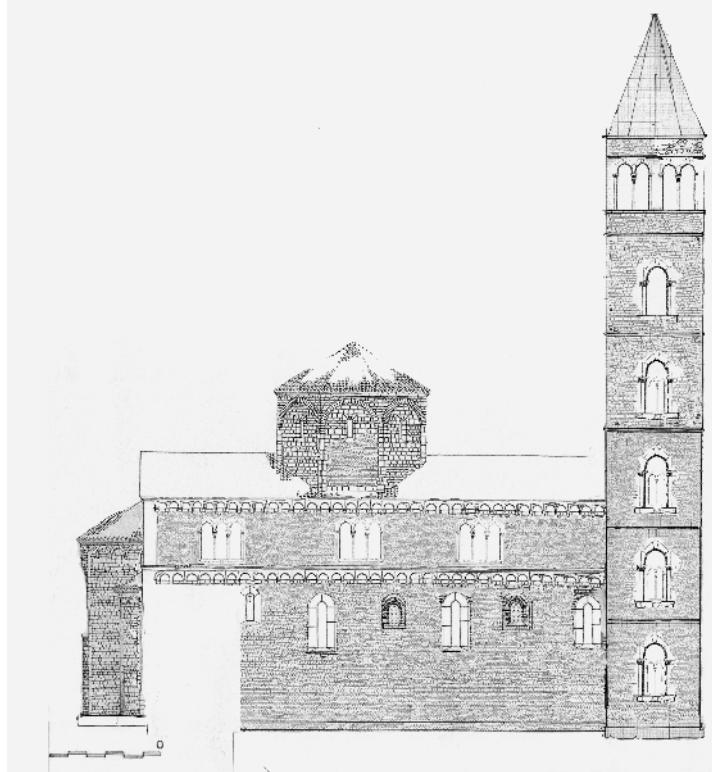
Sl. 43. Rekonstrukcija sjevernog pročelja katedrale sv. Tripuna, prazno područje predstavlja sakristiju (izradili: S. O. Živkov & Ivan Tomić)
Fig.43 Reconstruction of the north facade of the Cathedral of St Triphon, the blank area corresponds to the sacristy (made by: S. O. Živkov & Ivan Tomić)

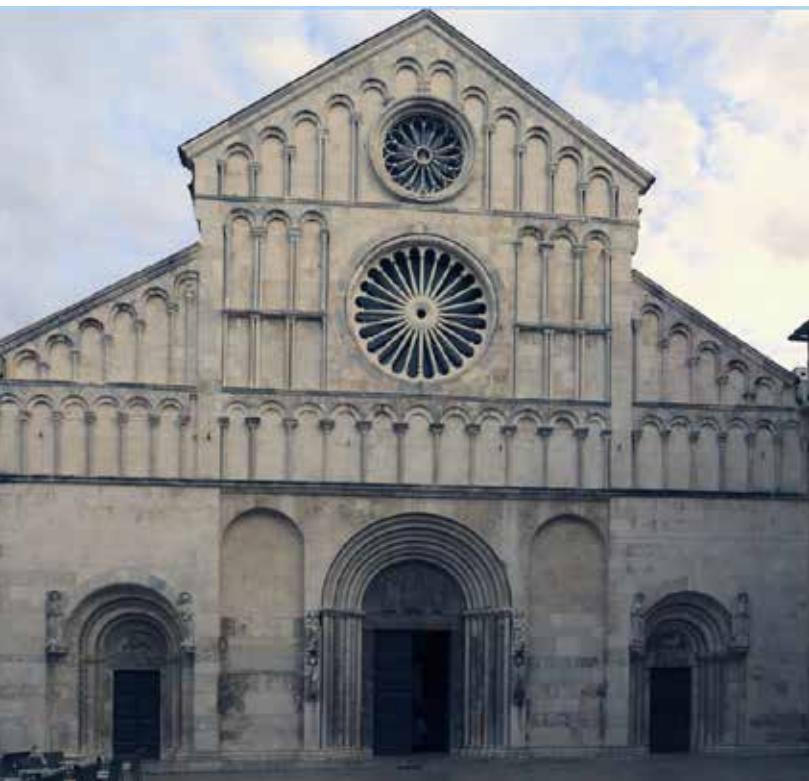
Sl. 44. Katedrala u Zadru
(izvor: Zbirka S. O. Živkova)
*Fig. 44 The Cathedral in Zadar
(source: collection of S. O. Živkov)*

¹¹¹ Romanička katedrala u Zadru izgrađena je na lokaciji starije bazilike, a njezina današnja arhitektura potjeće iz dviju faza iz 12. i 13. stoljeća, kada je proširena ponovnom uporabom brojnih ulomaka pročelja iz 12. stoljeća. Na donjoj su zoni tri portala s dvama nizovima slijepih lukova iznad kojih su dvije rozete. Osim toga, langobardsko je podrijetlo arhitekture prikazano i naizmjeničnim postavljanjem nosivih i nenosivih stupova u obliku višelinskoga svežnja. Nadalje, iz iste je arhitektonske radionice i projekt opatije sv. Krševana u Zadru. Uporaba raznobojnih kamenih blokova u izgradnji pročelja još je jedno obilježje iz sjeverne Italije.

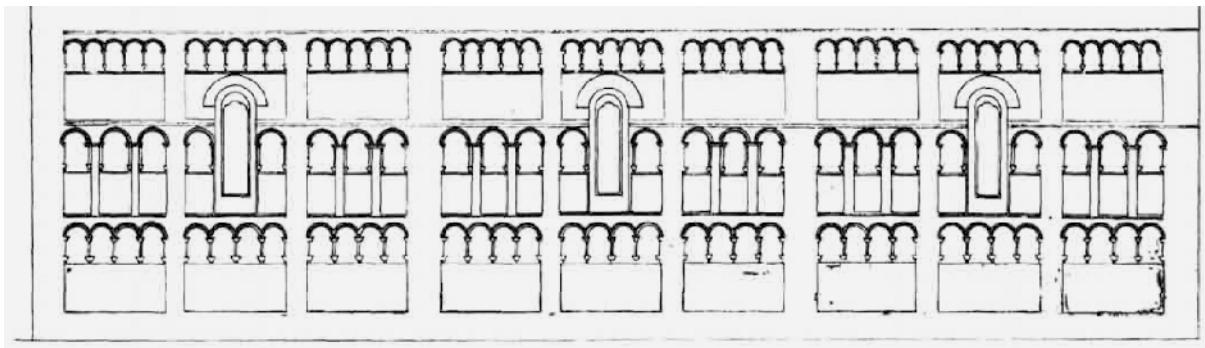
Sl. 46. Rekonstrukcija južnog pročelja katedrale u Senju (izvor: Viličić 1968)
Fig. 46 Reconstruction of the south facade of the Cathedral in Senj (source: Viličić 1968)

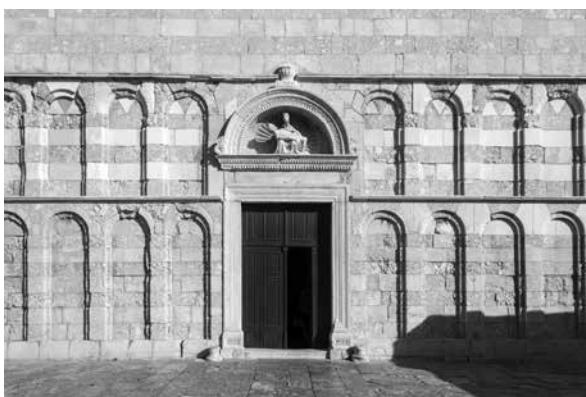
Sl. 47. Zapadno pročelje katedrale u Rabu
(izvor: Zbirka S. O. Živkova)
Fig. 47 West facade of the Cathedral in Rab
(source: collection of S. O. Živkov)

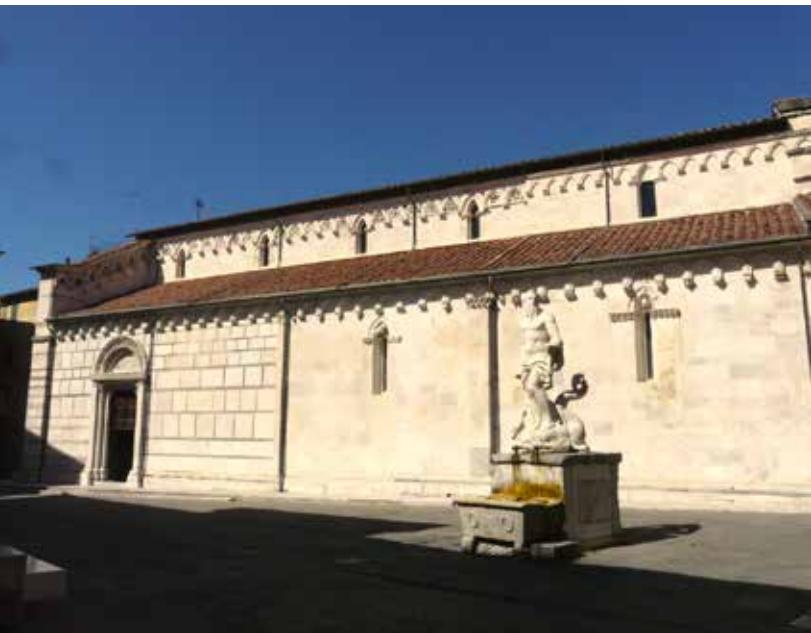
Sl. 49. Južno pročelje katedrale u Carrari
(izvor: Žbirka S. O. Živkova)

Fig. 49 South facade of the Cathedral in Carrara
(source: collection of S. O. Živkov)

¹¹³ The first written documentation of the Carrara Cathedral dates to 1099. In 1151 the second building phase began, lasting until about 1235.
