Izvorni znanstveni rad / *Original scientific paper*

## Arheološko istraživanje i prezentacija crkava sv. Luke i sv. Jurja u Kaštel Sućurcu

## The Archaeological Excavation and Presentation of the Churches of St Luke and St George in Kaštel Sućurac

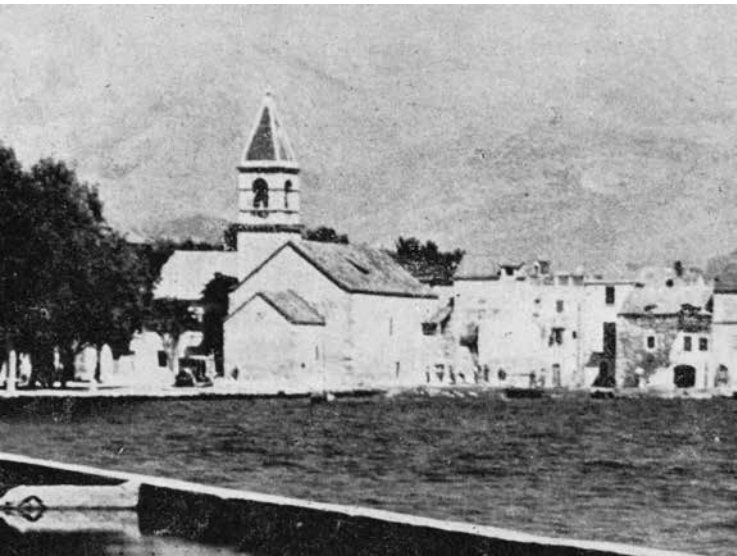
Sl. 3. Crkva sv. Jurja prije bombardiranja  
Fig. 3 Church of St George before the bombing

The new parish church, dedicated to St George, was completed in 1601, and was consecrated on the Feast of St Luke in 1693 (Figs. 3 and 4). “While the new church was being built, the old church stayed inside it until it was built”,<sup>13</sup> illustrating a common practice, since churches were often built for years, for decades even. Written in the inscription over the entrance door to the church, still in existence, is:

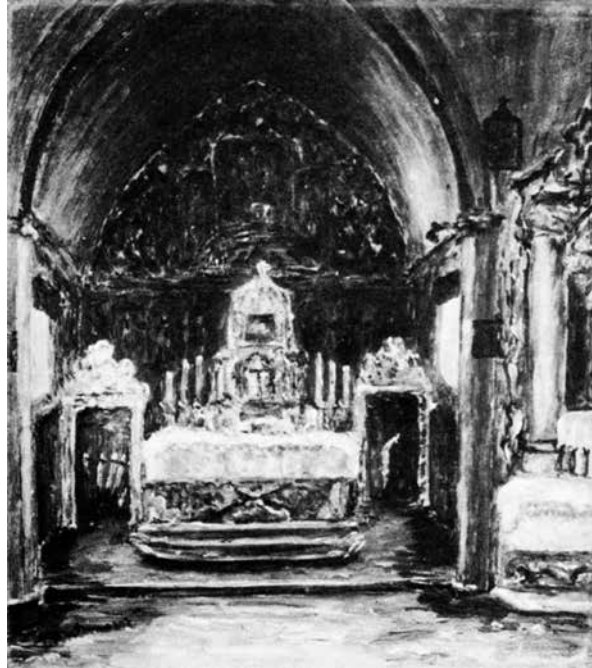
Sl. 4. Apsida crkve sv. Jurja  
Fig. 4 Apse of St George's church

Na gornjoj površini temelja crkve vide se u moru tragovi zidova širine 70 cm. Međutim, na temelju južnog zida apside vidi se trag zida koji je bio širok 90 cm, što navodi na zaključak da je apsida bila presvođena svodom te su zidovi na tom mjestu deblji kako bi preuzeli njegov horizontalni potisak. Postojanje svoda potvrđuje stari crtež unutrašnjosti crkve, gdje se vidi prelomljeni svod nad apsidom (sl. 4).

the walls were thicker at this place to withstand the horizontal thrust. The existence of a vault is confirmed by an old drawing of the interior of the church, where a pointed vault can be seen over the apse. (fig. 4)

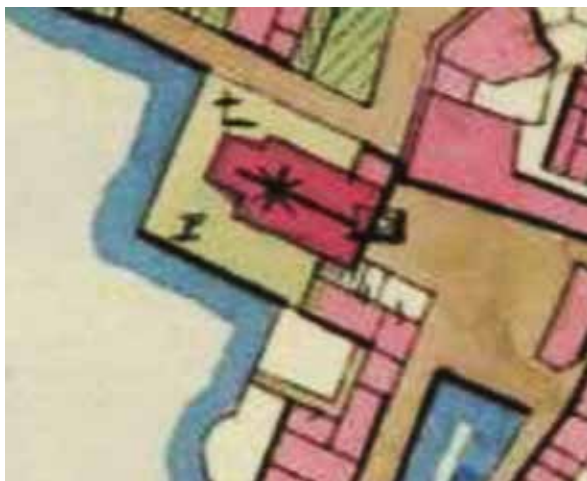
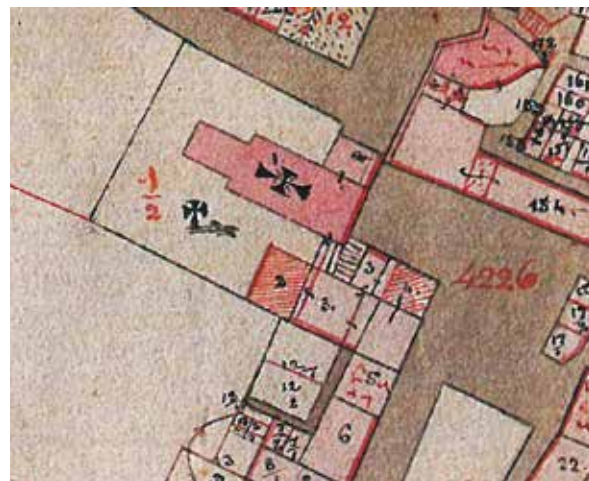
Sl. 5. Crkva Sv. Jurja na katastru iz 1831. godine (<https://maps.arcanum.com/en/map/cadastral>) i na istom katastru reambuliranom 1846. godine (Državni arhiv u Splitu, Arhiv mapa)

Fig. 5 Church of St George in the cadastre of 1831 (<https://maps.arcanum.com/en/map/cadastral>) and In the same cadastre that was re-surveyed in 1846 (State Archives in Split, Map archives)

Zvonik je sagrađen 1857. prema projektu split-skog inženjera Bubolotija. Prema katastru iz 1831. godine prije izgradnje zvonika postojala je na njegovu mjestu građevina kroz koju se ulazilo u selo, a opisana je kao “*Casa a differenti usi*” (kuća za razne namjene), u vlasništvu Općine Kaštel Sućurac. Ona je do reambulacije katastra 1846. godine porušena te je njezin katastarski broj 2 prekriven i upisan na ložu, koja je u istom razdoblju sagrađena južno od crkve (u katastarskom planu označena crvenom šrafurom). Oko crkve je bilo groblje (sl. 5).

of the next updating of the cadastre in 1846 it had been torn down, and its cadastral number, 2, was crossed out and inscribed on the loggia that was built at the same time to the south of the church (in the plan marked with red hatching). There was a graveyard around the church. (fig. 5)

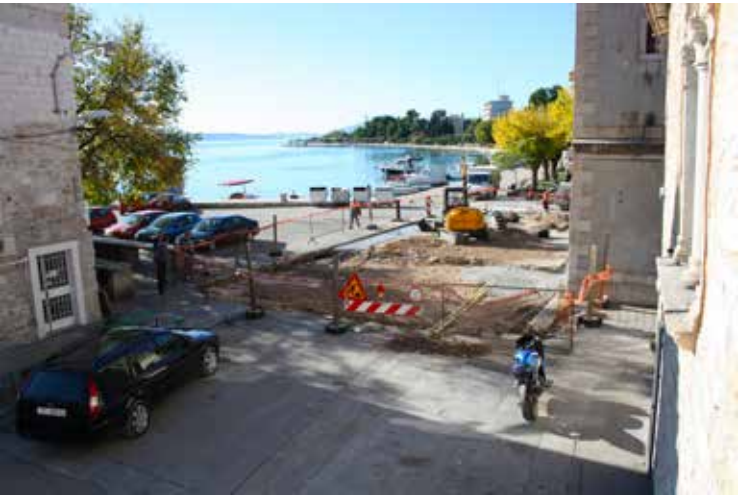
Sl. 6. Područje istraživanja  
Fig. 6 The research area

Istraživanja su započela krajem listopada 2013. godine skidanjem asfalta samo nad temeljima; planirano je da se sačuva asfalt u unutrašnjosti crkve kao i tri velika stabla murve koja su nakon II. svjetskog rata zasađena na tom prostoru. Tijekom radova odlučeno je da se murve ipak uklone te da se cijela površina crkve uredi na primjeren način (sl. 6).

Excavations started at the end of October 2013, when the asphalt was stripped off, just above the foundations, it being planned to preserve the asphalt in the interior of the church as well as three large mulberry trees planted in the area after World War II. During the works, however, the decision was made to remove the trees and to put the whole area of the church into proper order. (fig. 6)

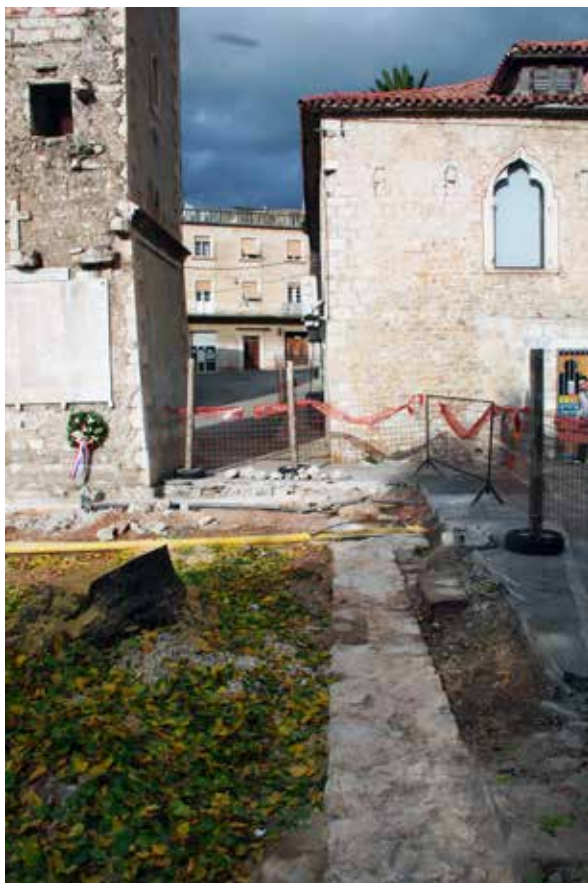
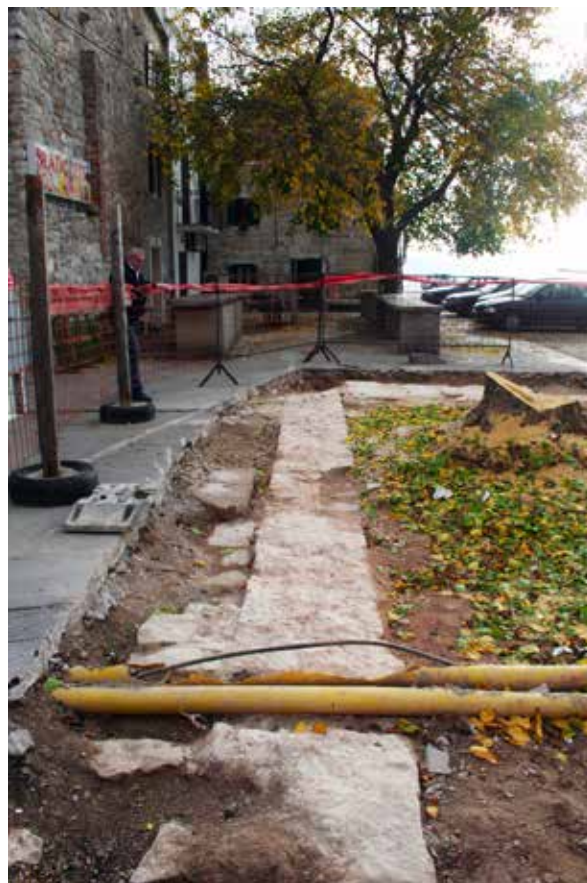
Sl. 8. Zid naselja iz 1509. godine ujedno zapadni zid crkve  
 Fig. 8 Wall of the settlement of 1509 that was also the western wall of the church

Na istoku istraženog područja pronađen je zid širine 70 cm, čiji se temelj može pretpostaviti na nižoj razini, do koje se nije kopalo. Građen je drugačijom tehnikom i nije zidarski spojen sa sjevernim i južnim zidom crkve te se nastavlja prema jugu i sjeveru, što potvrđuje ranije pretpostavke da je riječ o zidu naselja iz 1509. godine<sup>21</sup> (sl. 8).

In the east of the area investigated a 70 cm thick wall was revealed, the foundation of which can be assumed to be at a lower level, which was not reached by the digging. It was built in a different technique and was not bonded to the northern and southern walls of the church, and went on to the north and south, confirming earlier hypotheses that this was in fact the wall of the settlement of 1509<sup>21</sup> (fig. 8).

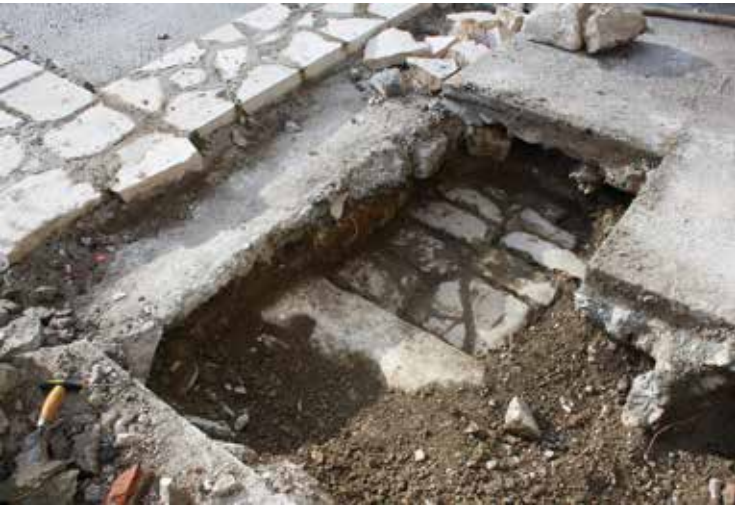
Sl. 9. Prag ulaznih vrata naselja iz 1509. i popločanje ispred njega

*Fig. 9 Threshold of the main gate to the settlement of 1509 and the paving in front of it*

U tom zidu, između sjeveroistočnog ugla crkve i Nadbiskupske palače, pronađen je južni dio kamenog praga ulaznih vrata naselja širine 23 cm, u dužini od 80 cm. Njegov se vrh nalazi na razini +0,54 m. Ispred njega (zapadnije) pronađena je površina popločena kamenom, 6 cm niža od praga (sl. 9). Površina praga je izlizana, osim na južnom dijelu, u dužini od 21 cm, gdje se još vidi izvorna obrada kamena, što pokazuje da je na tom mjestu stajao južni dovratnik vrata. Sjeverni dio praga ulaznih vrata uništen je prilikom polaganja instalacijskih vodova koji su ondje zatečeni. Ako položaj sjevernog dovratnika tih vrata pretpostavimo tik iza zid Nadbiskupske palače, širina vrata naselja iznosila bi 192 cm.

In this wall, between the north east corner of the church and the archiepiscopal palace, the southern part of the stone threshold of the entry gate of the settlement was found, 23 cm wide and 80 cm long. The top is at a level of + 0.54 m. In front of it (to the west) a stone-paved surface 6 cm lower than the threshold was found. (fig. 9) The surface of

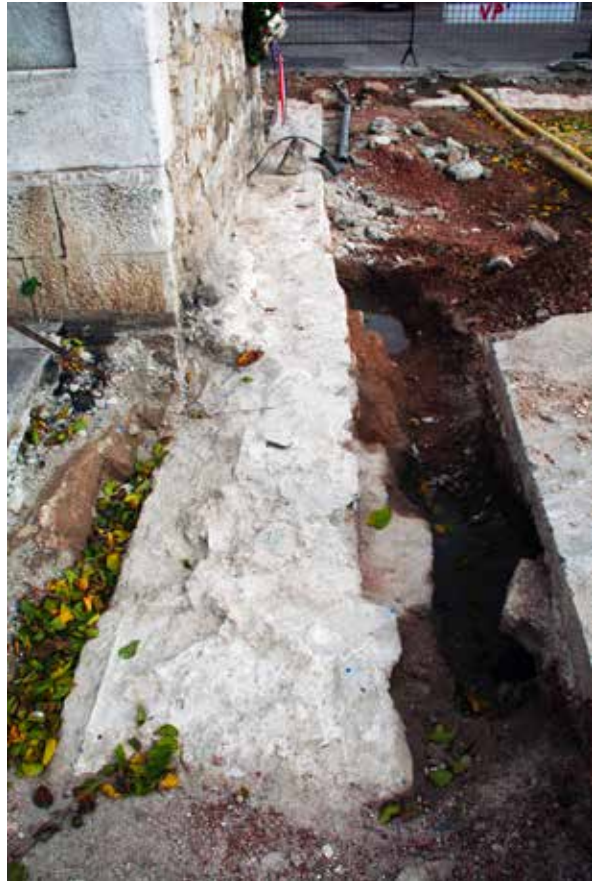
Sl. 10. Širi zid crkve sv. Jurja u prednjem planu i uži zid crkve sv. Luke u stražnjem planu

*Fig. 10 The wider wall of the Church of St George in the foreground and the narrower wall of St Luke's in the background*

Sjeverni zid crkve u svom je istočnom dijelu, u dužini od 5,50 metara, širok 54 cm, dok je dalje prema zapadu širok 70 cm, a njegov temelj 90 cm (sl. 10). Očito je da taj istočni, tanji dio zida pripada starijoj crkvi sv. Luke, iz 16. st., za koju znamo da je bila u funkciji sve dok nova župna crkva nije dovršena. Nakon što je sa cijele pretpostavljene površine crkve sv. Luke skinut asfalt, te obavljena iskapanja do razine +0,28 m, pronađen je i dio zapadnog zida crkve sv. Luke, i to samo njegovo unutarnje, istočno lice, u dužini od oko 4 metra (sl. 11). Apsida te ranije crkve nije pronađena unutar barokne crkve te je zaključeno da se ona nalazila južnije, na prostoru koji tom prilikom nije bio istražen.

The northern wall of the church was 54 cm thick in the 5.50 metre-long eastern part, while further off to the west it was 70 cm thick, and the foundation was 90 cm thick. (Fig. 10) Clearly this eastern and thinner part of the wall belongs to the older Church of St Luke of the 16<sup>th</sup> century, which we know to have been in use until the new parish church was completed. After the asphalt was stripped from the whole of the area assumed to have been occupied by St Luke's and the excavation had gone down to

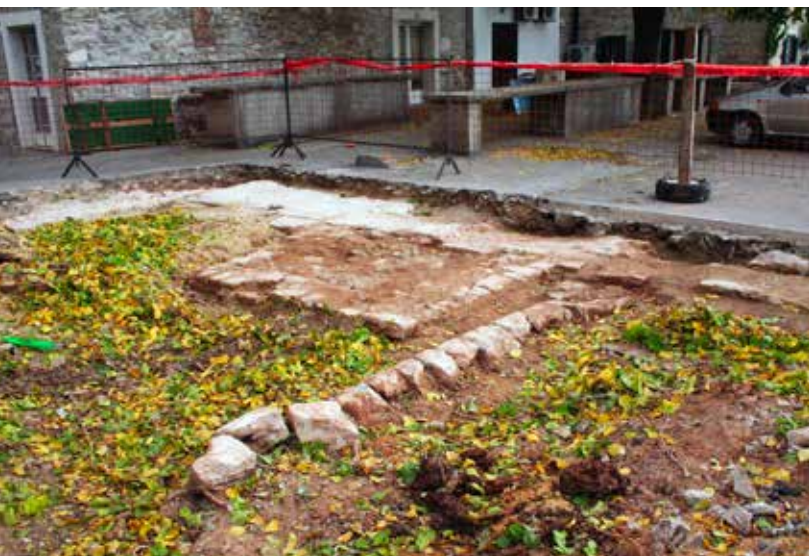
Sl. 11. Ostatak zapadnog zida crkve sv. Luke (u prvom planu) i temelj istočnog oltara na južnom zidu crkve sv. Jurja

*Fig. 11 Remnant of the western wall of the Church of St Luke in the foreground and the foundation of the eastern altar on the southern wall of St George's*

Od sedam oltara koji su postojali u crkvi pronađen je samo temelj oltara u jugoistočnom dijelu, tlocrtnih dimenzija 216 x 278 cm (sl. 11). Nasuprot njemu nije pronađen temelj drugog oltara, iako je taj prostor temeljito istražen, pa se može zaključiti da je bio od drva. Unutar apside crkve sv. Jurja nije se istraživalo, pa stoga nije utvrđen položaj glavnog oltara.

a level of + 0.28 cm, part of the western wall of St Luke's was found, only its internal, eastern face, over a length of about 4 metres. (fig. 11). The apse of this earlier church was not found within the Baroque church and it was concluded that it must lie to the south in an area that was not investigated on that occasion.

There were once seven altars in the church, but only the foundation of an altar in the southeastern part, plan dimensions 2.16 x 278, has been found. (fig. 11) The foundation of no other altar has been found opposite it, although the space has been thoroughly investigated, and it can be concluded that it was perhaps of wood. No research was done inside the apse of St George's, and so the position of the high altar has not been ascertained.

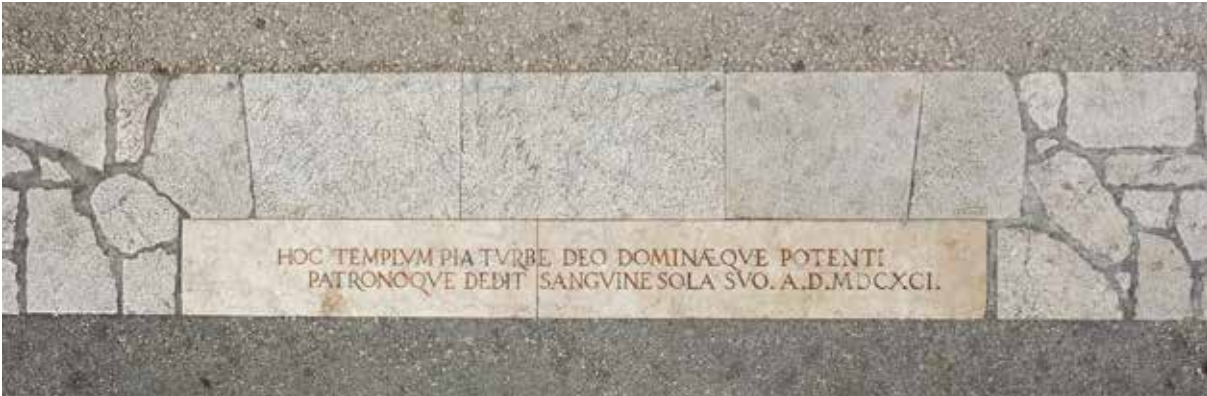
Sl. 12. Natpis koji je nekad stajao na nadvratniku glavnih vrata barokne crkve uklesan je u ploče koje tlocrtno prezentiraju ta vrata

*Fig. 12 The inscription that once stood over the lintel of the main door of the Baroque church is carved into the flagstones that present this door in ground plan*

All the finds of walls mentioned are presented in stone paving, the pattern of which conjures up the horizontal section through the wall. The doors are presented with larger sized flagstones placed without pointing, following the geometry of the horizontal section of the door. Carved on the threshold of

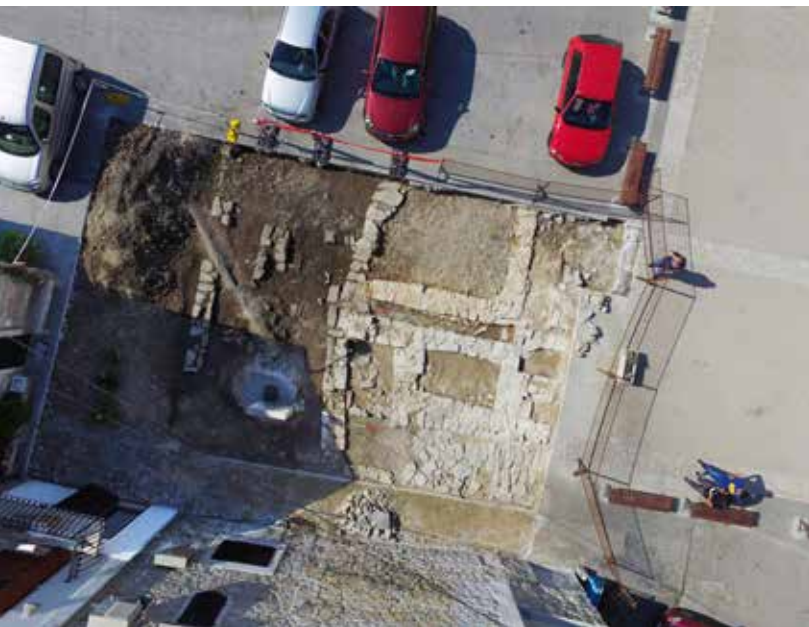
Sl. 13. Nalazi na prostoru tržnice iz 2017. godine  
*Fig. 13 Finds in the area of the market place from 2017*

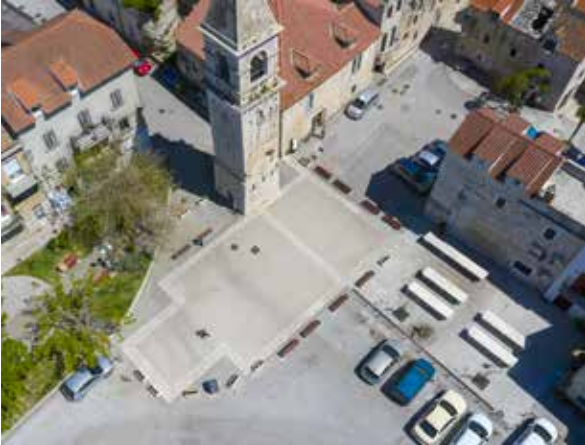
Sl. 15. Prezentacija nalaza u popločanju sućuračke rive  
*Fig. 15 Presentation of the finds in the paving of the Sućurac seashore*

During the reconstruction of the marketplace, the walls of the apse of St Luke's were presented with the same pattern of stone paving as in the continuation of the western wall of the settlement to the south, with the difference that the surface inside the apse and the whole area of the marketplace was done in concrete.
