Tihomir Glavaš
Maja Soldo

Zavod za zaštitu
kulturno-povijesne i prirodne baštine
Županije Zapadnohercegovačke
*Institute for the Protection of Cultural,
Historical and Natural Heritage
of the West Herzegovina County*
Stjepana Radića 37 b
88220 Široki Brijeg, BiH
soldo.maja15@gmail.com

Rezultati arheološkog istraživanja sjedišta stare župe Podbila kod Posušja

Results of the archaeological research of the seat of the old parish of Podbila near Posušje

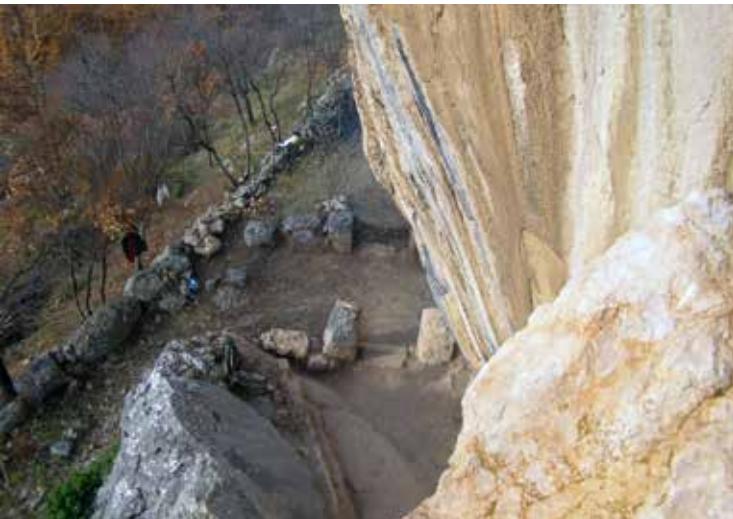
Sl. 2. Dvije zapadne prostorije, pogled s istočne litice
(foto: T. Glavaš)

*Fig. 2 Two western rooms, view from the east cliff
(photograph: T. Glavaš)*

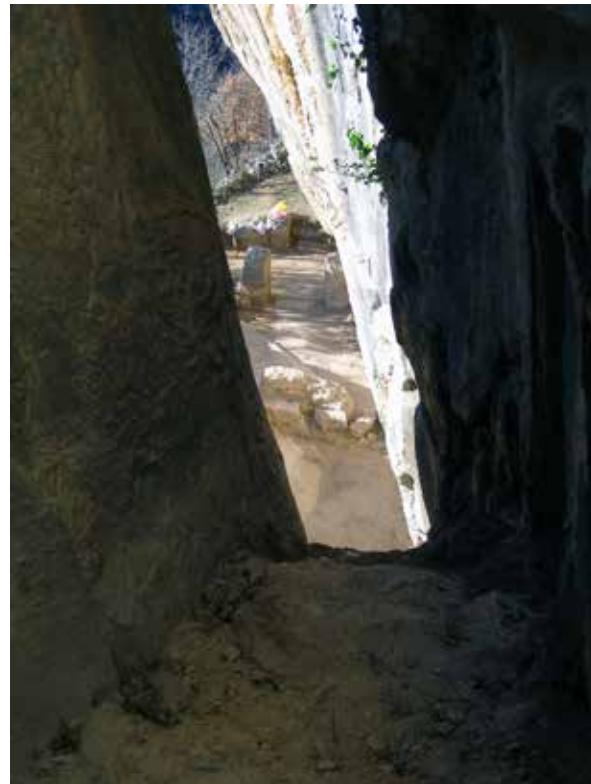
Sl. 3. Stube usječene u liticu na početku tajnog izlaza
(foto: T. Glavaš)

Fig. 3 Stairs cut into the cliff in the first section of the secret exit (photograph: T. Glavaš)

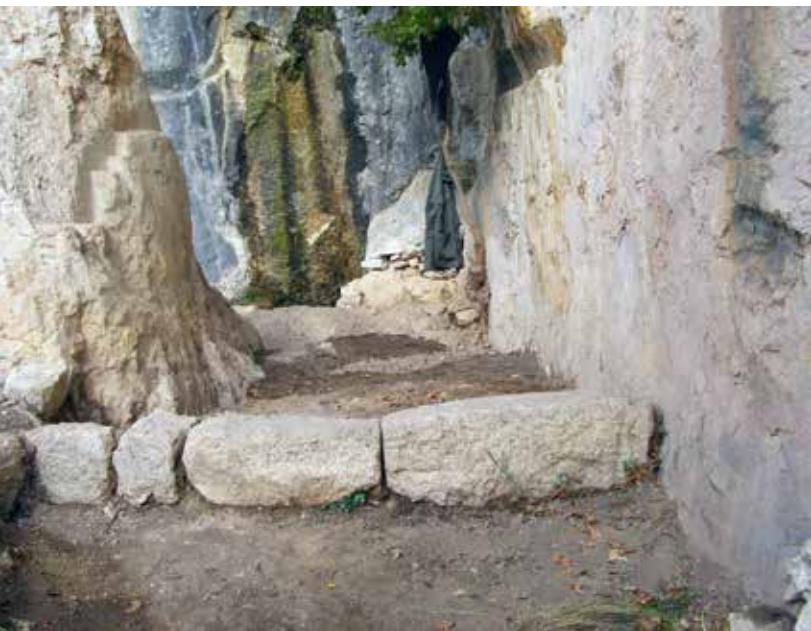
Sl. 4. Unutrašnjost bunara krstionice (?)
(foto: M. Soldo)
Fig. 4 Inside of the baptismal well (?)
(photograph: M. Soldo)

Najzapadnija prostorija, P. I., imala je podnicu od nabijene ilovače te bunar koji je izgrađen posebnim načinom gradnje, koja ostavlja mogućnost kako se radilo o krstionici, s obzirom na križiće usječene u blizini, ili se zapravo radi samo o spremištu pitke vode. Između sjeverne stijene i južne nakoso položene stijene naišlo se na prostor koji je

The westernmost room P. I. had a floor composed of rammed clay, and a well of special construction, which leaves open the possibility that it was a font, in light of the small crosses incised in the vicinity, or perhaps it was merely a drinking water tank? An archaeologically interesting area was found between the north rock and the south sloping rock, with certain points on the northern cliff which served as rests for the beams on the east face of the south rock. The space between these rocks is filled with construction debris. The south rock is separated from the east one, thus forming a partially enclosed space. Water leaks from three holes in the north cliff (a corner). In the eastern part of this area there were the foundations of the south wall (by a separate cliff) that extended all the way to the partition wall of the adjoining room to the west. Three more crosses carved in the cliff were found in the north-eastern part of the east room, once the ivy was removed from the north cliff. They were located slightly to the east of the previously known Christograms. The removal of construction waste in the adjacent room exposed the south wall of the room butting on the cliff dressed and joined with

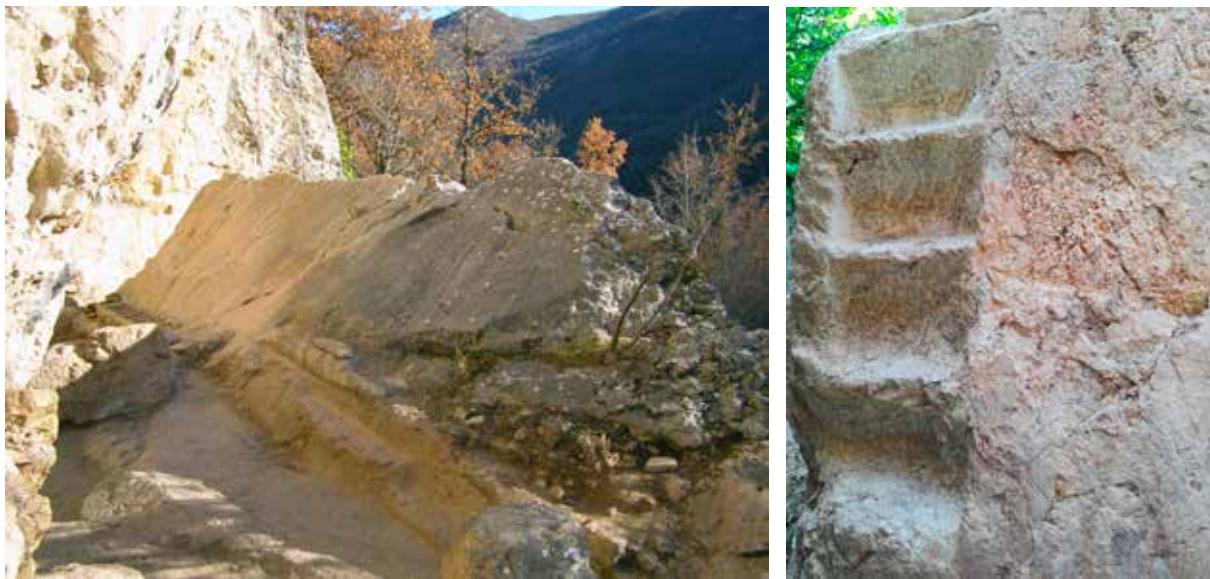
Sl. 6. i 7. Južna strana građevine, pogled sa zapada (foto: T. Glavaš, M. Soldo)
Figs. 6 and 7 South side of the building, view from the west (photographs: T. Glavaš, M. Soldo)

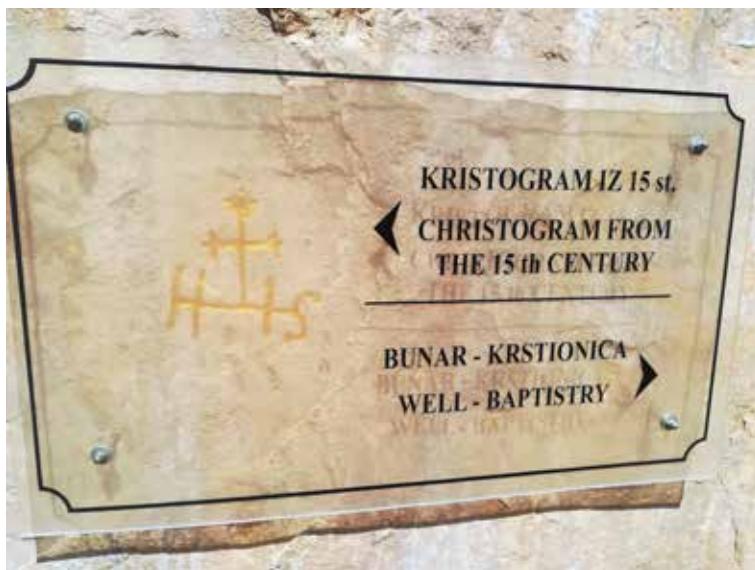
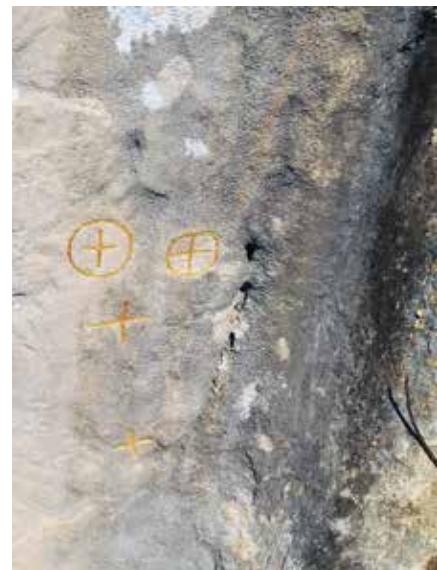
Sl. 8. i 9. prikaz kristograma i križića iznad bunara krstionice (?) (foto: M. Soldo)

Nakon grubog čišćenja nešto istočnije od ranije poznatih kristograma uočena su još tri u litici urezana križa. I na ovom se dijelu javlja južni zid prostorije naslonjene na liticu koja je priklesana (zaravnjena) za temelje zida. Širina ove i prethodne prostorije nije potpuno ista.

Coarse scouring revealed three more crosses carved in the cliff, slightly to the east of the previously known Christograms. The south wall of the room butting on the cliff dressed and joined with the wall foundations can also be seen in this section. This room and the previous one are not equally wide. The partition wall between these two rooms, visible around the middle at this level, is made of

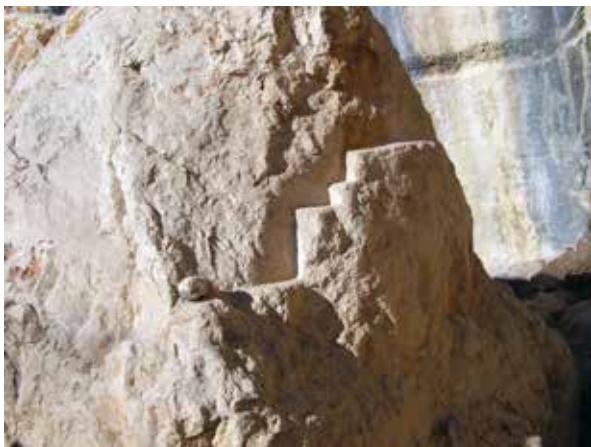
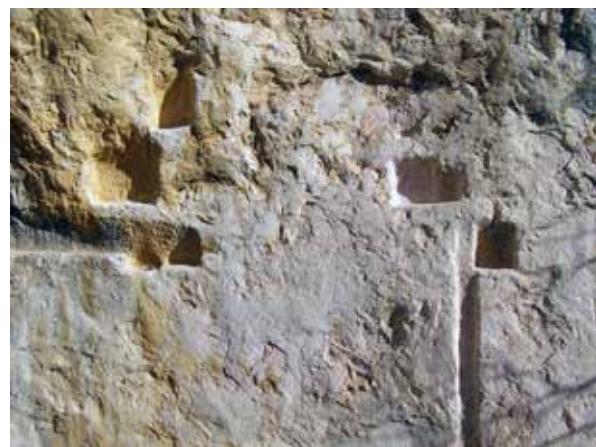
Sl. 10. i 11. Zapadna i istočna stijenka ulazne prostorije (foto: T. Glavaš)
Figs. 10 and 11 West and east walls of the entrance room (photographs: T. Glavaš)

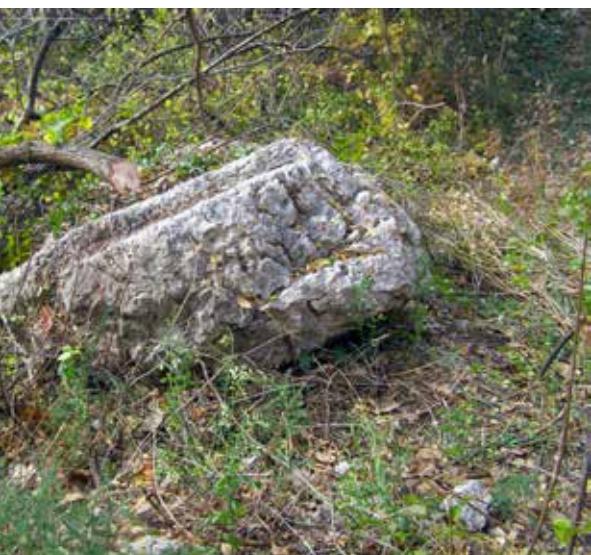
Sl. 12. Lijevi dovratnik istočnog ulaza (foto: T. Glavaš)
Fig. 12 Left jamb of the east entrance
(photograph: T. Glavaš)

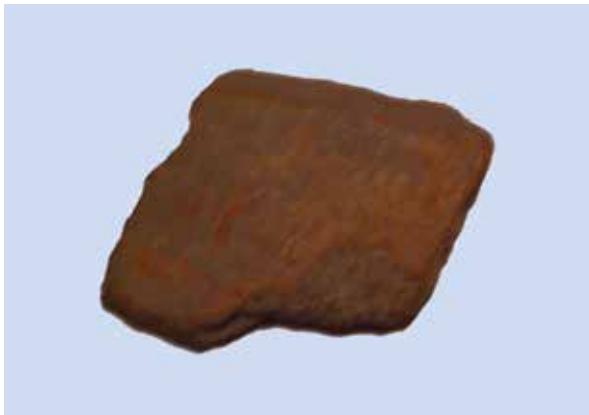
Sl. 13. Dio neolitičke bikonične posude
(foto: T. Glavaš)

Fig. 13 Part of a Neolithic biconical vessel
(photograph: T. Glavaš)

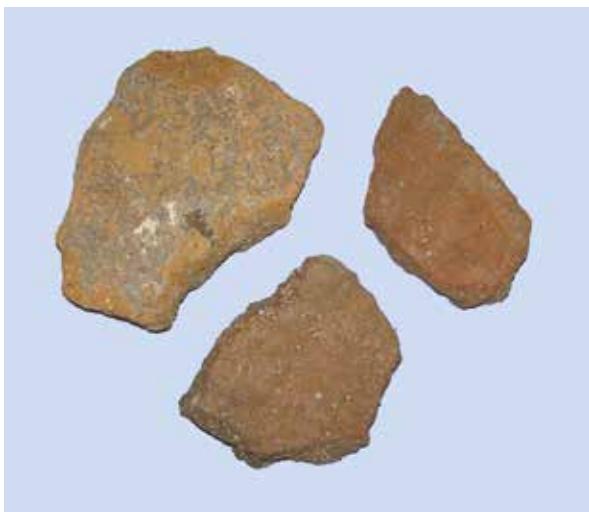
Sl. 14. Ulomci keramike bakrenog doba (eneolitika)
(foto: T. Glavaš)

Fig. 14 Fragments of pottery from the Copper Age
(Eneolitic) (photograph: T. Glavaš)

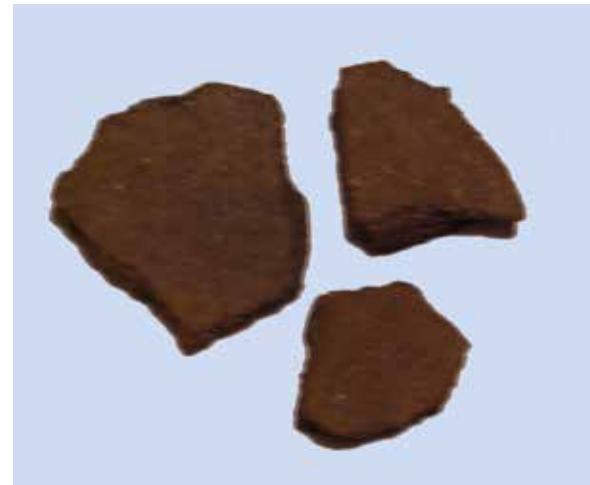
Sl. 15. Ulomci brončanodobne keramike
(foto: T. Glavaš)

*Fig. 15 Fragments of Bronze Age pottery
(photograph: T. Glavaš)*

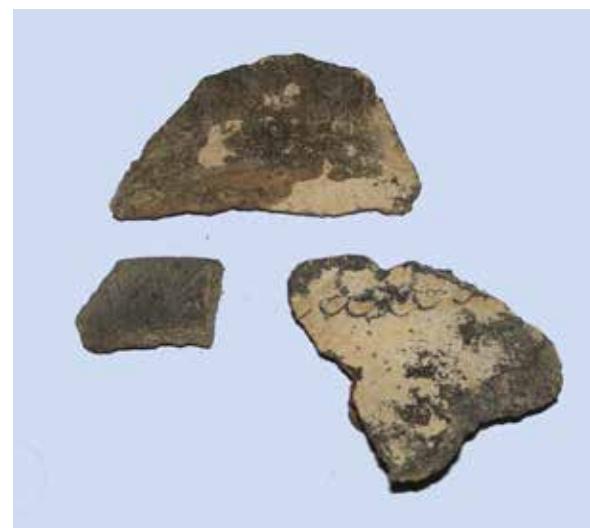
Sl. 16. Ulomci rubova i dna srednjovjekovnih posuda
(foto: T. Glavaš)

Fig. 16 Fragments of rims and a bottom of medieval vessels (photograph: T. Glavaš)

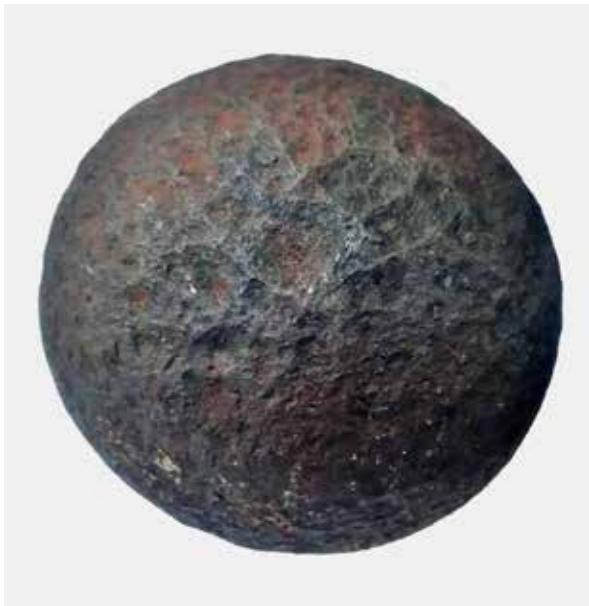
Sl. 17. Topovska kugla (foto: T. Glavaš)
Fig. 17 Cannon-ball (photograph: T. Glavaš)

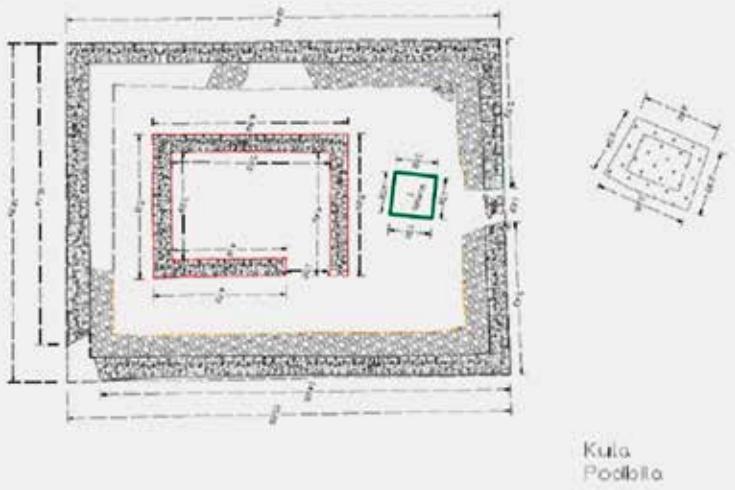
Sl. 19. Tlocrt utvrde (preuzeto iz: Oreč 2016, prilog 3)

Fig. 19 Ground plan of the fortification (taken from: Oreč 2016, appendix 3)

sanim kamenom poslaganim u dva reda. Tehnika zidanja utvrde sastojala se od površno priklesanog kamena i krupnih oblutaka uz vezivno sredstvo malter. Kutovi središnje prostorije ojačani su dodatnim blokovima kvalitetnije izrade.¹² Površina središnje prostorije iznosila je $21,60 \text{ m}^2$. Sjeveroistočni zid sačuvan je u visini od 1 m. Ulas se nalazio na jugoistočnom dijelu zida. Najveći broj pokretnih nalaza činili su keramički ulomci, koji su najvećim dijelom pronađeni uz stražarsku stazu. Većim dijelom radi se o neukrašenim ulomcima, a manji dio ukrašen je otiscima vrha prsta te geometrijskim motivima izvedenim oštrim predmetom; pronađeno je i nekoliko ulomaka glazirane keramike i stakla.¹³ Istražitelj je utvrdu datirao u 17. – 18. stoljeće, na temelju otkrivenih ostataka arhitekture i pokretnog materijala.

metres thick. The research discovered walls of the fortification and the patrol path made of stone and compacted earth, in line with the inner faces of a fortification wall. The path was 0.80 – 0.86 centimetres wide, and about 0.35 centimetres high. The fortification consists of a central room, while 3.66 metres north-east there is a square cistern walled with double-stacked semi-hewn stones. The masonry technique applied at the fortification consisted of stones with minimal dressing and large pebbles with mortar as binding material. The corners of the central room are reinforced with better-made additional blocks.¹² The area of the central room was 21.60 m^2 . The north-east wall has been preserved to a height of one metre. The entrance was in the south-east part of the wall. The bulk of movable finds were pottery fragments, mostly found along the patrol path. Most of them are undecorated fragments, while a small part is decorated with fingerprints and

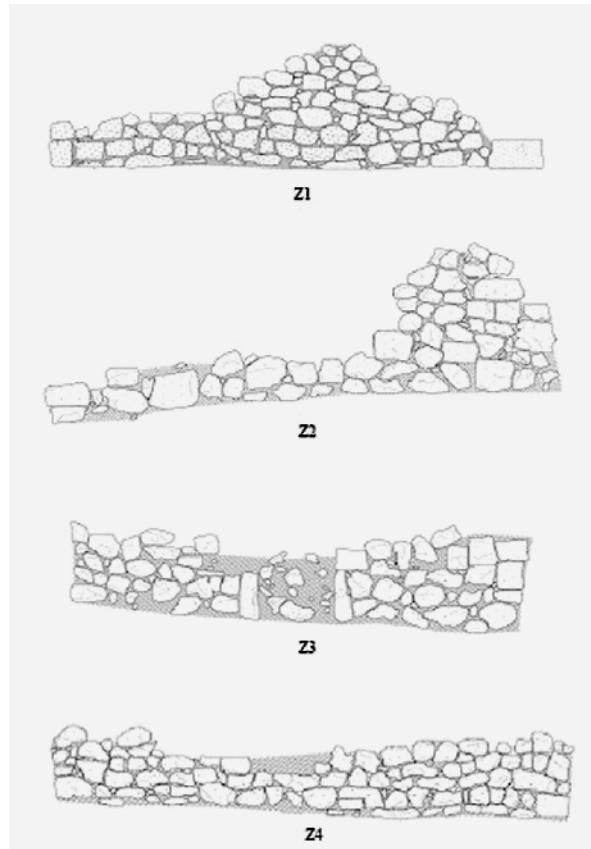
Sl. 20. Crtež zidova centralne prostorije s vanjske strane (preuzeto iz: Oreč 2016, prilog 3)

Fig. 20 Drawing of the walls of the central room, viewed from the outside (taken from: Oreč 2016, appendix 3)

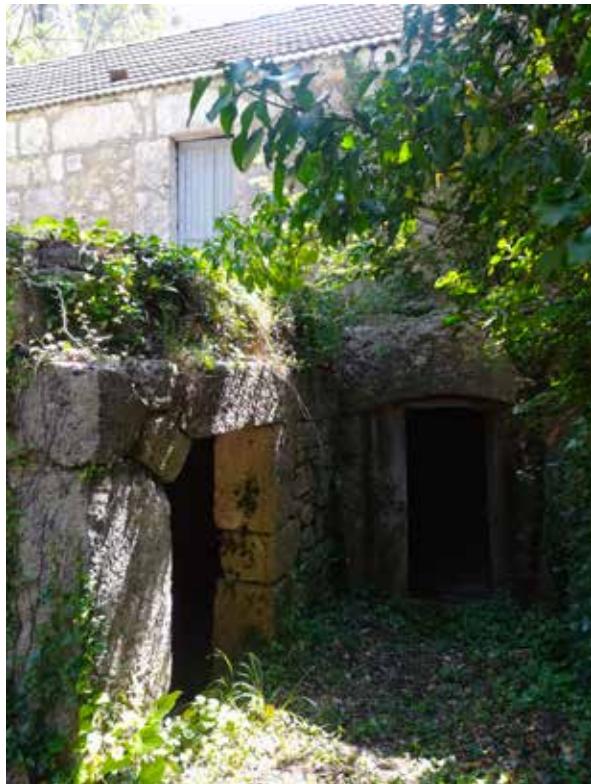
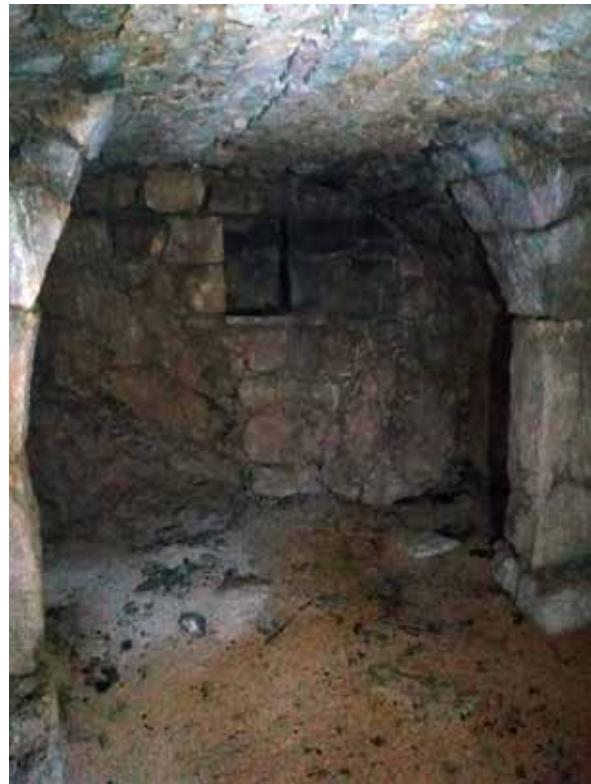
Sl. 22. i 23. Kapelica u Ćemerima iznad koje je podignuta kuća (foto: M. Soldo)
Figs. 22 and 23 Oratory in Ćemeri, above which a house was built (photograph: M. Soldo)

je strani također visoka litica, a na južnoj golema stijena visoka oko tri metra. Mjesto je bilo otvoreno samo prema zapadu, kuda je pucao dalek pogled na dolinu Ričine. Na okolnim liticama vidjeli su se usjeci koji su mogli služiti kao ležišta drvenim gredama, na zapadnoj polovici jednoetažne, a na istočnoj dvoetažne gradnje. Osim toga, na stijeni s južne strane usječena su ležišta greda i stepenice koje su vodile na kat. Na stijenama su bili usjećeni znakovi križa, ukupno njih šest. Južno od ovog kompleksa župne kuće, stotinjak metara južnije nalazila se mala kapelica, dužine 5,50 m, širine 3,30 m, visine 2,25 m. Nadsvođena je čemerom. Pokraj ove prostorije nalazila se još jedna prostorija, dimenzija 4,17 x 3,15 x 2,12 m. Tijekom vremena objekti su bili napušteni, iznad kapelice izgrađena je kuća, a prostorije u prizemlju (kapelica i možda sakristija) služile su kao podrumi. U blizini ove kuće (danас napuštene) nalaze se mlinice, koje su mještani obnovili te se koriste i danas. Istraživanje sjedišta stare župe Podbila predstavlja iznimski doprinos proučavanju kršćanstva i crkvene arhitekture tijekom stoljeća na području zapadne Hercegovine, ali i šire.

en beams, in the western half for one storey, and in the eastern for two floors. In addition, rests for beams and the staircase to the first floor were cut into the rock on the south side. A total of six signs of the cross were incised on the rocks. Some hundred metres to the south of the parsonage complex there was an oratory, 5.50 metres long, 3.30 metres wide, and 2.25 metres high. It is vaulted. Next to this room there was another one, measuring 4.17 x 3.15 x 2.12 metres. The buildings were abandoned over time, and a house was built above the oratory, while the rooms on the ground floor (the oratory and possibly a vestry) served as cellars. In the vicinity of this house (now abandoned) there are watermills, restored and still used by the locals. The research of the seat of the old parish of Podbila represents a huge contribution to the study of Christianity and church architecture through the centuries in western Herzegovina and beyond.
