# Rolling Bearing Fault Detection in the Range of Ultrasound

Goran ŠINIKOVIĆ\*, Nenad GUBELJAK, Emil VEG, Mladen REGODIĆ, Darko JAGARINEC, Ivana MEDOJEVIĆ, Zorana JELI

**Abstract:** Acoustic signals have been used widely to detect the integrity of metal parts and the soundness of their contact. Diverse methods are developed to evaluate the actual quality of metal-to-metal contact having a lubricating layer. These methods are sensitive to the sound waves resulting from the sliding and rolling contact of the adjacent items. The ongoing research and operational experience created an effective and reliable method for acoustic detection of rolling bearing damage. Sound waves are detected by an appropriate transducer (sensor). The signal is processed, and the resulting root-mean-square (RMS) voltage is tracked. An increase in the voltage level indicates deterioration in bearing conditions. In practice, however, such an application almost always involves several considerations, including a significant amount of interfering background noises, unacceptable sound wave attenuations, and inaccessibility of the desired sensor locations.

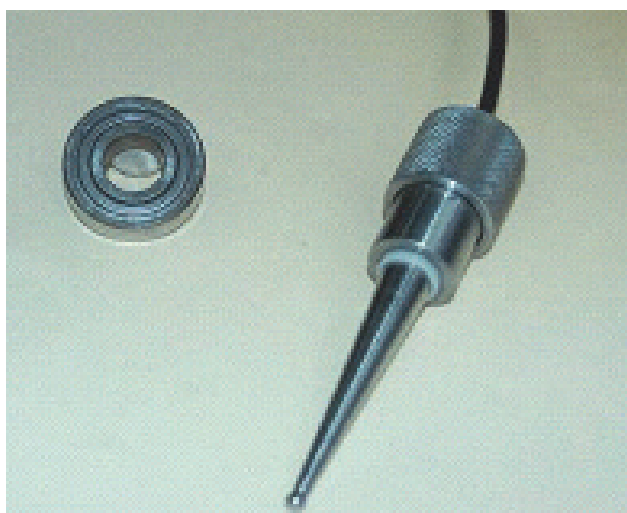
Figure 1 Ultrasonic transducer

The ultrasonic transducer (Fig. 1) used in the experiment uses sensors (Fig. 2) with piezo-electric quartz crystals excited by the energy of high-frequency acoustic vibrations.

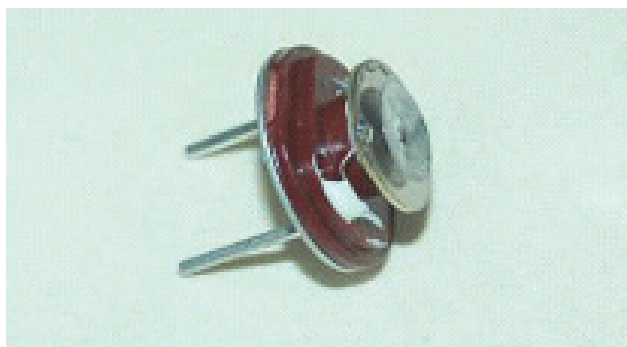
Figure 2 Ultrasonic sensor

The sensor measurement range is from 100 to 500 kHz. The optimal range in bearing detection is in the range of 100-250 kHz. A custom bandpass filter was created precisely according to this characteristic. It practically suppresses all signals below 100 kHz and above 250 kHz. The electronic module also provides a gain of 24 dB and a low output impedance. A 9 V battery is used to minimise interference from the power supply, providing more than 4 hours of autonomy. The electronic module has high-quality, low-noise operational amplifiers NE5532 and NE5534. They are characterised by a noise density at the input of 5 nV/ $\sqrt{\text{Hz}}$  and a GBW (Gain Bandwidth Product) of 10 MHz.

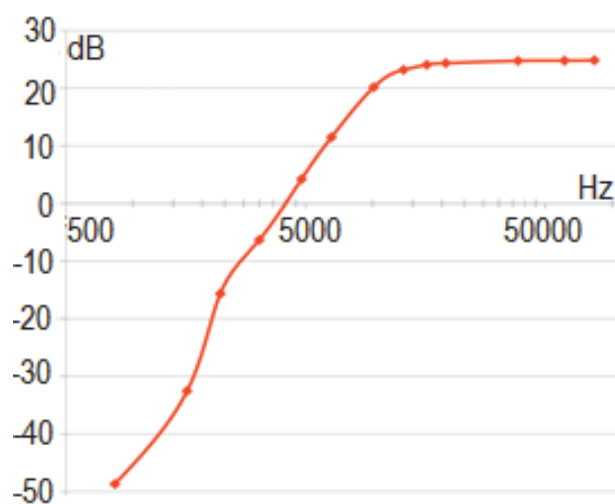
The realised amplitude characteristic was measured. A maximum 24 dB per octave slope was observed in the range from 1200 Hz to 4000 Hz, which then changed to a slope of 12 dB per octave up to 12 kHz.

Figure 4 The transfer characteristic of the high-pass filter
