Nonlinear static analysis of the behavior of an existing masonry building under seismic action

Abstract: In the territory of Herzegovina there is a large number of masonry buildings, the age of which exceeds 50 years. These are mostly smaller buildings, with one to two floors, while the load-bearing walls are mainly made of cut stone in lime mortar. Larger buildings with load-bearing walls made of bricks and concrete blocks in cement-lime mortar appeared a little later. The floor structures mainly consist of timber oak beams, supported by load-bearing walls, with boarding on the upper side and plaster, on reed netting, on the lower side. Such structures are exceptionally sensitive to seismic action, and almost certainly could not withstand the design seismic load without significant damage and collapse. A nonlinear static analysis of the structure of one such building was performed in this paper. A check of the existing condition was performed in the first analysis, and a check of the partially strengthened structure in the second. It is evident from the analysis that such strengthening significantly improves the bearing capacity, while the increase in deformability (ductility) is

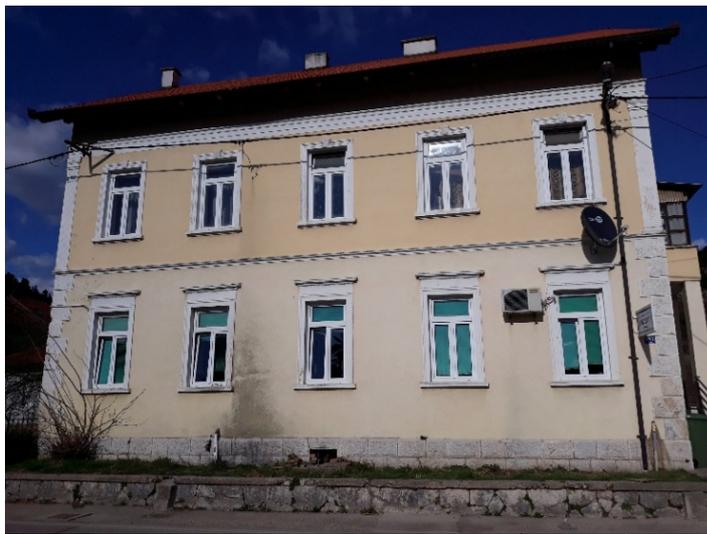
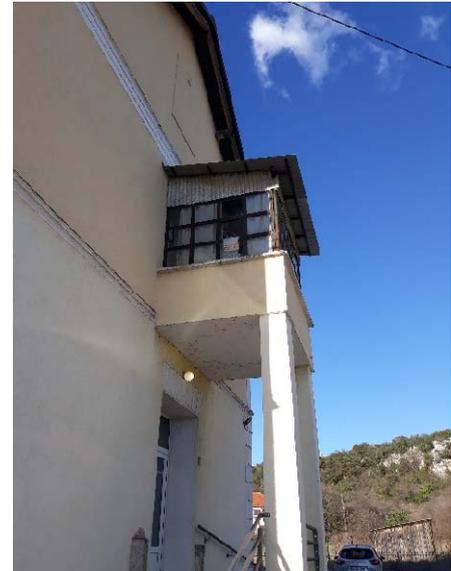
Figure 1. Photographs of the building

In this paper, a nonlinear analysis of the structure of an existing building, constructed in the 1950s, was performed, and the effect of strengthening the structure by adding prestressed steel bars at the level of the floor structures, and strengthening individual walls in the same way, was analyzed. The building has dimensions of 14.6x10.5m, and three floors, one of which is a basement. The ceiling above the basement is vaulted with an arch made of bricks, of a standard size (25x12x6.5 cm). Due to the great stiffness of the basement floor and the fact that it is almost completely embedded in the ground, it will not be taken into account when analyzing the structure for earthquake action. Also, the subsequently added part above the entrance to the ground floor was not taken into account due to its very low stiffness in relation to the original building. The roof is a classic gable roof, with a timber roof structure made of softwood. The roof is covered with tiles. The floor structure above the ground floor and first floor consists of timber oak beams, at an approximate axis distance of 65 cm, and single-layer boarding. The beams are supported by the longitudinal load-bearing walls and it

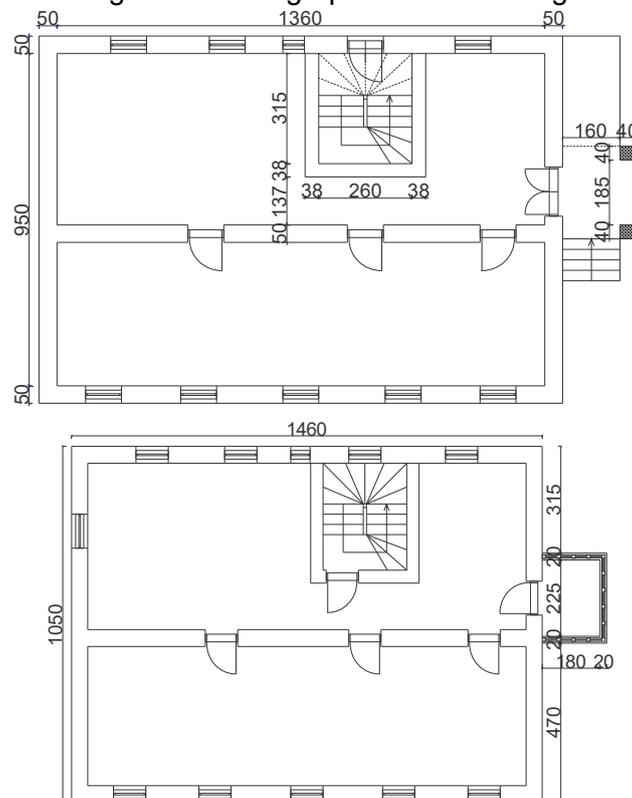
Figure 2. Ground floor and first floor plans

can be assumed that they are not sufficiently connected to the load-bearing walls. The load-bearing walls have a thickness of 50 cm, and they are constructed of bricks of normal size. The vertical communication between the ground floor and the first floor consists of a wooden spiral staircase, framed by brick walls, 38 cm thick (Figure 2).

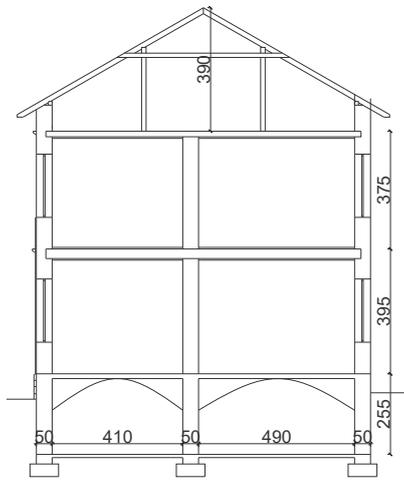
Figure 3. Cross section

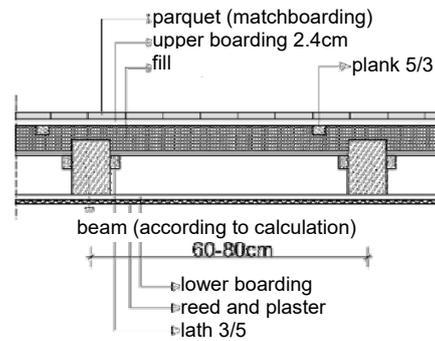
Figure 4. Typical section of the timber floor [16]

Another important structural characteristic of such buildings are the timber floor structures, made of timber beams and boarding. The beams are mainly made of hardwood (oak), while the boarding is made of softwood (fir, spruce). Timber floors have low stiffness in their plane, as well as low bending stiffness, and their connection with load-bearing walls is weak, which directly leads to the poor behavior of such structures under seismic action.

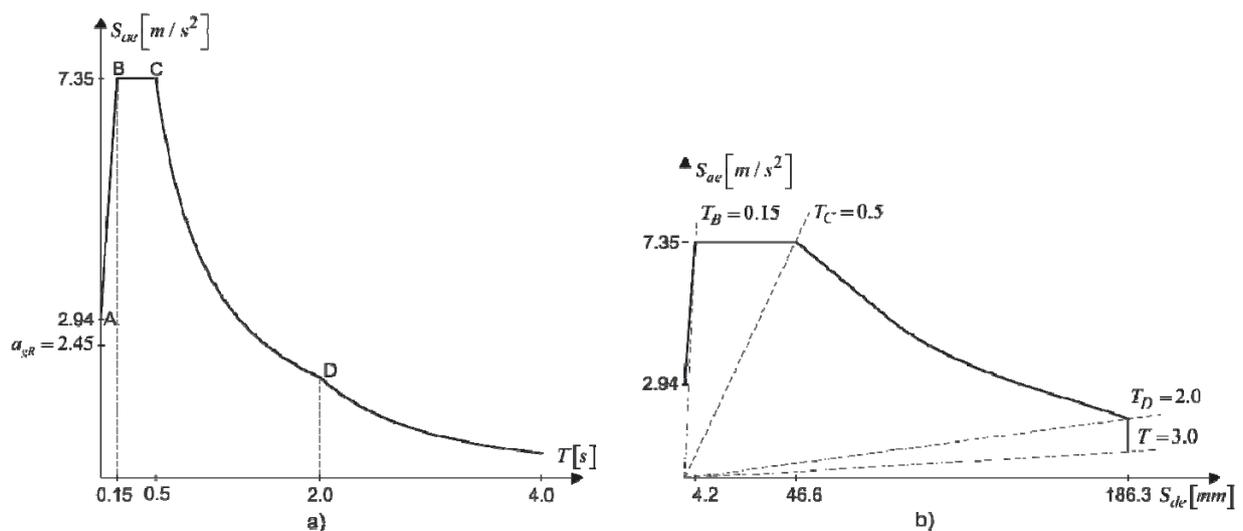
Figure 5. a) elastic spectrum for soil type B and damping of 5% [1], b) AD format

The maximum ground acceleration of the building location, for the return period of $T_{NCR} = 475$ years, is $a_{gR} = 0.25g$, with the probability of exceedance of 10% in 50 years [11]. This value is taken for the control of limit state SD (significant damage), while limit state DL (damage limitation) and limit state NC (near collapse) are not controlled in this text [1]. Figure 5 a) shows the elastic acceleration spectrum, for soil type B and damping of 5%, while Figure 5 b) shows the elastic spectrum in AD format. The importance factor of the building is $\gamma_I = 1.0$, so that the design ground acceleration is equal to $a_{gR} = 2.45 \text{ m/s}^2$.

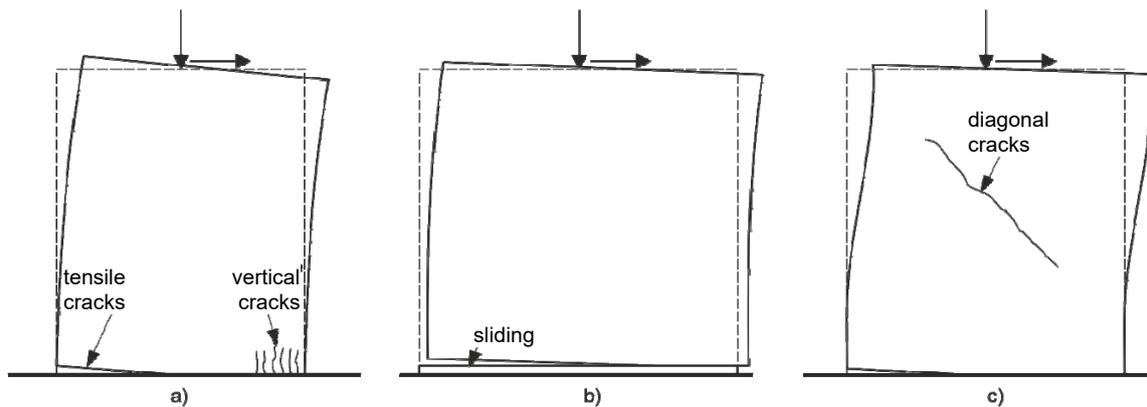
Figure 6. Typical modes of masonry panel failure [6]: a) uplift, b) shear sliding, c) diagonal cracking

Typical failure mechanisms of masonry walls are shown in Figure 6. There are several factors that influence the failure mechanism of masonry walls, such as the wall geometry (the wall length to height ratio, and the size and position of openings in the wall), the quality of the material (wall element and mortar), boundary conditions and the load on the wall. Flexural failure (a) occurs due to the lifting and lowering of the ends of the wall, where the pressed edge of the wall is crushed. Sliding failure (b) occurs due to poor mortar quality and low level of vertical compressive stress. The mechanism of diagonal cracks (c) is also a consequence of shear forces. In this case, the crack can occur along horizontal and vertical joints (stepwise), which is a consequence of the poor quality of the mortar. A diagonal crack can also extend through the wall element, which is a consequence of the insufficient tensile strength of the wall elements (bricks, blocks).

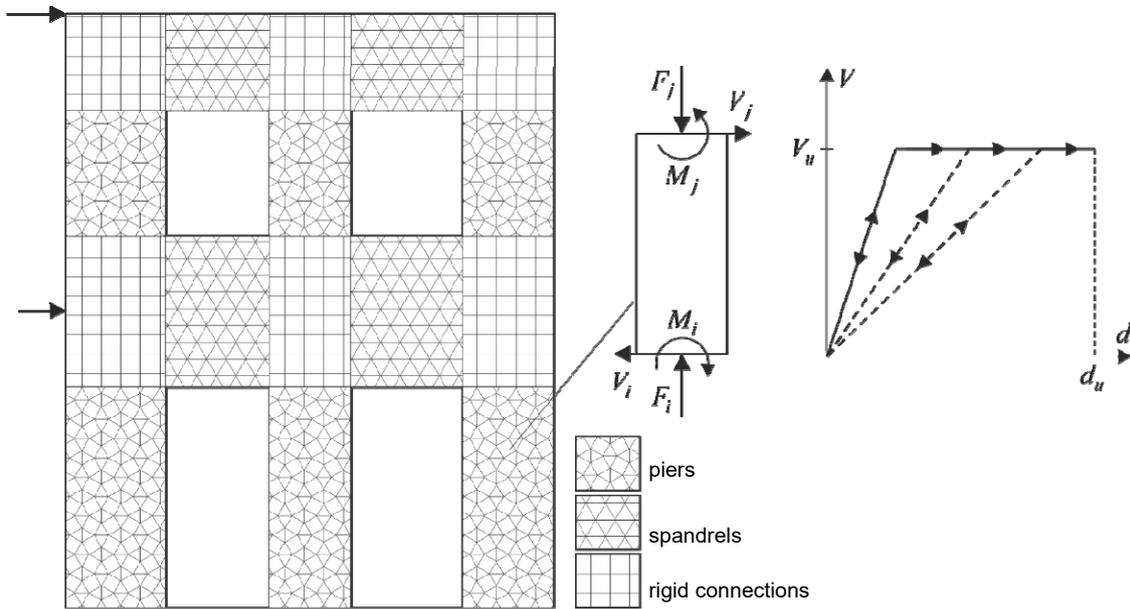
Figure 7. Idealization of the wall with an equivalent frame [6]

Equivalent frames are a simple approach to the nonlinear analysis of masonry structures. The walls are observed as idealized frames, where the deformable elements, piers and spandrels, are connected by rigid connections (Figure 7). The nonlinear behavior of the walls includes a cyclic relationship of stresses and deformations, where the tensile strength of the walls is excluded. The piers are the main load-bearing vertical elements, which take lateral and vertical loads, while the spandrels are called secondary horizontal elements, which connect the adjacent deformable piers. They affect the boundary conditions of the piers, and therefore have a significant influence on the behavior of the wall loaded with seismic forces.

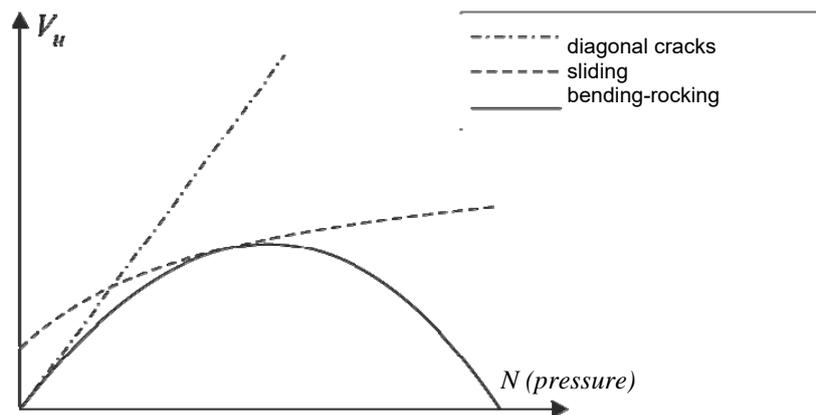
Figure 8. Comparison of criteria [4]

Shear failure is defined by the Turnšek-Čačović criterion [13], which is more appropriate for existing masonry structures than the Mohr-Coulomb criterion:

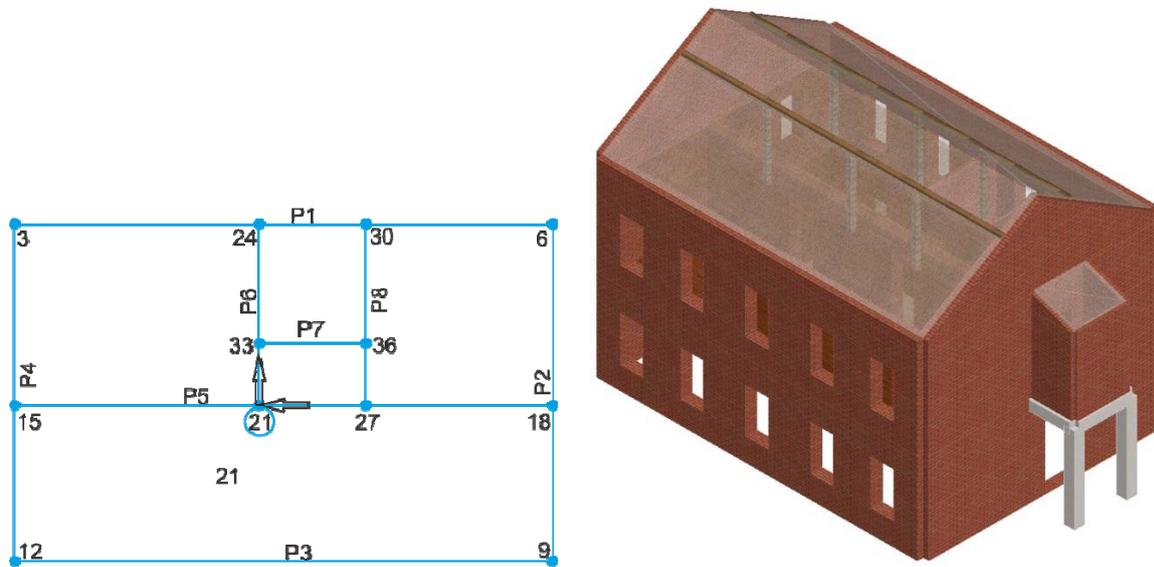
Figure 9. Position of walls and nodes, and 3D model of the building

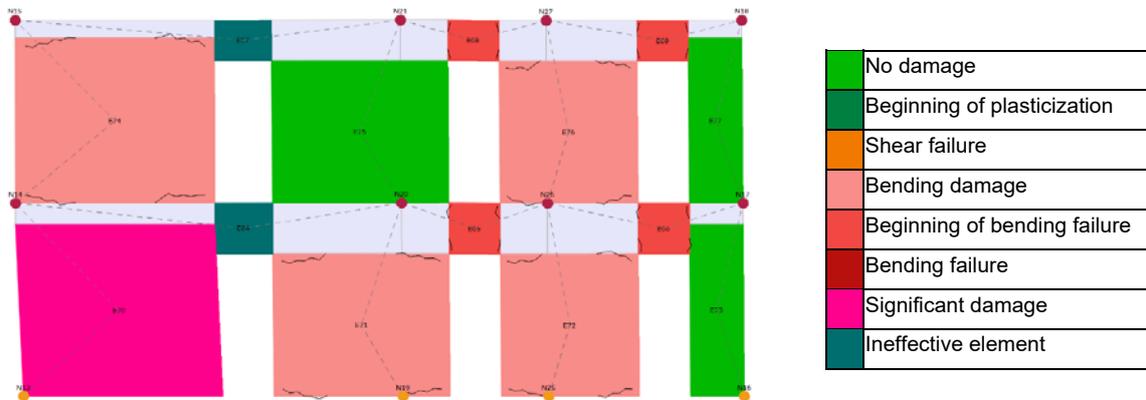
Figure 10. Failure mechanism of wall P5 when the displacement $d_m = 13.4 \text{ mm}$ is reached (3)

For the X direction, analysis 4 is the most significant, while for the Y direction, analysis 6 is the most significant. Figure 10 shows the degree of damage to wall P5, for the maximum displacements reached in the X direction, while Figure 12 shows the degree of damage to wall P2.

From table 4 it can be seen that the relative displacement of the first floor of wall P5 is 0.9%, of the second floor of wall P7 it is 0.47%, of wall P3, in the second floor 0.57%, while the relative floor displacement of wall P1 in the second floor is 0.51%. Therefore, wall P5, which extends in the X direction, does not meet the criteria given by expression (5) or (1).

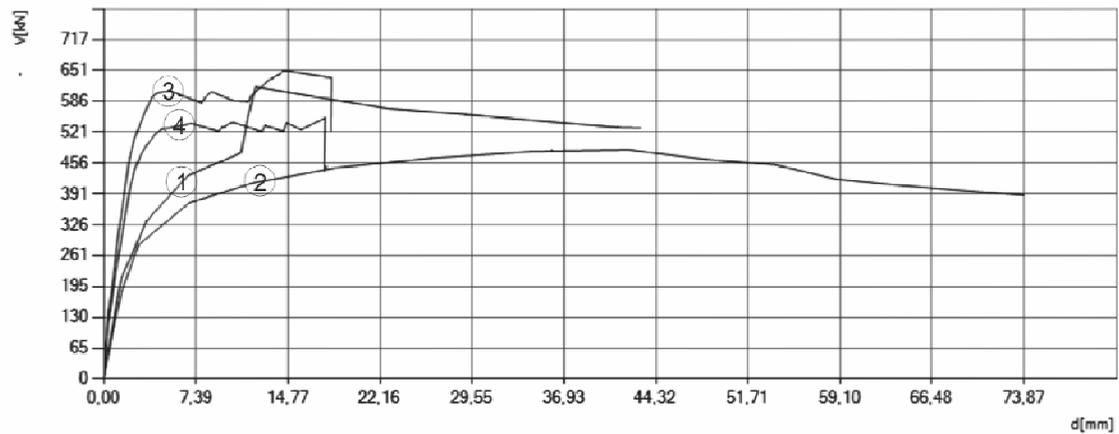
Figure 11. Pushover (capacity) curves for the X direction (actual state)

(Figures 11 and 15, and 12 and 16) shows a significant increase in the bearing capacity of the structure in both directions, while the deformability capacity is much less pronounced.

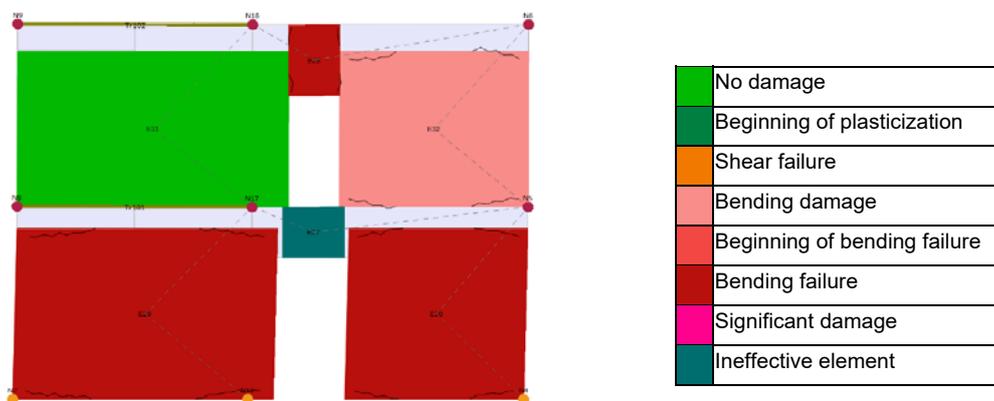
Figure 12. Failure mechanism of wall P2 when the displacement $d_m = 10.8 \text{ mm}$ is reached (6)

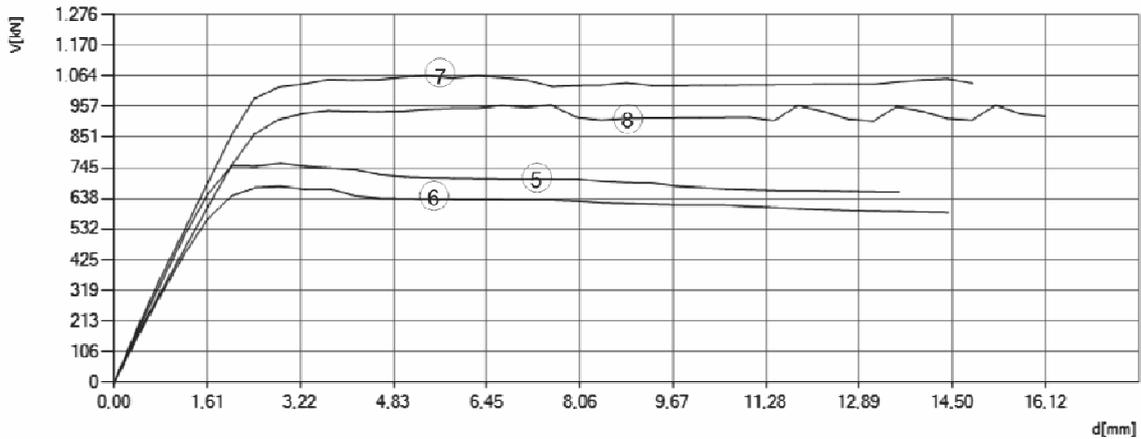
Figure 13. Pushover (capacity) curves for the Y direction (actual state)

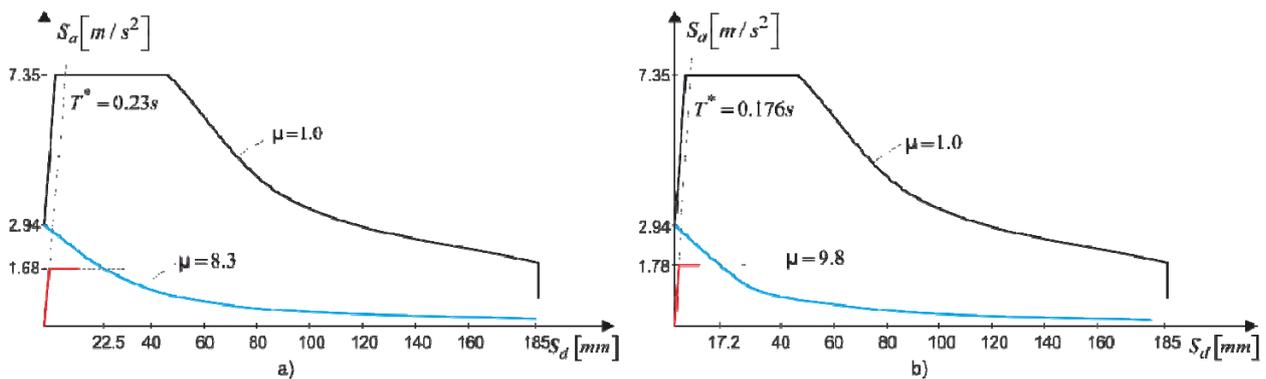
Figure 14. Results of the analysis of the unstrengthened str., a) analysis 4, b) analysis 6

This should be observed in the light of the fact that the existing structure have not met the requirement defined by the spectrum (Figure 14). The same applies to the Y direction.

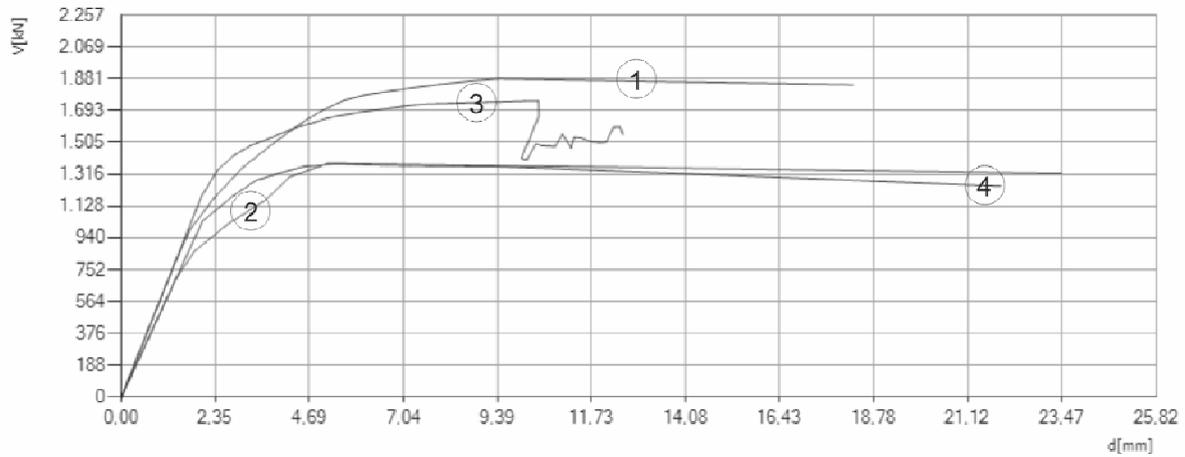
Figure 15. Pushover (capacity) curves for the X direction (strengthened structure)

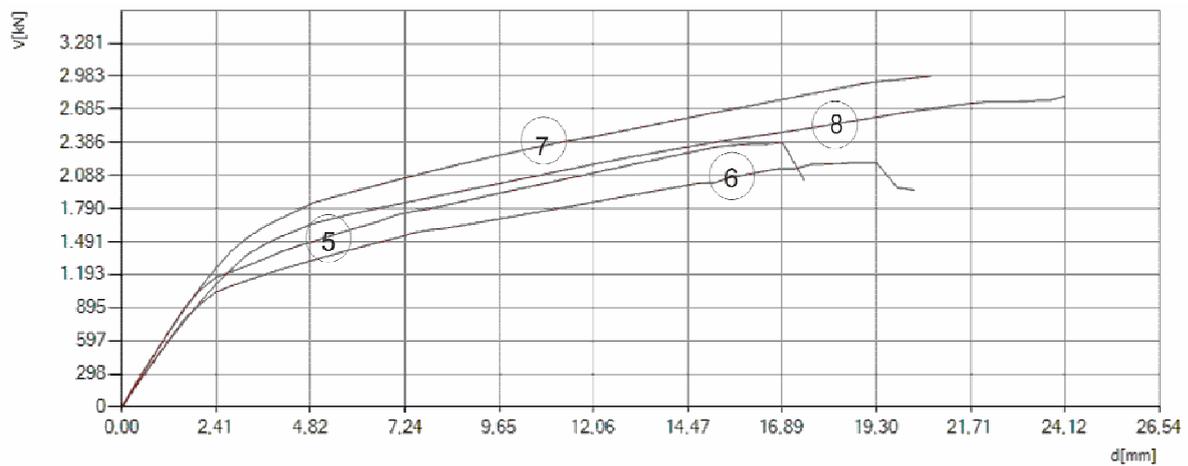
Figure 16. Pushover (capacity) curves for the Y direction (strengthened structure)

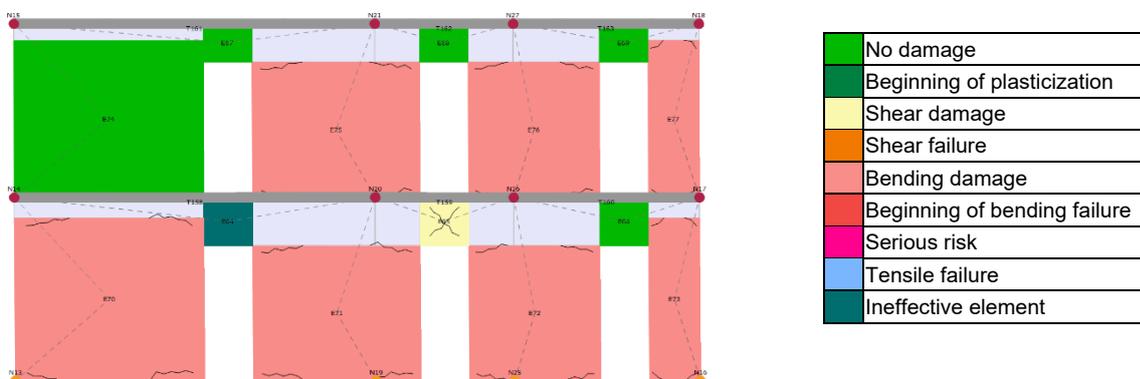
Figure 17. Damage levels to wall P5 (6) at target displacement (strengthened structure)

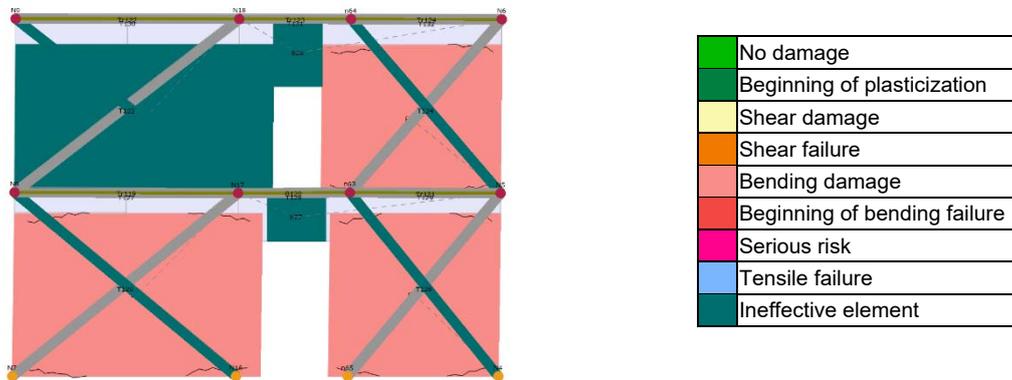
Figure 18. Damage levels to wall P2 (3) at target displacement (strengthened structure)

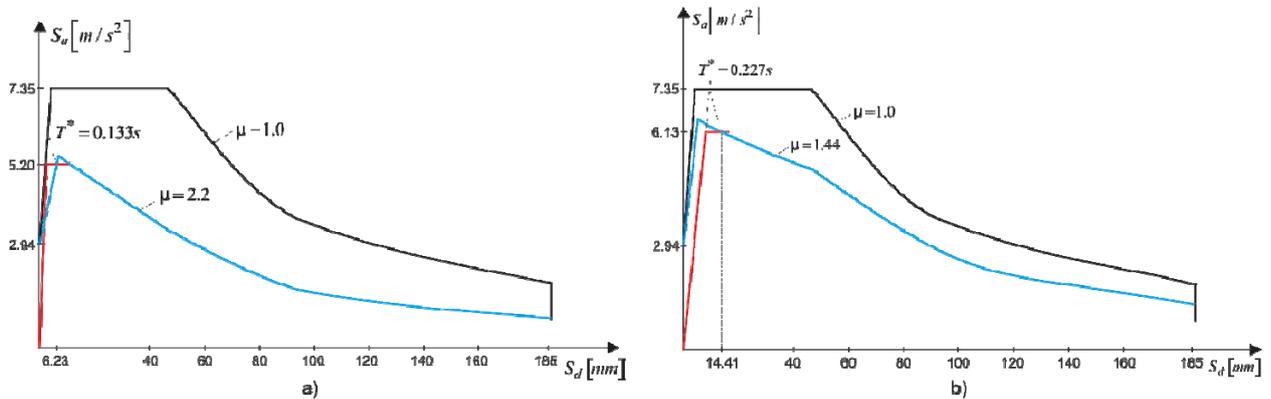
Figure 19. Results of the analysis of the strengthened structure, a) analysis 3, b) analysis 6

After strengthening the structure by adding prestressed steel elements (4Φ16~1Φ32) at the height of the floor structure, as well as by strengthening the walls P2, P6 and P8, an improvement in its load-bearing capacity is visible. A comparison of the capacity curves
