O PADU ZRAKOPLOVA B 24 LIBERATOR KOD SELA BRNJICE*

THE CRASH OF THE B 24 LIBERATOR AIRCRAFT NEAR THE VILLAGE OF BRNJICA*

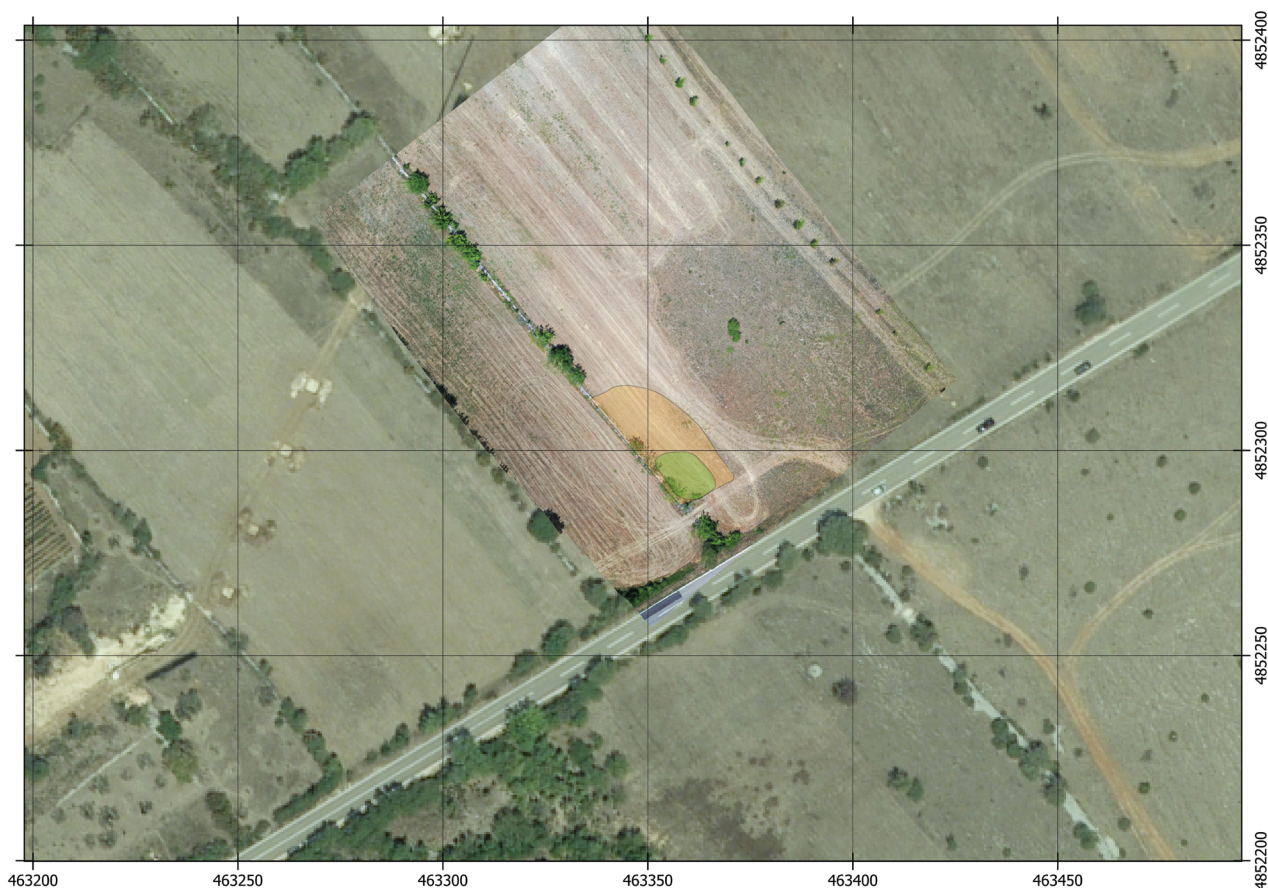
Slika 2. Ortofoto mjesta pronalaska dijelova zrakoplova. Zelenom bojom označeno je područje gdje su pronađeni rastaljeni dijelovi, dok žuta boja označava mjesto gdje su pronađeni ostali dijelovi zrakoplova (izrada: Ruina d.o.o.).

Figure 2. An orthophoto of the location in which the aircraft parts were found. The area where the melted parts were found is marked in green, and the place where other parts of the aircraft were found is marked in yellow (by Ruina d.o.o.).

Tijekom studenoga i prosinca 2019. godine napravljeno je više ciljanih terenskih pregleda tog područja, no bez rezultata. Konačno, 2. siječnja 2020. godine u suhozidu nedaleko od spomenute prometnice pronađena su dva komada aluminijske oplata koja su prepoznata kao dijelovi zrakoplova. Suhozid se nalazi između katastarskih čestica 5131/1 i 5128/2, katastarska općina Konjevrate. Neposredno pokraj suhozida na k. č. 5128/2 primijećeno je i manje uleknuce u zemlji na čijoj je površini pronađena veća količina rastopljenih aluminijskih dijelova. U sljedećih nekoliko navrata na spomenutoj kat. čestici i susjednoj 5128/1 intenzivnim površinskim pregledom pronađeno je 206 dijelova koji su pripadali zrakoplovu (v. Sl. 2).

During November and December 2019, several targeted field surveys of the area were made that yielded no results. Finally, on January 2, 2020, two pieces of aluminium plate were found in a drywall not far from the aforementioned road, which were recognized as the pieces of the aircraft. The drywall is located between cadastral plots no. 5131/1 and no. 5128/2, of the cadastral municipality of Konjevrate. Right next to the drywall on the cadastral plot no. 5128/2, a smaller depression in the ground was also noticed, and a larger amount of melted aluminium parts was found on the surface. During the next several visits to the mentioned cadastral plot, and the neighbouring plot no. 5128/1, an intensive field survey revealed 206 airplane parts (see Fig. 2).

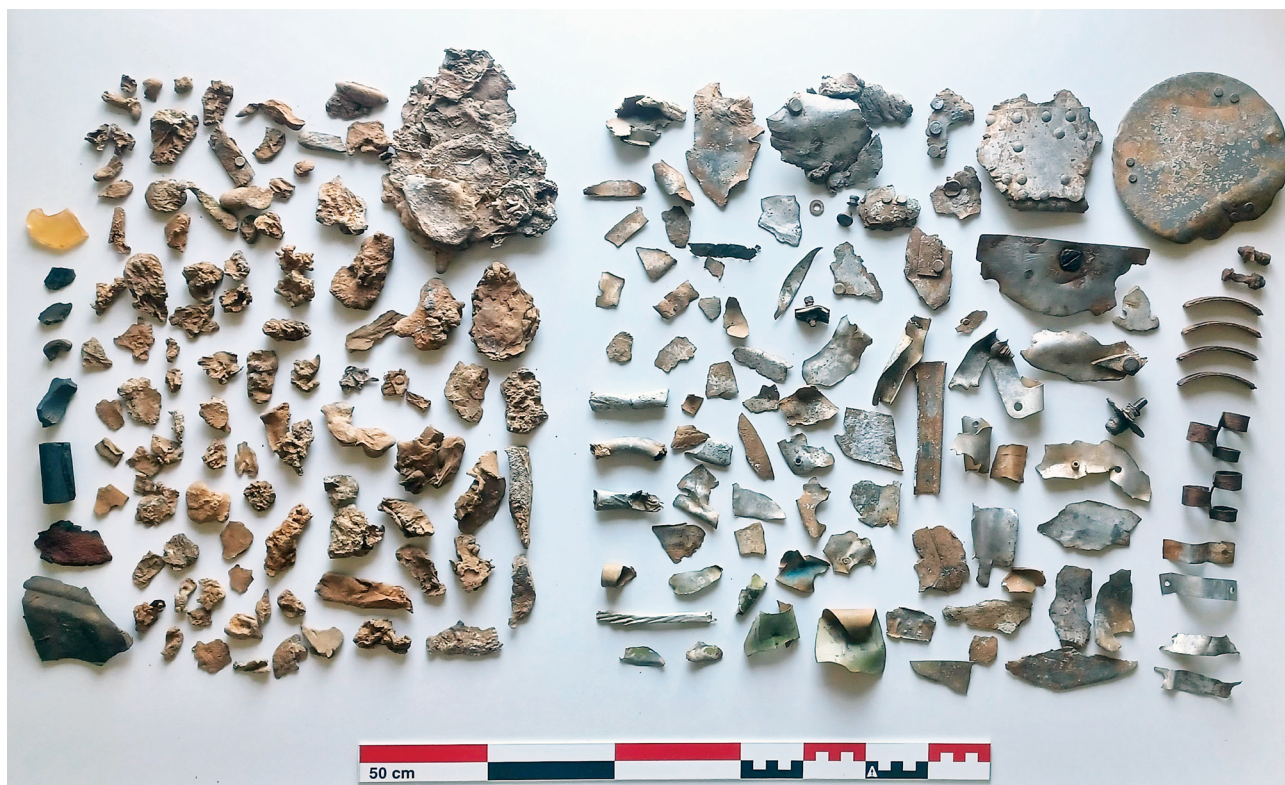
Slika 4. Dijelovi zrakoplova pronađeni na mjestu pada (foto: autor).

Figure 4. Parts of the plane found at the crash site (photo by: the author).

Osim zračnog snimanja, GPS uređajem zabilježen je precizni obris lokacije na kojoj su pronađeni rastopljeni dijelovi aluminijske legure te obris šireg prostora gdje su površinskim pregledom pronađeni i ostali dijelovi zrakoplova. Zasebno je snimljena pozicija na suhozidu na kojoj su uočena prva dva ulomka. Rezultati dobiveni zračnom fotogrametrijom reljefne površine na kat. česticama 5128/1 i 5128/2 jasno ukazuju na postojanje plićih uleknuća nepravilnog oblika, iako su parcele naknadno intenzivno korištene u poljoprivredne svrhe, o čemu svjedoče i karakteristični tragovi preoravanja (v. Sl. 4).

In addition to aerial photography, the GPS device recorded a precise outline of the location where the melted parts of the aluminium alloy were found, as well as the outline of a wider area where other parts of the aircraft were also found by field survey. The position on the drywall where the first two fragments were found was recorded separately. The results obtained by aerial photogrammetry of the relief surface on the cadastral plot no. 5128/1 and no. 5128/2 clearly indicate the existence of shallow depressions of an irregular shape, although the parcels were subsequently used intensively for agricultural purposes, as evidenced by the characteristic traces of ploughing (see Fig. 4).
