Natural building stone in the construction and renovation of the Zagreb Cathedral

Rudarsko-geološko-naftni zbornik
(The Mining-Geology-Petroleum Engineering Bulletin)
UDC: 553.5; 622; 622.3
DOI: 10.17794/rgn.2023.3.3

Review scientific paper

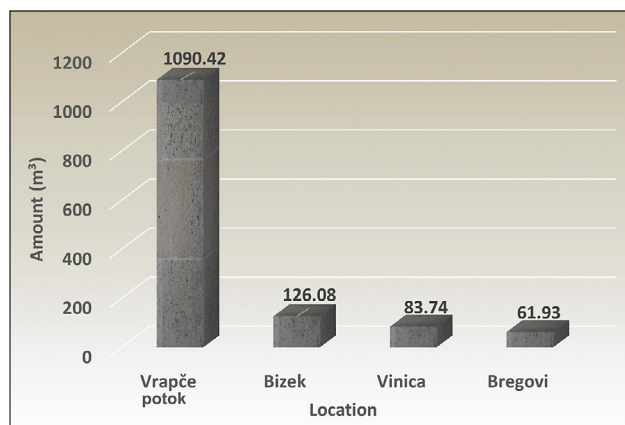
Figure 10: Quantities of stone used during Bollé's restoration

Since no records were kept in the earliest times, it is not possible to determine the exact amount of each type of stone used in the Cathedral construction. After the restoration guided by Hermann Bollé it was possible to determine the exact quantity of various stone types, as shown in quantitative data published by Crnković (1992a), and in Figure 10. The most used variety was lithothamnium from the Vrapče potok Quarry.
