# Operational plan for responding to and rescuing works of art in the event of a fire: a case study for the Sacred Art Collection in Trogir, Croatia

**Objective:** To develop a model of an operational plan for rescuing cultural heritage on the example of the Sacred Art Collection in the city of Trogir, Croatia.

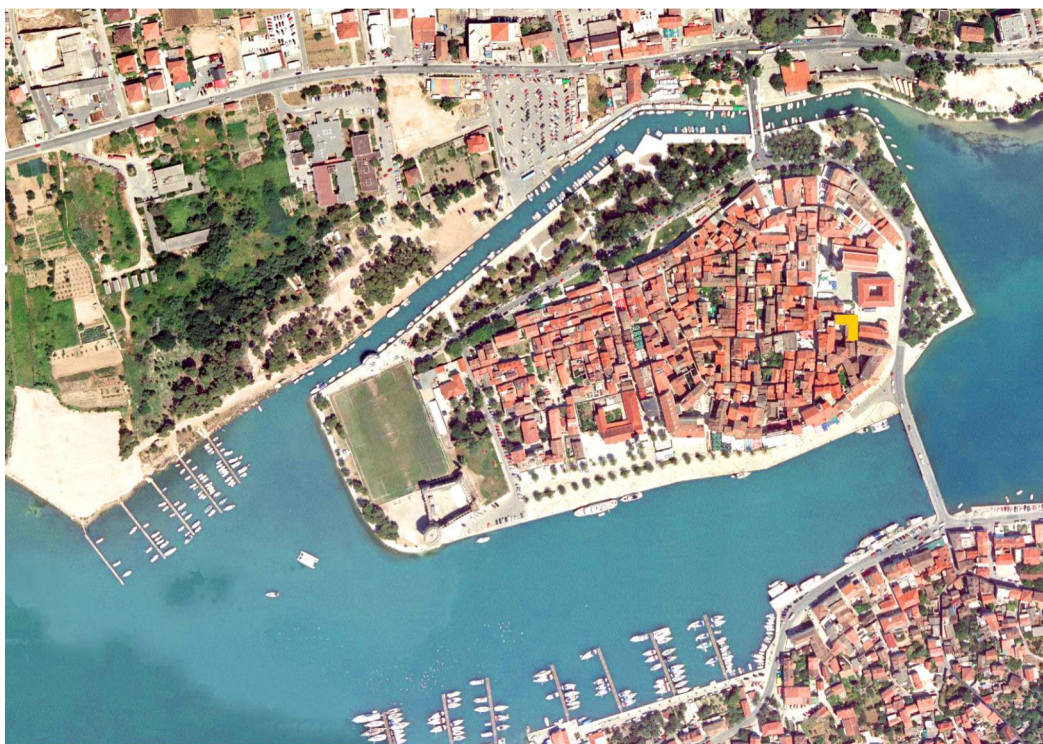
**Figure 1.** The city center of Trogir, the location of the Parish house building is marked in yellow (Buble & Popović, 2022a, reprinted with permission).

Among some general information and definitions, the introduction contained information about Plan storage locations and the planned time of the document's revision. The other important documents contained facility information: the address, textual location description, location on the satellite map, and main contact for the building (Figure 1).

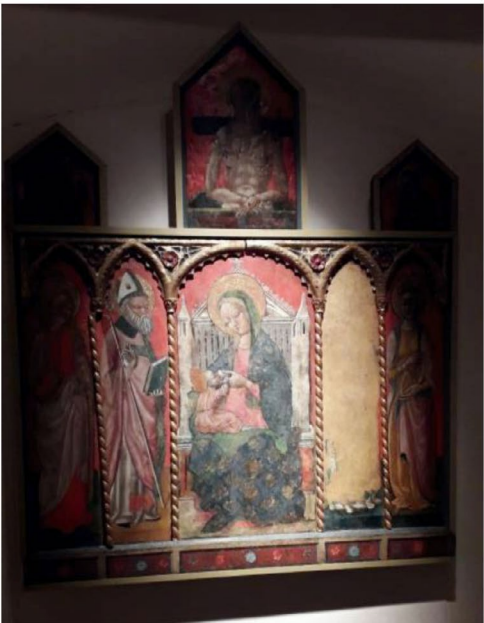
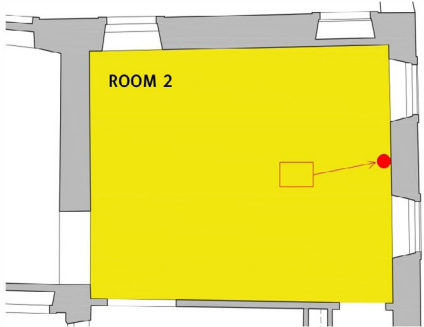
ITEM	PLACEMENT IN SPACE

**Figure 2.** The artifact Our Lady with Saints, its special placement in space (marked with an arrow), and the corresponding photograph (Buble & Popović, 2022a, reprinted with permission). Note: For the protection of this cultural heritage the special placement does not correspond to the actual situation.

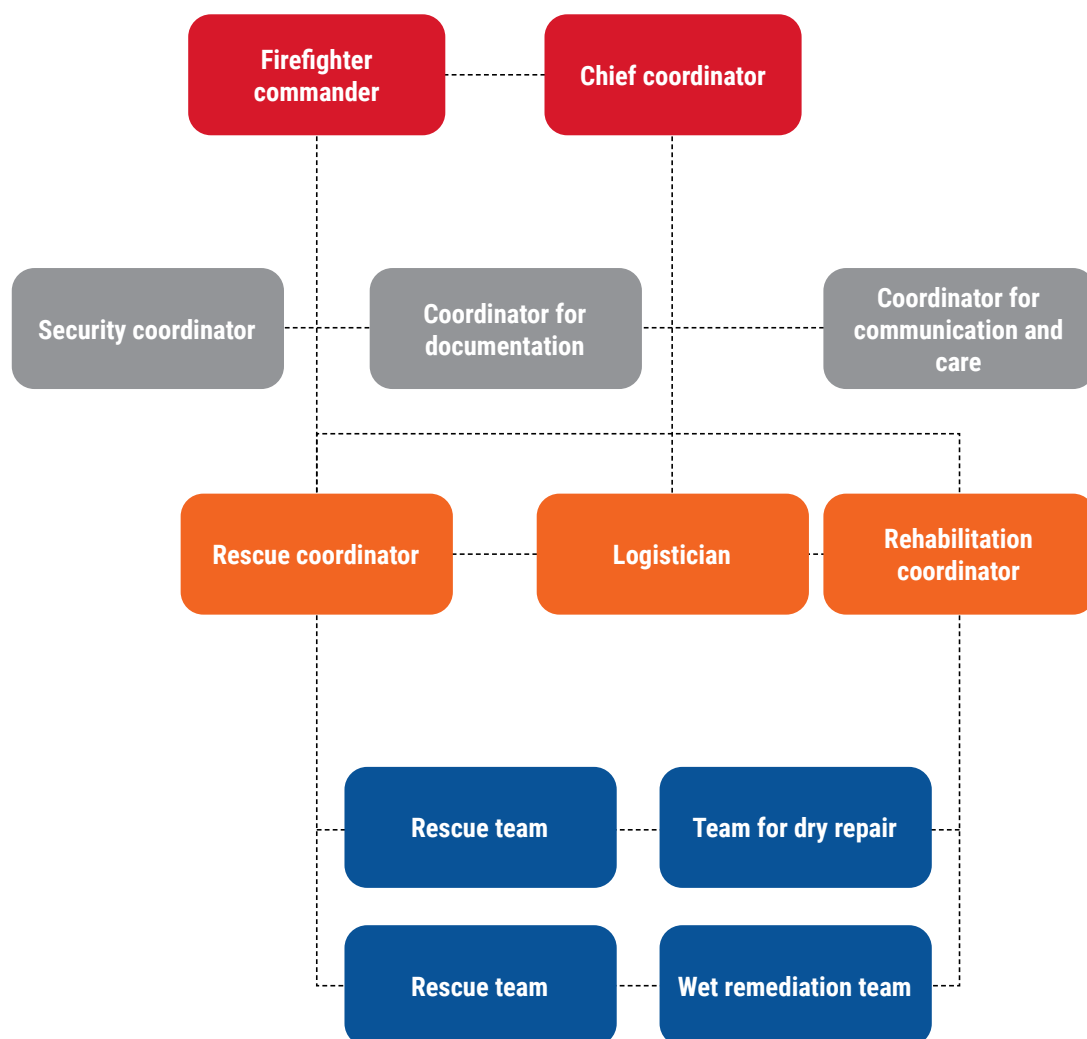
**Figure 3.** Management structure of the responsible personnel (Buble & Popović, 2022a, reprinted with permission).

A diagram was used to visually represent the emergency management hierarchy, which included all the roles that, in an ideal case, would be necessary to systematically carry out the rescue operation.

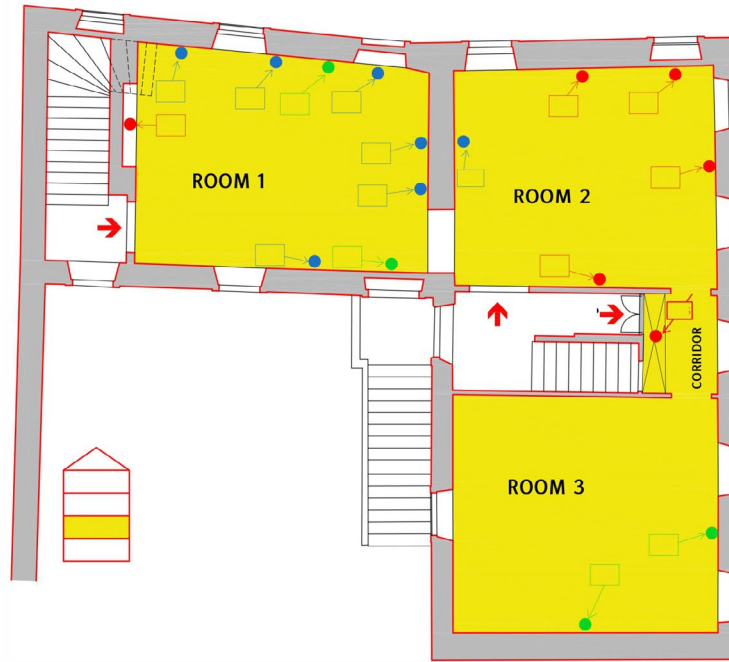
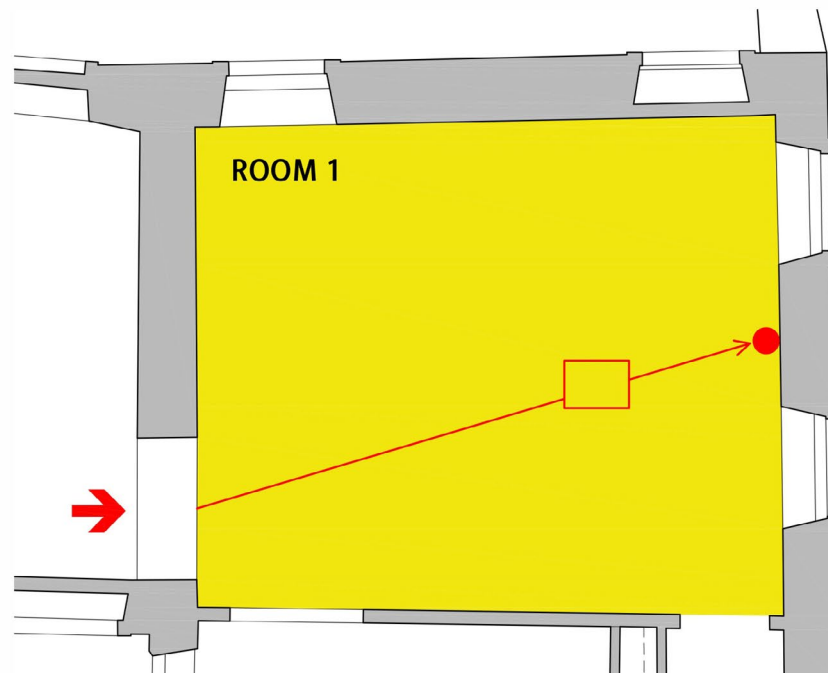
## FIRST FLOOR

**Figure 7.** The first-floor plane with the position of the artifacts in space. Enlarged position of the Madonna in the Rose Garden, and evacuation pathways (Buble & Popović, 2022a, reprinted with permission), red arrow showing the special placement of the item. Note: For the protection of this cultural heritage the special placement does not correspond to the actual situation.
