UNUTARNJI DIO KOMPLEKSA DVOJNIH VRATA U PULI

THE INNER ZONE OF PULA'S PORTA GEMINA COMPLEX

Investigation, Preservation, and Interventions

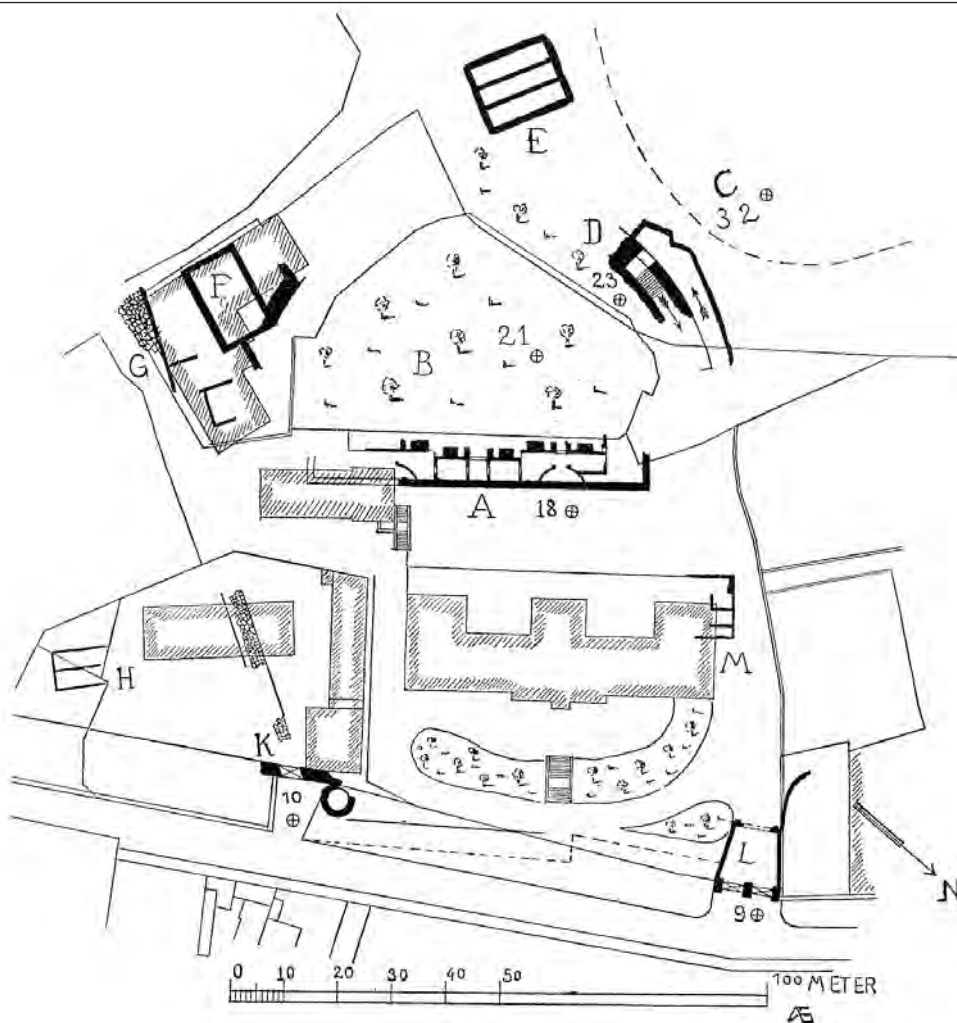
Sl. 1 Tlocrt područja gradskih zidina početkom 20. stoljeća; Dvojna vrata označena su slovom L (preuzeto iz Gnirs 1912).
Fig. 1 Plan of the city wall area in the early 20th c.; the Porta Gemina is indicated as "L" (after Gnirs 1912).

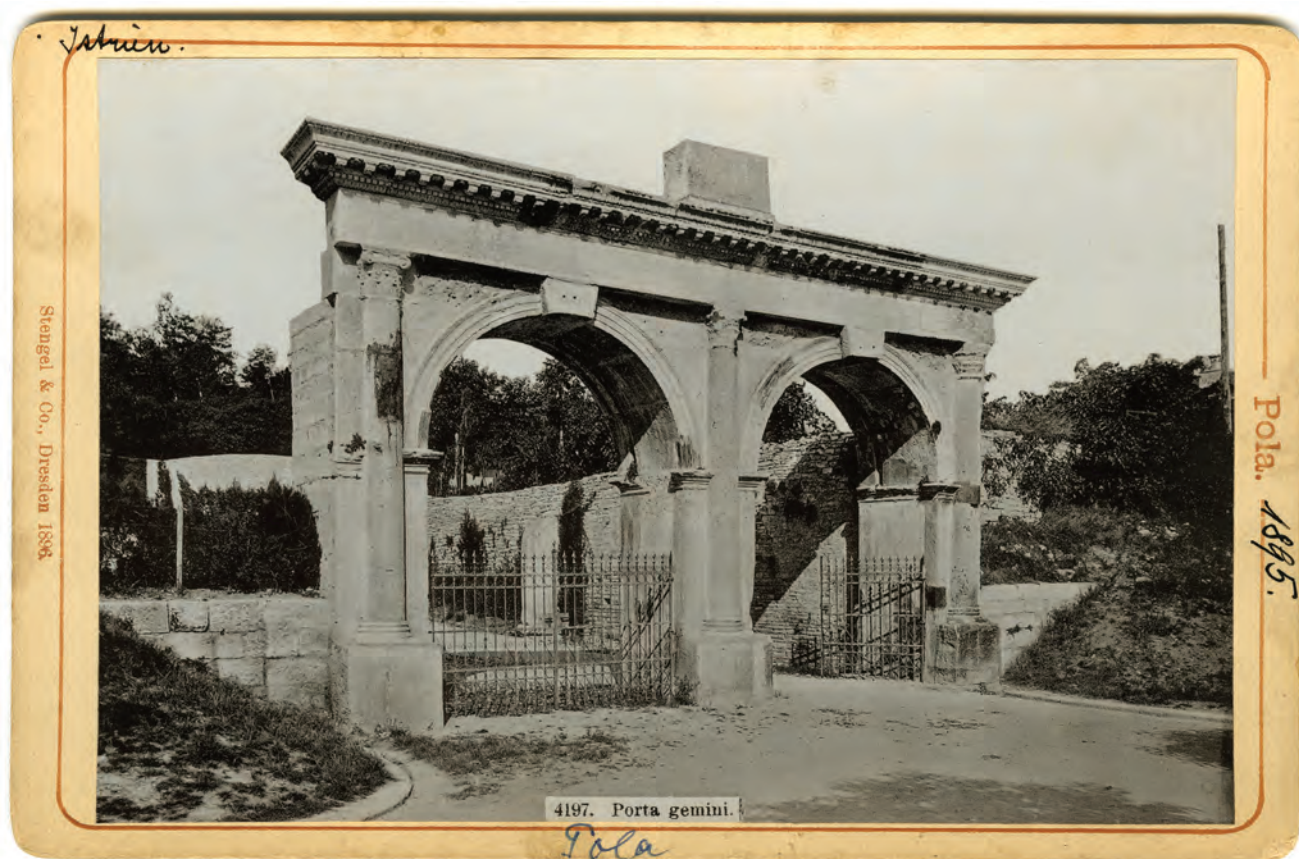
Sl. 2 Pogled na Dvojna vrata s vidljivim pilastrom u pozadini (Dokumentacijski odjel AMI-ja).

Fig. 2 View of the Porta Gemina with a pilaster visible in the background (AMI Documentation Department).

Naravno, povjesničari i arheolozi primijetili su pilastre i povezali ih s realnim stanjem. Vrijeme izgradnje Dvojnih vrata, podignutih na ostacima starijih rimskih vrata, na sjeveroistočnoj strani pulskih gradskih zidina, smješta se u kraj 2. stoljeća (Matijašić, Buršić-Matijašić 1996, 61), ali bitno je napomenuti da Fischer prema dekoraciji vijenca smatra da bi se mogla smjestiti i u polovicu 1. stoljeća (Fischer 1996, 66-67). U pozadini se nalaze dvije kamene baze koje na sebi nose četvrtaste pilastre ukrašene s gradske strane. Na zapadnom pilastru prisutan je ostatak kaneliranog polustupa s bazom, dok je na istočnom preostala samo baza. Ova su dva pilastra bili dijelovi antičkog kompleksa gradskih vrata koja su se vezivala na Dvojna vrata u nastavku gradskih zidina, tvoreći zatvoreni ulaz. Prvobitno su vrata imala trapezoidni tlocrt koji se pružao prema unutrašnjosti grada (Mlakar 1978, 28). Isti je trapezoidni tlocrt istaknut danas ogradnim zidom dvorišta Arheološkog muzeja Istre i dvorišta Hrvatske gospodarske komore, a moguće je pretpostaviti da relativno vjerno prikazuje originalne poteze vrata s obzirom da su u istom pravcu pružanja označeni zidovi i tijekom povijesnih istraživanja (Sl. 2).

Historians and archaeologists have, of course, observed the pilasters and their actual relationship. The erection of the Porta Gemina, raised atop the remains of an older Roman gate at the northeast side of Pula's walls, has been dated to the late 2nd c. (Matijašić, Buršić-Matijašić 1996, p. 61), but it is worth noting that, based on the decoration of the cornice, Fischer is of the opinion that the date could also be in the mid-1st c. (Fischer 1996, pp. 66-67). To the back are two stone bases bearing rectangular pilasters, decorated on the side facing the city. On the pilaster to the west we see the remains of a fluted engaged column with its base, while on the east pilaster only a base survives. These two pilasters were part of an antique period enclosed entrance complex that included the Porta Gemina where the city wall ran. Initially the gate complex had a trapezoidal footprint tapered towards the city (Mlakar 1978, p. 28). The same trapezoidal footprint is presently apparent in the fence wall of the courtyard of the Archaeological Museum of Istria and of the Croatian Chamber of Commerce building, and we can posit that it relatively faithfully shows the original line of the gate, given that walls were recorded along the same line during historical investigation episodes (Fig. 2).

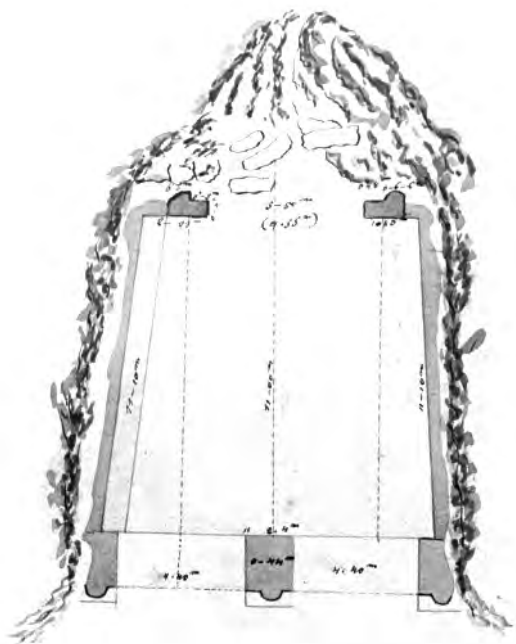
Sl. 3 Prikaz gradskih vrata nakon istraživanja 1843. godine (Fondo fotografico di Trieste, CMSA F NV 3, Inv. 2453d).

Fig. 3 The city gate following the 1843 investigation (Fondo fotografico di Trieste, CMSA F NV 3, Inv. 2453d).

smjeru ‘Grčke crkve’...” (današnja pravoslavna crkva sv. Nikole). Odmah iza vrata pronađeni su mnogobrojni ulomci koji su im pripadali. Najznačajniji su: tri kamena bloka samoga luka, dva dijela bočnog dovratnika s ostacima reljefnih stupova, dva dijela arhitrava i tri dijela friza koji su ukrašavali gornji dio. Friz je kompozitno korintski i izvrsno je izrađen, a tragovi obrade ukazuju da je nekada podržavao i atiku. Carrara se nada da će u nasutoj zemlji biti u mogućnosti pronaći i veći dio ostatka vrata (Weisshäupl 1894). Izvještaji Carrare govore o namjeri da se vrata rekonstruiraju pronađenim ostacima ili da se ulomci barem sačuvaju na okupu (Weisshäupl 1892) (Sl. 3).

polygonal blocks, rises from the level of the Double Gate towards this single-arched gate. Also present on the paving stones are the deep furrows of wheels, which turn towards the ‘Greek church’ immediately upon passing the gate” (the referenced Greek church is the present-day orthodox Church of St Nicholas). Numerous fragments of the gate were identified in the area just beyond its location. Of these the most significant are: three stone blocks from the arch [voussoirs], two parts from a pier with the remains of columns in relief, two parts of the architrave, and three parts of the frieze that adorned the upper part. The frieze was done in the composite Corinthian style and exhibits excellent workmanship, with traces of tooling indicating that it once supported an attic. Carrara expressed his hope that most of the remains of the gate would be found in the earthen embankment (Weisshäupl 1894). The reports drawn up by Carrara speak to his intention that the gate be reconstructed with the recovered remains or that the fragments be at least preserved as a group (Weisshäupl 1892) (Fig. 3).

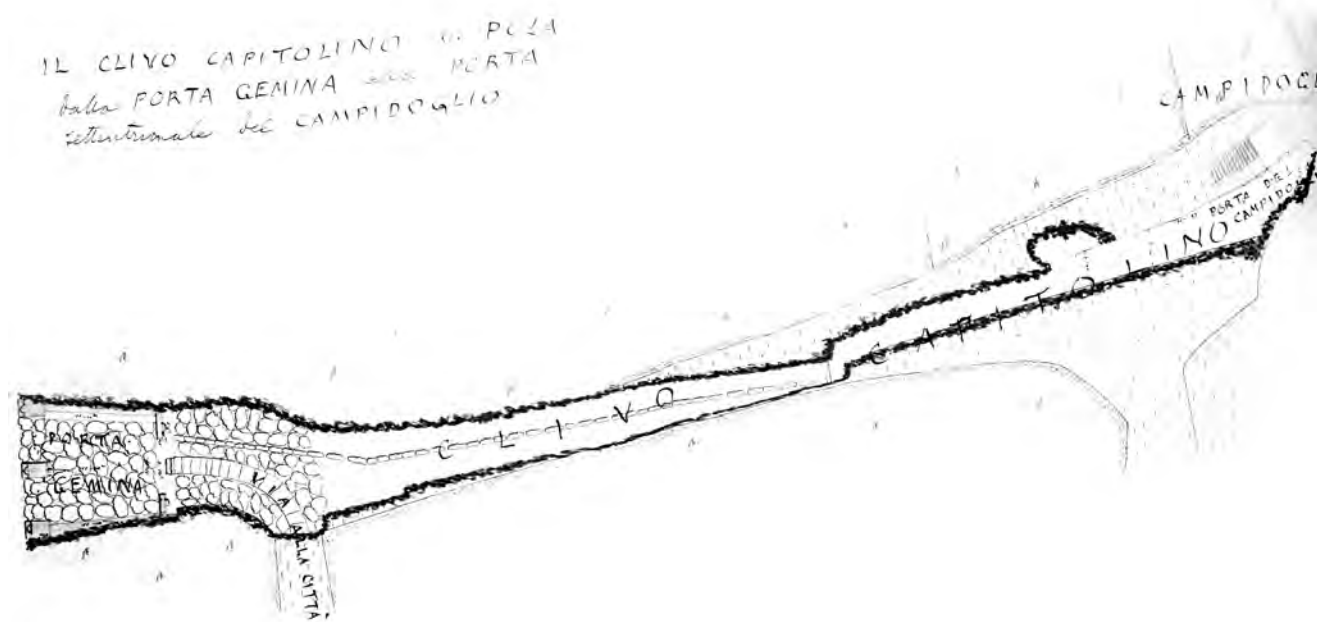
Sl. 4 Prikaz gradskih vrata i nastavka ceste tijekom arheoloških istraživanja polovicom 19. stoljeća (Fondo fotografico di Trieste, FO74745).
 Fig. 4 The city gate and the continuation of the road during the archaeological investigative work of the mid-19th c. (Fondo fotografico di Trieste, FO74745).

Danas više ne znamo gdje su izvještaji koji bi nam prenijeli što se s područjem iza Dvojnih vrata događalo u vrijeme Carrarinog istraživanja 1845. godine i za vrijeme iskopavanja za potrebe izgradnje Gimnazije 1890. Postoji međutim dokument kojim gradska uprava 31. ožujka 1862. prijavljuje Kandleru iskopavanja iza Dvojnih vrata, pri čemu vojne snage ne obavještavaju o nalazima, ali koriste kamen koji tamo pronalaze te čak ruše dva još postojeća pilastra da bi ih iskoristili negdje drugdje (Kandler, *Atti del Conservatore*, No 278, svezak 3, Sveučilišna knjižnica Pula). Godine 1892. Weisshäupl navodi da su baze vrata zajedno s pripadajućim polustupovima pronađene ponovno tijekom iskopavanja za potrebe izgradnje Gimnazije (1890. godine), ali da ne zna gdje su nestali ostali ulomci koje Carrara nabraja (Weisshäupl 1892). Po ovim zapisima moguće je zaključiti da su unutarnja gradska vrata nakon otkrivanja 1845. godine ponovno zatrpana te da su pripadajući ulomci bili sakupljeni negdje u blizini samih vrata. Prostor je s vremenom ponovno prekriven nanosima zemlje i drugog materijala, ali je 1862. godine tijekom iskopavanja vojska preuzela arhitektonske elemente vrata te srušila dva pilastra s polustupovima. Vrata su ponovno otkrivena oko 1890. godine, kada se provode iskopavanja zbog izgradnje Gimnazije te se dodatno kopa i oko Dvojnih vrata jer su im "baze bile s vremenom prekrivene nanosima". Inženjer Natale Tommasi započinje iskopavanja upravo na poziciji jednostrukih vrata u pozadini, kada vraća blokove s polustupovima na njihovo mjesto (Mader 2011). Vezano uz zahvate koji su obavljani na predmetnim pilastrima zanimljiva je i bilješka koju Weisshäupl iznosi 1901. godine, gdje kaže da su unutarnja jednostavnija vrata bila široka 5,5 metara, ali je današnja širina vrata 4,75 metara. Pilastri su vjerojatno bili pomaknuti te su tijekom rekonstrukcije postavljeni bliže nego u izvornoj situaciji (Weisshäupl 1892) (Sl. 4).

Porta Gemina during the period of Carrara's investigative efforts of 1845 and the period of excavation works for the construction of a gymnasium (secondary school) in 1890. There is, however, a document in which the municipal administration on 31 March 1862 notified Kandler of excavation work behind the Porta Gemina, where the military did not file reports concerning finds, but did exploit stone found there and even took down two extant pilasters in order to use them elsewhere (Kandler, *Atti del Conservatore*, No. 278, Vol. 3, Sveučilišna knjižnica Pula). In 1892 Weisshäupl notes that the bases of the gate and the attendant engaged columns were re-discovered during excavation work for the construction of the gymnasium (1890), but that he is unaware of where the fragments enumerated by Carrara are (Weisshäupl 1892). Based on these written observations we can conclude that the inner gate, following its discovery in 1845, was re-buried, and that the fragments in question were collected somewhere in the proximity of the gate. Over time the area was once again covered by deposits of earth and other material, but in 1862 the army, in the course of excavation work, took possession of the architectural elements of the gate, and took down two pilasters with engaged columns. The gate was re-discovered around the year 1890 in the course of excavation work for the construction of the gymnasium, with additional excavation performed around the Porta Gemina as "over time their bases had become covered by deposits". Engineer Natale Tommasi commenced excavation works at precisely the position of the single-arched gate to the back during which time he restored blocks with engaged columns to their positions (Mader 2011). Notable in relation to interventions performed with the pilasters in question is a note written by Weisshäupl in 1901 in which he states that the simpler inner gate had a breadth of 5.5 metres, while the breadth of the gate now stands at 4.75 metres. The pilasters were likely shifted in position and placed in the course of this reconstruction closer to one another than in their original configuration (Weisshäupl 1892) (Fig. 4).

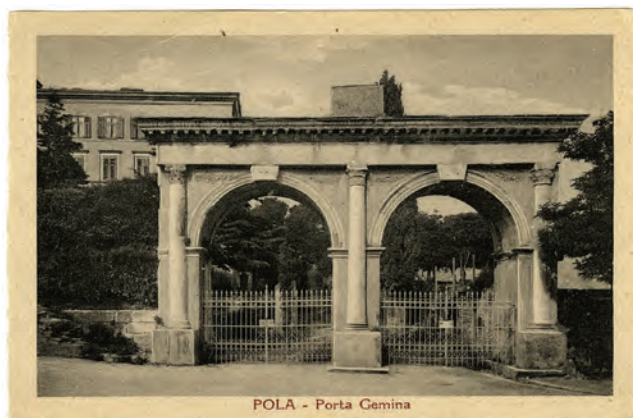
Sl. 5 Dvojna vrata početkom 20. stoljeća, u pozadini su slabo vidljiva unutarnja vrata (Dokumentacijski odjel AMI-ja).
 Fig. 5 The Porta Gemina early in the 20th c., with a partly obscured view of the inner gate in the background (AMI Documentation Department).

with cement-based mortar. New slots were drilled into the blocks to receive and hold the reinforcing iron bands. Also attached to the pilasters was an iron fence for which slots were again drilled into the stone to receive its ends, affixed in this case only with cement-based mortar (Fig. 5).

željeznim elementima, u blokovima su izbušene nove rupe u koje su umetnuti trakasti klinovi. Na pilastre se vezivala i željezna ograda za čije su potrebe također izbušene rupe u kamenu te je ona učvršćena samo cementnim mortom (Sl. 5).

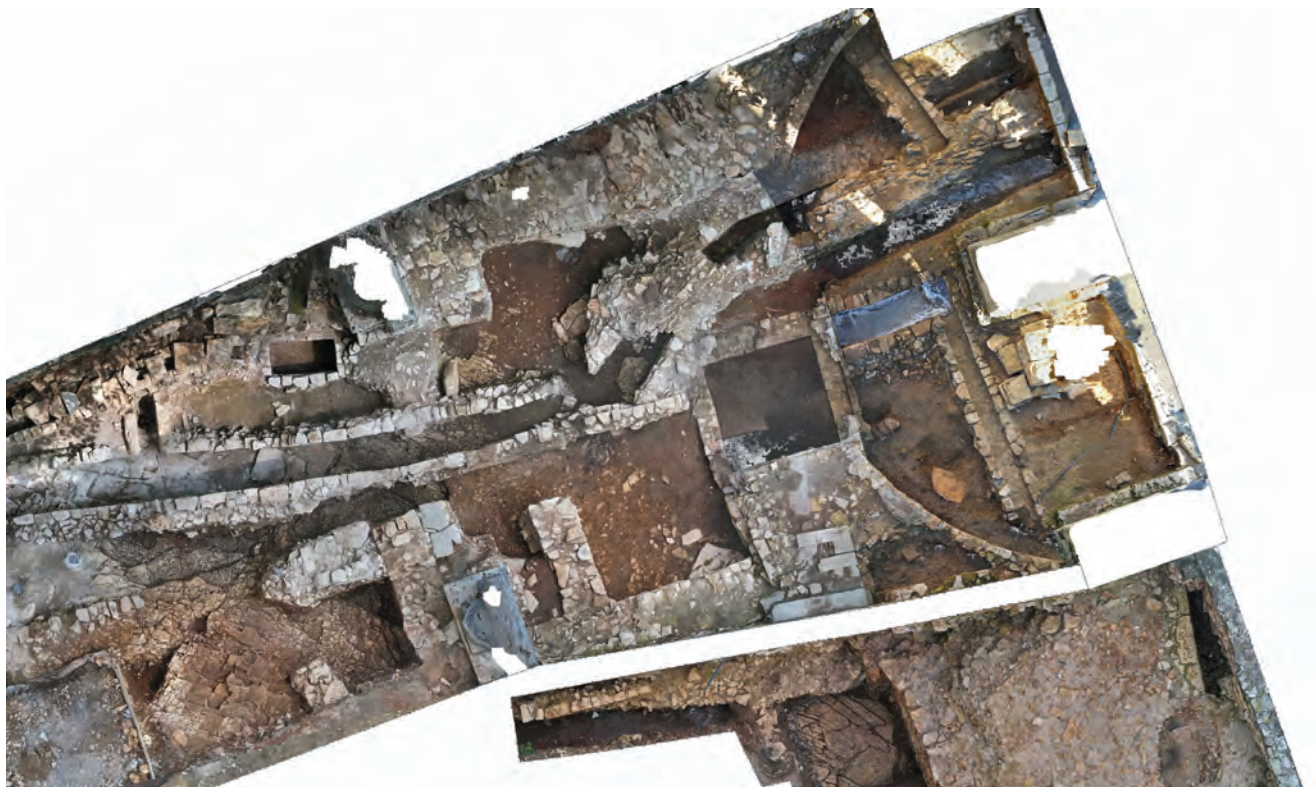
Sl. 6 Gradska vrata tijekom recentnih arheoloških istraživanja (Dokumentacijski odjel AMI-ja).
 Fig. 6 The city gate during recent archaeological investigation (AMI Documentation Department).

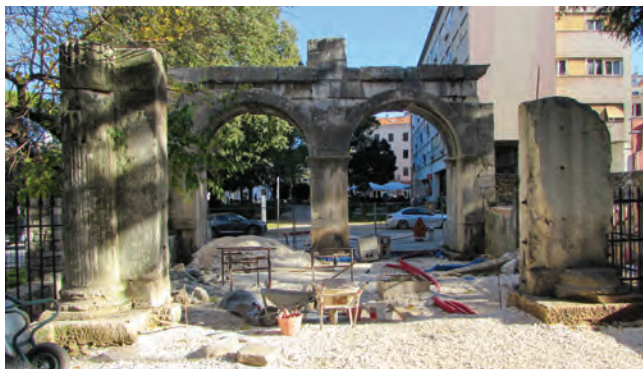
view, and the installation of a two-winged iron gate that closed the space between the pilasters, thus redirecting the flow of pedestrians, had the net effect of setting this monument in an effectively obscured position (Fig. 7).

Sl. 7 Kompleks gradskih vrata prije početka zahvata konzervacije i restauracije (fotografija: Đ. Gobić-Bravar).

Fig. 7 The city gate complex prior to the commencement of the conservation and restoration intervention (photo: Đ. Gobić-Bravar).

brežuljku. Sadnja stabala koja su ih gotovo u potpunosti zaklonila te postavljanje željeznih dvokrilnih vrata koja su zatvarala prostor između pilastara i tako preusmjerila protok prolaznika, završno su postavili spomenik u gotovo nevidljivu poziciju (Sl. 7).

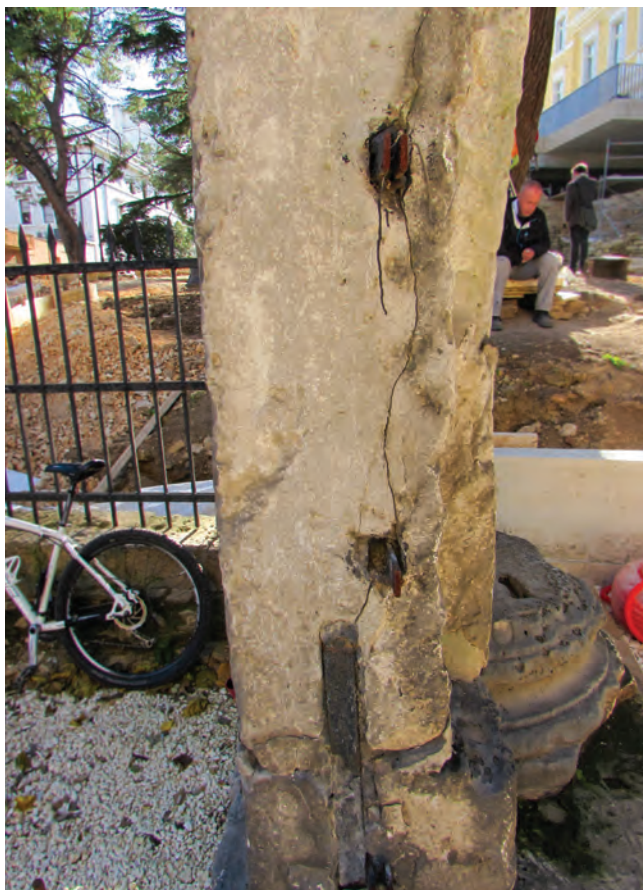
Sl. 9 Duboka i dugačka pukotina uzrokovana dilatacijom željeza na sjevernom pilastru (fotografija: Đ. Gobić-Bravar).

Fig. 9 A deep and long crack in the pilaster to the north caused by the expansion of iron (photo: Đ. Gobić-Bravar).

Postala je vidljiva i površinska ispucanost kamena, kao i veće strukturne pukotine. Do pucanja je vjerojatno došlo tijekom postavljanja blokova u sadašnju poziciju, a ono je tijekom vremena napredovalo uslijed unutarnjih napetosti prouzročenih dilatacijom korodiranih željeznih dijelova. Naime, zbog različitih koeficijenata termičke dilatacije cementa i kamena, s vremenom se stvorila mreža pukotina koja je omogućila vodi pristup željeznim klinovima te njihovu koroziju i dilataciju. Odlomljeni dijelovi vraćeni su na originalnu poziciju dvokomponentnim epoksidnim ljepilom.

Also revealed was surface cracking and large structural cracks in the stone. The cracking was likely produced during the installation of the blocks in the current position, and progressed over time as the result of internal stresses caused by the dilation of corroding iron parts. Over time differences in the thermal expansion coefficients of cement and stone formed a network of cracks that opened the way for water to penetrate to the iron clamps leading to their corrosion and expansion. The parts that had spalled off were restored to their original positions using a two-component epoxy adhesive.

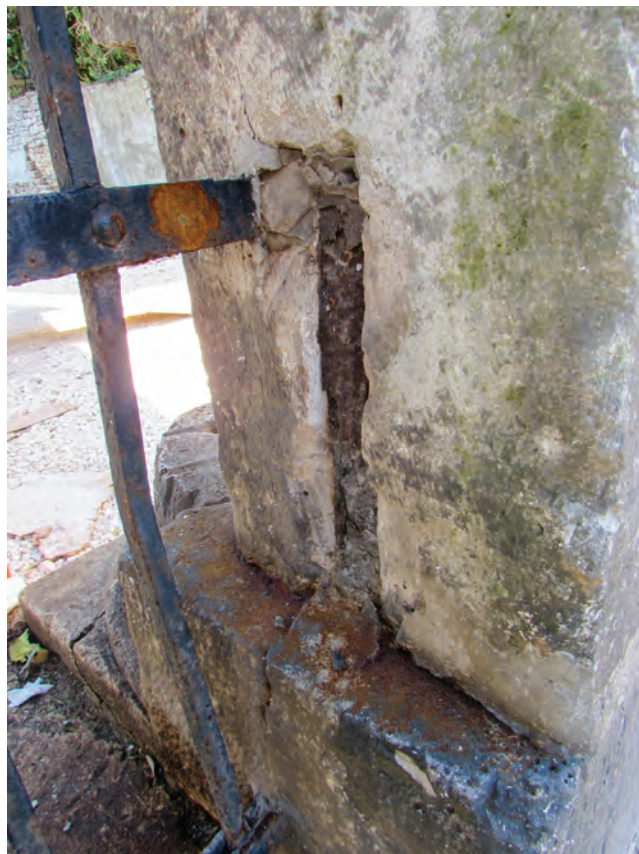
The numerous inserted iron elements posed the greatest hurdle to the preservation of this monument (Fig. 8). Most have corroded over time and thus caused both large and small fractures in the structure of the stone (Fig. 9). The cement filling present in places has deteriorated and become separated, leaving openings in which water and dirt have accumulated, thus creating the conditions for degradation caused by the freeze-thaw cycle and the growth of tall plants. The surface of the monument was covered with algae and lichens, and exhibited black and grey patina.

Sl. 8 Detalj umetnutih željeznih elemenata (fotografija: Đ. Gobić-Bravar).

Fig. 8 Detail of the inserted iron elements (photo: Đ. Gobić-Bravar).

Najveći problem za očuvanje spomenika su mnogobrojni umetnuti željezni dijelovi (Sl. 8). Većina ih je s vremenom korodirala i izazvala veće i manje pukotine u strukturi kamena (Sl. 9). Cementne su ispune dotrajale i odvajale su se ostavljajući otvore u kojima su se skupljale voda i nečistoća, stvarajući tako uvjete za degradaciju uvjetovanu ciklusima zamrzavanja vode i rastom višeg bilja. Površina spomenika bila je prekrivena algama i lišajevima te je površinski prisutna crna i siva patina.

Tijekom zahvata mehanički su uklonjene željezne spojnice zajedno s olovnim amortizacijama, kao i mnogobrojne cementne nadogradnje. Utvrđeno je da je cement prisutan duboko unutar strukture pilastra jer je vjerojatno pri povijesnoj rekonstrukciji korišten u vidu amortizacijskog morta, a ne samo za ispunjavanje pukotina. Spomenik je opran vodom te su aeroabrazivnim čišćenjem sintetičkim kalcijevim karbonatom uklonjene vezane nečistoće, uglavnom crne kore prisutne na bazama pilastara. Završna faza čišćenja sastojala se u odstranjivanju kolonija algi i lišajeva, što je učinjeno kemijskom metodom – proizvodima na bazi kvaternih amonijevih soli.

The interventions included the mechanical removal of iron clamps and the attendant lead fillings, and of the many cement integrations. It was found that cement was present deep within the structure of the pilasters, it having likely been applied in the course of the past reconstruction as a damper (oscillation absorbing) layer of mortar, rather than simply as a fill for cracks. The monument was washed with water, while air-abrasive cleaning with synthetic calcium carbonate was used to remove bound dirt, for the most part the black crust present at the bases of the pilasters. The final phase of cleaning involved the removal of colonies of algae and lichens; this was achieved by applying a chemical method using products based on quaternary ammonium salts.

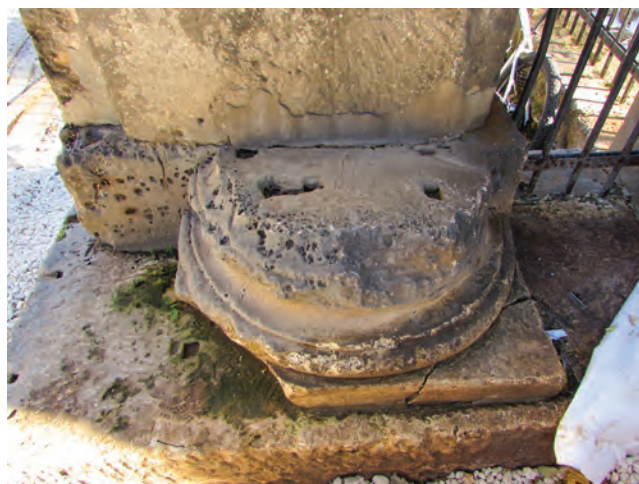
Thick deposits of tar, small areas of graffiti, and surface scratches were present at numerous positions. Spalling and the loss of parts of the original structure are especially evident at the bases and the engaged column. Large fractures, and the presence of deep alveolisation in the lower parts of the monument, were of primary structural significance (Fig. 10).

Sl. 10 Detalj alveolizacije baze polustupa (fotografija: Đ. Gobić-Bravar).

Fig. 10 Detail of alveolisation at the base of the engaged column (photo: Đ. Gobić-Bravar).

Na mnogim su pozicijama bile prisutne debele naslage katrana, manji grafiti i površinske ogrebotine. Okrhnuća i gubitak originalnih dijelova posebno su bili vidljivi na bazama i polustupu. Strukturalno su važne bile velike pukotine, a u nižim dijelovima spomenika prisutnost duboke alveolizacije (Sl. 10).

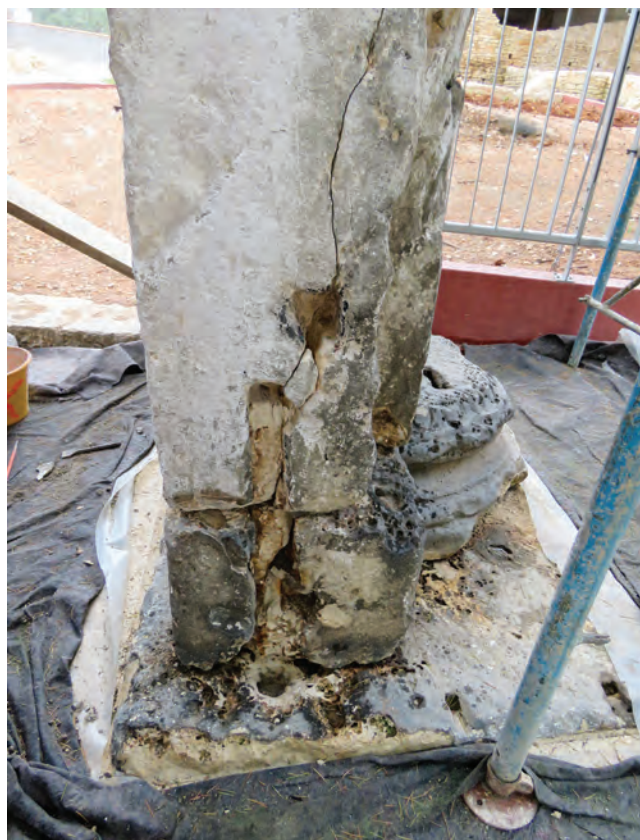
Nakon odstranjivanja svih nečistoća i stranih materijala sa spomenika bilo je moguće dobiti potpuni uvid u površinsku degradaciju kamena (Sl. 11). Na spoju baze i gornjeg dijela spomenika po odstranjivanju cementnih nadopuna postala je vidljiva degradirana površinska struktura, koja se razlikuje od one na dijelovima izloženim atmosferskim utjecajima. Naime,

Sl. 11 Detalj pukotina i šupljina nakon odstranjivanja željeznih klinova i cementnih ispuna južnog pilastra (fotografija: Đ. Gobić-Bravar).

Fig. 11 Detail of cracks and cavities revealed in the south pilaster following the removal of iron clamps and cement integrations (photo: Đ. Gobić-Bravar).

Following the removal of all impurities and foreign materials from the monument we were able to obtain a complete picture of the surface degradation of the stone (Fig. 11). Where the base and the upper part of the monument meet the removal of cement integrations revealed the degraded surface structure, which differs from the areas that were exposed to atmospheric action. The horizontal surface of the stone that had been covered by the cement integrations was severely eroded, exhibiting very rough structure. This is likely the result of degradation that occurred following the reconstruction of the monument in the late 19th c. given the absence of cement in numerous eroded cavities. The cause of the degradation was likely the seasonal freeze-thaw cycle; once the cement had cured, water gradually penetrated under the cement and was trapped on the surface of the stone (Fig. 12).

Nakon odstranjivanja cementnih zapuna primijećena je i velika količina šupljina u spomeniku. Kameni su blokovi na mnogim pozicijama cementnim mortom povezani tek površinski, dok su duboke šupljine u unutrašnjosti pukotina i između blokova ostavljene prazne. U njima se nalazila velika količina zemlje i biološkog otpada te mravinjaci. Sve su šupljine ispuhane i isprane od nečistoća. Nakon čišćenja injektirane su tekućim mortom na bazi prirodnog hidrauličnog vapna i kamenog brašna, a manje su pukotine injektirane tekućim epoksidnim

Also observed following the removal of the cement integrations were a great number of cavities. At many points the stone blocks had been bonded with mortar at the surfaces only, while deep cavities inside cracks and between blocks were left empty. These voids contained a significant quantity of soil, organic detritus, and ant nests. All of the cavities were cleared with compressed air and cleansed of impurities. Cleaning was followed by the injection of a natural hydraulic lime and stone powder liquid mortar, while smaller cracks were injected with a liquid two-component epoxy adhesive. Finally, most of the cavities present on the surface of the stone as the result of alveolisation were filled. These cavities, besides compromising the aesthetics of the monument, constitute loci open to the penetration of water and degradation processes caused by the freeze-thaw cycle and salt crystallisation, necessitating infilling with reversible mortar.

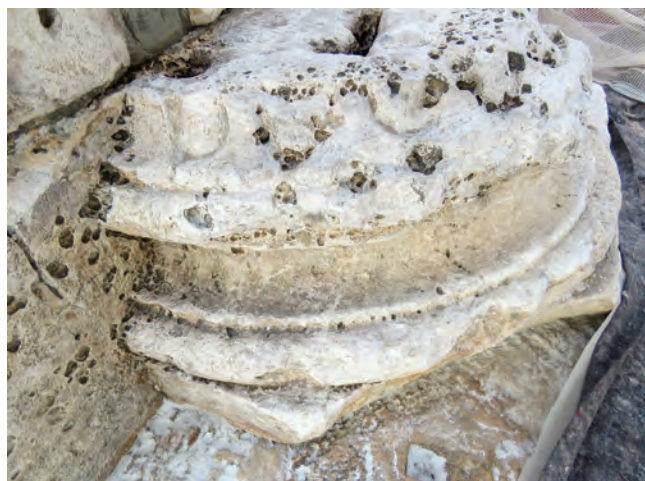
Sl. 12 Detalj alveolizacije baze polustupa južnog pilastra (fotografija: Đ. Gobić-Bravar).

Fig. 12 Detail of alveolisation at the base of the engaged column of the south pilaster (photo: Đ. Gobić-Bravar).

horizontalna površina kamena koja je bila prekrivena cementnim nadopunama teško je erodirana, izuzetno hrapave strukture. Vjerojatno se radi o degradaciji koja je nastala nakon rekonstrukcije spomenika krajem 19. stoljeća, s obzirom da u mnogobrojnim rupama erozije nema cementa. Uzrok degradacije su vjerojatno ciklusi sezonskog zamrzavanja vode koja je nakon sušenja cementa polako prodirala ispod njega te se zadržavala na površini kamena (Sl. 12).

dvokomponentnim ljepilom. Završno, zatvorena je i većina šupljina prisutnih na površini kamena zbog procesa alveolizacije. Ove šupljine, osim što narušavaju estetiku spomenika, predstavljaju pozicije otvorene za prodor vode i degradacijske procese uzrokovane ciklusima zamrzavanja i kristalizacijom soli, stoga ih je bilo nužno zatvoriti reverzibilnim mortom.

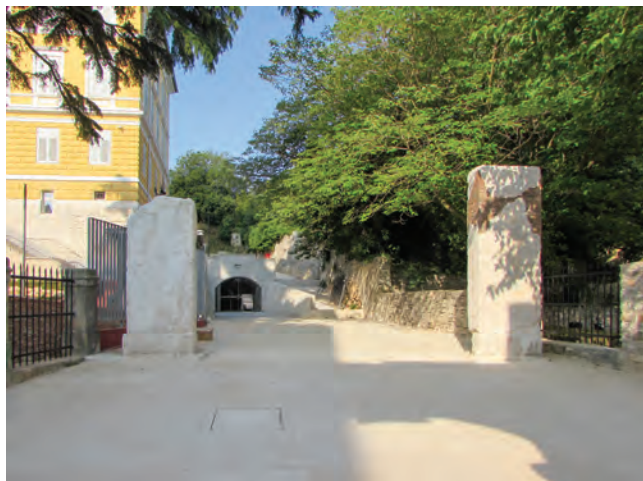
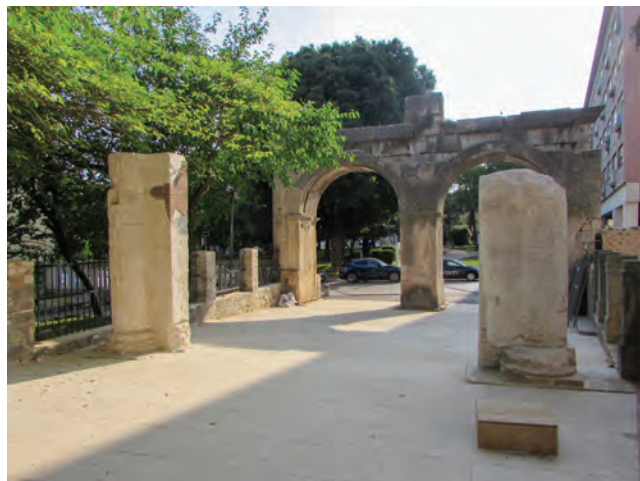
Sl. 13 Pogled s istoka na pilastre nakon zahvata (fotografija: Đ. Gobić-Bravar).
Fig. 13 The pilasters as viewed from the east post-intervention (photo: Đ. Gobić-Bravar).

Sl. 14 Pogled sa zapada (sa strane antičkog grada) nakon zahvata (fotografija: Đ. Gobić-Bravar).
Fig. 14 View from the west (from the side of the antique period city core) post-intervention (photo: Đ. Gobić-Bravar).

All stone surfaces were coated with a nanolime based consolidation agent and provided with a final coating of a water-resistant vapour permeable agent based on silane and siloxane in an aqueous solution (Figs. 13, 14).

Sve su kamene površine premazane konsolidacijskim sredstvom na bazi nano-vapna te završno premazom vodootpornog paropropusnog sredstva na bazi silana i siloksana u vodenoj otopini (Sl. 13, 14).
