Assessment of Condition of Wooden Mill in Kovačevići Area in Bosnia and Herzegovina

ORIGINAL SCIENTIFIC PAPER

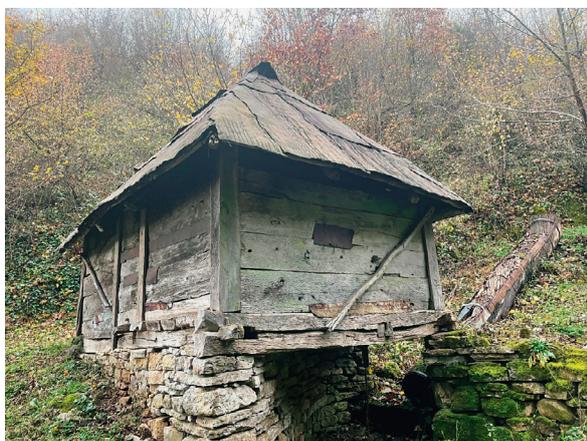
Figure 1 Water mill in the area of Kovačevići
Slika 1. Vodeni mlin u naselju Kovačevići

The analysis was carried out at one single mill (Figure 1) founded at the entrance to the gorge of the Gračarica River near the village of Kovačevići (GPS coordinates: 45.020898, 15.871152), whilst there are several other mills at this location. The investigated mill is a representative example of traditional architecture and construction. It was powered by water as the region was cut off from the leading electricity grid during the war in the 1990s. The wooden mill in question was built in the early 1930s and rebuilt after the floods of 1962. The majority of the construction is almost 100 y old. In the 60s the roofing, water wheel and water channels were rebuilt. The analysis of the mill described in this paper was carried out on November 16, 2022.

The outer part of the logs exposed to weathering was grey (Figure 1). Loose cellulose fibres can be seen on the microscopic image. The surface of the wood absorbs light due to the presence of lignin. As a result of UV irradiation, the lignin is degraded and leached from the surface layers. Loose cellulose fibres remain on the surface resulting in the silver-grey colour of weathered wood (Kropat *et al.*, 2020). No blue colouration was observed in oak and sweet chestnut wood. The presence of extractives seems to limit the growth of blue stain fungi on the wood surface (Vek *et al.*, 2019).

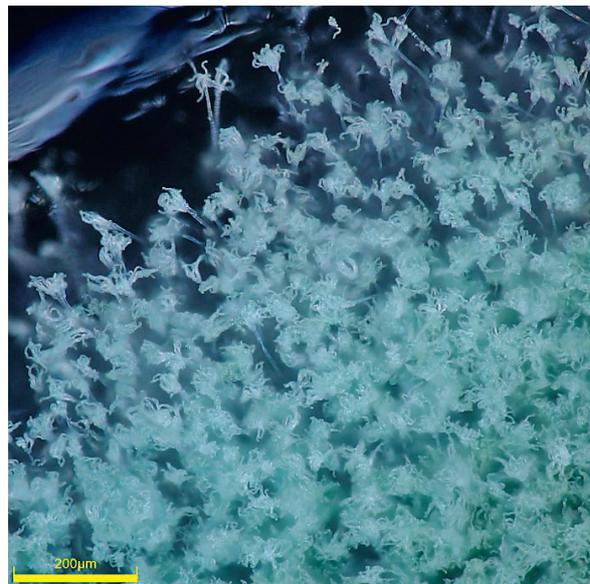
Figure 4 Fungal conidia that developed from collected spores belonging to genus *Penicillium*

concentration in the mill (1625 CFU/m^3) and before the mill (3480 CFU/m^3) was determined. Usually, between 360 and 1230 CFU/m^3 are reported in the air (Flores *et al.*, 2014). As higher values are reported in the vicinity of the mill, this indicates the potential of the fungus in the environment. From the microscopic analysis, it can be concluded that the majority of the colonies identified belong to the genus *Penicillium* (Figure 4). *Penicillium* is a genus of ascomycetous fungi that is part of the mycobiome of several species and is of great importance in the natural environment.

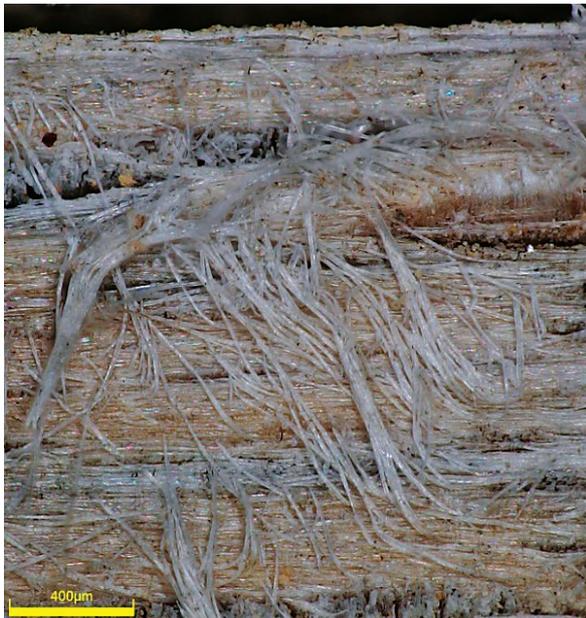
Figure 6 Presence of loose cellulose fibres on weathered wood surface
Slika 6. Gubitak celuloznih vlakana na površini drva izloženoga vremenskim utjecajima

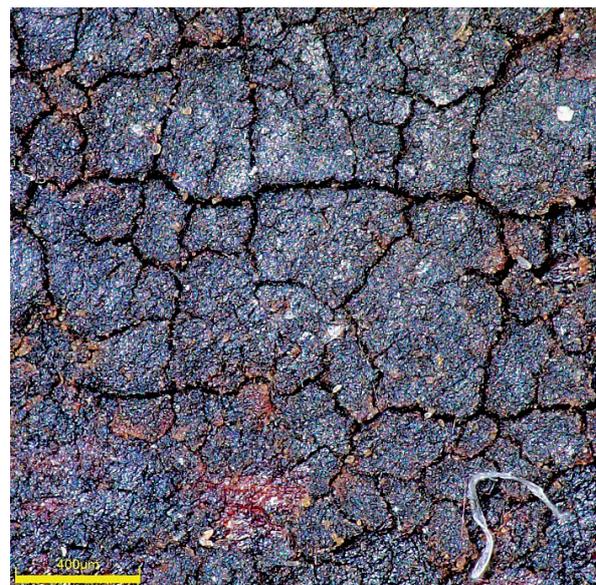
easily spread over the entire volume of the building and escape through the opening in the roof. It should be remembered that the mills also operated at night, so the fire was the source of light and heat. Rahmat and co-workers (2020) reported that condensed gases from wood burning have fungicidal effect. As can be seen from the XRF spectra of the corresponding deposits, they contain high concentrations of iron (Fe), sulphur (S), chlorine (Cl), cadmium (Cd) and manganese (Mn). These elements are assumed to have originated from the corrosion of metal roof and smoke (Humar, 2010). However, it should be noted that these deposits were present only on the interior side of the beams.

Figure 10 Deposits on oak beams surface in mill interior
Slika 10. Naslage na površini hrastovih greda u unutrašnjosti mlina
