Research on leakage hazards of embankments based on 3D electrical resistivity tomography technology

Research Paper

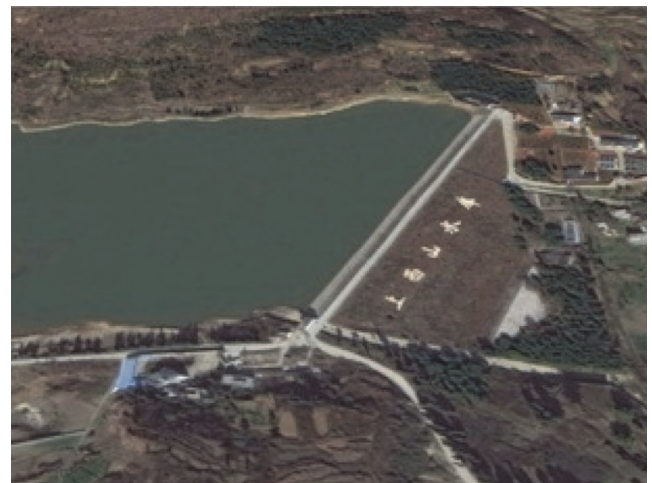
Figure 2. Actual view of the project

The Shangxishan Reservoir in Qujing City, Yunnan Province, is located beside Shangxishan Village in the Development Zone 10 km west of Qujing City (Figure 2).

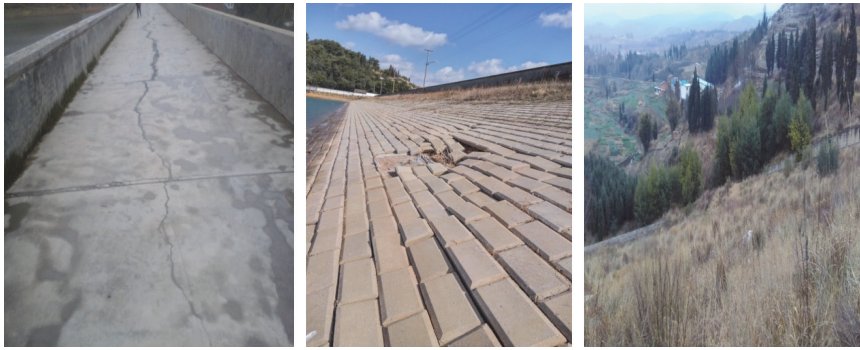
Figure 3. Map of the current condition of the top, face and back of the earth and rock dams

The Shangxishan Reservoir dam is oriented approximately north-south. The dam crest is covered with a cement-hardened road surface. The side facing the water was sloped at a ratio of 1:2.95, making it relatively flat, and the surface was covered with precast blocks. The side facing away from the water was also sloped, with a slope ratio ranging from 1:2.75 to 1:2.5 and was covered with dense vegetation. Agricultural fields are located below slopes. The foundation of the Shangxishan Reservoir Dam is situated on Quaternary residual slope deposits and heavily weathered sandstone shale. Because of the loose structural composition of these geological materials, the foundation of the dam lacks stability. In addition, during the dam construction process, various factors such as technological limitations, equipment constraints, and financial considerations influence the choice of materials for the dam body. The dam body predominantly consisted of gravel-containing clay with inadequate compaction density. Consequently, since the completion of the reservoir in 1977, dams and their foundations have frequently experienced seepage issues, which pose a threat to dam safety. According to incomplete records, dozens of instances of seepage have occurred over the past four decades, including two major seepage incidents. While remedial grouting measures were implemented in response to these significant seepage incidents, they were unable to eliminate risks owing to constraints related to funding and technology.

dam bodies are in a deteriorated state, making it challenging to assess the extent of infiltration damage. Given the poor initial condition of the dam and its extensive treatment history, evaluating the infiltration damage within the dam is complex. The site investigation found that the dam top along the axial direction of a number of cracks, the surface has been filled with asphalt sealing, the widest cracks up to 2 cm, the height difference between the two sides of 2 ~ 3 cm, micro-surface cracks up to several hundred, the site did not take any treatment measures; dam to the surface of the water surface with prefabricated blocks berms, the site was found to have 4 collapse pit, the largest collapse pit diameter of up to 1 metre, the depth of 12 cm, and part of the collapse pit area of the surface of the prefabricated blocks Lost; dam back water surface is covered by dense weeds, trees, vegetation development is good, in the dam back water surface of the northeast corner of the near mountain there is a place under the weeds of water, recent seepage of good increase, see Figure 3.
