## Research Paper

# Optimised technology for repair of vertical surface of concrete bridge elements

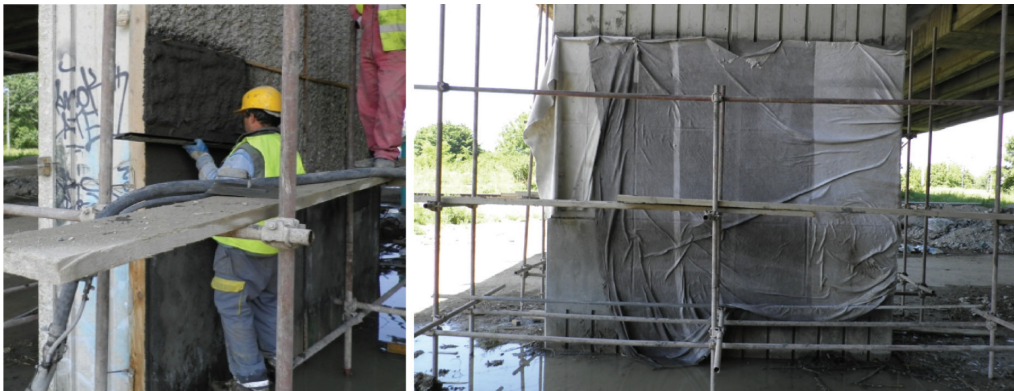
Fig. 3: Finishing of repair mortar surface (left) and curing of repair mortar (right).

and then additional finishing was applied (Figure 3). The repair mortar was cured by wrapping the surface with geotextile and spraying with water once a day (Figure 3).

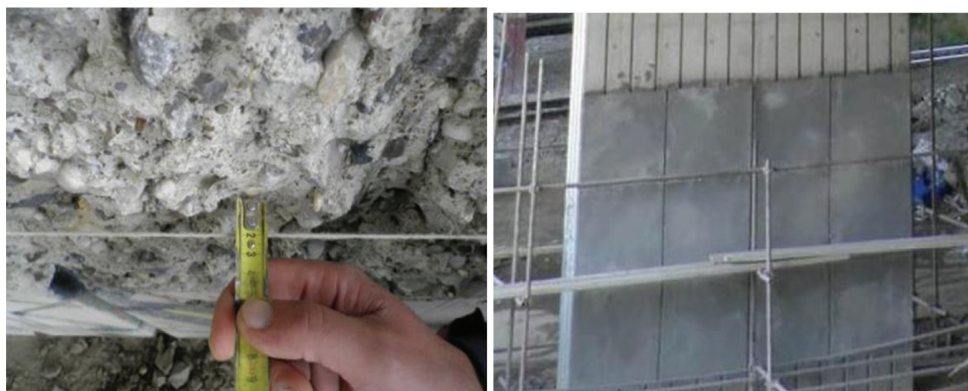
Fig. 4: Appearance of concrete surface after surface preparation by hydrodemolition under high pressure (left) and test fields before pull off testing (right).

The column surface was divided into 24 vertical segments, each with an area of 1 m<sup>2</sup>. The existing concrete was removed by hydrodemolition to an average depth of 1.5–2 cm. At this depth, large aggregates were broken, which is a visual indicator of strongly bonded constituents in the concrete substrate. Hydrodemolition was performed using a Hammelmann HDP 114 high-pressure pump at a pressure of 2,100 bar.

Figure 4 shows the surface of the concrete column after hydrodemolition and the test segments.

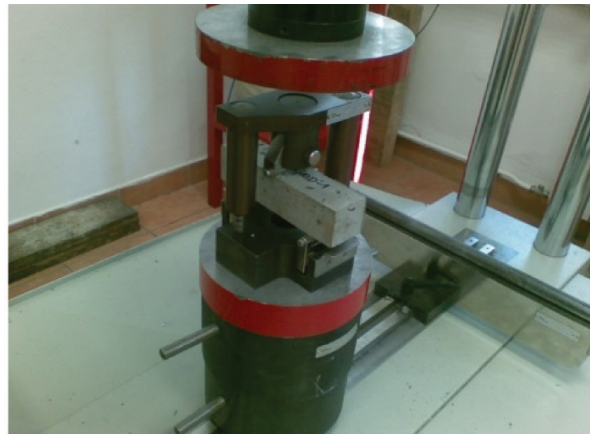
**Fig. 7:** Mortar samples for compressive and bending strength testing (left) and testing of bending strength (right).

moulds for prisms with dimensions 40 mm x 40 mm x 160 mm and in cylinders with diameter 100 mm and height 200 mm. The samples were cured in the laboratory under water at  $20 \pm 2^\circ\text{C}$  until testing. Figure 7 shows the mortar compacted in moulds for strength testing and the performance of the bending strength test.

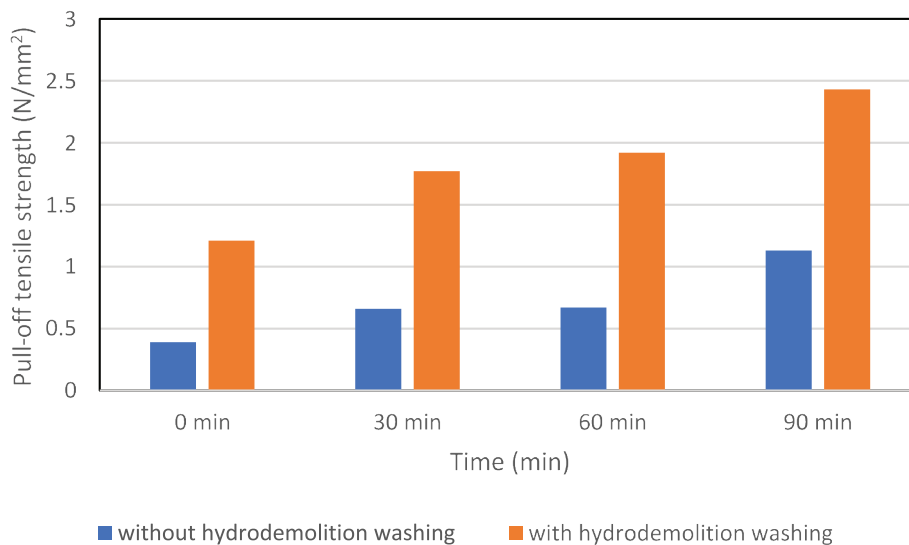
Fig. 9: Comparison of the pull-off tensile strength test results for two cases: with and without surface preparation by washing with a roto nozzle.

Figure 9 compares the pull-off strength results of the repair mortar with and without surface preparation. The pull-off tensile strength of the repair mortar applied without surface preparation is on average 62% lower than

the repair mortar applied on washed surface. This is due to the presence of fine, unbound particles that can be recognised by running the palm over the surface. These particles are mostly chemically inert and contain some amount of unhydrated cement from the existing concrete. This weakens the bond between the substrate and the repair mortar, and failure during the pull-off test occurs predominantly at the contact between these two layers. In addition, surface cracking was observed on the surface of the repair mortar applied without surface preparation, regardless of the same curing method used on the other test fields. This shows that it is essential to wash the surface before applying the repair mortar.
