HISTORY OF HYDROLOGICAL MONITORING IN VARAŽDIN

Review paper

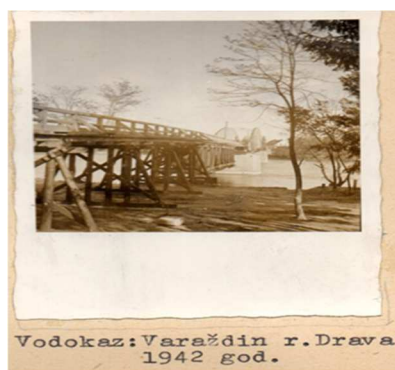
Figure 1 Damaged bridge in 1942, water gauge relocated to the right bank (DHMZ)

the then existing road bridge, about 100 m downstream from the railway bridge, approximately at the location where it stands today. A significant change occurred in 1935 when the gauge was fixed to the first river pillar of the bridge, on the right bank of the river. This is a vertical gauge made of cast iron, with height markings divided into 2 cm. During World War I, the destruction of the road and the nearby railway bridge, about 100 m away, resulted in the relocation of the gauge. On August 1, 1945, the restored gauge was placed as a pilot in the riverbed, 30 meters downstream from the collapsed bridge. The new construction included metal plates with a division of 5 cm, while the zero point was lowered by 9.7 mm, reflecting the change in the water level between the old and new locations. Nevertheless, the zero point was retained and recorded unchanged at 166.06 m, preserving consistency in data recording. Water level monitoring was performed by Špičko Nevenka, an official from the Technical Department of the District N.O. in Varaždin. The technical report to the Federal Order of the Ministry of Construction F.H. was submitted by Vodopivec Dragutin and Perger Vladimir on August 7, 1945, in Zagreb. A temporary wooden bridge was built not far from the then-collapsed railway bridge, and due to difficulties in maintaining the gauge on the pilot, on November 7, 1953, the gauge was moved to another pillar of the bridge from the right bank, ranging from 0 to 400 cm. The reference point was then returned to the original height of 166.06 meters above sea level. Furthermore, in the same year, a new reinforced concrete bridge was built at the site of the former railway bridge, which still serves road and rail traffic today. Therefore, on January 8, 1954, the gauge was moved from the temporary wooden bridge to the newly constructed railway bridge, and it was placed on the third concrete pillar from the downstream side, on an oak plate attached to the pillar of the bridge with iron brackets, with plates facing the right bank. The old gauge was not removed, and the observer was instructed to simultaneously read the water level on both gauges since both were set to the same reference point. The observer of the Varaždin gauge, due to having to read two gauges and the temperature of the water, requested an increase in compensation to 2000 dinars quarterly. The changes related to the location of the gauge are shown in **Figures 1-3**.

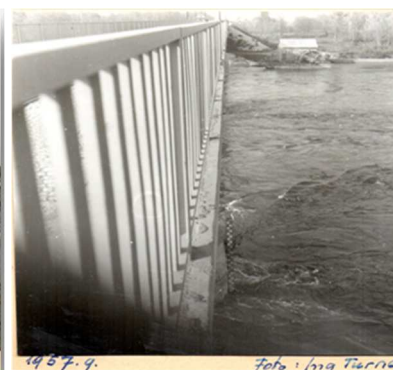
Figure 3 Water gauge on the bridge pillar on the downstream side
Photo: Turner, 1957 (DHMZ)

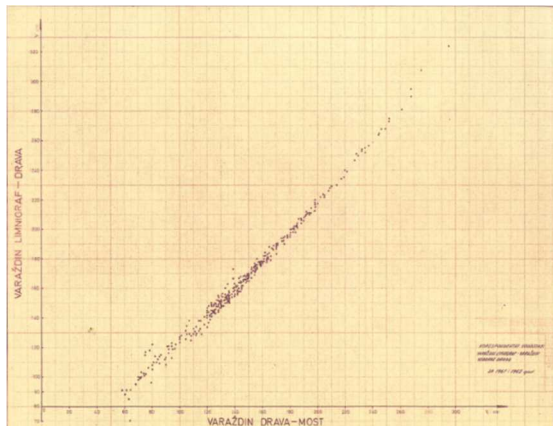
Figure 4 Correlation between water levels measured at the water gauge and the limnigraph during 1961 and 1962 (DHMZ)

Furthermore, the water gauge, which was temporarily installed on November 7, 1953, was later dismantled, and the materials were transported to Zagreb. A technical report was submitted to the administration of the Hydrometeorological Service of the People's Republic of Croatia by Satler Leon on January 25, 1954, in Zagreb. In 1960, the construction of a limnigraph began, 150 meters downstream from the road-rail bridge, on the right bank of the river. Alongside the limnigraph, a water gauge with the same reference point was installed. To determine differences in water levels due to the drop in water level between the limnigraph and the bridge, as well as the depression behind the bridge pillar, water levels were simultaneously recorded at both water gauges. Measurements at both locations were conducted from July 7, 1960, to December 31, 1962. The corresponding limnigraph-Varaždin water levels for 1961 and 1962 are shown in **Figure 4** (DHMZ archive).

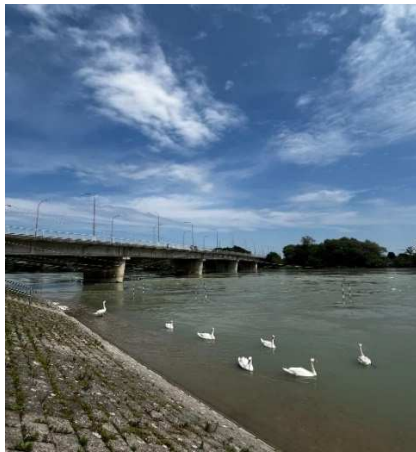
Figure 7 New road-rail bridge Varaždin – Čakovec, June 24, 2024, Photo: Maloić, J.

As part of the Water Ecological Monitoring and Risk Analysis (VEPAR) project in 2023, the station was modernized, and a radar system was installed on the downstream side of the bridge to monitor water levels in real time (Figure 7).

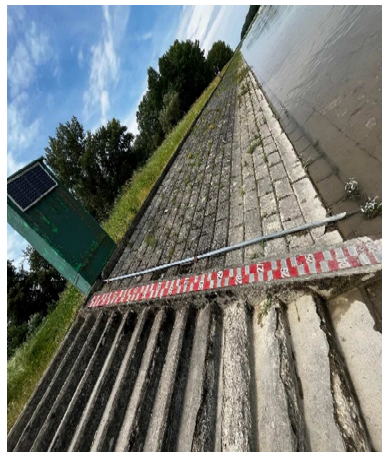
Figure 8 Hydrological station Drava-Varaždin and water gauge, June 24, 2024, Photo: Maloić, J.

In August 2016, the station underwent reconstruction, during which the water gauge boards were replaced. The water gauge became a three-section combination: a vertical section in the riverbed ranging from 0 to 100 cm, and an inclined section along the bank protection steps, spanning 100 to 222 cm and 222 to 402 cm (Figure 8).

On August 5, 2018, a new electronic limnigraph, OTT-CBS, was installed and put into operation (Figure 9). Prior to this, a new pressure conduit and solar power supply were set up, along with the establishment of remote water level reporting (Figure 8).

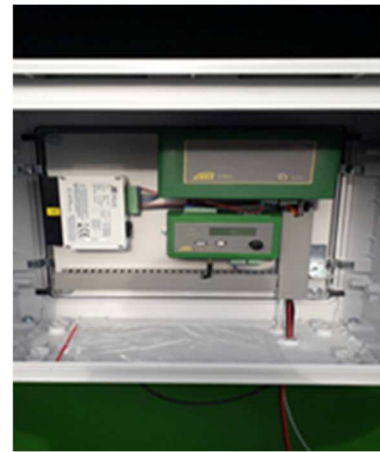
Figure 9 Limnigraph, January 19, 2021, Photo: Oskoruš, D.

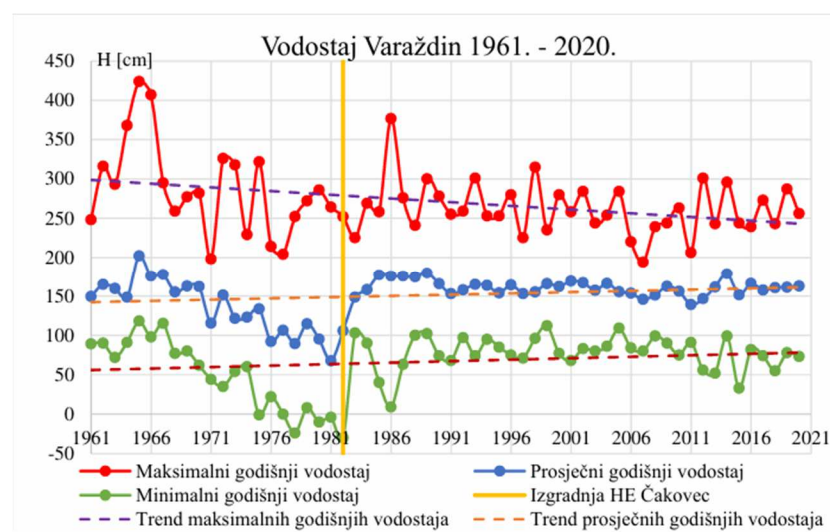
**Figure 15** Maximum, average, and minimum annual water levels at HP Varaždin in the period 1961–2020, with trends (Kos 2023)

Table 1 provides an overview of hydrological data collected at the Drava-Varaždin station, which are stored in the national HIS 2000 database. Furthermore, Figure 15 presents a graphical depiction of maximum, average, and minimum annual water levels from 1961 to 2020, along with trend lines (Kos 2023).

At the Varaždin hydrological station, a negative trend is observed in maximum annual water levels, while minimum and average water levels show a positive tendency. This pattern can be explained by the influence of reservoirs and the operation of hydroelectric power plants in Slovenia, which mitigate peak flows by retaining them in reservoirs. Additionally, it can be noted that after 1982 (yellow line), water levels stabilized due to the construction of the Čakovec reservoir and the formation of a backwater effect. Following the construction of HE Čakovec, flow measurements at the Varaždin station were discontinued. Figure 16 illustrates the flow rates for the period 1961–1981, where a decline in average annual flow rates can be observed (Kos 2023).

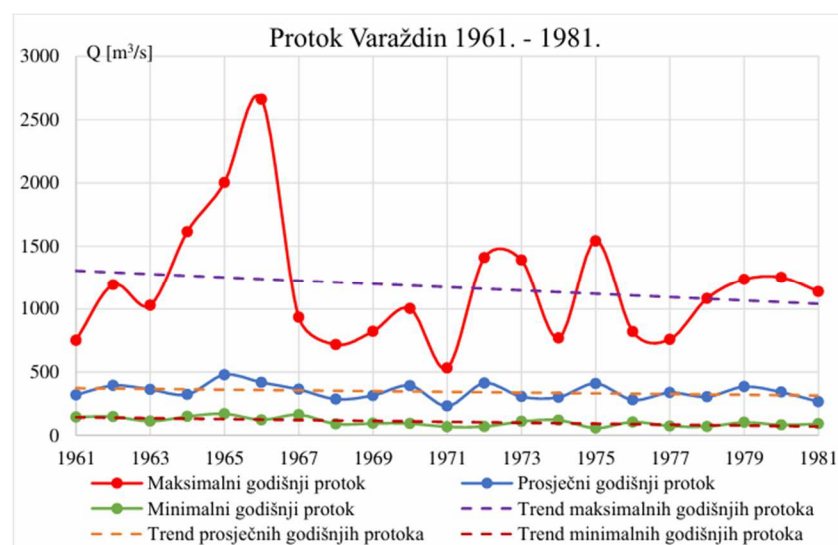
**Figure 16** Maximum, average, and minimum annual flow rates at HP Varaždin in the period 1961–1981, with trends (Kos 2023)
