**Perica Špehar**

## Ranosrednjovjekovna naselja i crkve u ruralnim područjima današnje Vojvodine: Studija slučaja Crkveno brdo

## Early Medieval settlements and churches in rural areas of modern Vojvodina: Crkveno brdo case study

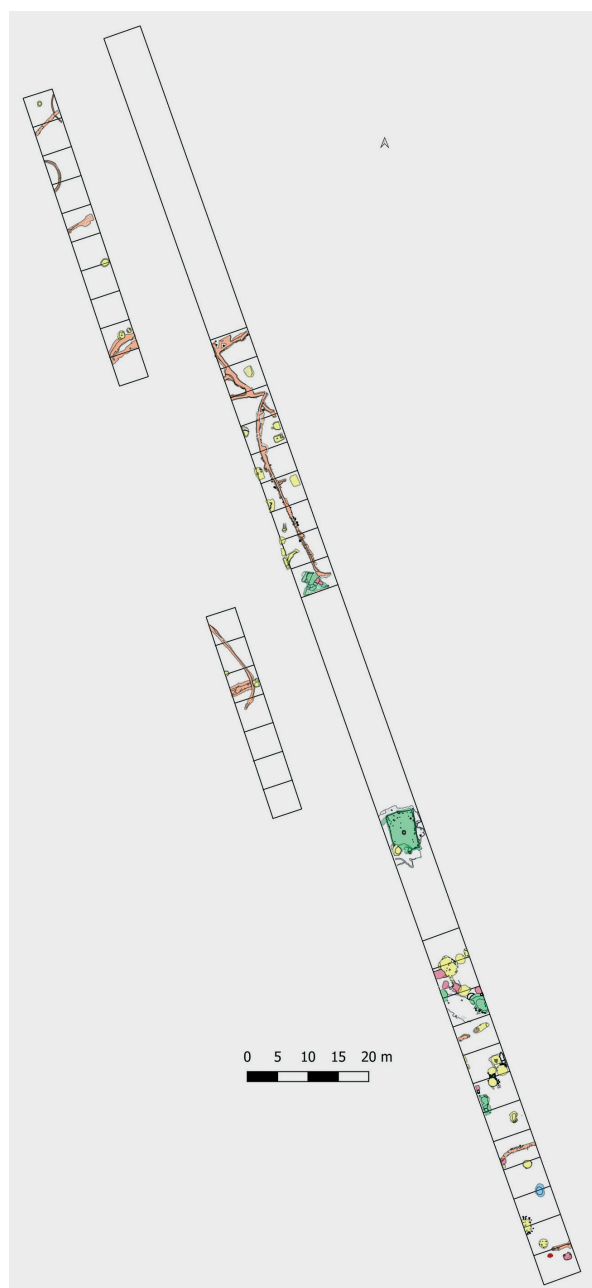
Sl. 2. Tlocrt naselja  
(prema Špehar, Marković, Jović 2021, sl. 3)  
*Fig. 2 Ground plan of the settlement*  
(after: Špehar, Marković, Jović 2021, Fig. 3)

je površina od cca 1250 m<sup>2</sup> na lijevoj padini danas gotovo presušene rijeke. Istraživanjem je otkriveno pet kuća, devet peći, četrdeset i jedna jama, jedan bunar kao i trinaest rovova različitih dimenzija i oblika (sl. 2).<sup>5</sup>

archaeological excavations conducted in 2019, an area was investigated of approximately 1250 m<sup>2</sup> on the left slope of a now almost dried-up river. This investigation revealed five houses, nine furnaces, forty-one pits, one well, as well as thirteen trenches of various dimensions and shapes (fig. 2).<sup>5</sup>

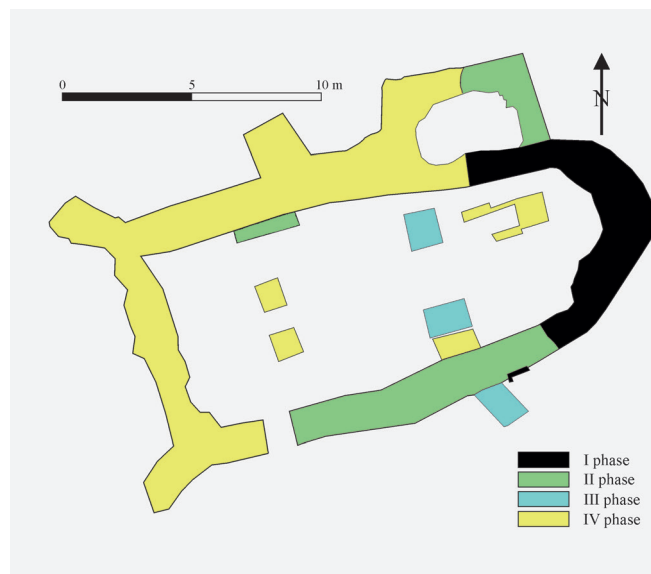
Sl. 6. Tlocrt crkve s fazama izgradnje

Fig. 6 Ground plan of the church with building phases

later western wall. It appears that during the first phase the church was a simple single-nave building with semicircular apse, 15 m long, from the outer face of the original western wall to the outer wall of the apse, and around 8 m wide. It obviously underwent various alterations in centuries to follow, which resulted in its greater size and more representative appearance.

The first subsequent change implied the repairing of the southern wall and erection of the rectangular northern annex, that most probably had the role of the sacristy. Unlike the walls of the first phase, which were built by using whole bricks tied by mortar, all walls dated to the second phase were built by broken bricks tied by mud. The walls were 1.5 m thick. A coin of Geza II (1141–1161),<sup>19</sup> discovered within the foundations of the eastern part of the annex, suggests that this phase can be dated around the middle of the 12<sup>th</sup> century (fig. 7). It appears that some other small alterations happened not long after. Namely, the south-eastern buttress was added, as well as two massive pillars that separated altar from the naos. Both pillars and a buttress were once again built of regular rectangular bricks tied by mortar, similar to the architectural elements erected during the first phase. Yet, since the foundations of the south-eastern buttress cut the remaining original part of the southern wall, it can with certainty be said that this alteration did not belong to the first phase despite the similar construction method. This

tehnikama gradnje i vrlo malom broju kronološki osjetljivih nalaza. U prvoj fazi izgrađeni su apsida i manji dio južnog zida (sl. 6). Zidovi apside bili su široki 1,2 m, a od južnog zida sačuvano je samo nekoliko opeka koje su stršile prema jugu, a koje su najvjerojatnije označavale prijelaz iz apside u nešto širu izvornu lađu. I apsida i spomenuti dio zida bili su ukopani u les i zidani opekama dimenzija oko  $25 \times 15 \times 5$  cm, koja je bila vezana mortom debljine do 2 cm. Negativ zapadnog zida iz prve faze potvrđen je 3,5 m istočno od unutrašnje strane kasnijeg zapadnog zida. Čini se da je crkva u prvoj fazi bila jednostavna, jednobrodna građevina s polukružnom apsidom, koja je od vanjskog lica prvotnog zapadnog zida do vanjskog zida apside bila duga 15 m, a široka oko 8 m. Očito je da je u narednim stoljećima doživjela razne preinake, što je rezultiralo njezinim povećanjem i reprezentativnijim izgledom.

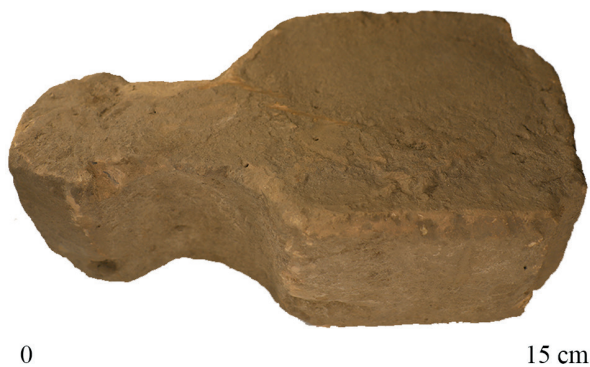
Sl. 8. Opeka nepravilnog oblika  
*Fig. 8 Brick of irregular shape*
