# ANALIZA ANTROPOGENOG UTJECAJA NA MORFOLOŠKE PROMJENE ŽALA U PODGORI (SREDNJI JADRAN, HRVATSKA)

## ANALYSIS OF ANTHROPOGENIC IMPACT ON MORPHOLOGICAL CHANGES OF BEACHES IN PODGORA (CENTRAL ADRIATIC, CROATIA)

Izvorni znanstveni rad / *Original scientific paper*

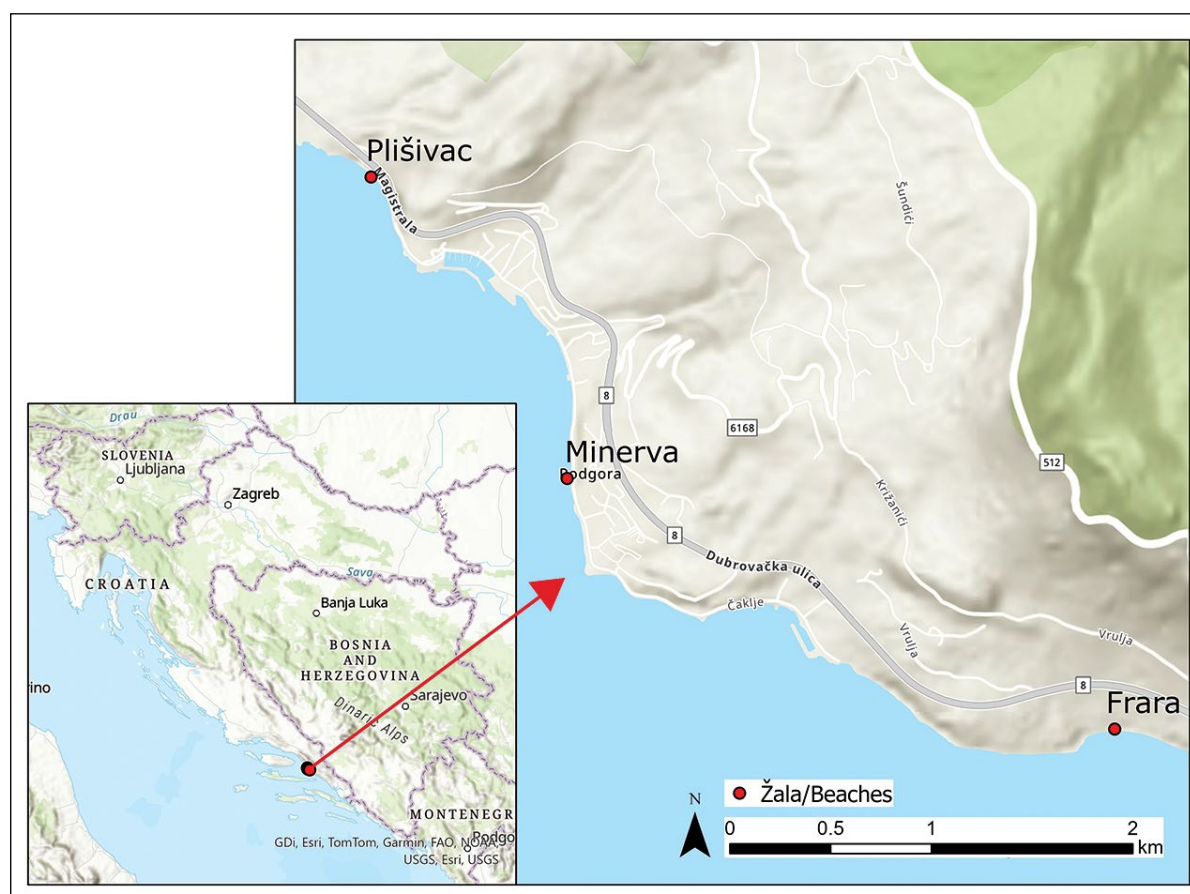
SLIKA 1. Područje istraživanja s označenim žalima  
FIGURE 1 Study area with beaches locations

This study analyses the morphological changes of three beaches: Minerva, Plišivac, and Frara (Fig. 1) in the municipality of Podgora, which is part of Makarska Riviera, one of the most important tourist coastal areas in Croatia. The development of tourism, which began in the second half of the 20th century, has led to accelerated littoralisation, which has significantly affected the morphological characteristics of the beaches. Considering these processes, the aim of this study is to quantify the morphological changes of beaches over the last 70 years using remote sensing methods. For this purpose, satellite and aerial images as well as, data collected by unmanned aerial vehicles (UAVs) are used. In addition, in order to quantify changes, this research also aims to compare morphodynamics of anthropogenically modified beaches with those of natural beaches. Furthermore, we aim to assess the potential of remote sensing methods in detecting anthropogenic interventions in order to better understand the mechanisms of change and provide guidance for future coastal management.

images from the Google Earth Pro application, and orthomosaics generated from drone images were used (Fig. 2). The analysis was carried out on selected beaches that are evenly distributed within the Podgora settlement area: Plišivac (northern part), Minerva (central part), and Frara (southern part) (Fig. 1). From 1951 to 2024, the temporal resolution of the available data increased, and for certain years — such as 2005, 2018, and 2019, several images from the same year were used (Tab. 1).

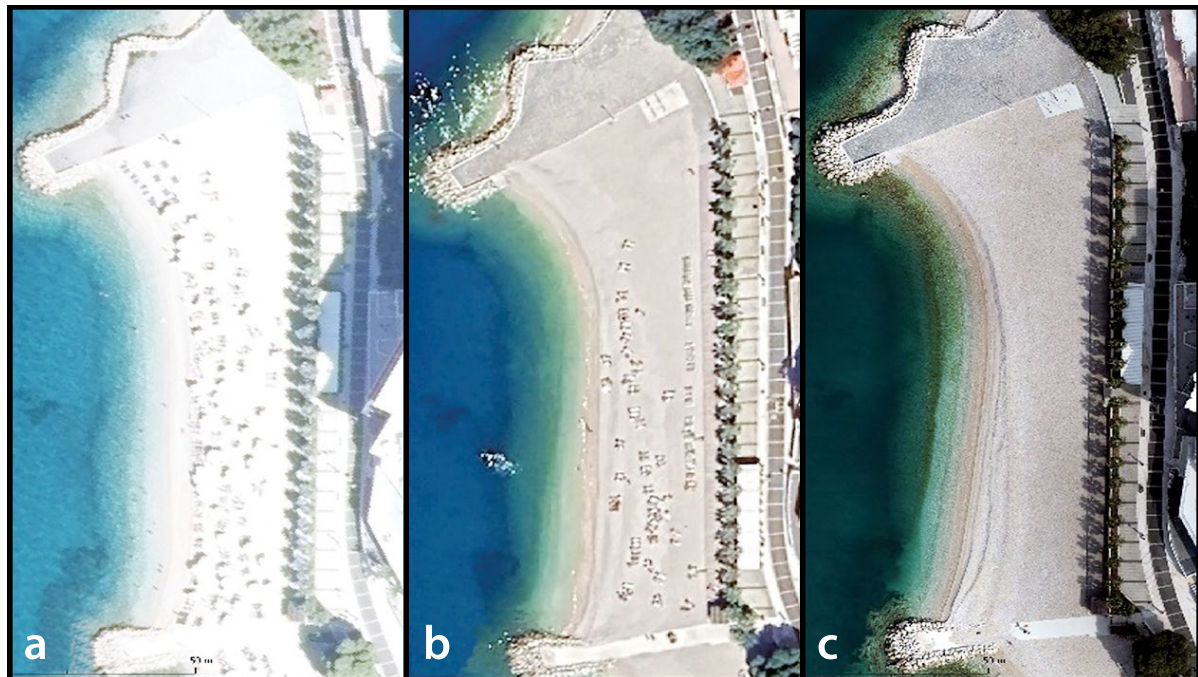
SLIKA 2. Žalo Minerva prikazano na različitim kartografskim podlogama: a) Aviosnimka iz 2023. godine; b) Satelitska snimka iz 2023. godine, c) Ortomozaik (UAV) iz 2023. godine

FIGURE 2 Minerva beach on different cartographic bases: a) Aerial image from 2023; b) Satellite image from 2023; c) Orthomosaic (UAV) from 2023

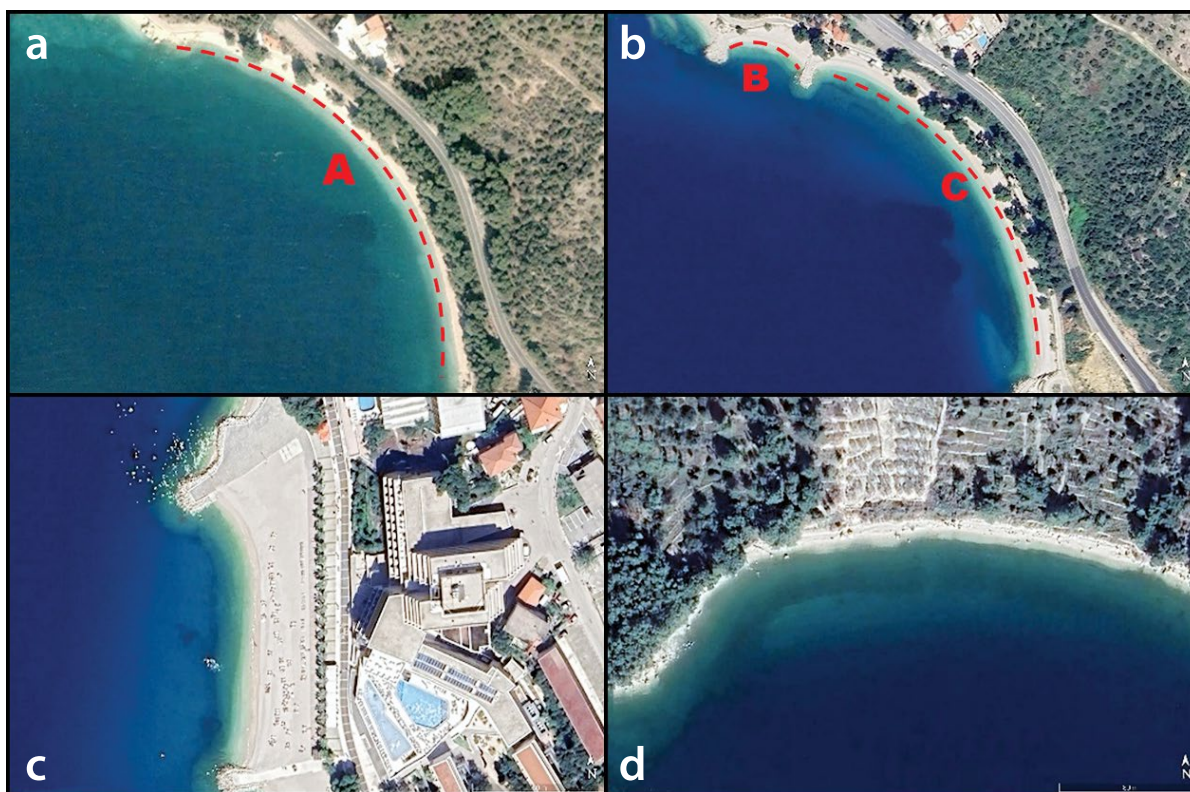
**SLIKA 4.** Lokacije istraživanja u Podgori: a) Žalo Plišivac prije provedbe antropogenih intervencija, označeno slovom A; b) Žalo Plišivac nakon antropogenih intervencija, podijeljeno na dva dijela, označena slovima B i C; c) žalo Minerva; d) žalo Frara

**FIGURE 4** Study sites in Podgora: a) Plišivac beach before the anthropogenic interventions, marked as section A; b) Plišivac beach after the anthropogenic interventions, divided into two parts, marked as sections B and C; c) Minerva beach; d) Frara beach

The analysis of the collected cartographic sources shows that the surface of Plišivac beach changed significantly over the observed period (Tab. 2; Figs. 4, 5, and 10). The first measurements from 1951 showed an area of about 2,470 m<sup>2</sup>. From 1951 to 1972, only slight fluctuations in the surface area were observed. A notable increase in surface area began in 2005, when it grew to almost 2,900 m<sup>2</sup>. A further increase occurred in 2014, with the largest increase occurring in 2020, when the beach

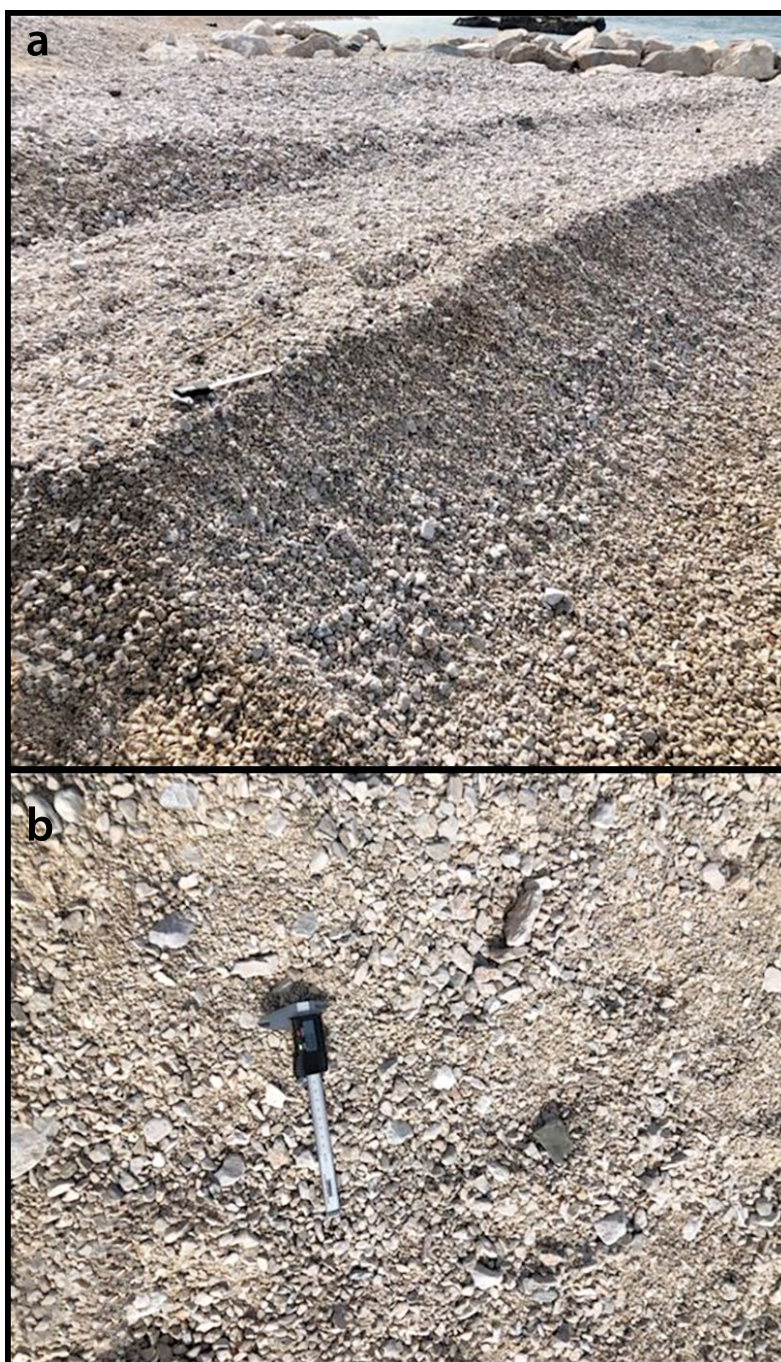
SLIKA 13. *Velicina i oblik dohranjenog sedimenta na žalu Minervi*

FIGURE 13 *Size and shape of the nourished sediment at Minerva beach*

It is obvious that restoration measures have become a regular necessity, especially after severe storms. For example, after a natural disaster in December 2019, emergency measures were carried out to replenish sediments and stabilise groynes, as clearly demonstrated by the data collected for Plišivac and Minerva beaches. As the availability of natural (local) sediment in this
