# Research on Damage Assessment and Reinforcement Method of Concrete Bridge After Fire

**Keywords:** concrete bridge; fire; reinforcement research; quick detection

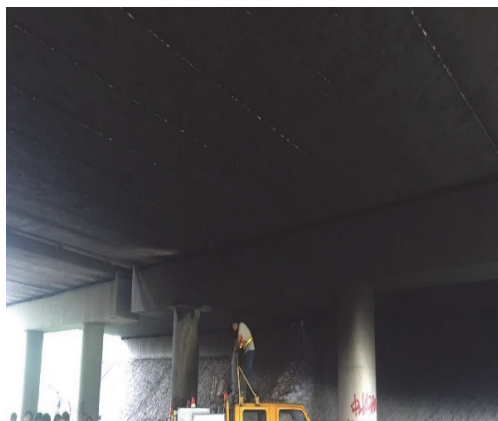
Figure 6 After the hollow plate and cover beam

The bottom of the first hollow plate of the left and right width of the bridge was smoked by flame, and the concrete surface was black. The fire occurred near pier 1 - 1 of the left bridge, and the cover beam on the pier also was burned to fire. The concrete outside the cover beam was smoked, and the surface of the concrete was dark black. The L1-1 # pier column under the bridge was badly burned, and the apparent concrete about 2 m above the ground was smoked into black. In the body of no. 1-pier 1 close to the ground, the peeling area was about  $2.2 \times 0.8 \text{ m}^2$ , and the stirrup and longitudinal main reinforcement were exposed. Details are shown in Fig. 6 to Fig. 8.

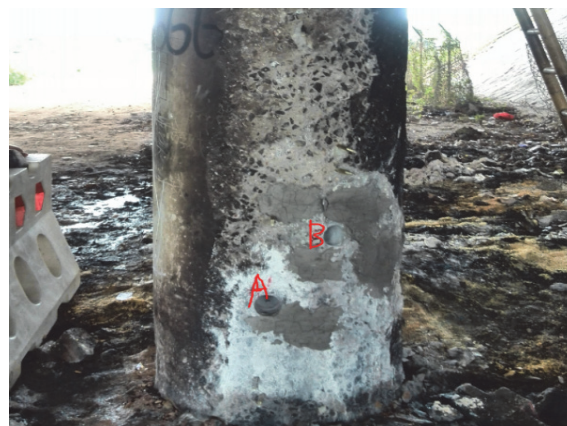
Figure 10 Core location

Area one: the concrete strength is obviously reduced, and the depth is larger, the concrete cover spalling renders rebound hammer testing inapplicable. The core extraction method was used to detect the depth of fire impact, and 2 cores were taken in the area, as shown in Fig. 10.

Core sample A is drilled in the horizontal direction at the bottom of the pier column, with a diameter of 6 cm and a length of about 29 cm, which is broken into three sections in the process of drilling. Core sample B is drilled in the horizontal direction at the bottom of the pier column slightly higher than hole A. Its diameter is 6 cm and its length is 28 cm, which breaks into 2 sections in the process of drilling.

According to the damage of the core sample, it can be seen that the maximum fire impact depth is 8 to 9 cm, and the core sample is as in Fig. 11 and Fig. 12.
