Professional paper

## Load testing of the Drivuša bridge

**Abstract:** This paper details the static and dynamic proof load testing of the Drivuša bridge near Zenica on Corridor Vc. It includes a description of the bridge structure and the testing methodology. The measurement process and the equipment utilized are presented. The final section provides the measurement results and their comparison with the theoretically calculated values. It has been determined that the measured results correlate well with the numerical calculations.

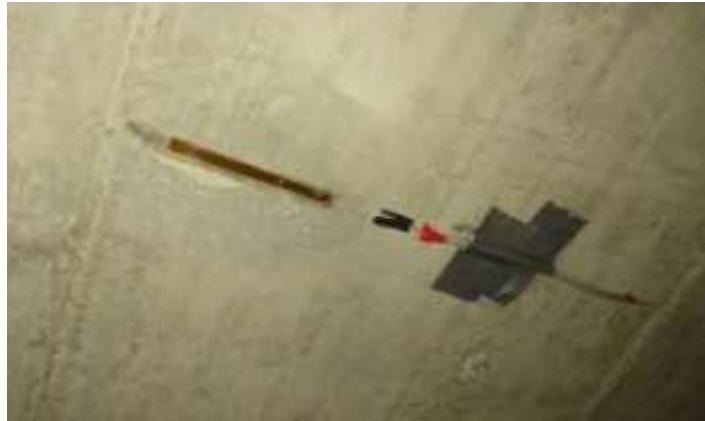
Figure 5. - Strain gauge at the test location

A total of 32 measurement locations were observed on the Drivuša bridge, where strain gauges were installed on the concrete structure inside the bridge (Figure 5).

For measuring relative deformations, strain gauges manufactured by HBM, type K-LY411-15-120-0, were used (Figure 6).

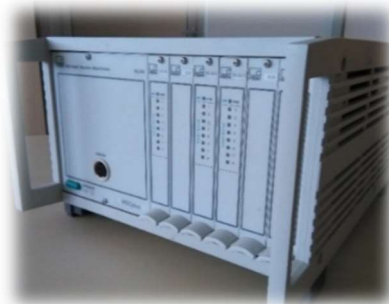
b) "MGC plus" device

Acceleration was measured using an acceleration transducer, namely an HBM uniaxial accelerometer, type B12/500 (Figure 7a). The measured values were collected by the *MGC plus* system (Figure 7b) and were processed in the Catman AP software package.

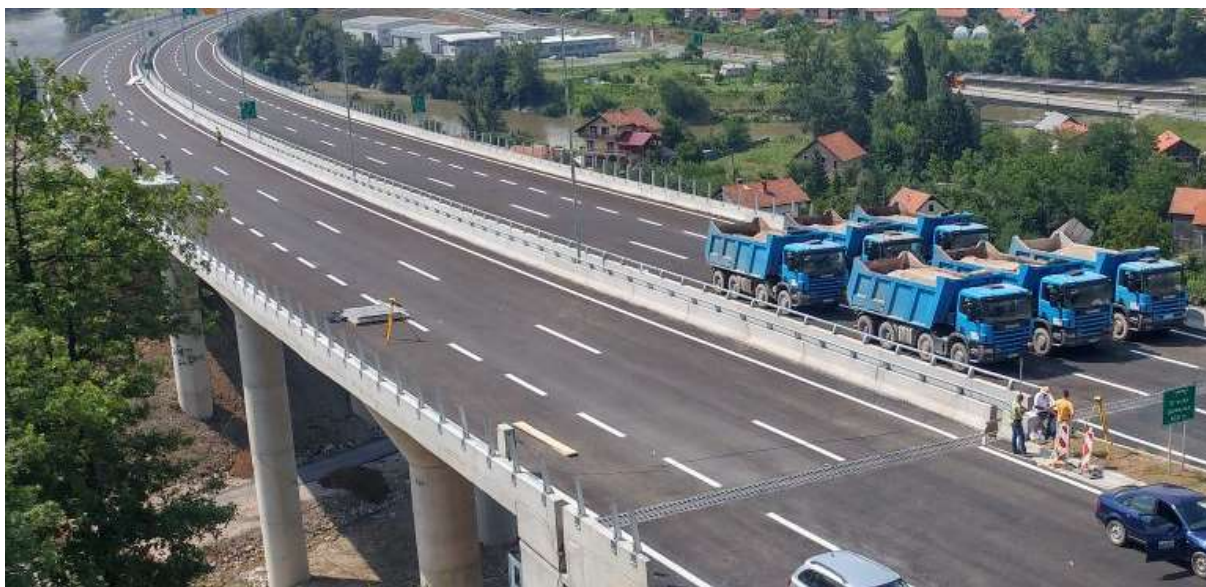
Figure 8. – Load placed in position

Static tests (Figure 8) were carried out according to the loading schemes presented in Chapter 3. The test results for vertical displacements and strains will be presented in the following text.

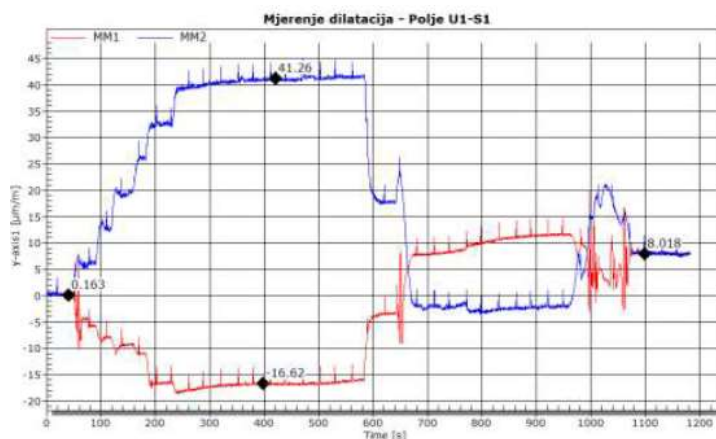
Figure 10. – Example of measured values of relative deformations for span U1-S1 (left bridge)

The load test results are presented in tables and in diagrams obtained by processing the measured values in the Catman AP software package. Based on the measured strains and known values of the modulus of elasticity for concrete, the stresses are determined according to the formulas:

- Stress for concrete (C40/50):  $\sigma = \varepsilon(\%) \cdot 35000(\text{MPa})$

Due to the large number of results, an example of a diagram for span U1-S1 (left bridge) will be shown (Figure 10), after which a comparison of stresses by measurement points on the left bridge will be presented in a table (Table 2).

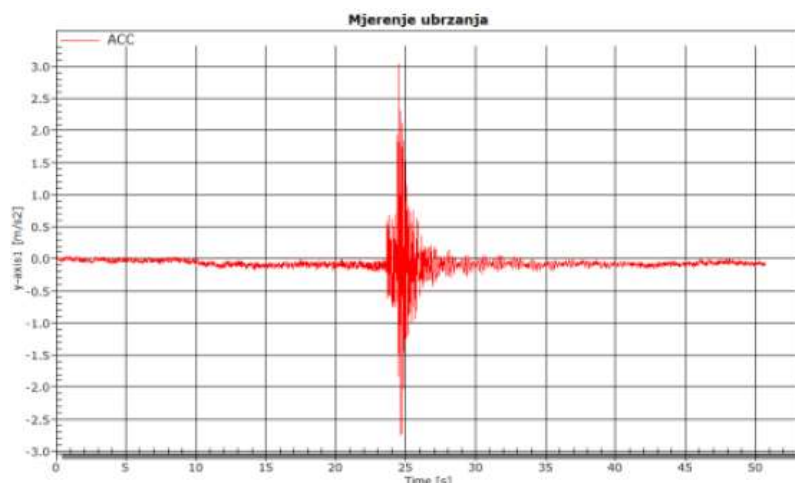
Figure 11. - Acceleration record obtained by the accelerometer

In the dynamic testing of the bridge, vertical accelerations induced by excitation with a vehicle traveling at approximately 30 km/h over a 5 cm thick wooden plank in span S15-S16 were measured using an accelerometer (Figure 11). After processing the results, a diagram of the oscillation frequencies of the bridge was obtained (Figure 12).

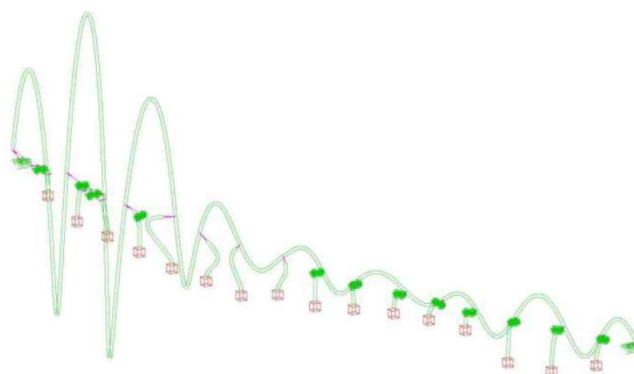
Figure 13. - First calculated modal shape of oscillation (T= 4.01 Hz)

Modal shapes of oscillation were determined using the computational model (Figure 13). The results were then processed to determine the bridge oscillation frequencies, which were compared with the calculated values (Table 3).

Frequency (Hz)	Value 1	Value 2	Value 3
Calculated values	4.01	4.13	4.24
Measured values	4.55	5.36	5.53
