## Load testing of the Hercegovina bridge

**Abstract:** The paper presents static and dynamic load testing of the Hercegovina bridge over the Neretva River. In addition to presenting the basic structural elements of the bridge, the paper briefly describes the testing method, and provides the basic characteristics of the equipment used for testing. The conducted tests included measurements of vertical displacements, strains and accelerations. Given the excessiveness of the testing, the paper presents the most important results, along with an analysis and comparison of the measured parameters. These procedures determined the static and dynamic characteristics of the constructed structure with the aim of assessing the quality of construction.

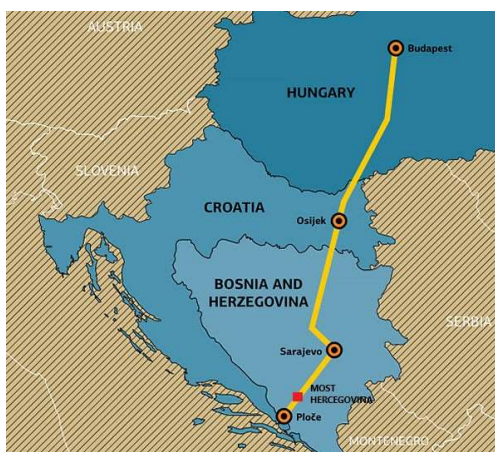
Figure 1. - Bridge location on Corridor Vc

The subject of this paper is a presentation of the results obtained from the load testing of the Hercegovina bridge. The bridge is located on Corridor Vc in the Počitelj-Bijača section (Figure 1). It crosses the Neretva river valley, the M17 highway and the railway line (Figure 2). The bridge was constructed by a consortium consisting of Azvirt Limited Liability Company (Azerbaijan), Sinohydro Corporation Limited (China) and Powerchina Roadbridge Group Co. Ltd. (China), while the subcontractor that carried out most of the works was Hering d.d. Široki Brijeg, Bosnia and Herzegovina [1].

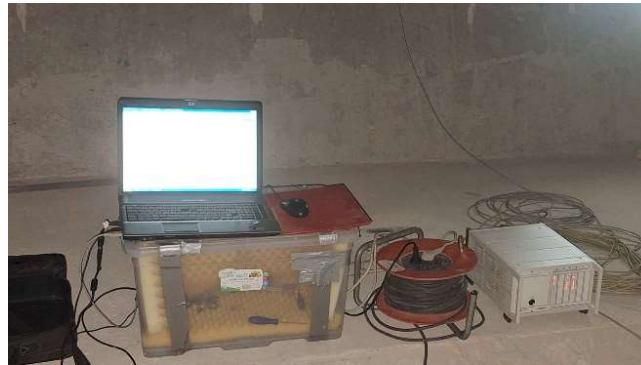
Figure 9. - Measurement equipment at the test site

A total of 20 measurement locations were observed on the Hercegovina bridge, where strain gauges were installed on the concrete structure inside the bridge (Figure 9).

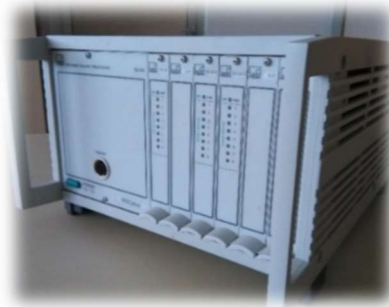
b) "MGC plus" device

Acceleration was measured using an acceleration transducer, specifically an HBM uniaxial accelerometer, type B12/500 (Figure 11a). The measured values were collected by the *MGC plus* system (Figure 11b) and were processed in the Catman AP software package.

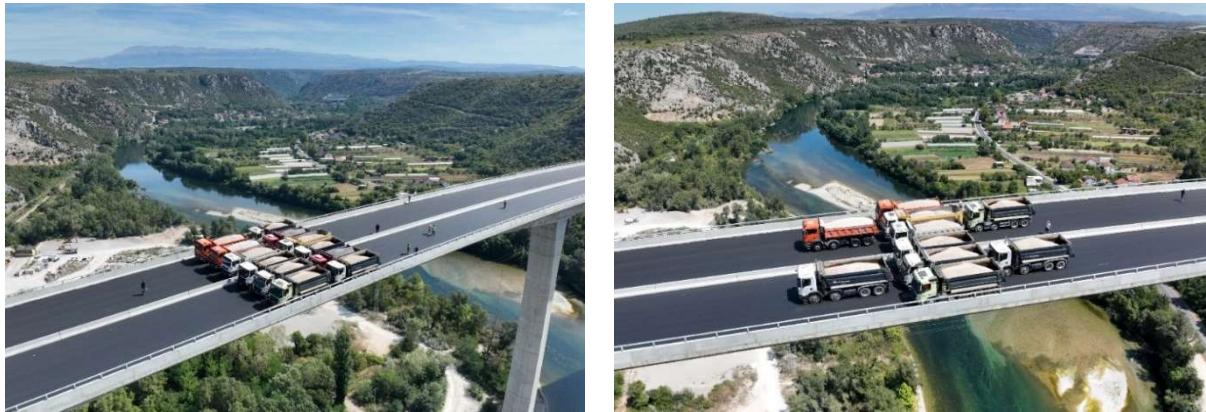
Figure 12. - Placing the load in position for static testing

Static tests (Figure 12) were carried out according to the loading schemes presented in Chapter 3. The test results for vertical displacements and strains will be presented in the following text.

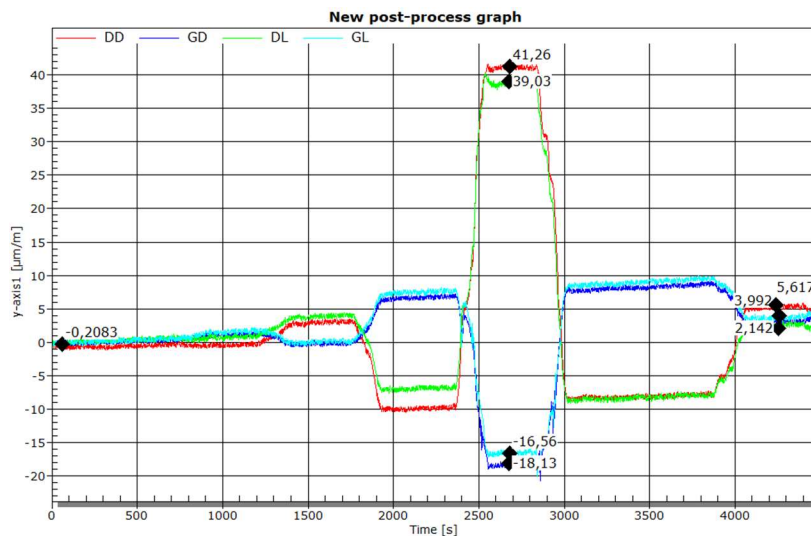
Figure 19. - Time history of strains for span 4

GL	GD	DL	DD
Calculated stress (MPa)	-1.21	-1.18	+2.85	+2.87
Measured stress (MPa)	-0.60	-0.66	+1.36	+1.53

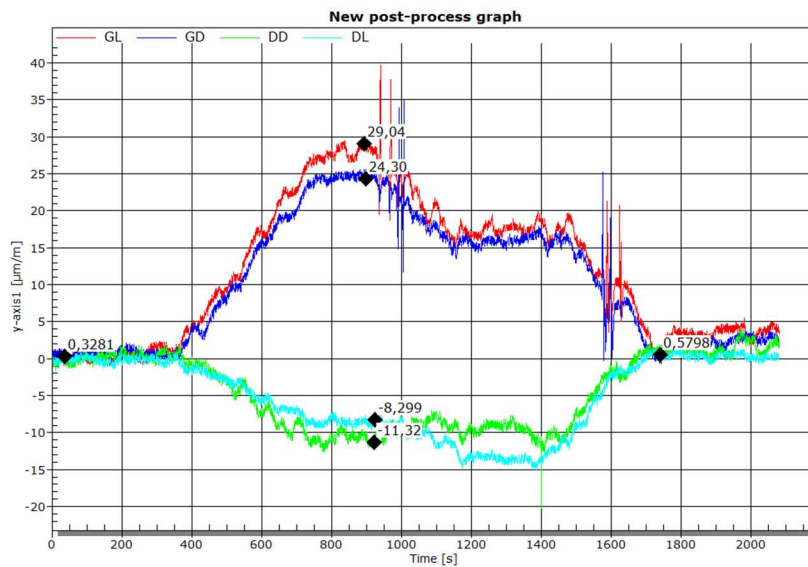
Figure 21. - Time history of strains at pier S2

GL	GD	DL	DD
Calculated stress (MPa)	+1.12	+1.11	-1.05	-1.05
Measured stress (MPa)	+1.06	+0.88	-0.31	-0.43
