Obtaining of Thermal, Vibration, Air Flow Speed and Performance Analysis of Stator Fin Failure of Three Phase Squirrel Cage Induction Motor

Abstract: Under normal operating conditions, induction motors reach a higher temperature value than the initial operating temperature. The higher this temperature value is, the more the losses in the motor increase, negatively affecting the performance of the motor. The increased heat needs to be removed from the motor. There are several ways to do this, the most commonly used of which are the use of fans, fins in the stator frame and fins in the rotor end ring. In this study, the cooling fins in the stator frame of an induction motor were spiraled to create a faulty motor frame. The focus of the study is to experimentally obtain the effects of thermal analysis on the faulty motor body. In addition, performance analyses, vibration analyses and air flow analyses of the motor were performed. These four analyses obtained from the faulty motor were compared with the healthy motor. In order to obtain the data, the motor was tested in no-load, short circuit and loaded operation. The data obtained showed that the temperature values in the faulty moto

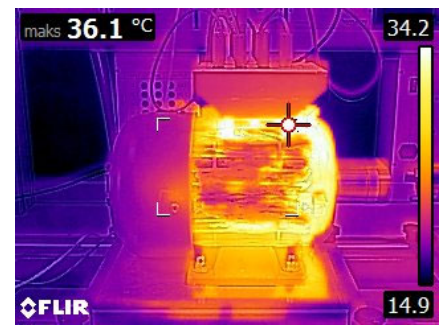
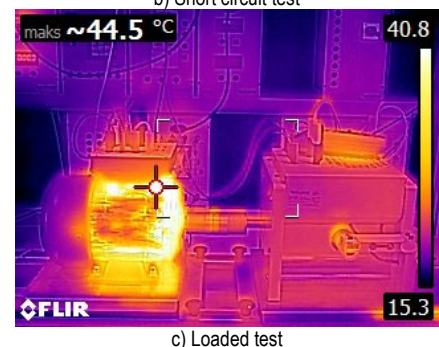
Fig. 5a shows the thermal camera images of the faulty motor during the no-load operation test, Fig. 5b the short circuit operation test, and Fig. 5c the loaded operation test.

Figure 5 Thermal images of the faulty motor

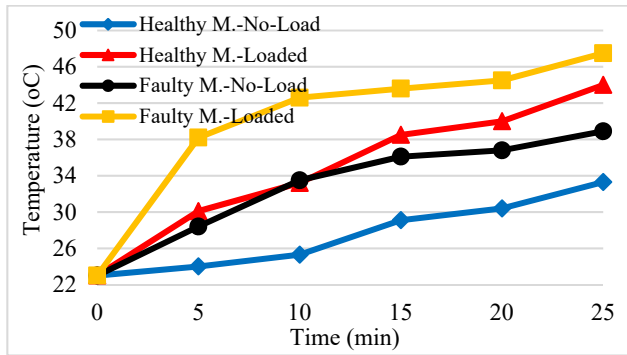
In Fig. 6, the temperature changes of the healthy and faulty motors during no-load and loaded operation are given. An image was taken every 5 minutes, and the experiment duration was set as 25 minutes. The initial temperature was 23 °C, which is the room temperature of the laboratory. When the figure is examined, it is seen that the temperature values increase with the increase in time. In the no-load operation test, since the current value is not very high, the temperature values are seen to be around 33 °C for the healthy motor and 39 °C for the faulty motor. During the loaded operation, it is seen that the temperature values increase rapidly. Especially in the faulty motor, it is seen that the temperature values are higher due to the uneven temperature distribution. In the loaded operation, it was determined that the temperature value of the faulty motor was 7.95% higher than the temperature value of the healthy motor at the 25th minute. This result clearly shows the importance of the fins in the stator frame in cooling the motor.

Figure 6 Time-temperature changes of the healthy and faulty motor during no-load and loaded operation

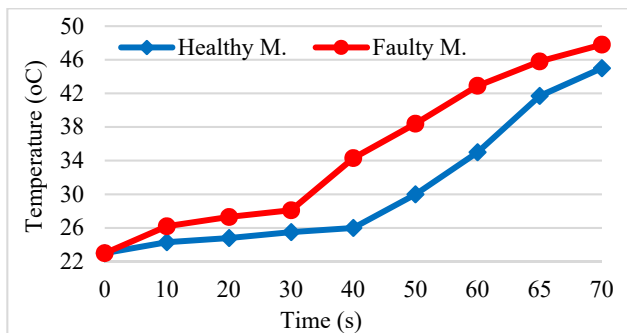
Fig. 7 shows the time temperature changes during short circuit operation for healthy and faulty motors. The test period was set to 70 seconds due to the high current value drawn during short circuit operation. Again, the initial temperature value was 23 °C. When the figure is examined, it is seen that the temperature increases rapidly especially after the 30th second and the temperature values exceed the temperature values in no-load and loaded operation in a very short time. The temperature difference between the faulty motor and the healthy motor at the 70th second is 6.22%.

Figure 7 Time-temperature changes in short circuit operation of healthy and faulty motors

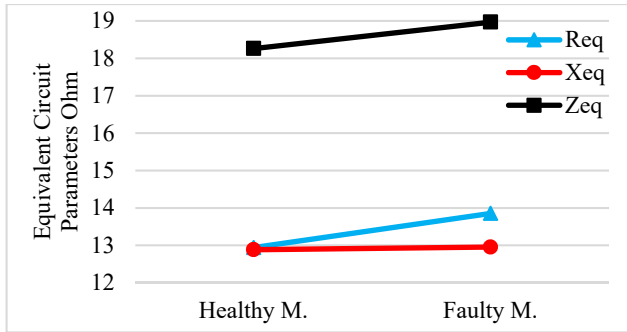
Equivalent resistance, reactance and impedance changes of healthy and faulty motors are given in Fig. 8. Units are given in ohms.

Figure 8 Changes in equivalent circuit parameters of healthy and faulty motors

It is understood that the absence of cooling fins on the stator frame caused the winding resistance of the faulty motor to increase. Because, although the values obtained from the no-load test and the calculations were close to each other in the experiments under the same conditions, the fact that the temperature on the motor could not be properly transferred to the frame and the heat could not be removed from the frame by means of fins caused the values obtained from the short circuit test and the equivalent circuit resistance to be higher.
