# MULTI-FRAGMENTARY FRACTURE OF THE TIBIAL COMPONENT: A CASE REPORT OF A RARE COMPLICATION AFTER TOTAL KNEE ARTHROPLASTY

**SUMMARY** – Total knee arthroplasty is a surgical procedure which is usually indicated in cases of severe osteoarthritis associated with knee pain, which is unmanageable using nonsurgical methods. Although total knee arthroplasty is a well-established treatment modality, it still has several complications which can lead to catastrophic result; implant fracture is one of them. In this case report, we described the case of a 74-year old female who presented with a rare complication of total knee arthroplasty — tibial component fracture. We also presented potential causes and treatment options for such complicated cases.

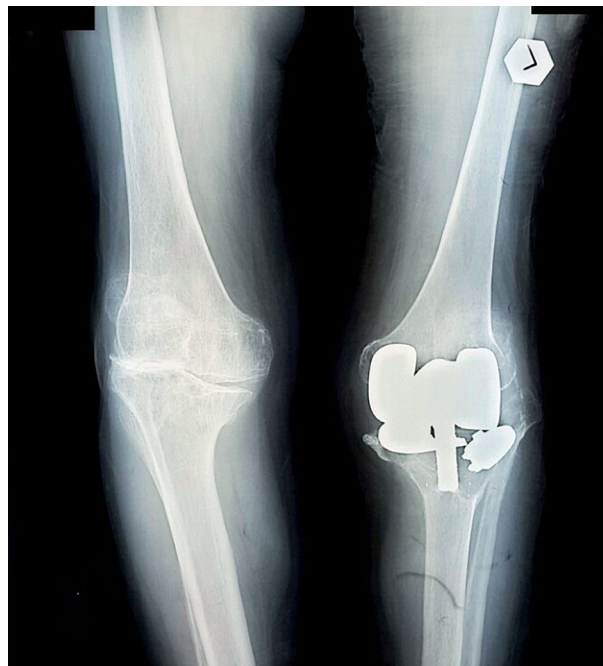
Figure 1. Knee standing radiographs in AP projection

was very painful and the range of motion was 10-30 degrees in flexion. Radiographs of both knees were performed in the standard anteroposterior (AP) and lateral views. The radiographs revealed tibial component breakage (Figure 1).

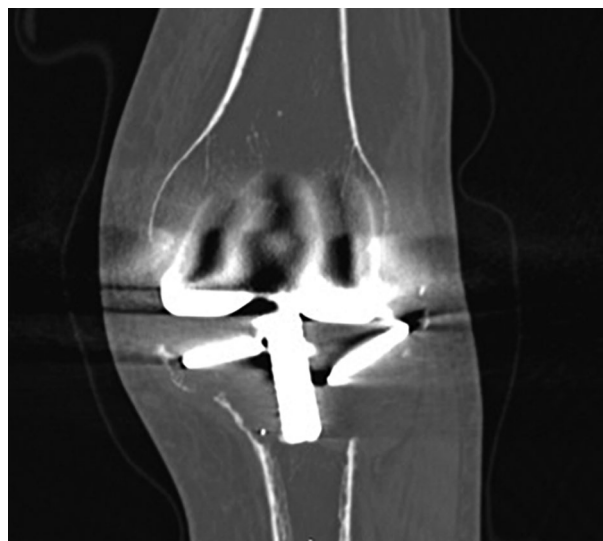
Figure 2. CT scan of the left knee

Computerized tomography (CT) of her left knee was also performed. The CT confirmed implant fracture together with tibial plateau depression and revealed a large zone of osteolytic reaction under the fractured part of the prosthesis, which impacted in the collapsed bone (Figure 2).
